**FINAL REPORT ON SERIOUS INCIDENT TO M/s EMIRATES
BOEING 777-300ER AIRCRAFT A6-EBO
WHILE OPERATING FLIGHT EK 373 (BANGKOK-DUBAI)
ON 07.11.2012**

**AIRCRAFT ACCIDENT INVESTIGATION BUREAU
MINISTRY OF CIVIL AVIATION
NEW DELHI INDIA**

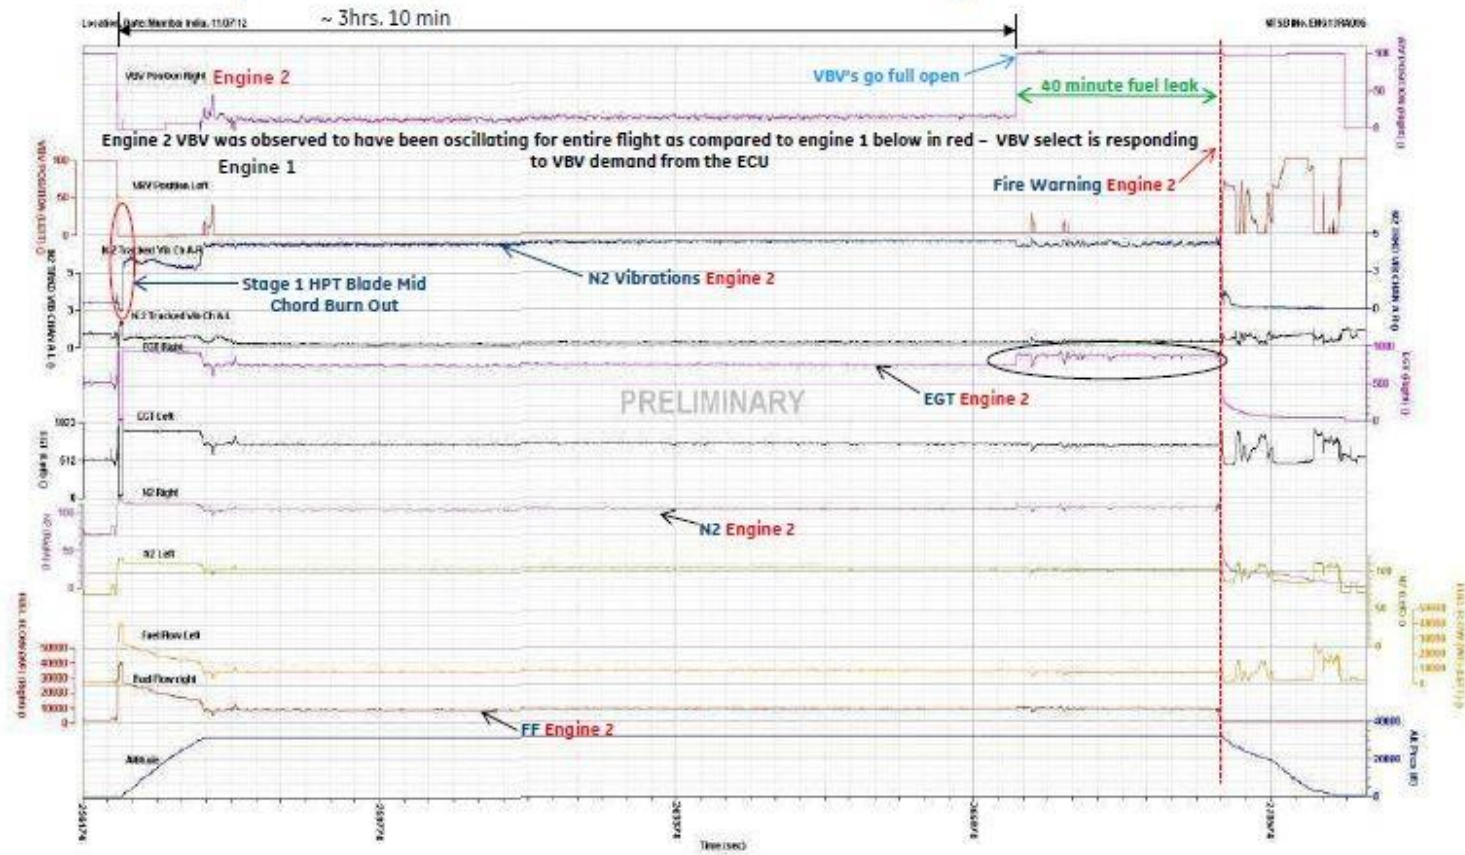
QAR Data (NTSB Plots) - Entire Event Flight

- General time line of key event points. (flight)
- Plot of the QAR data for the entire event flight. (N₂ vibrations, fuel flow for both engines)
- Event summary » take off, climb & cruise (TLA, CAS, Air/ground mode, N₂, Pressure Altitude.
- Fuel flow and EGT for the last two flights.
- Tables showing the GE experience of the 8 occurrences of the leaking VBV fuel supply tubes. The 3 locations of leak are inside drain shroud; crack in tube bend outside drain shroud; and crack at weld outside drain shroud. Vibrations levels and aircraft effect for these instances is also documented.

- Fuel Loss Estimate: ~ 600 gallons (2 tonnes) in 38 minutes

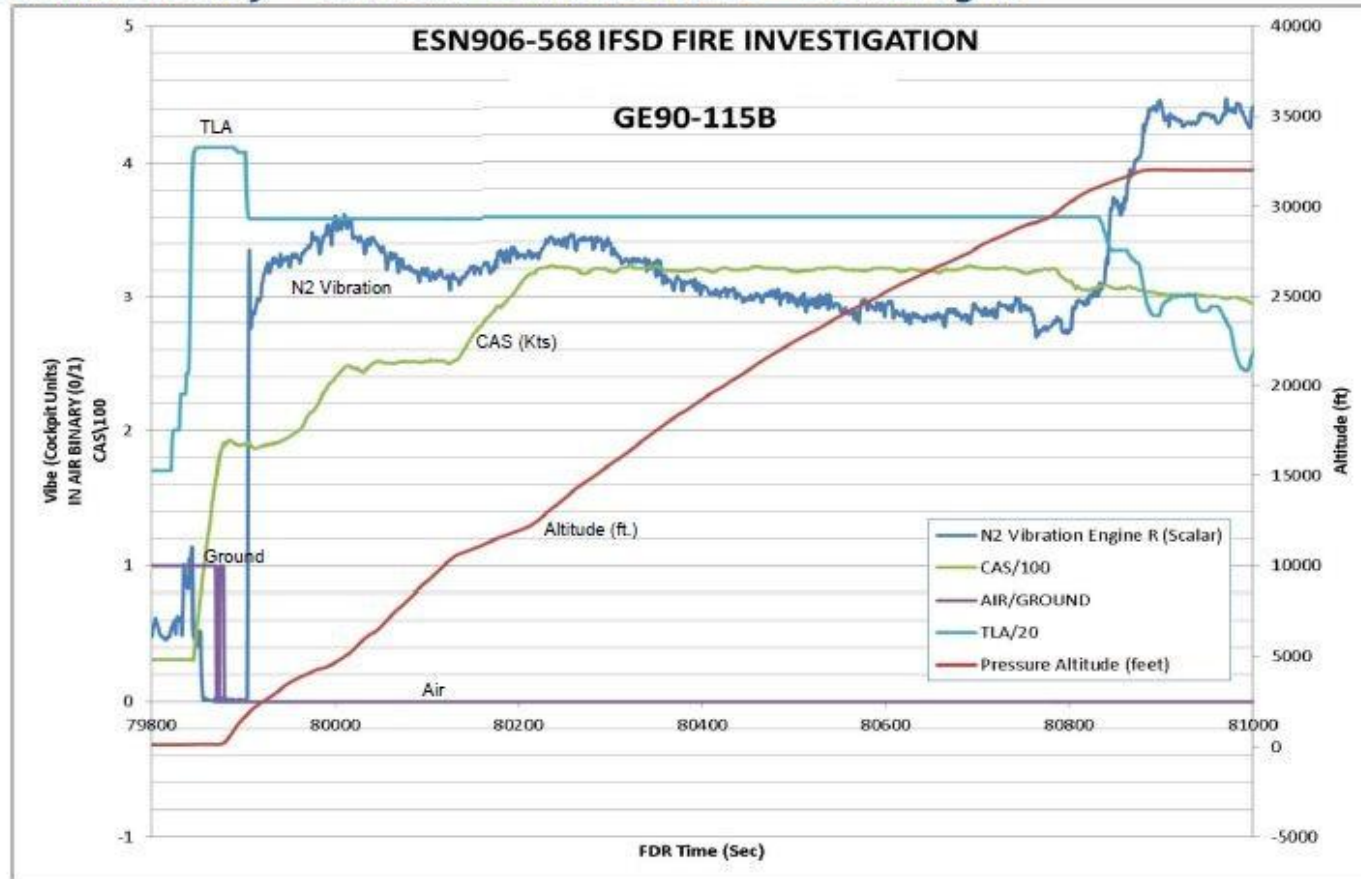
**Factual
Event Summary - Takeoff / Climb to Cruise - Event Flight**

- 1) During take-off on incident flight N2 vibration increased due to HPT Distress/ Damage. (Stage 1 HPT Blade mid chord burnout). HPT deterioration was noticed.

- 2) As the airplane approached top of climb and commenced cruise, right engine N2 vibrations were steady at 4.4 units with higher EGT.
- 3) The right engine EGT was observed to be 30°C higher than the left engine EGT.
