**FINAL INVESTIGATION REPORT ON
RUNWAY EXCURSION TO
M/s AIR INDIA EXPRESS LTD BOEING 737-800 NG AIRCRAFT
VT-AXT ON 10/07/2018 AT MUMBAI**

**GOVERNMENT OF INDIA
O/o, DIRECTOR AIR SAFETY, WESTERN REGION,
NEW INTEGRATED OPERATIONAL OFFICE COMPLEX,
SAHAR ROAD, VILE PARLE (EAST), MUMBAI-400099**

On 10st July 2018, M/s Air India Express Ltd Boeing 737-800 aircraft VT-AXT was involved in runway excursion incident during landing while operating flight IX - 213 (VOBZ-VABB).

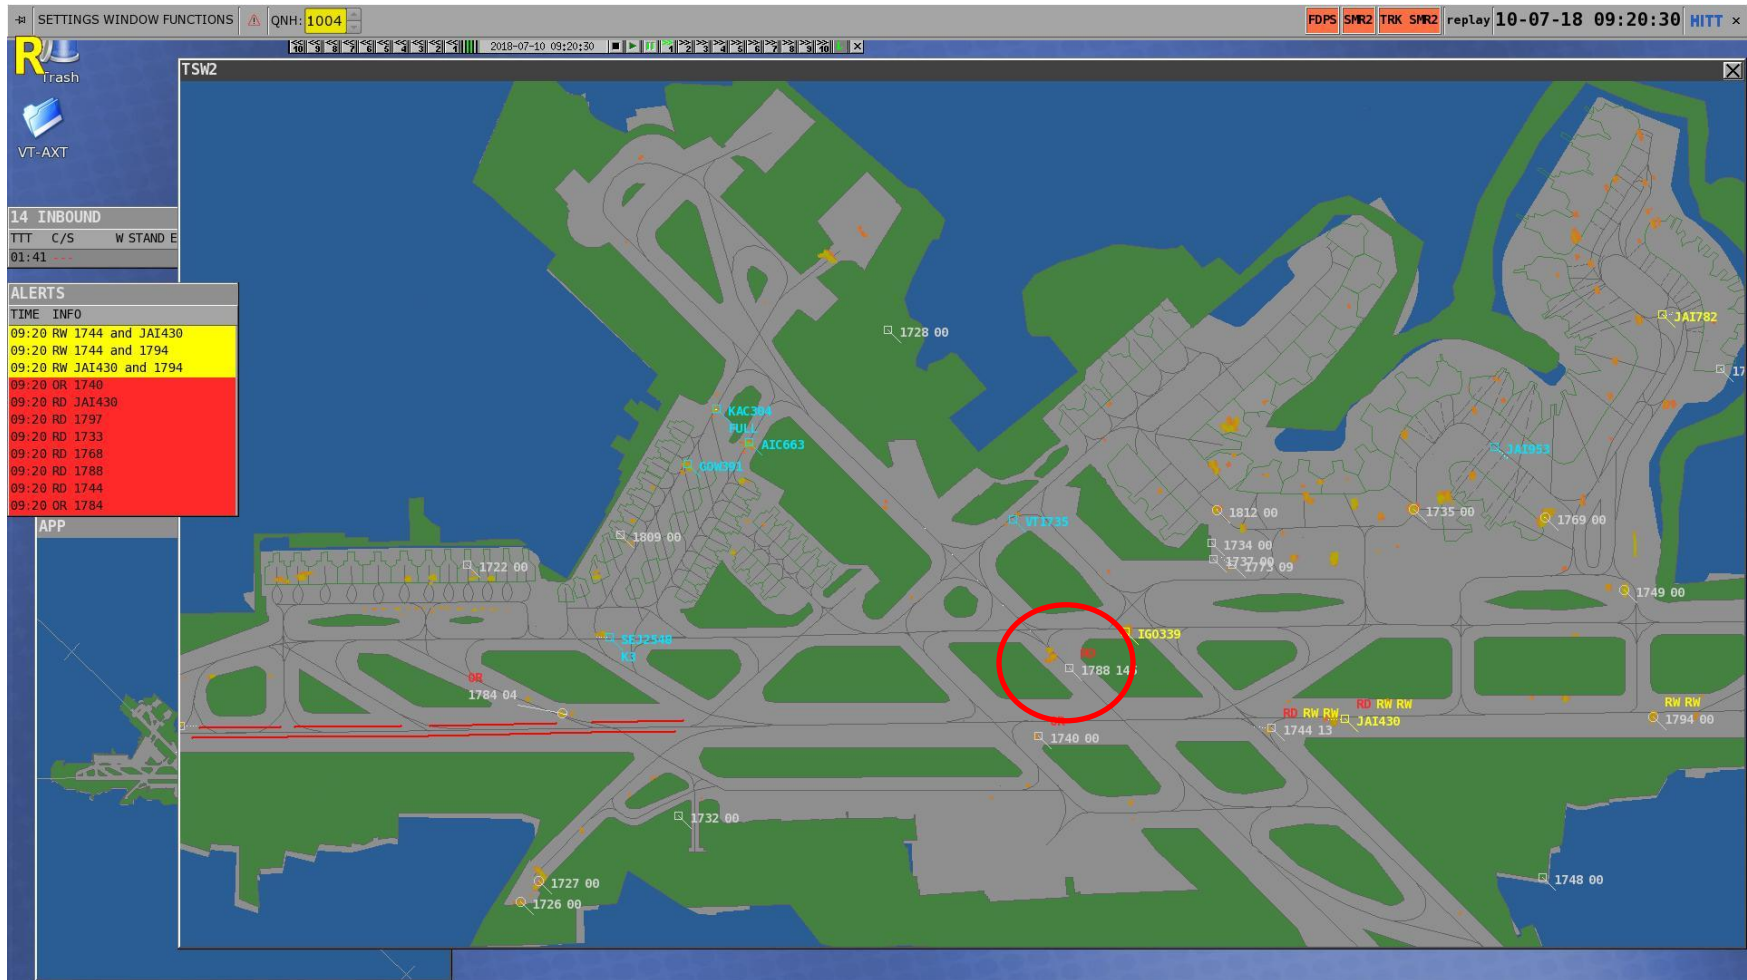
Figure # 1 SMGCS snapshot depicting the touchdown point of IX- 213

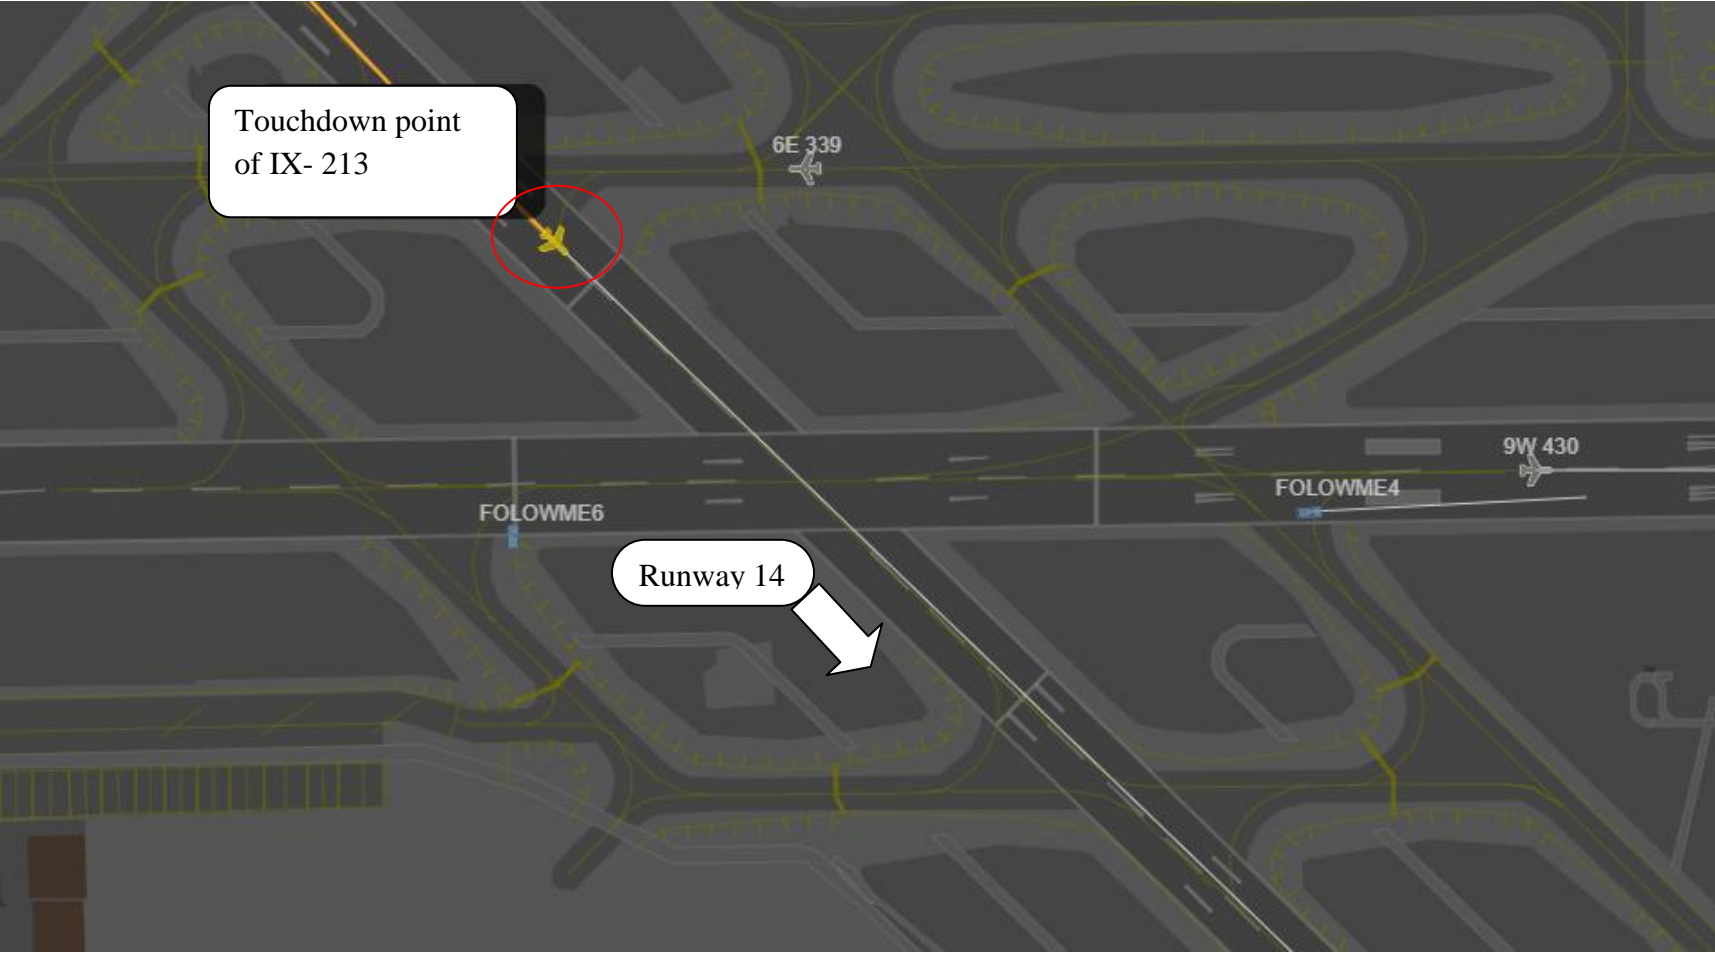
Figure # 2 Touchdown point of IX- 213 on Runway 14

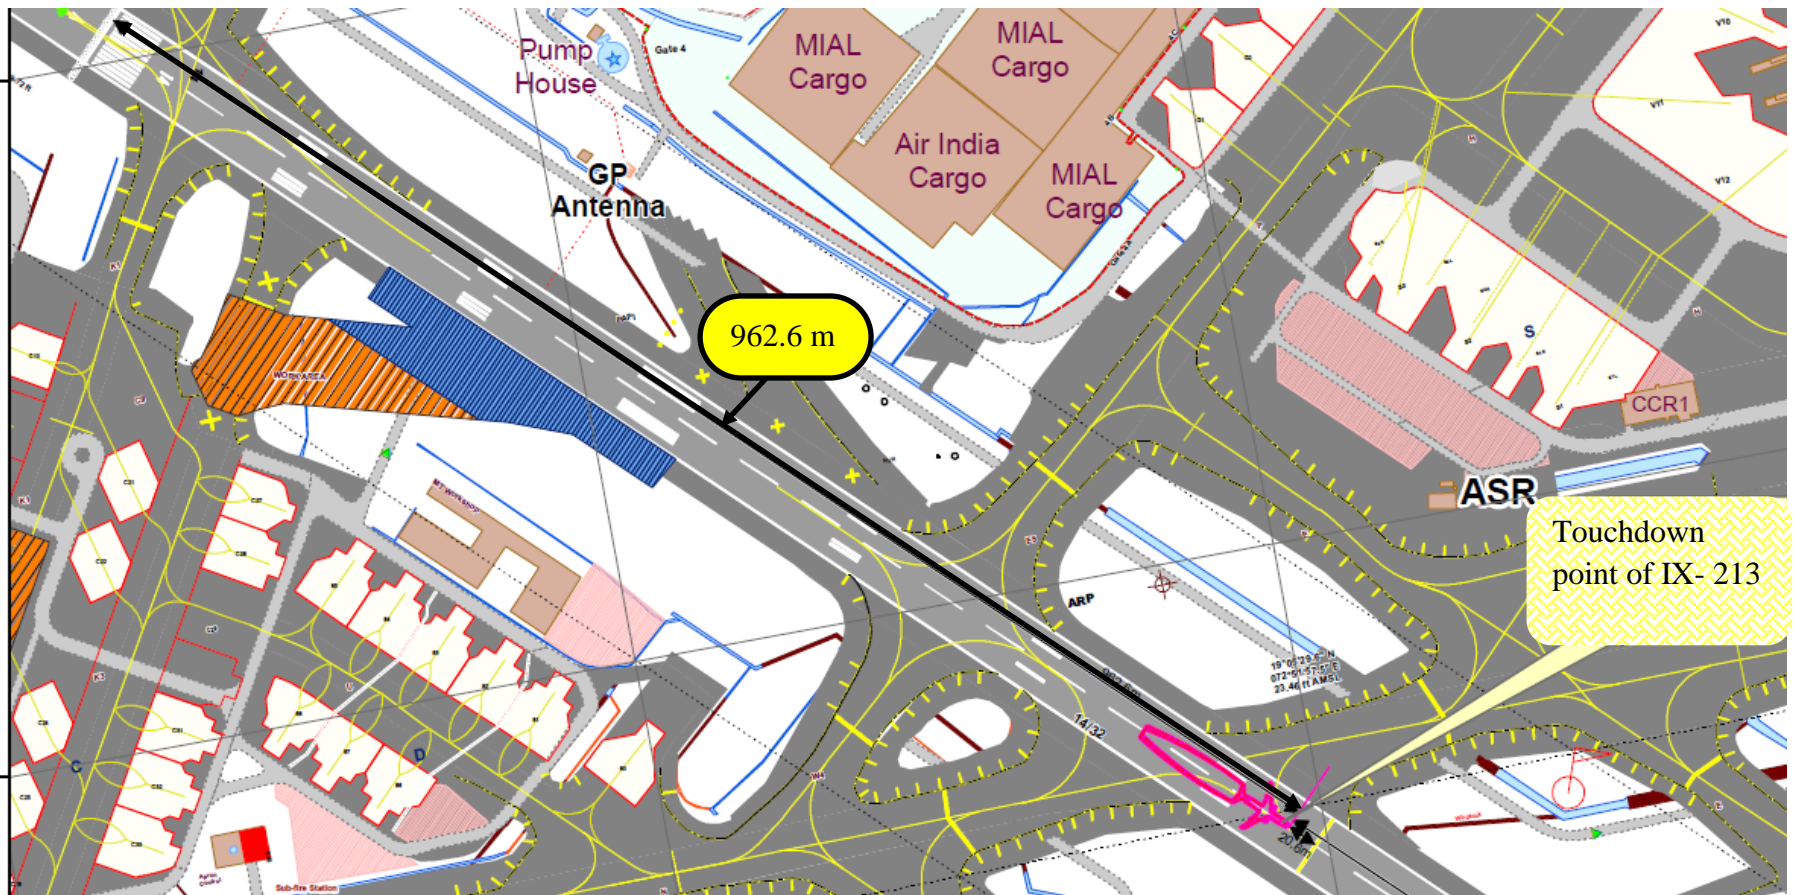
The aircraft was at around 50ft RA at threshold. The flare started at threshold by increasing the pitch of the aircraft. The aircraft was slightly high on power with varying winds having tail wind component. After 14 seconds of flare, aircraft made firm touchdown at 09:20:30 hrs with a vertical acceleration of 1.15 g in tail wind of around 8 knots. The aircraft touch down at approximately 962 meters from runway 14 threshold at 09:20 hrs.

Figure # 3 Distance from threshold of Runway 14 to touchdown point= 962.6 m

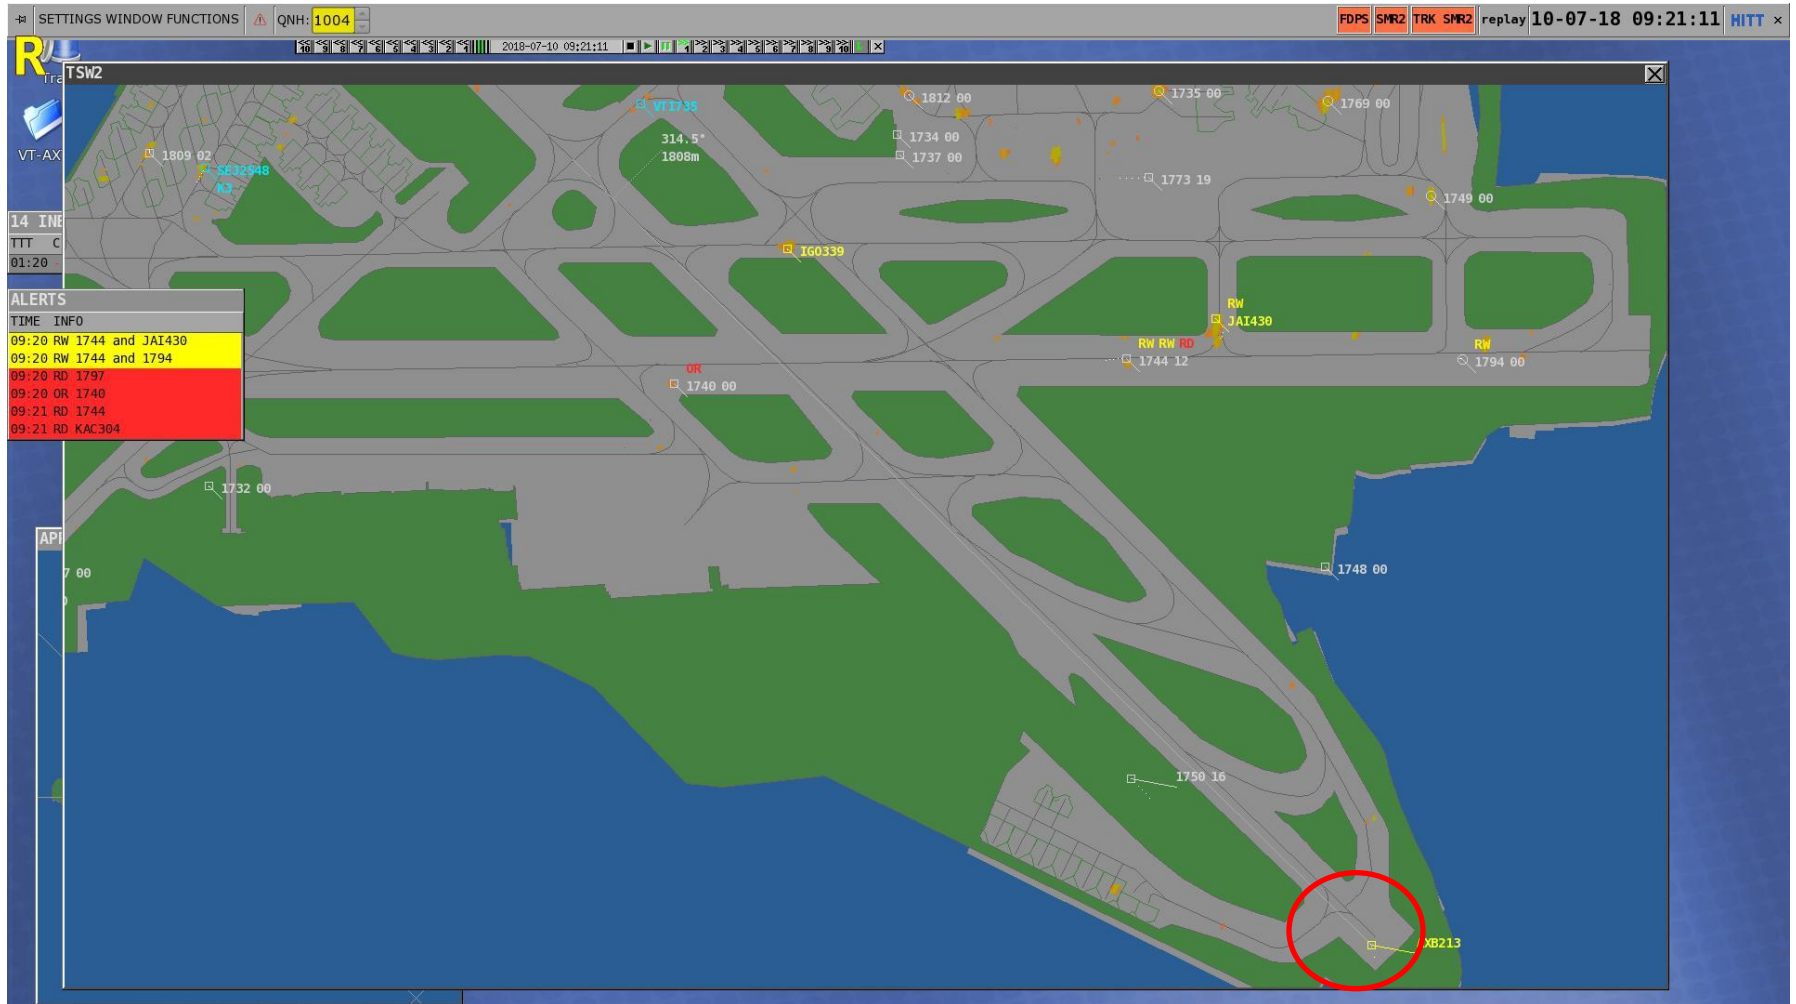
Figure # 4 SMGCS snapshot depicting the final halt point of IX- 213

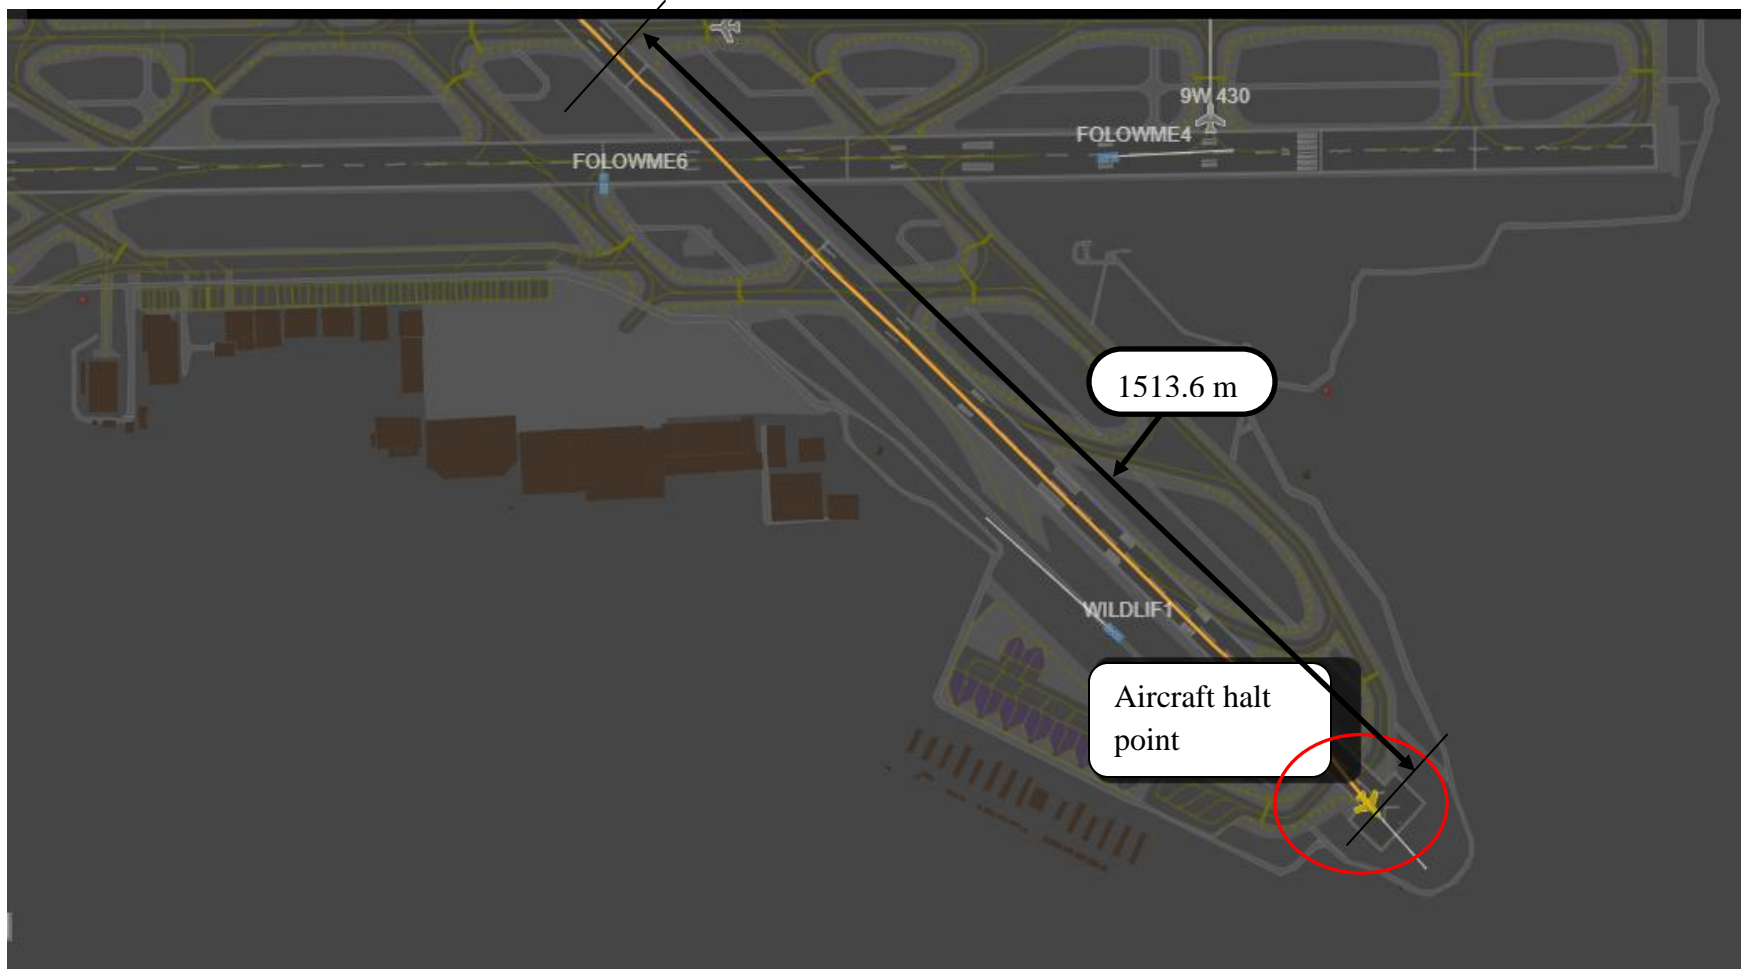
Figure # 5 IX-213 overrun the Runway 14 end and halted on paved surface after travelling 1513.6 m from touchdown

Landing distance required in prevailing weather conditions for the landing aircraft configuration without thrust reverser was calculated to be 7874 ft. However, the aircraft stopped after travelling 4965.8 ft from touchdown which substantiate that the brakes were effective enough.

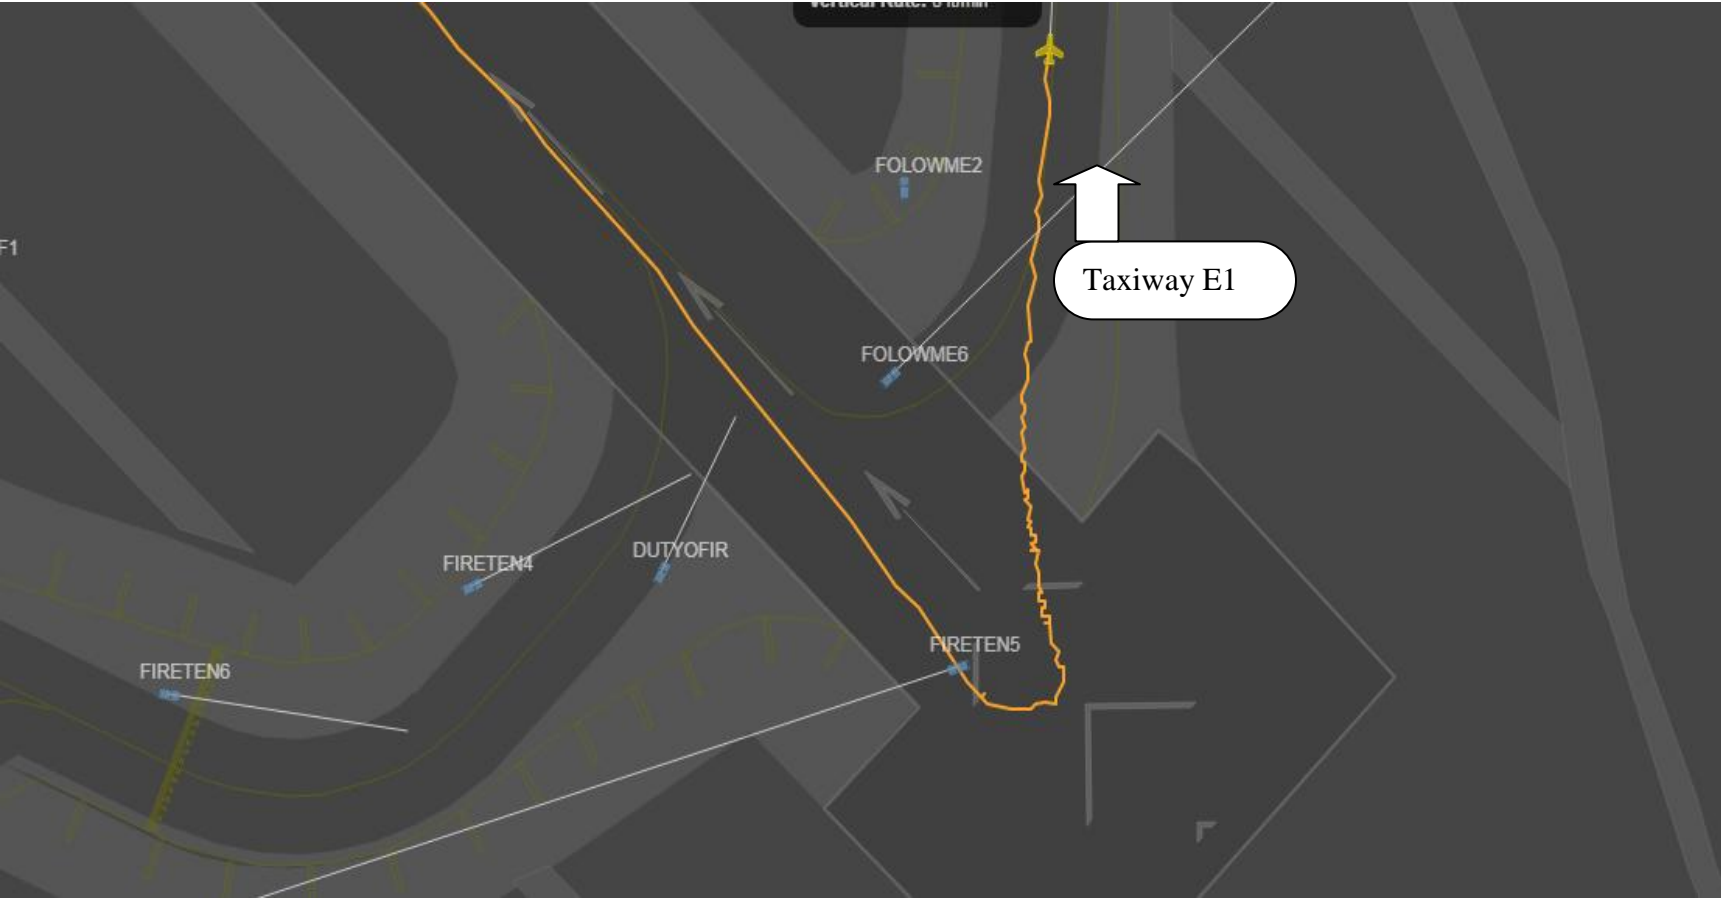
Figure # 6 Trajectory of IX- 213 depicting it vacated via taxiway E1

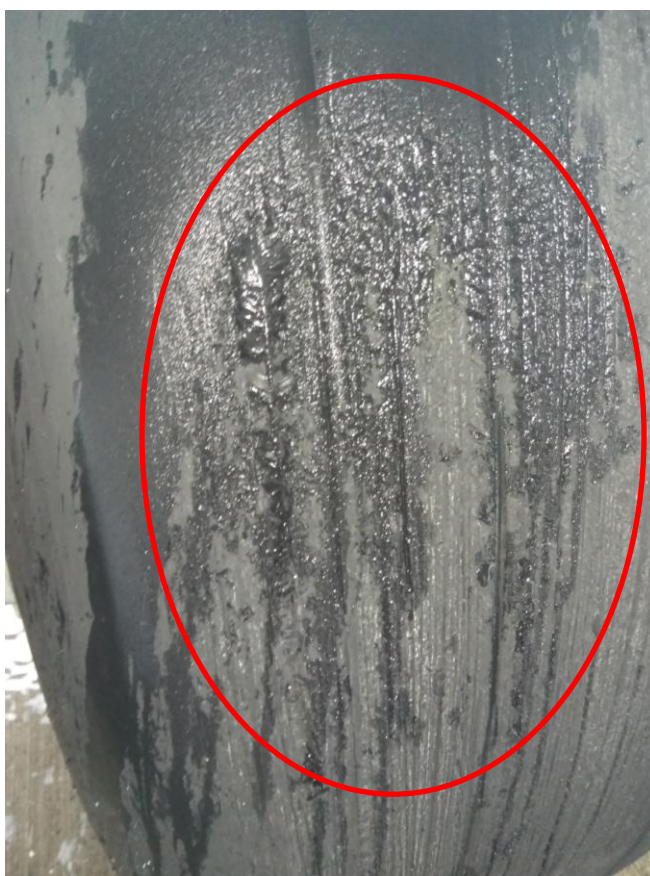
Tyres of Main wheel # 1 & 2 found worn out due to excessive braking action.

Figure # 7
Tyre # 1 worn out

Further, during physical inspection it was observed that Tyre#1 & 2 are found worn out due excessive braking. Brake wear pins (Wheel# 1, 2, 3 & 4) were found to be within the limits. Except the excessive braking worn marks, tyres # 1 & 2 and their treads were in satisfactory condition.

- Main wheel # 1 & 2 were replaced as per AMM task 32-45-11 as found worn out.
- On inspection found inboard sleeve not in sync with outboard sleeve. FIM task 78-34 task 802, reverser message show amber, reverser thrust lever does not move to full reverser thrust. Hydraulic leak check carried out for deploy and stow line from wheel well area to engine strut, drain line, thrust reverser flex shaft and no leak found. On inspection thrust reverser module area found with excessive hydraulic leak traces. Same replaced.

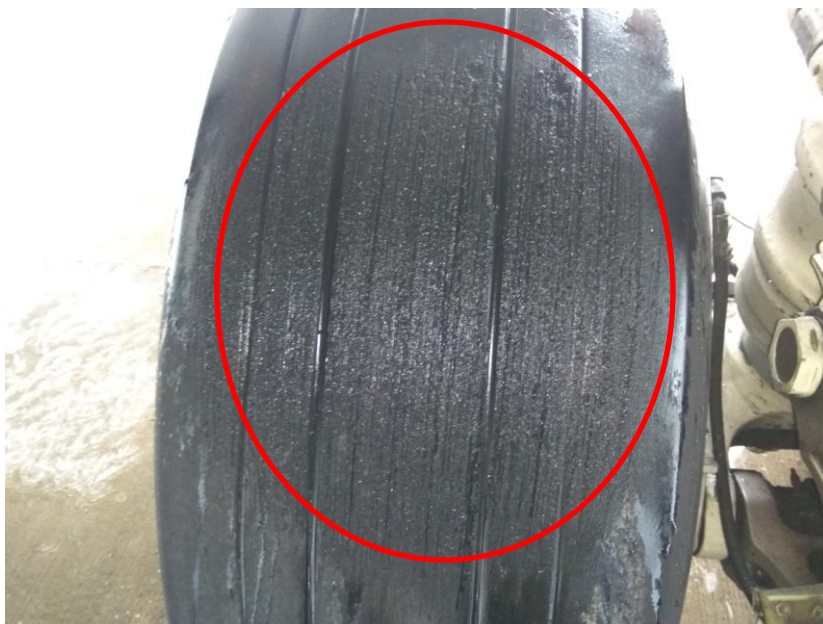
Figure # 8
Tyre # 2 worn out

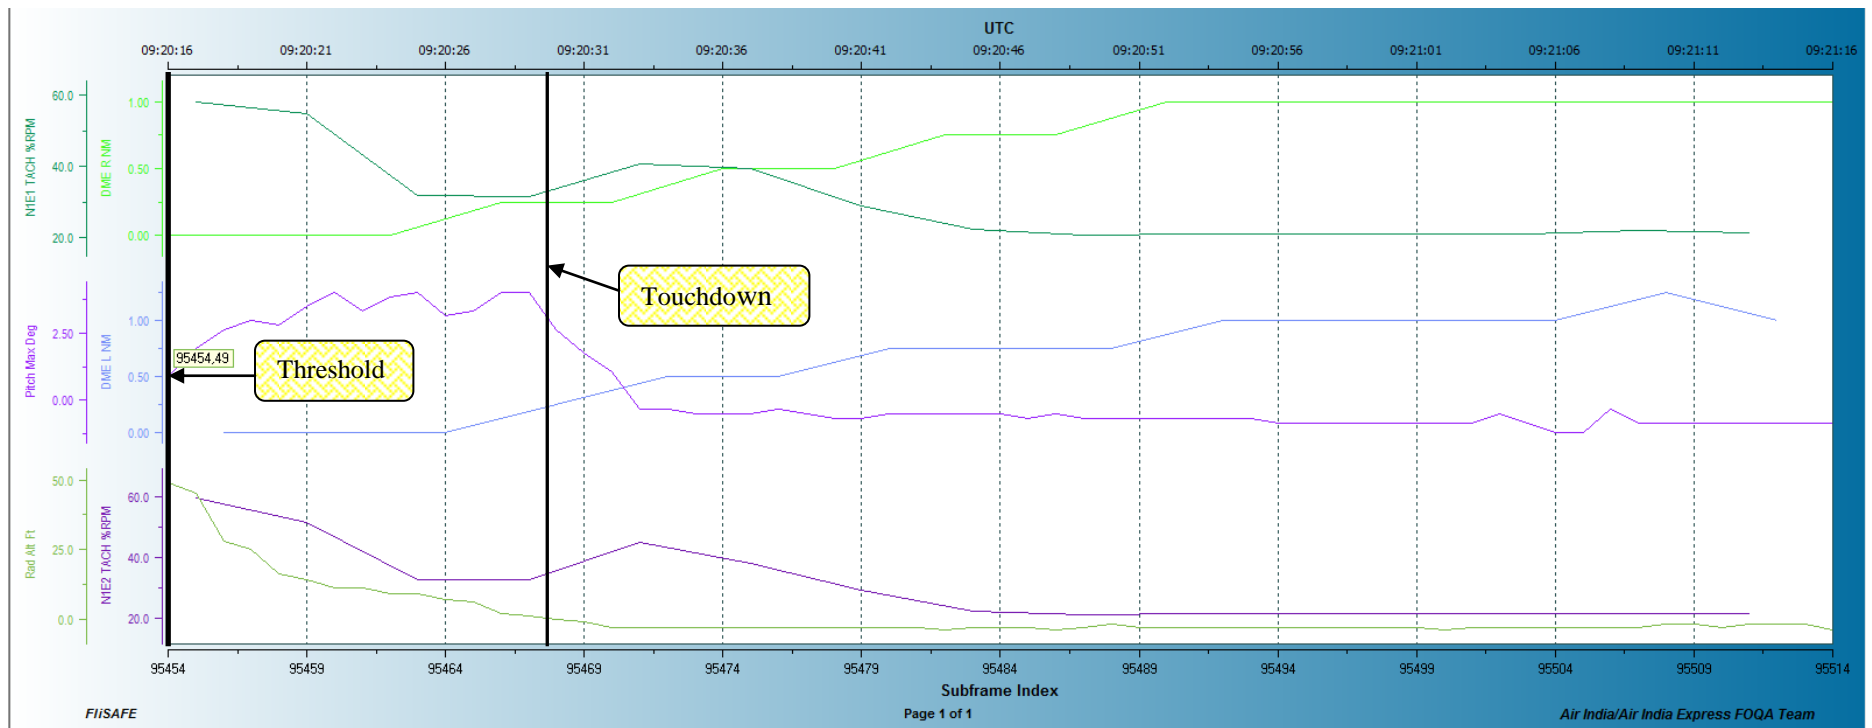
Figure # 10 Graphical representation of FDR data

The above graph depicts that the aircraft was at around 50ft RA at threshold which was considered slightly higher than normal. As per FCTM, in normal approach the aircraft is about 30ft RA on threshold. The flare started at threshold by increasing the pitch of the aircraft. The maximum pitch recorded during flare was 4.04°, which was normal. The power from Engine # 1 & 2 was observed to be 58.2% N1 and 59.5% N1 respectively at threshold which was lowered down to IDLE, 32% N1 and 32.75% N1 respectively, at 09:20:25 hrs. Subsequent to lowering the power, aircraft made firm touchdown at 09:20:30 hrs. The power was considered to be slightly higher during flare. Aircraft touched down after 14 seconds of flare at 962.6 m/ 3158 ft from the threshold. The power of Engine # 1 & 2 was immediately reduced after deployment of right thrust reverser.

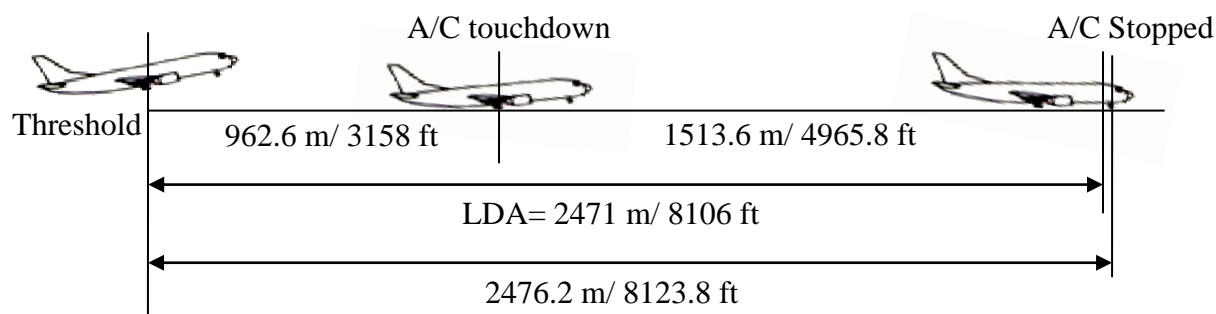
Figure # 12 Total distance covered by aircraft from threshold to final halt point

Total distance travelled from threshold was 2476.2m/ 8123.8 ft and aircraft crossed end of Runway 14 by around 5.2 m/ 17ft.

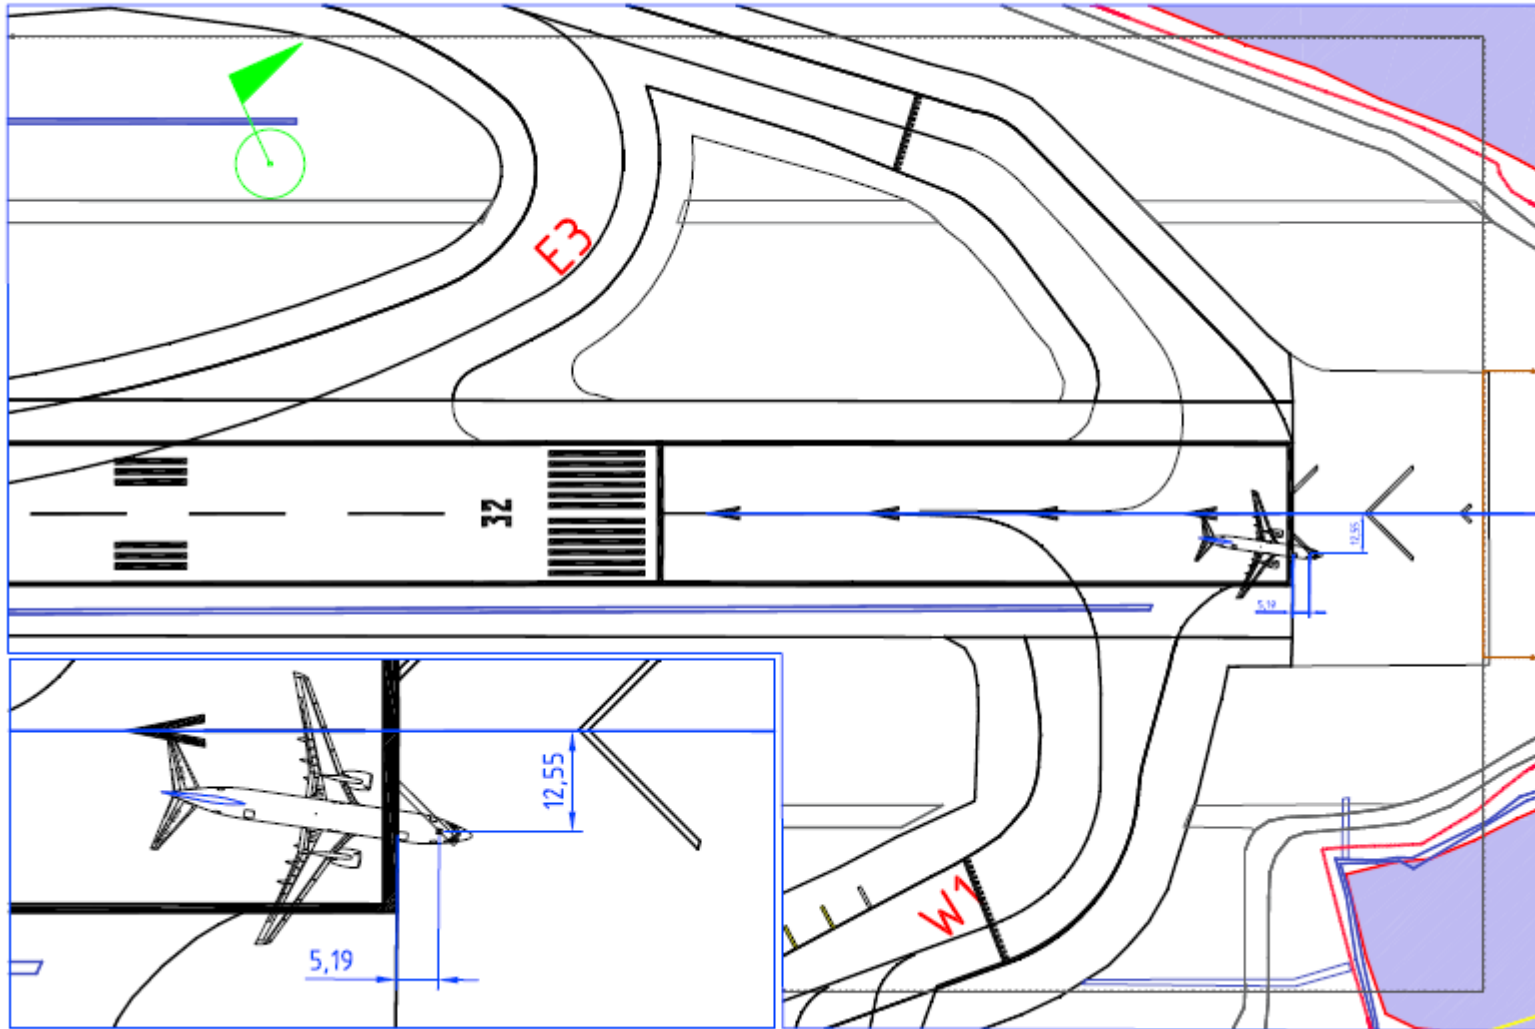
Both PIC and FO applied manual brakes and simultaneously the rudder input was also given to effectively maintain the directional control of the aircraft. With application of maximum manual brakes, the aircraft could be stopped on the paved surface after crossing the Runway 14 end by 5.2 meters and at 12.55 meters right of the center line.

Figure # 13 Depicting the aircraft overrun the Runway 14 end by 5.19 m and halted 12.55 m right of the center line
