Final Investigation Report on Accident to
M/s Air India Express Ltd. B-737-800 Aircraft
VT-AYB on 04-09-2017 at Cochin Airport

**FINAL INVESTIGATION REPORT ON ACCIDENT TO M/s AIR INDIA EXPRESS LTD.,
BOEING B 737-800 AIRCRAFT VT-AYB AT COCHIN AIRPORT ON 04-09-2017**

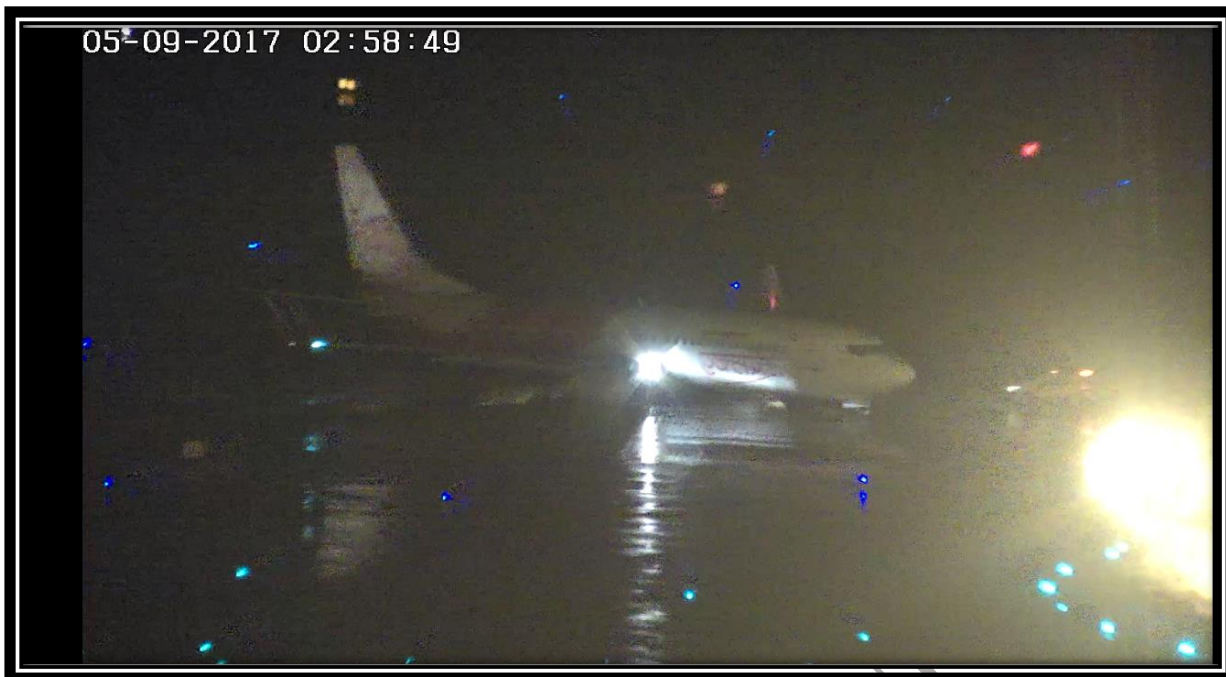
CCTV Indicates that blue Edge lights & Taxiway location signs were glowing

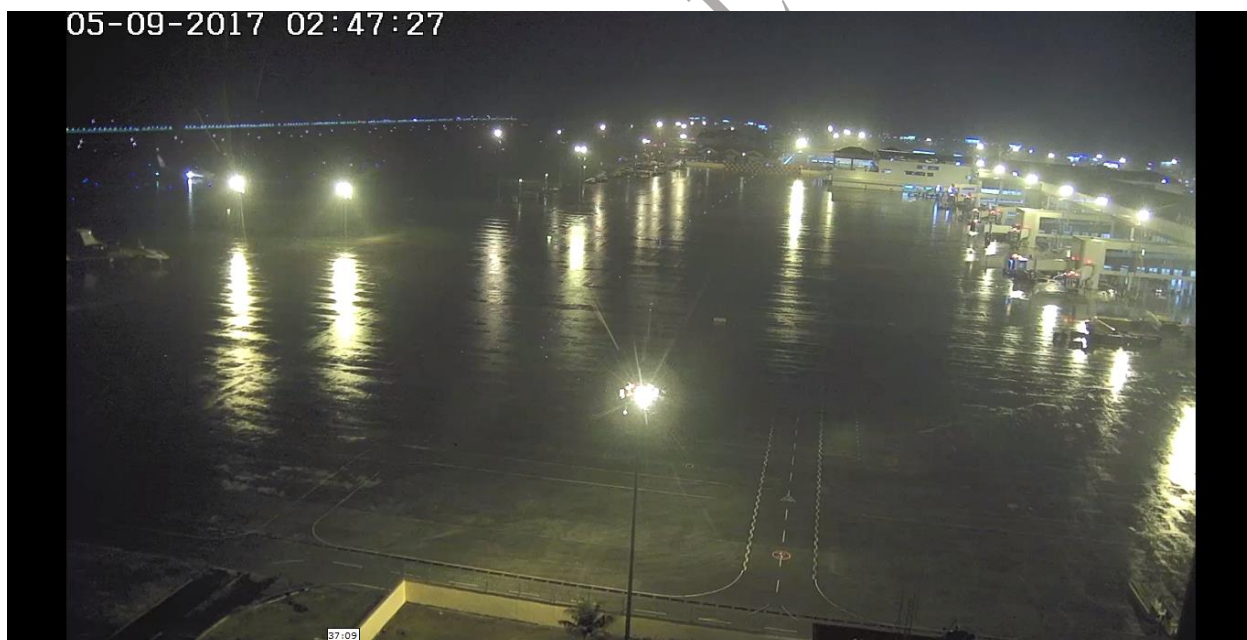
Apron Green taxi way center light glowing low before the accident.

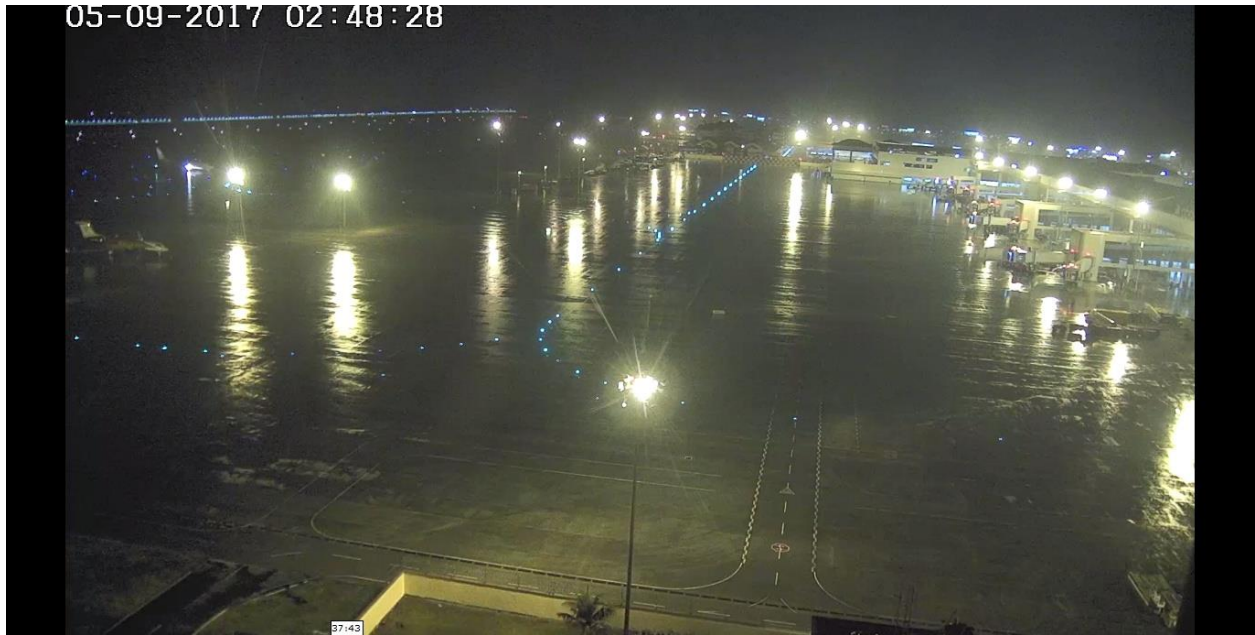
Apron Green taxi way center light intensity increased to high after accident (211327 UTC)

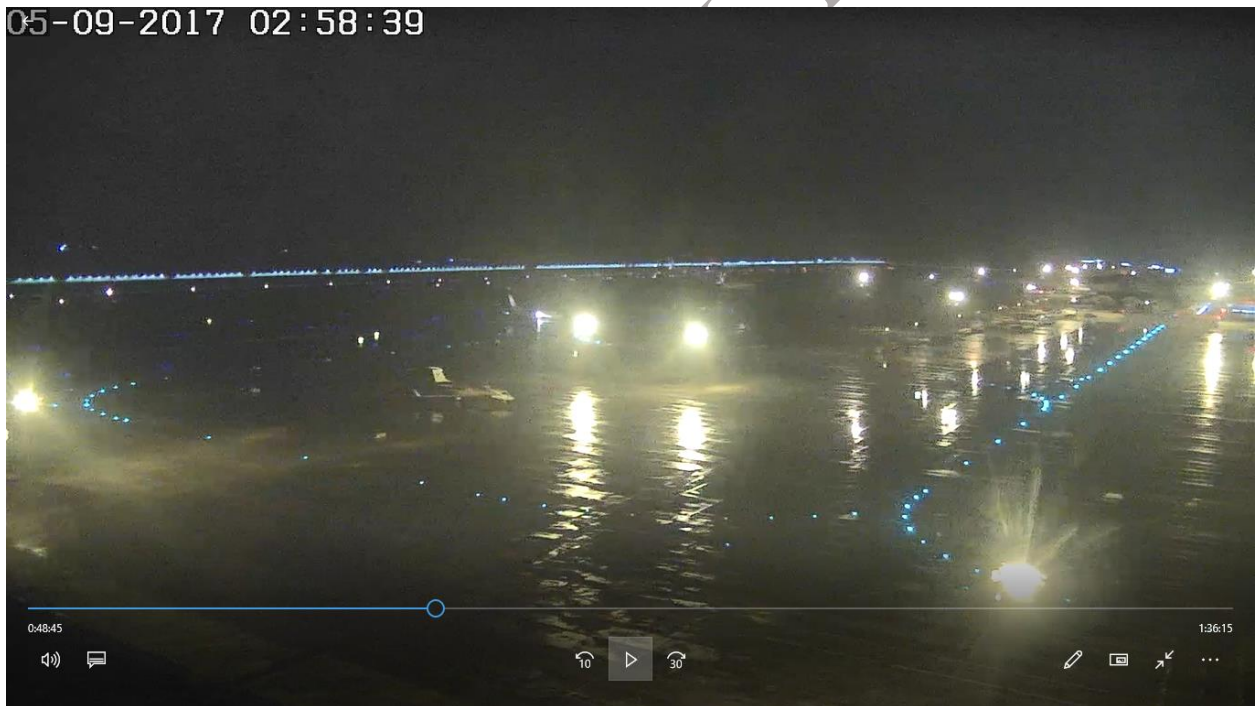
Green Centreline light extending upto the taxi track link Taxiway F.
Review of ATC tape reveals, no request was made by VT-AYB for increasing the intensity of lights

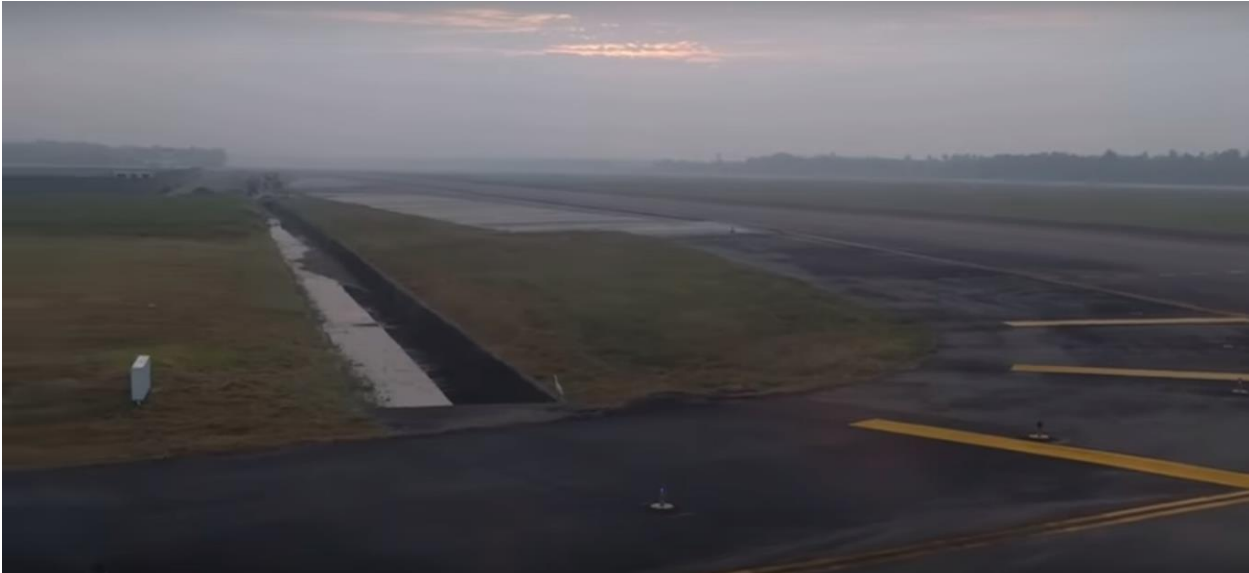
Markers installed near airport drains act as hazard identification and risk mitigation. Markers installations near drains are not mandatory. The markers were not installed at drains at Cochin. However, Markers installed near few airport drains are as under.

Darin Parallel to Taxiway C at Cochin Airport
