**REPORT
OF
COMMITTEE OF INQUIRY**

**ACCIDENT TO BSF (AIR WING) DHURUV HELICOPTER VT-BSH
AT KUNTI VILLAGE, NEAR RANCHI ON 19th Oct 2011**

**FINAL INVESTIGATION REPORT OF ACCIDENT TO
BSF (AIR WING) DHRUV HELICOPTER VT-BSH
AT KUNTI VILLAGE, NEAR RANCHI ON 19TH OCTOBER 2011**

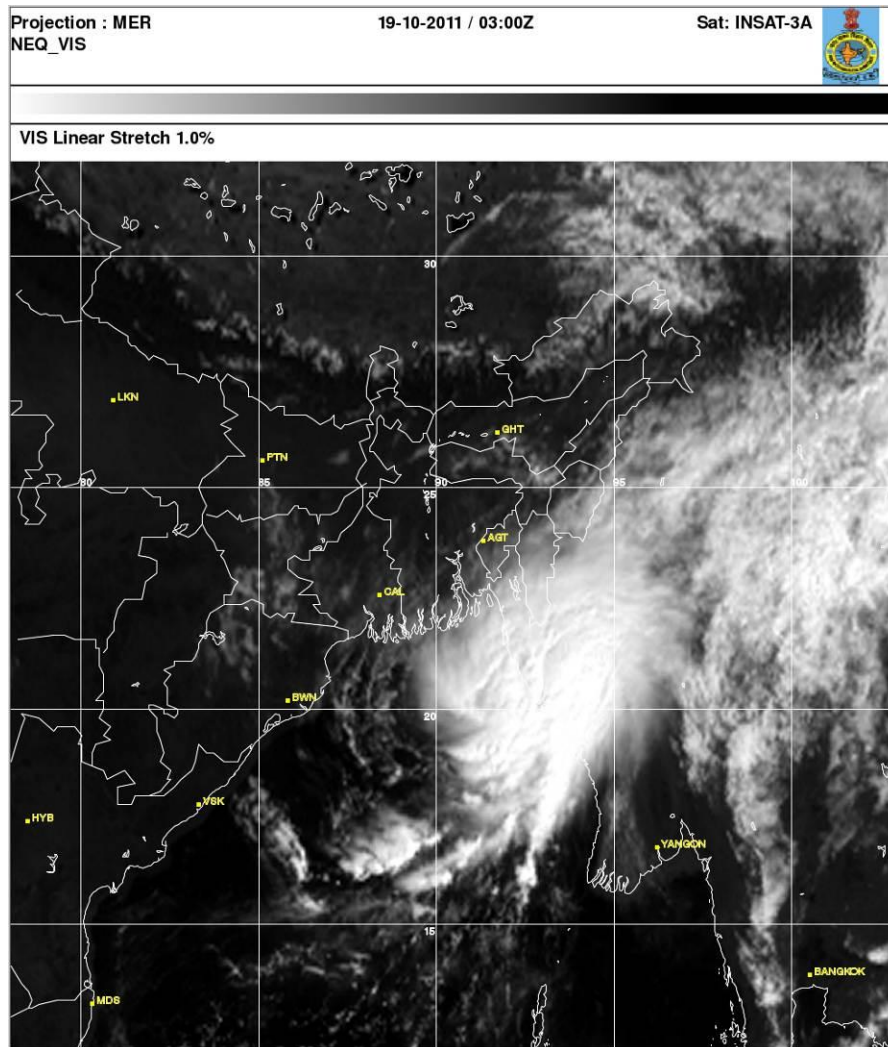
1.7.4. The clouding reported by Ranchi Met was 'Few' at 1500 ft. However, the SAR helicopter which flew in the area approx two hours after the accident had reported significant clouding 5 NM out of Ranchi and at the crash site. The Pilot of the SAR

helicopter had reported heavy clouding above 1000 ft from approximately 5 NM distance out from Ranchi. For the search and rescue, they had to maintain below 1000 ft AGL. This corroborates the CVR details wherein the Pilot had commented on excessive clouding while climbing through 1500 ft AGL.

Figure 1 INSAT 3 A picture for Ranchi area of 0300 UTC 19th October 2011

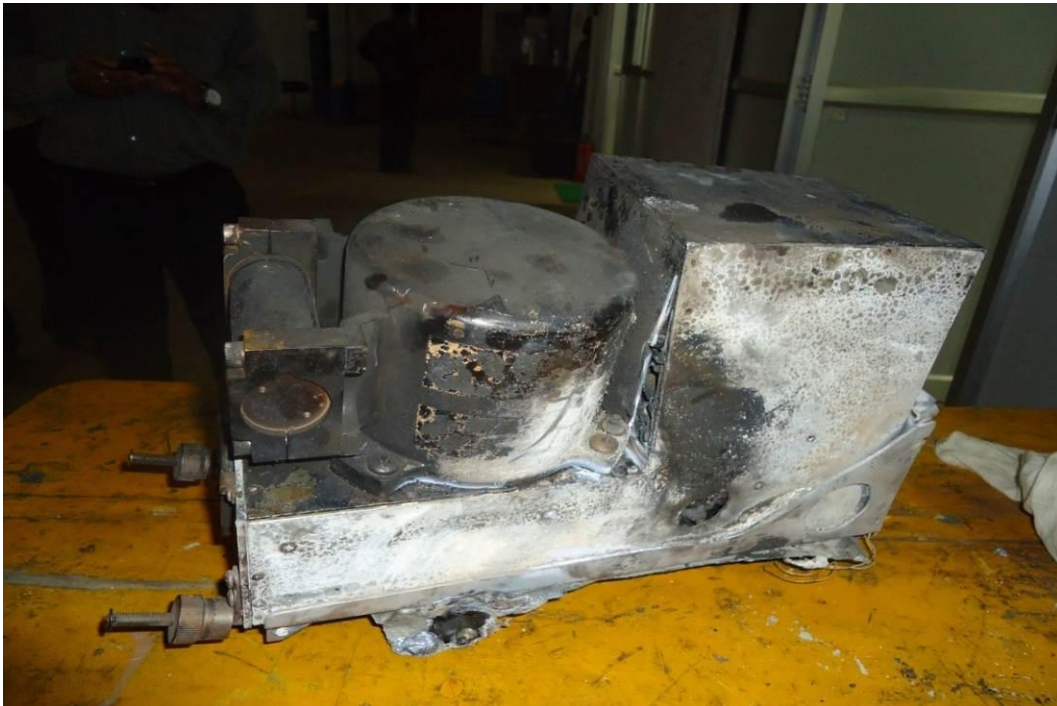
1.11.1. Dhruv helicopter VT-BSH was fitted with Cockpit Voice and Data Recorder Model No. FA2300, Part No. 2316-1501-01. The recording unit was severely damaged externally because of prolonged exposure to fire (refer Fig.2). However, the data captured by the Flight Data Recorder (FDR) and Cockpit Voice Recorder (CVR) was stored and could be recovered.

Figure 2 Recovered FDR/CVR of VT-BSH Helicopter

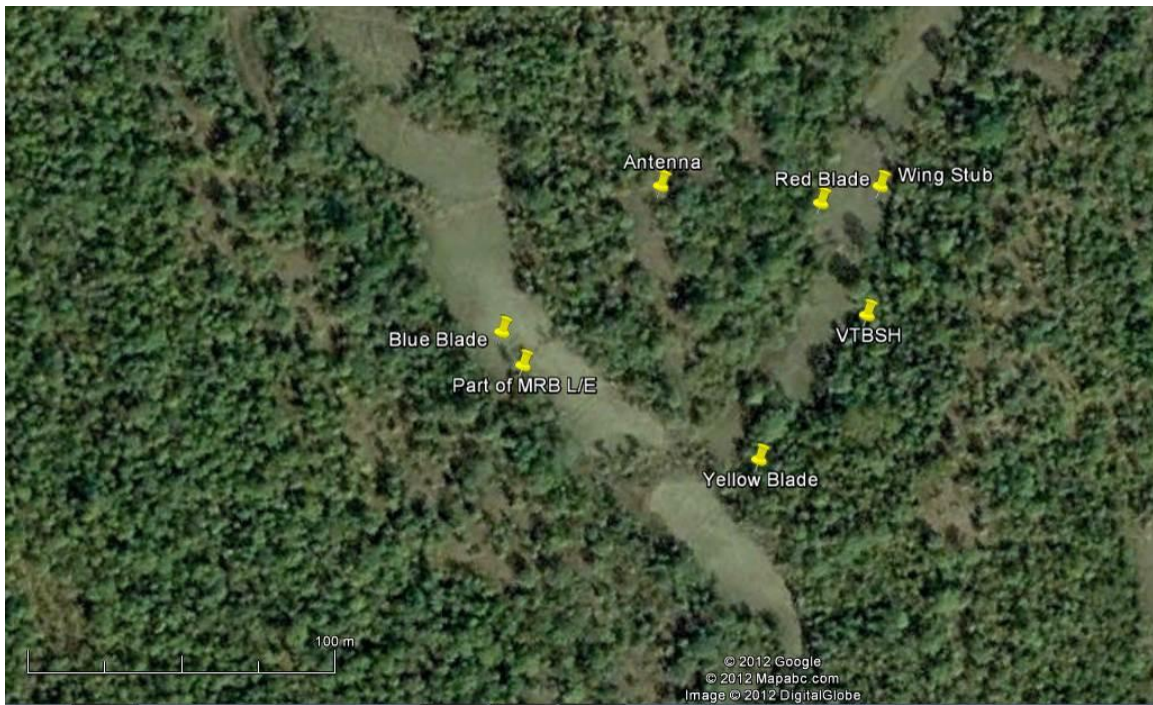
1.12.1. The helicopter VT-BSH crashed in a hilly and forested terrain. As per the eyewitness accounts, one blade of the helicopter had separated in air from the helicopter. The same (Green Blade) was found in Mara Buru village, 1.2 km away from the main wreckage site. The main wreckage of the helicopter was lying in a North – South orientation. The damage to the tree tops also indicated that the helicopter was descending in a southerly direction. The tail boom was found to have got separated from fuselage and lying un-burnt along with the tail rotor assembly, tail gear box, tail rotor control rod and drive shaft; all these were lying upside down with the horizontal stabilizer and other accessories. The Integrated Dynamic System (IDS) was found lying by the side of tail boom in un-burnt condition. The fire consumed the complete cabin along with all the accessories. The available evidences indicated that the fuselage impacted with the ground at a high speed in an inverted condition with steep nose down attitude. The impact was on a surface having slope causing the fuel to spill uni-directionally up to a distance of approx 80 ft in the down hill direction, and approx 20 ft in the uphill direction. The spillage of fuel and the subsequent fire, damaged the paddy plantation and the trees in the uphill area. The main wreckage was confined to within 12-15 m except for the main rotor blades, which were found broken and lying away from the wreckage. The distribution of the separated parts with respect to the main wreckage is given below:

Figure 3 Satellite view of the area of crash with wreckage distribution

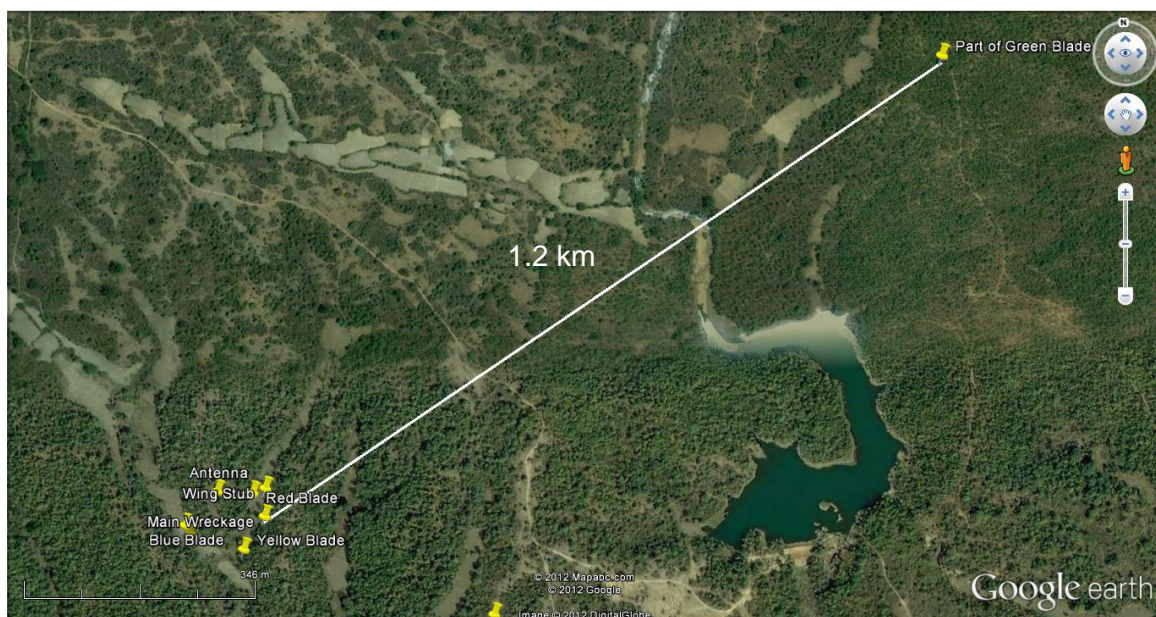
Figure 4 Satellite view of main wreckage and place from where part of green blade was found

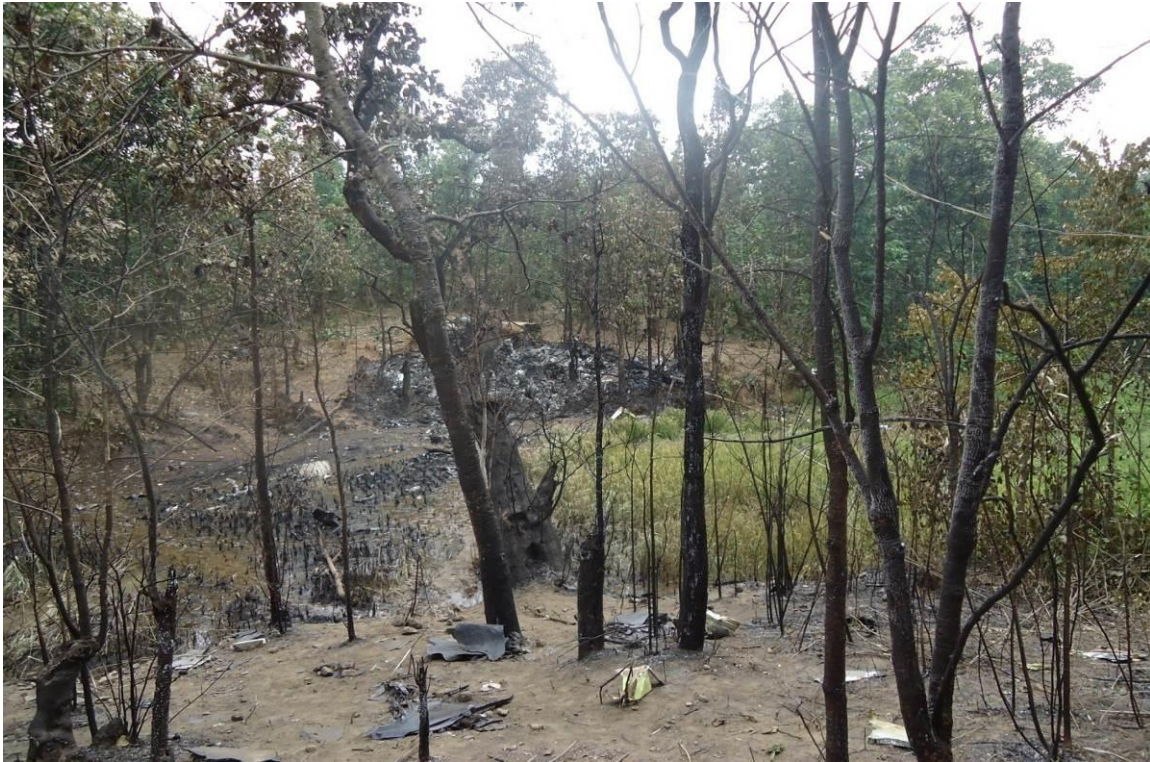
Figure 5 View of the main wreckage

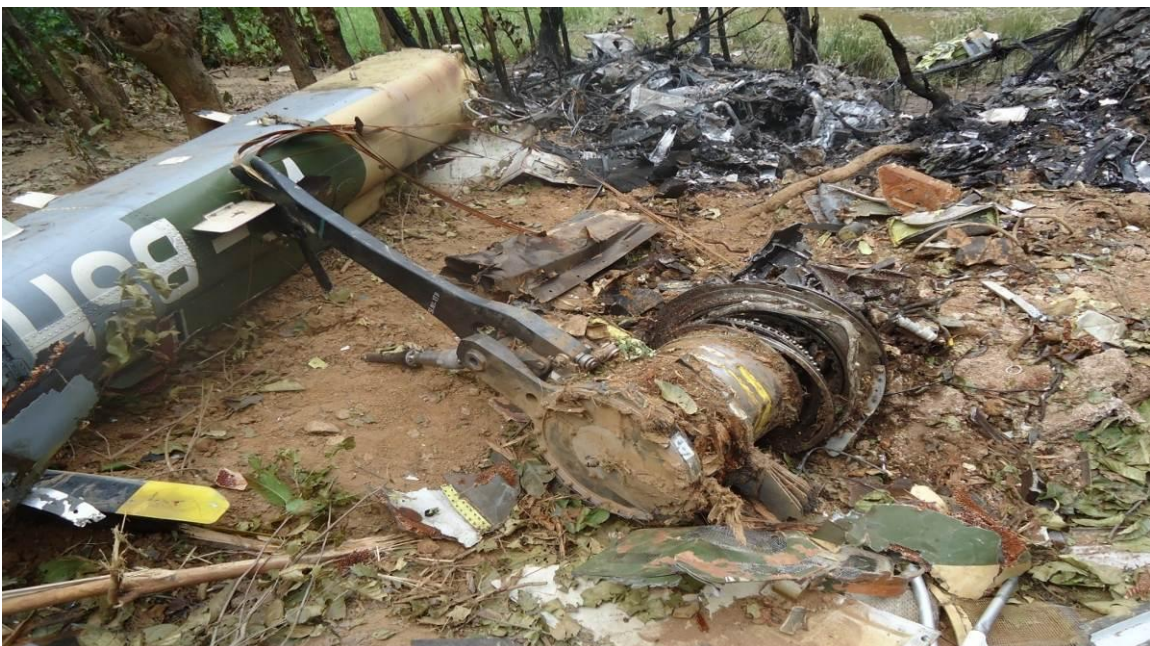
Figure 6 View of main wreckage area

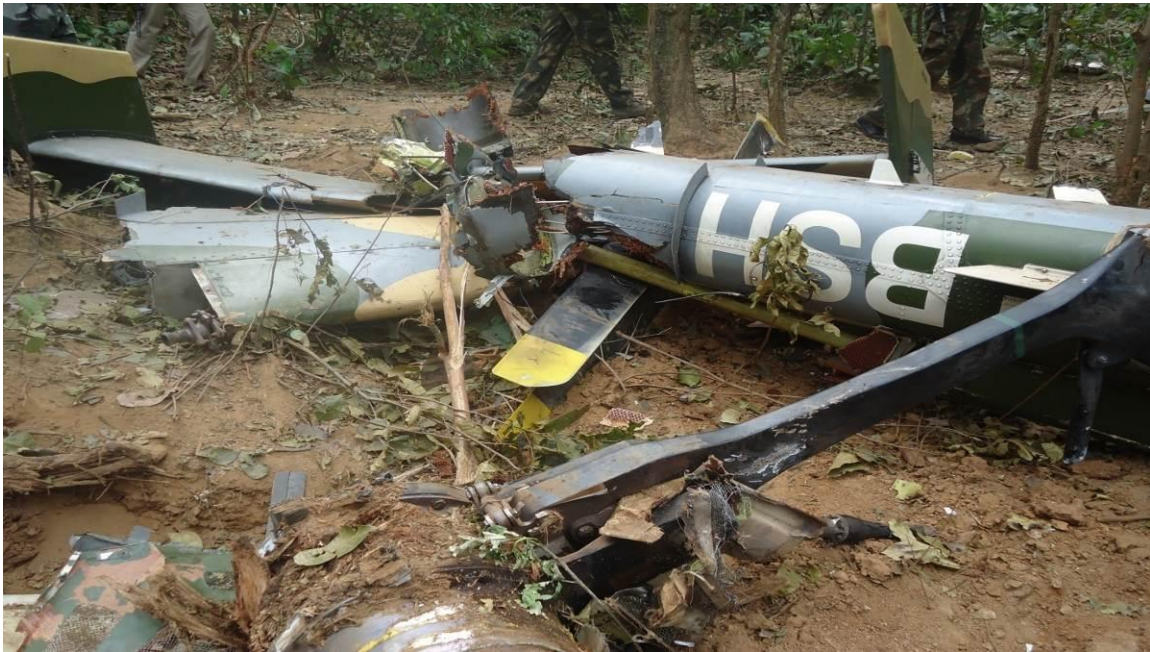
Figure 7 View of MRH with Green blade attached and un-burnt tail boom with horizontal stabiliser and tail rotor assembly

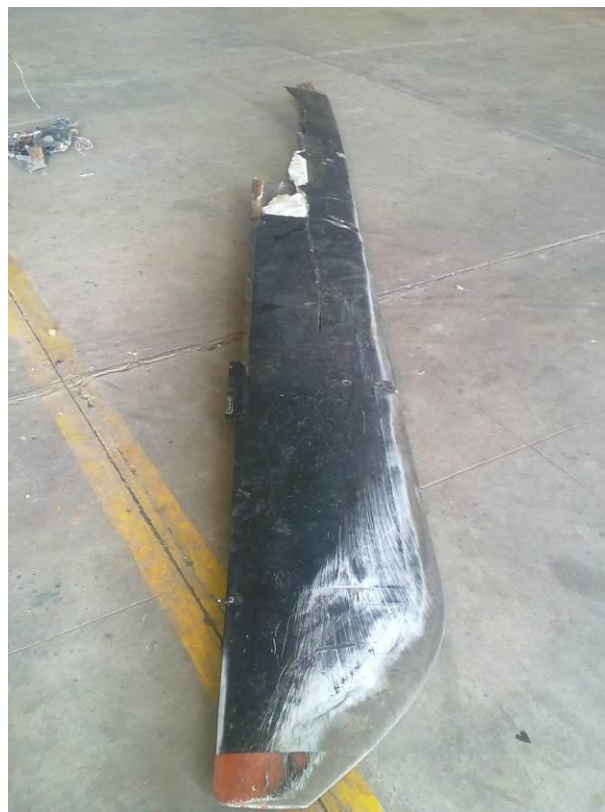
Figure 8. Portion of Green Blade recovered from Vill Mara Buru 1.2 km from Main Wreckage

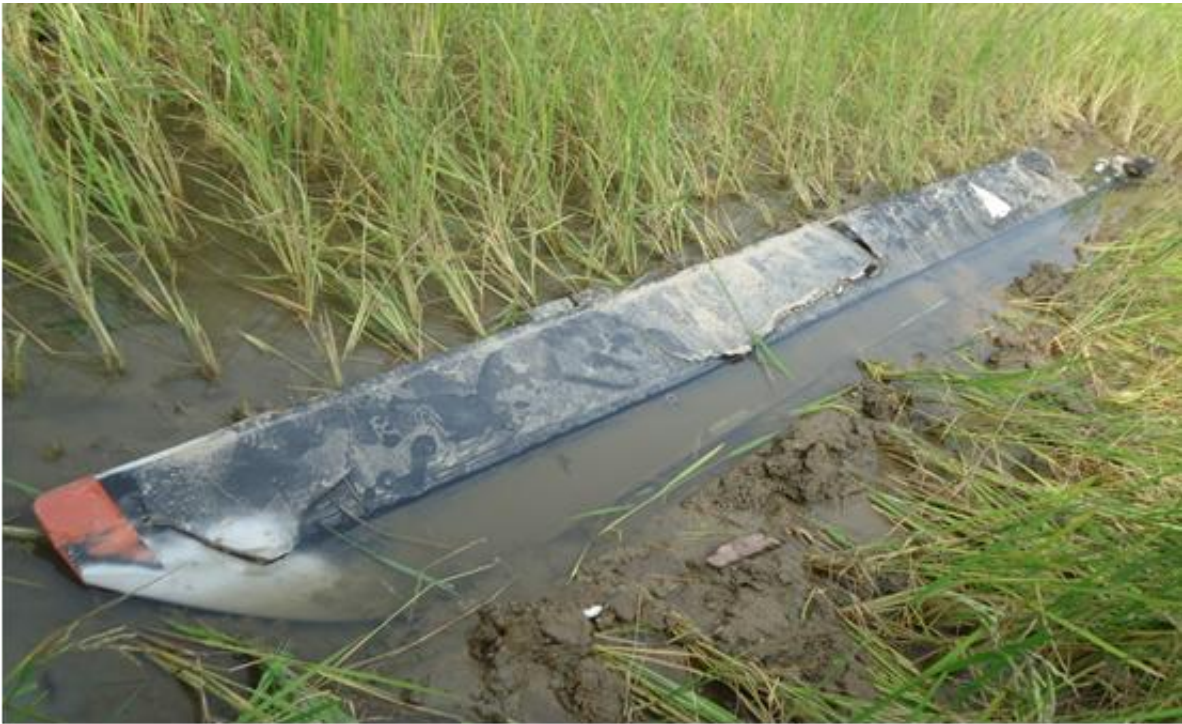
Figure 9 Blue blade found lying in a paddy field at distance of 121 m from the main wreckage

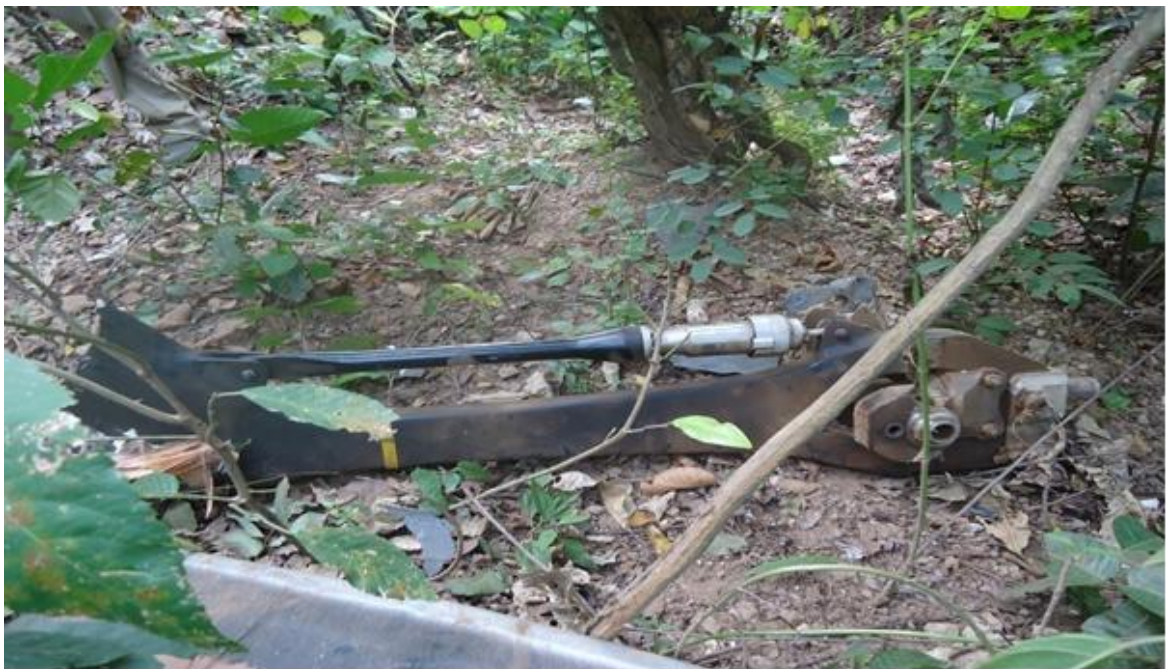
Figure 10 Yellow blade found lying at a distance of 60 m from the main wreckage

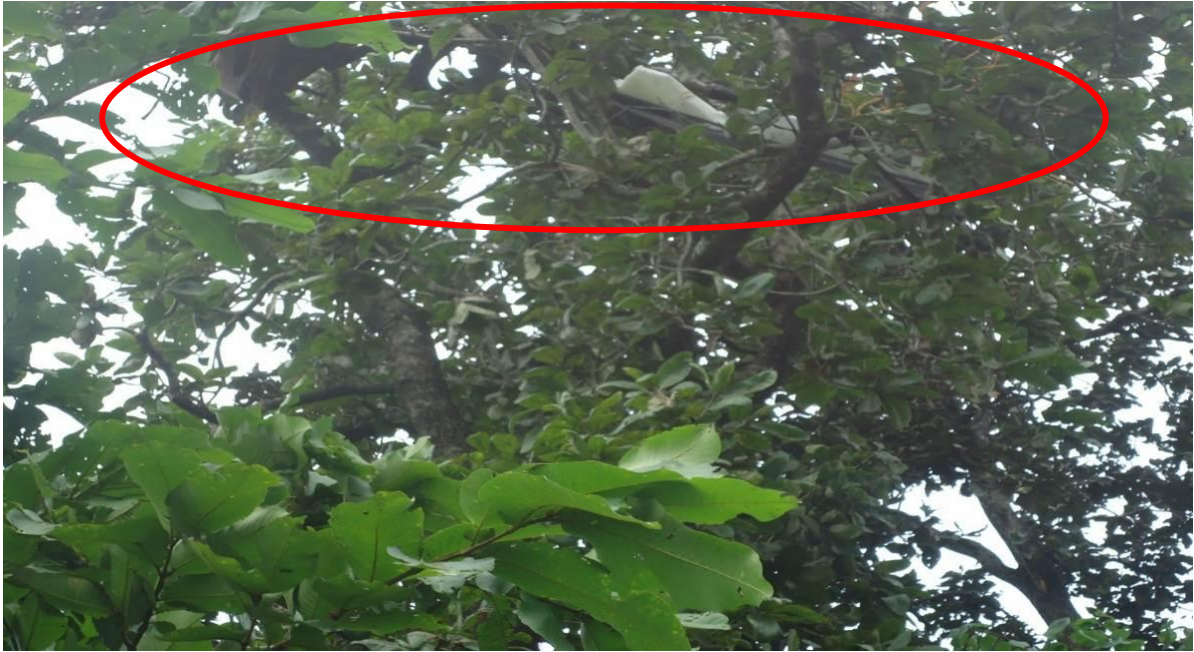
Figure 11 Red blade found hanging on the top of a tree

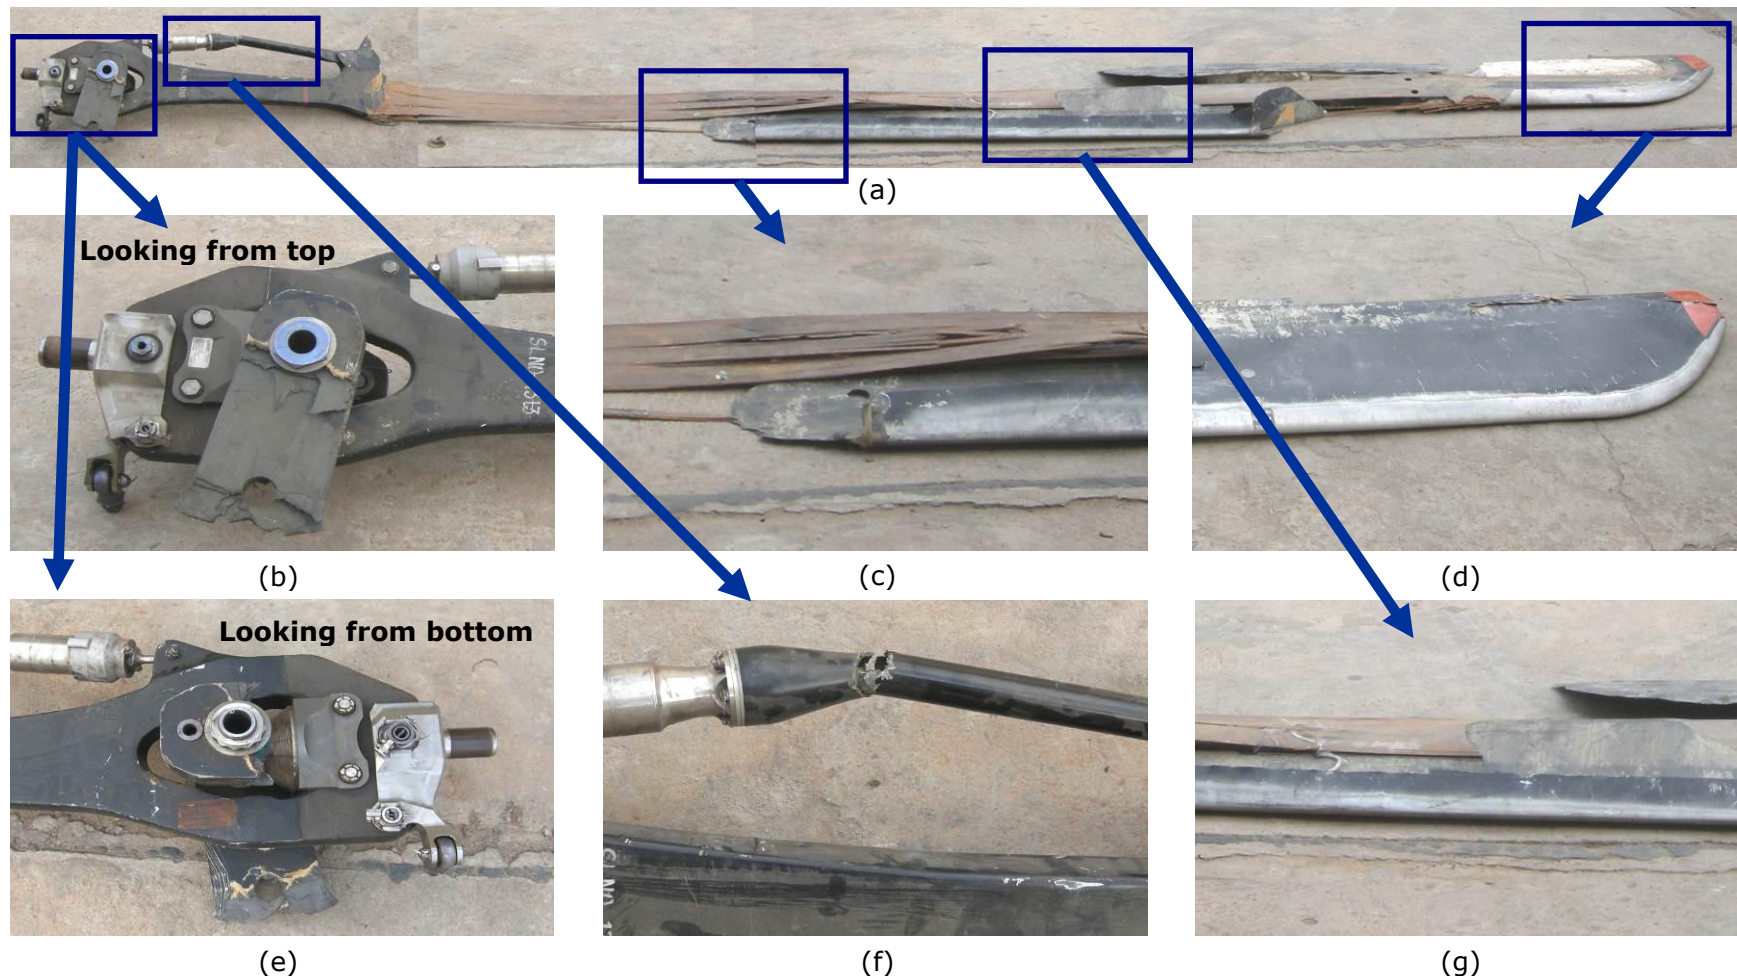
1.16.1.1. Examination did not show any characteristic hit marks on any of the available parts of the Main Rotor Blades (MRB) (refer Fig.12-15). This clearly indicates that all the four MRBs had got separated from the IDS in air and not due to impact with any objects. Three of the four blades, viz., red, blue and yellow blades got separated from the IDS by fracturing the hub plates. In all these cases, the failure of the hub plates were found to be identical such that the top hub plate fractured at the hole position while the bottom hub plate got fractured at the main bolt location.

1.16.1.2. The failure patterns suggest that the fracturing of the hub plates took place under tensile load superimposed with upward bending. Under the loading conditions mentioned above, the top hub plate would have been under compressive load and the main bolt head collar would press against the plate. The concentrated compressive load by the bolt head collar would result in fracturing of a few laminates at this location. Once this failure occurs, the load bearing capacity of the hub plate would reduce, leading to further bending of the plate followed by fracture at the hole position. In contrast, the main bolt hole on the bottom hub plate would be under tensile load and hence, the fracture on this plate is expected to occur across the hole itself. The failure patterns seen on the red, blue and yellow blades substantiate this hypothesis.

Figure 12 Photographs of the red main rotor blade showing: (a) full blade assembled with available parts, (b) failure pattern in top hub plate, (c) blade spar, (d) tip of the blade with airfoil, (e) failure pattern in bottom hub plate, (f) broken damper rod, and (g) a part of the leading edge of the airfoil retrieved from the wreckage site; note no hit marks on the available parts of the blade

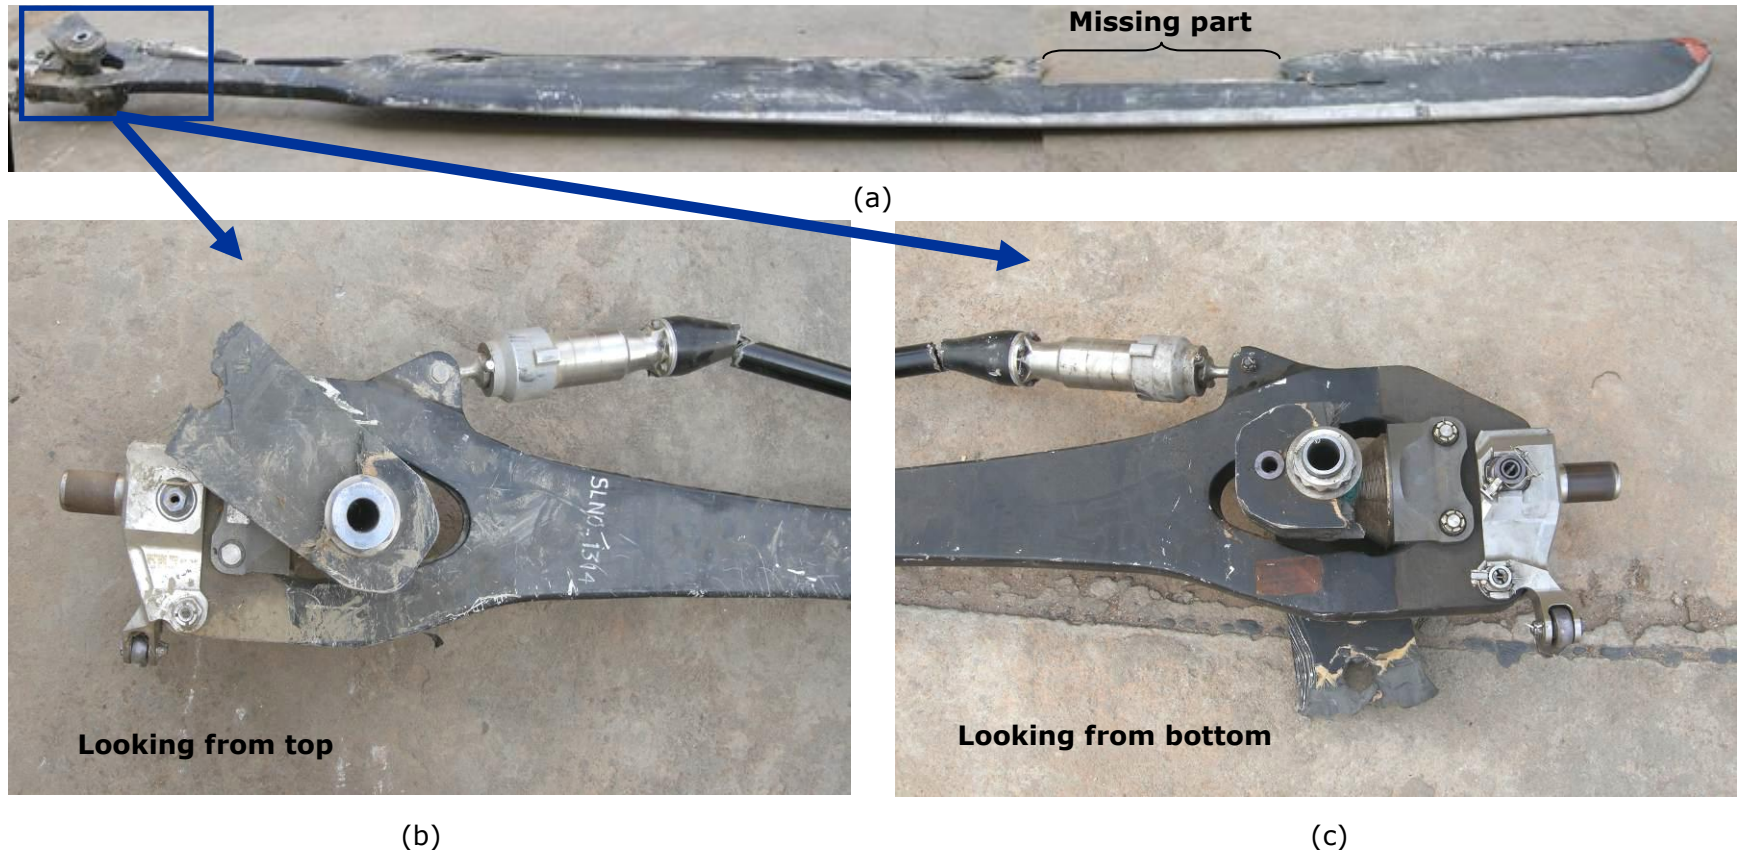
Figure 13 Photographs of the blue MRB showing (a) complete blade as retrieved from the wreckage, (b) failure pattern on the top hub plate, and (c) failure pattern on the bottom hub plate; note the failures of the hub plate to be identical of those shown in case of red MRB (refer Fig.1(b) and (e))

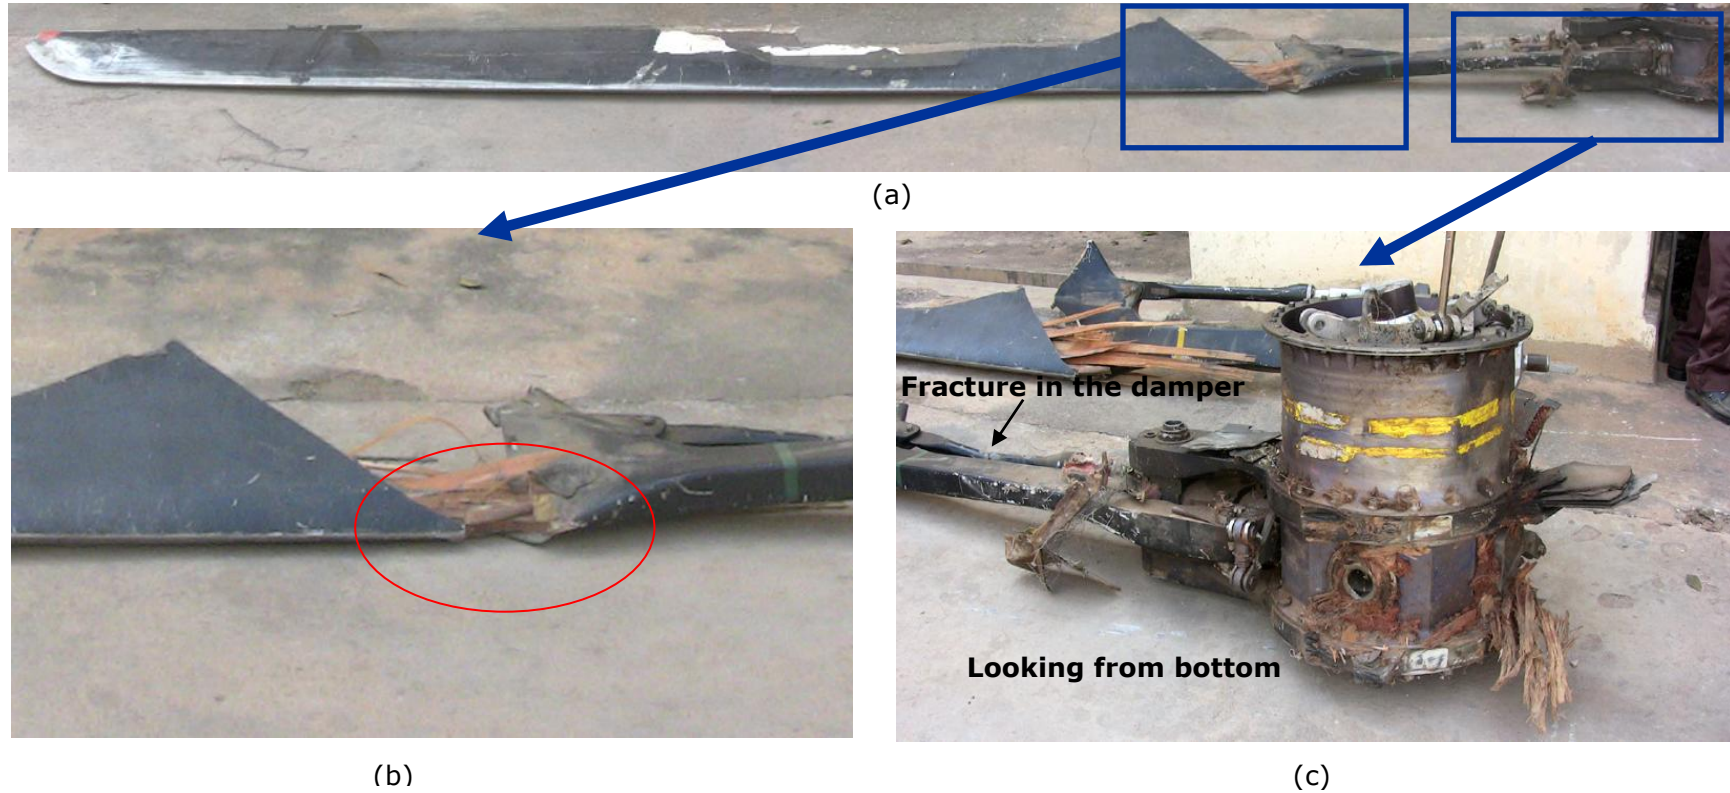
1.16.1.3. Examination revealed that the green blade has failed from the transition zone and there was no external damage at this fracture location. There were no evidences to suggest that the blade failure was due to impact with any object. It appears that this blade has failed under aerodynamic loads superimposed with excessive twisting of the blade.

1.16.1.4. Based on the wreckage distribution and the laboratory analysis, it appears that the green blade has failed first in air. Followed by this, the other three blades got separated from the IDS by fracturing the hub plates. The primary reason for the failure of the blades appears to be excessive aerodynamic loads. There were no evidences to suggest that any deficiencies in the blades or blade assemblies were responsible for the failure.

Figure 14 Photographs of the green MRB showing (a) full blade assembled with the available parts, (b) close-up view of the failure location at the transition zone (encircled); note presence of no hit marks, and (c) IDS with spoon (root) of the blade showing failure location in the damper rod; note buck of the tree picked up during impacting with a tree

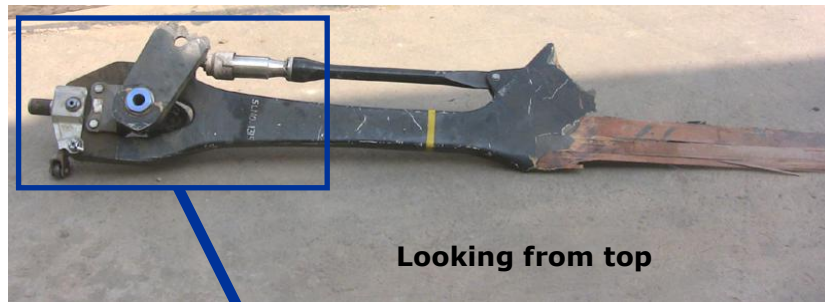
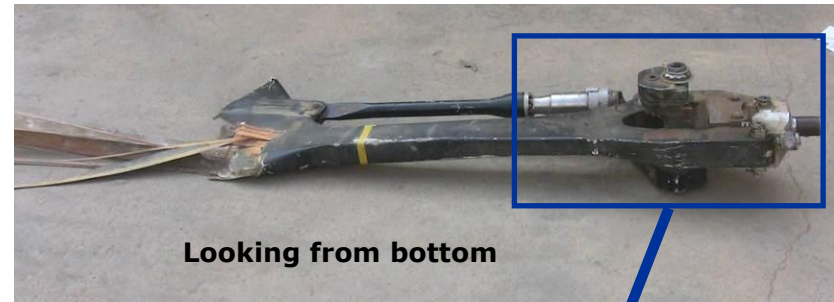
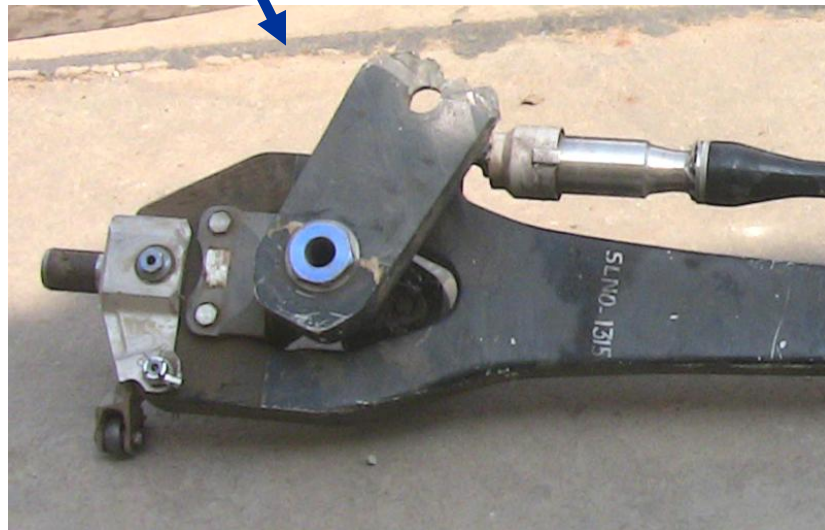
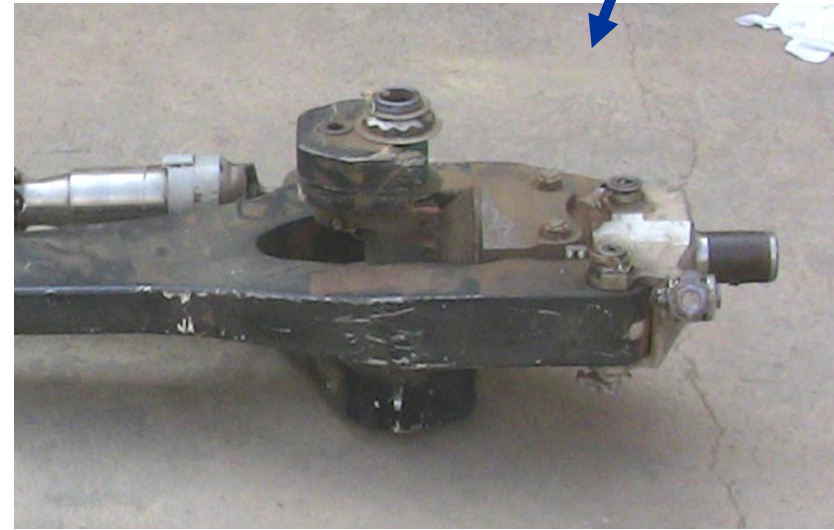
Figure 15 Photographs of the yellow MRB showing (a) and (b) part of the blade with the spoon, and (c) and (d) close-up views showing failure patterns in the top and bottom hub plates respectively; note no failure in the damper rod
