**REPORT  
OF  
COMMITTEE OF INQUIRY**

**ACCIDENT TO BSF (AIR WING) DHRUV HELICOPTER VT-BSN  
AT RAIPUR AIRPORT ON 15<sup>th</sup> JAN 2012**

**FINAL INVESTIGATION REPORT ON ACCIDENT  
TO  
BSF DHRUV HELICOPTER VT-BSN AT RAIPUR AIRPORT  
15<sup>TH</sup> JANUARY 2012**

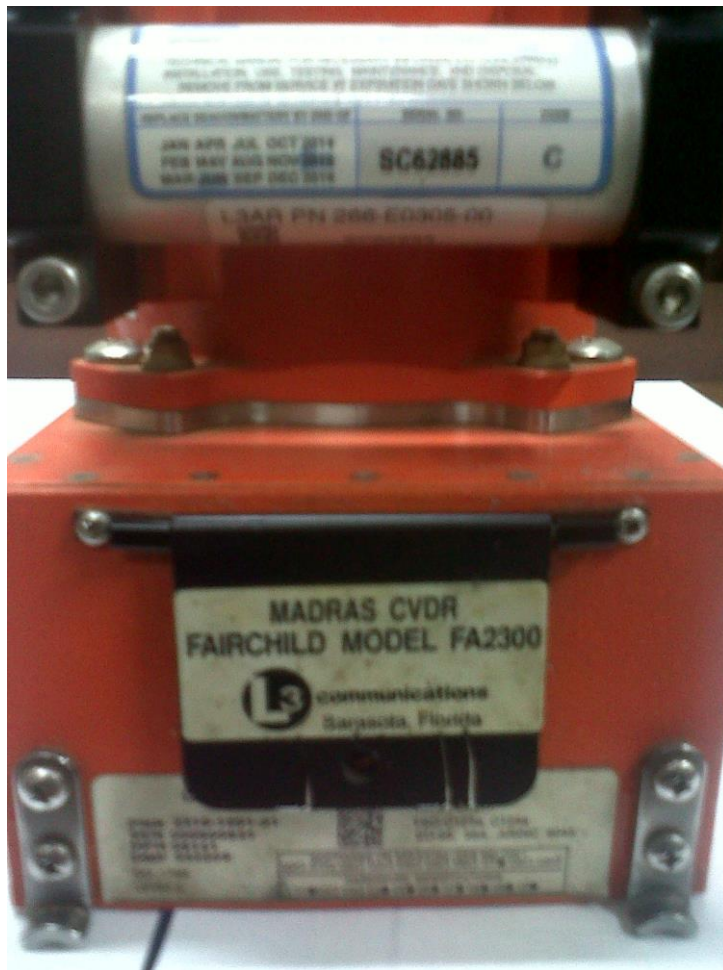
*Fig. 1 Recovered CVDR*

**1.11.1** The helicopter was equipped with Model FA 2300 Madras – CVDR manufactured by L-3 Communications, Part No.2316-1501-01, Sl. No. 000600831. There was no damage to the unit (Fig. 1). The data was retrieved at HAL facility. CVDR records FDR time and GMT/UTC time. GMT/UTC recorded in the CVDR matches with time recorded by ATC. However, internal FDR time is 29 min 23 seconds behind UTC. Correlation between CVR and DFDR is given in Appendix-1.

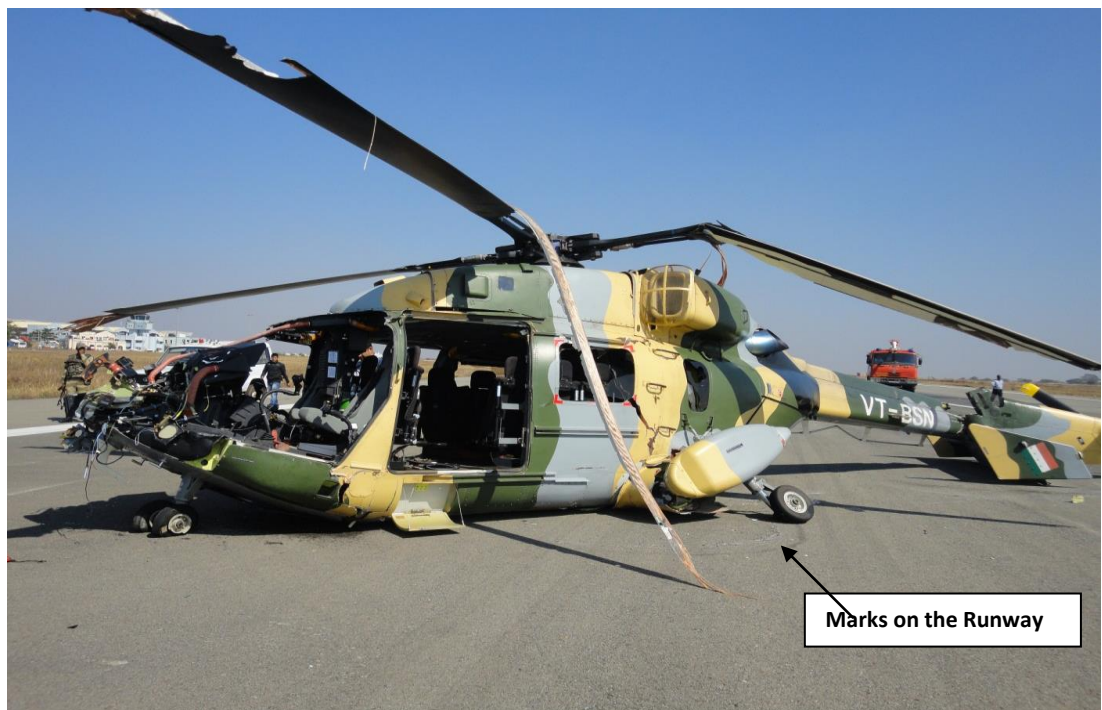
*Fig. No. 2 Helicopter in the final resting position on the Runway*

**1.12.2** Deep circular marks at two places were seen on the runway surface indicating that the helicopter had lifted up after initial impact and then settled back. Before coming to rest at the final position, the helicopter turned by 360 degree and the ground marks were made by the collapsed right main landing gear and the tail skid bumper. Helicopter was resting on its belly and the belly area was damaged (Figs 2 & 3). Fuel was leaking from fuel tank. A patch of 1m x 1m was observed on runway and its top bituminous surface had loosened. The damage was caused due to leakage of ATF from fuel tank. Separated parts of the helicopter were spread over the runway.

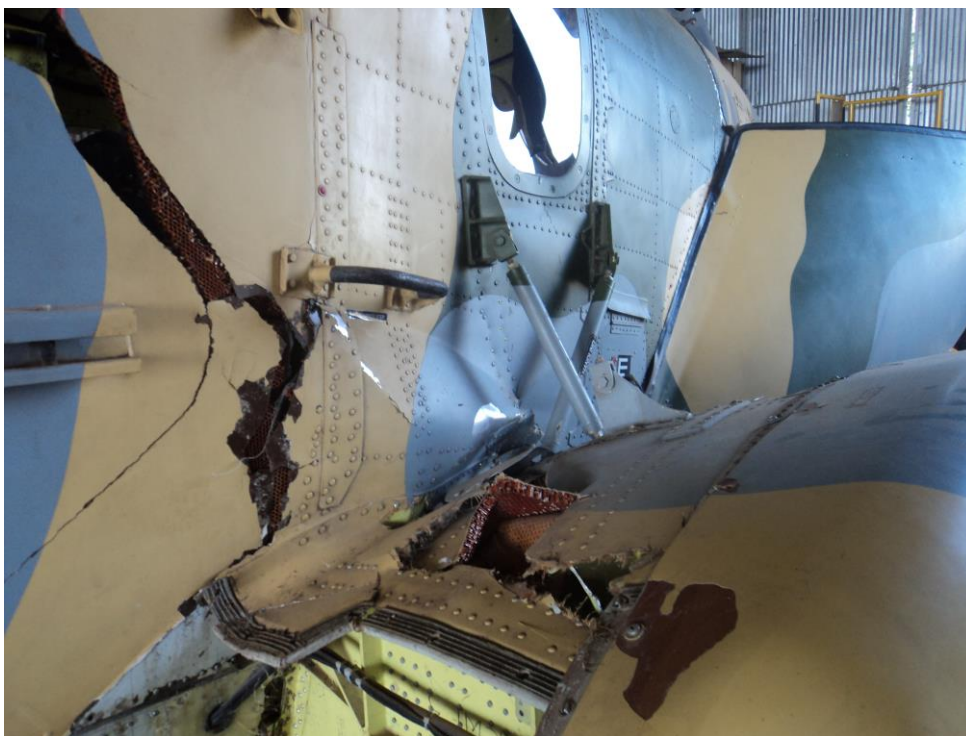
*Fig. No. 4 Left Stub Wing*

**1.12.3.8 Stub Wing** Damage was observed on both LH and RH Stub Wing Assembly. On the left stub wing side strut found damaged and separated from the stub wing mounting point ( Fig. 4)

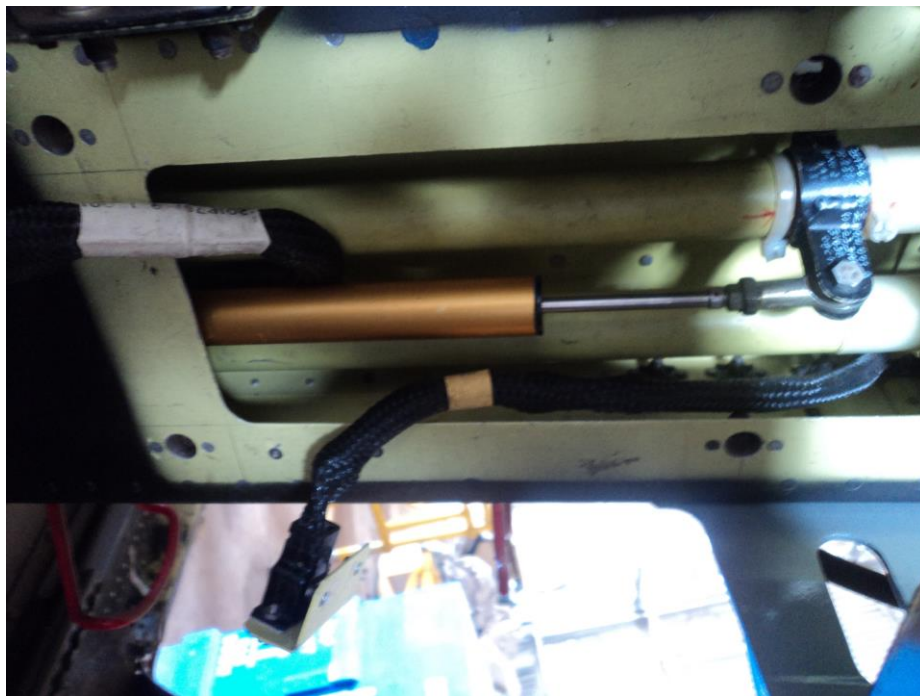
*Fig.No. 5 CPA in Situ Condition*

**1.12.3.13** Flight control circuit was checked for collective pitch anticipator (Fig. 5) and Booster control rods, connecting the upper control system and MR collective actuators and found satisfactory.

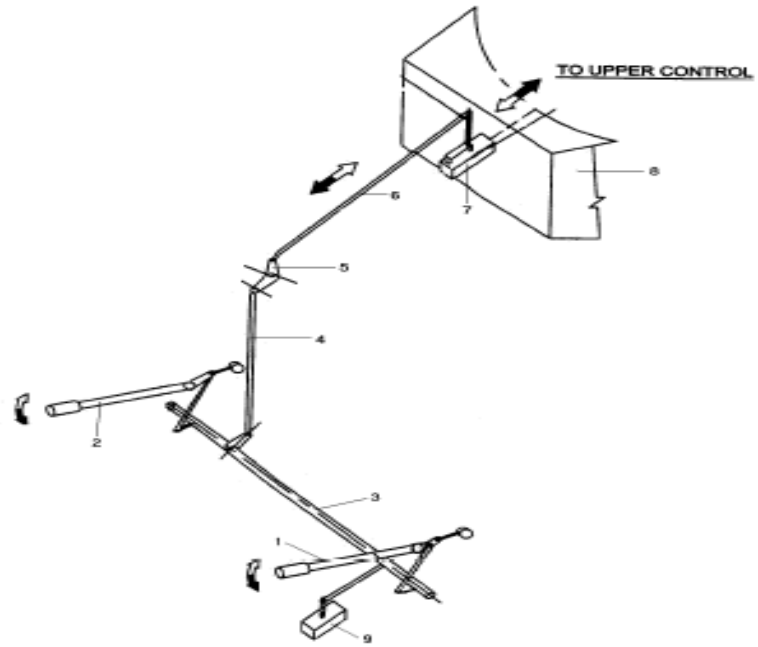
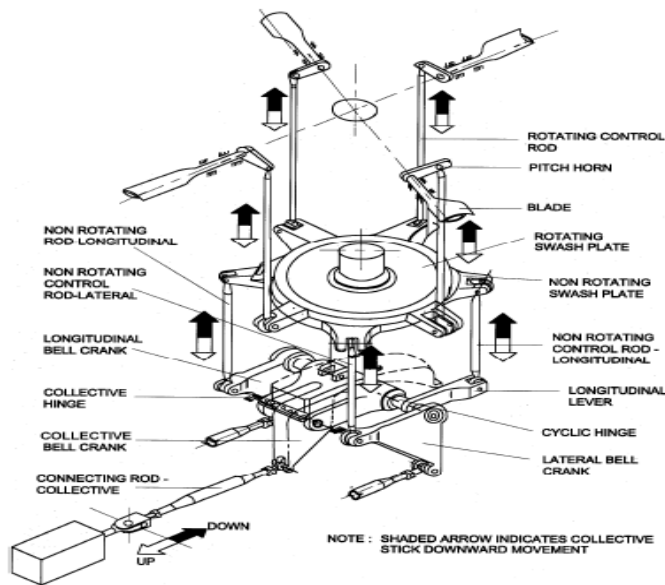
**Fig. No. 6 Collective Control Channel**

**1.12.3.14** All the linages, couplings and joints in the collective control system from crew collective control lever to the bell crank on swinging arm; from bell crank on swinging arm to collective servo actuator; from collective servo actuator to collective bell crank were inspected. These were found to be intact. No Bending or damage was seen on any of the linkages and torque tube (Fig. No. 6 & 7).
