FINAL INVESTIGATION REPORT ON ACCIDENT
TO M/S. CHIMES AVIATION C-172R AIRCRAFT, VT-CAJ
ON 3RD FEB. 2012 AT DHANA AIRSTRIP, DIST., SAGAR, M.P.

**FINAL INVESTIGATION REPORT ON ACCIDENT TO M/s. CHIMES AVIATION,
CESSNA 172R AICRAFT VT-CAJ
ON 03.02.2012 AT DHANA AIRSTRIP, DIST., SAGAR, MP**

SH. R. RAJENDRAN- ASSISTANT DIRECTOR OF AIR SAFETY,
OFFICE OF DIRECTOR AIR SAFETY (WESTERN REGION), MUMBAI.

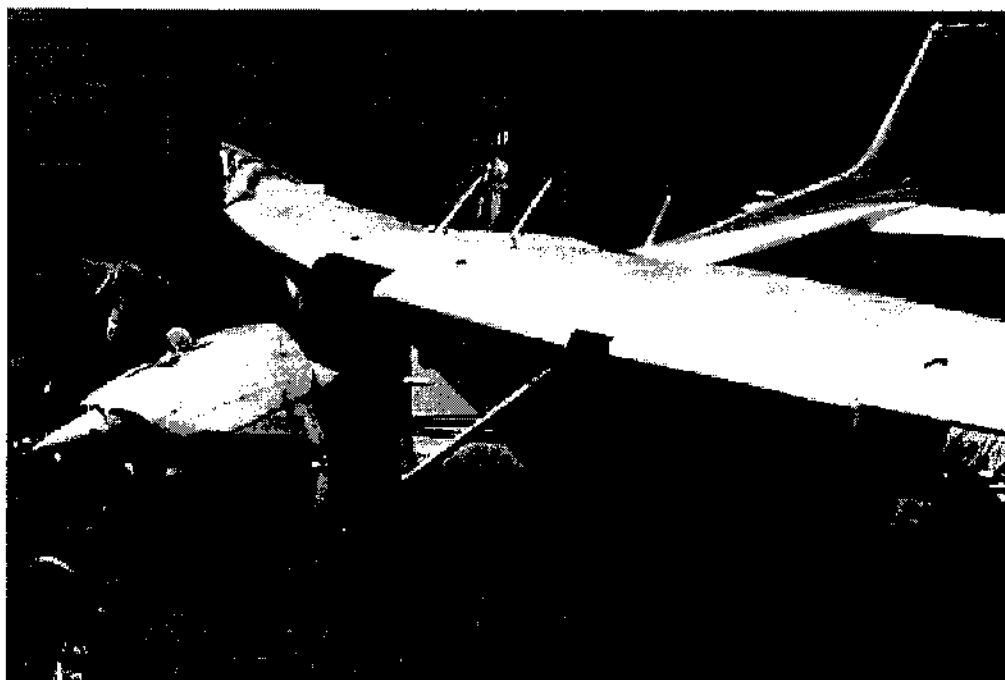
Following major structural damages were observed:

Aircraft was severely damaged in nose section & wing tips. The propeller twisted and both tips were sheared off. Engine Mount found broken & nose landing gear found sheared off from its attachment due to impact. Both wings were bent upward at wing tip area. Firewall buckled & moved slightly inwards. Cabin & rear section intact with minor buckling at some places and both main landing gears were intact. The airbag assembly was found inflated on pilot seat.

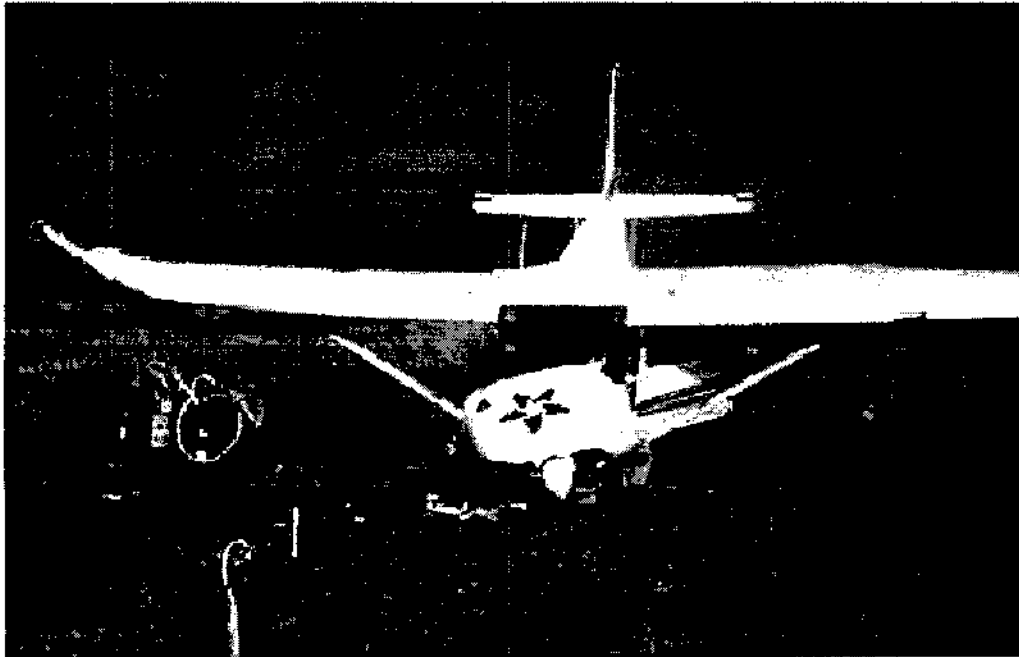
1.3.3 Nose section

Nose section severely damaged.

1. LH lower cowling separated at mount section, the attachment rivets found sheared off. The FRP section torn to the exhaust tail pipe opening. RH Side of nose Cowling found broken. RH lower Cowling found attached to nose cowling.
2. All anti shock cowl mounts found sheared off.
3. The fuel filter bowl found opened and fuel return hose pipe Found to be sheared.
4. Nose landing gear sheared off from attachment.
5. Firewall found crushed & buckled.
6. The main electronic junction box found bent with cover broken. All internal components except main CB's which sheared from panel. Battery found intact with minor deformation, no evidence of acid leakage were observed.

7. Lower portion of forward fuselage crushed. LH & RH Steering Rod found bend with part of steering arm attached on it. Upper Nose gear mount found missing and lower nose gear mount sheared and attached to fuselage.
8. Engine mount found to be broken at all four mounting points towards engine. The shock mounts & frame found attached to the engine. The mount structure at fuselage found attached to firewall at all four points.
