## **SYNOPSIS:-**

M/s. AR Airways Cessna Citation 550 aircraft VT-CLC involved in an Accident while carrying out Proficiency check flight for the Co-pilot by DGCA, FOI at Surat Airport. At around 1230UTC, the Co-pilot carried out landing and the landing was normal but immediately after landing, the aircraft viciously started going to the right. The Pilot of the aircraft took over the controls and tried to prevent the aircraft from going to the right. However, he could not able to control the aircraft and the aircraft left the runway, went over the adjacent uneven grassy area and came to a complete stop by a rainwater drainage channel of approx. 6feet width and 4feet depth on its way.

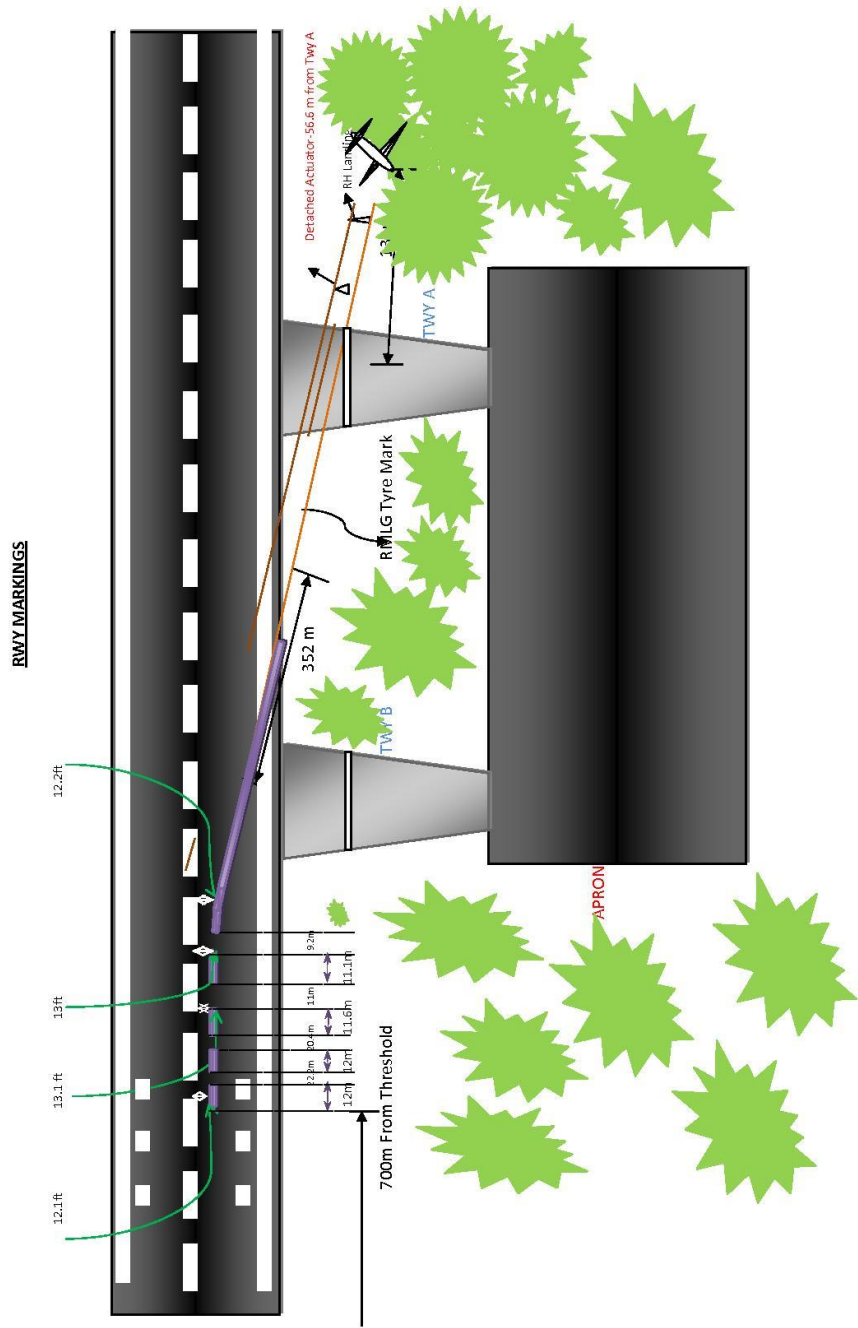
Fig 1

Aircraft made touch down at the touchdown zone on the Rwy 22. Immediately after touchdown, RMLG intermittent tyre marks was found predominant at 4 places parallel to the rwy centre line before making continuous deviation markings from the Rwy22.

First segment of RMLG tyre mark found on the rwy for a length of 104ft parallel to the Rwy 22 centre line between the RWY lights 1/16 and 2/15 at a distance of 12.1ft from the centre line of Rwy22 on the RHside. After a gap of approx. 74ft, second tyre mark noticed between the lights 2/15 and 1/15 is for a stretch of 41 feet and 12.5 ft away from runway centre line edge. Again after a gap of approx.68ft, the third mark observed between lights 1/15 and 2/14 for a stretch of 39 ft and is 12.1 ft away from centre line. After a gap of approx. 36.5ft, fourth mark has been noted between lights 2/14 and 1/14 for a stretch of 37 ft and is 12 ft away from the runway centre line edge. After a gap of 31ft, continuous veering mark of RMLG rub marks noticed toward right side of rwy 22 centreline from the RWY light 1/14 which is approximately 352 meter till it entered the grassy area initially. After that the aircraft rolled out, crossed the Twy 'A' and entered in to the grassy Kacha land.

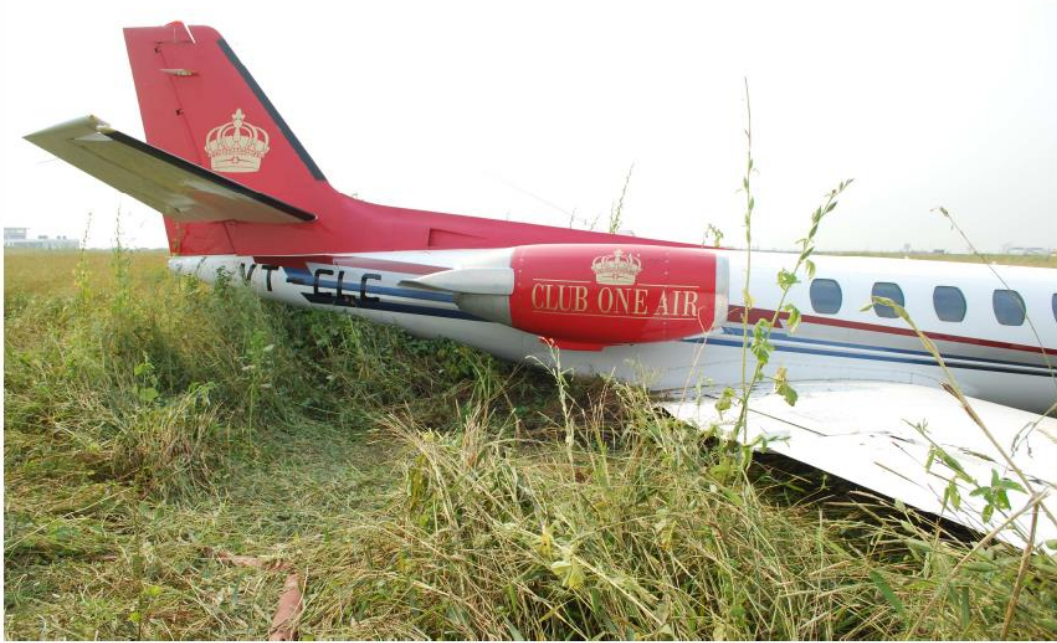
Fig 2

After crossing of Twy 'A', Landing gear actuator & RHMLG found detached and laying on the path of the aircraft. The aircraft came to a final halt, as this got trapped by the rainwater drainage channel of approx. 6ft width and turned more than 180 degree before it came to rest.

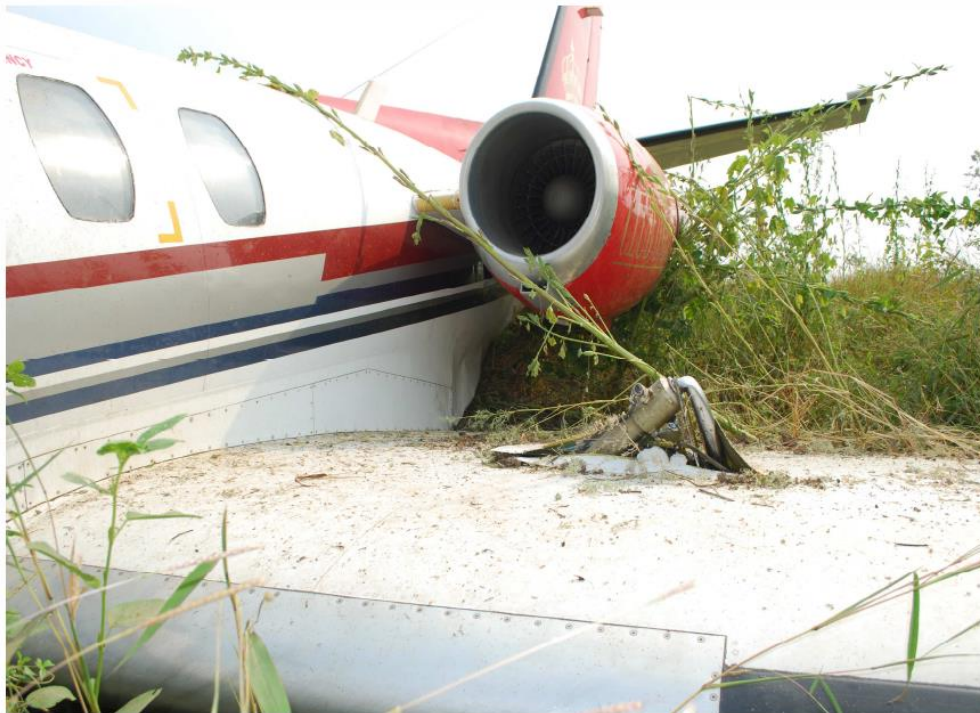
Fig 3

The accident occurred immediately after landing. The aircraft was intact. Only the Starboard side Main Landing Gear Assembly and Landing Gear Actuator got sheared off and were found lying away from the incident aircraft with partially damaged tyre on the wheel hub.(approx 250 from Stbd. wing tip). Actuator and MLG assembly were laying approx 20 feet apart from each other.

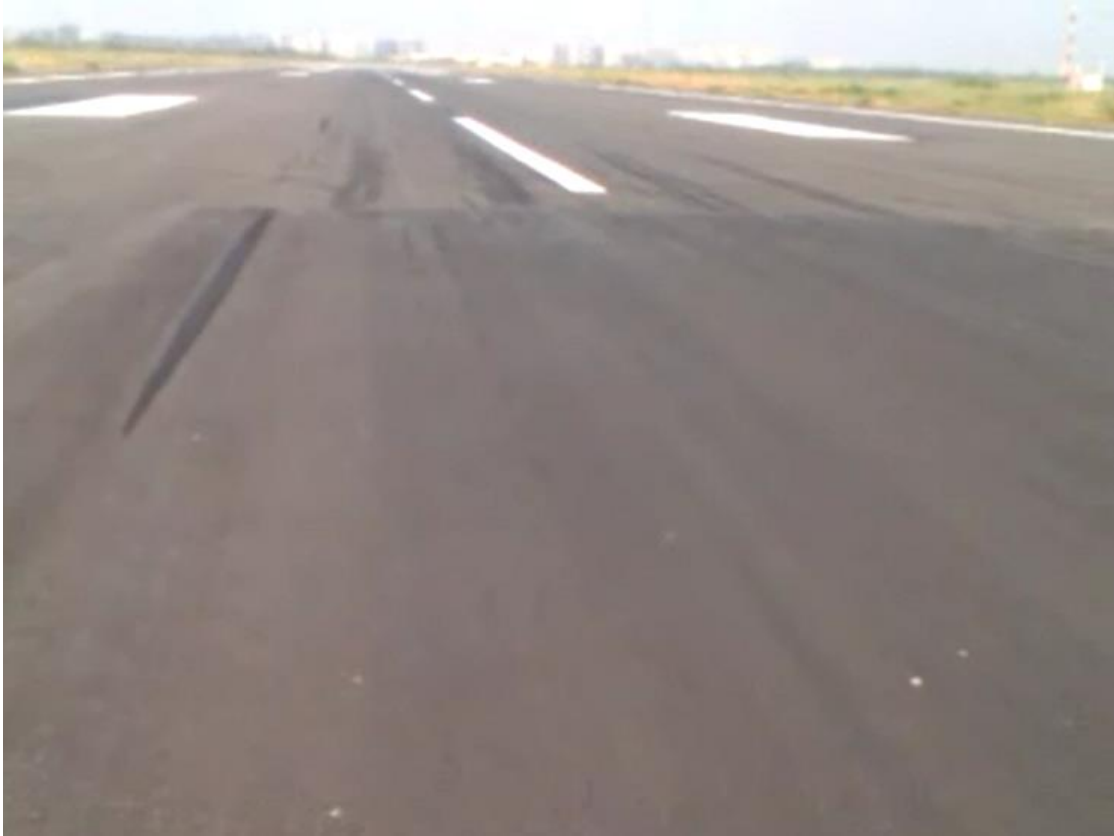
Fig 4 (view from the other side of Rwy)

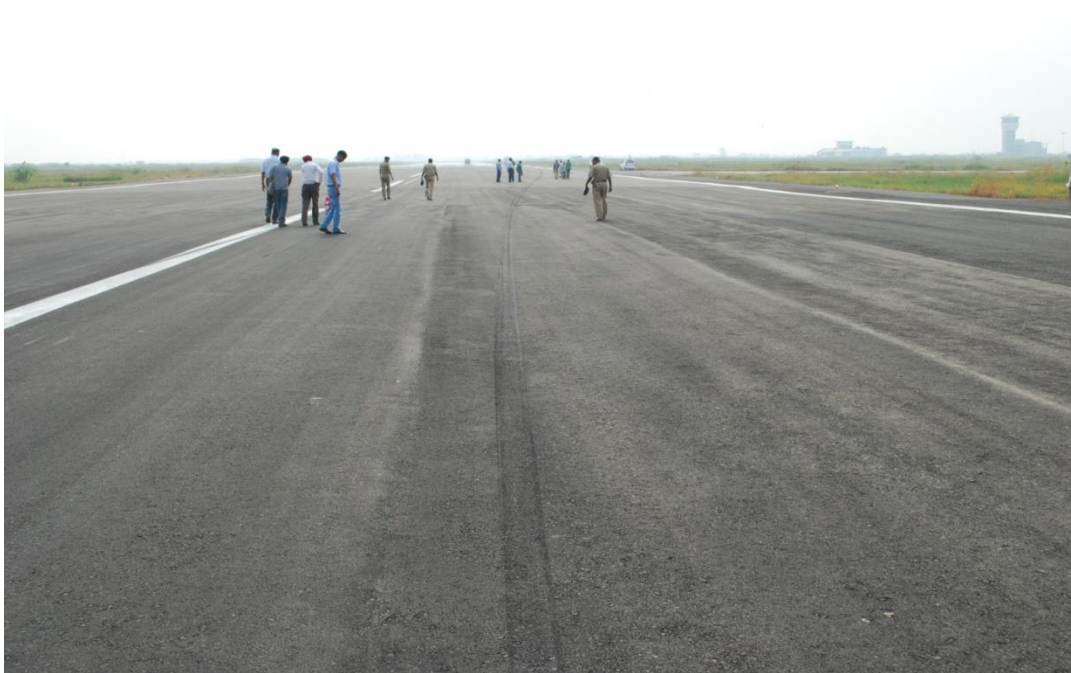
Fig 5 (view from the landing side)

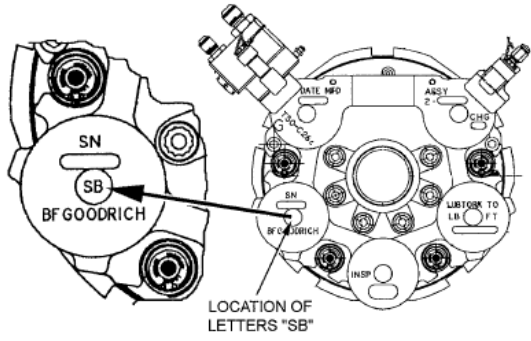
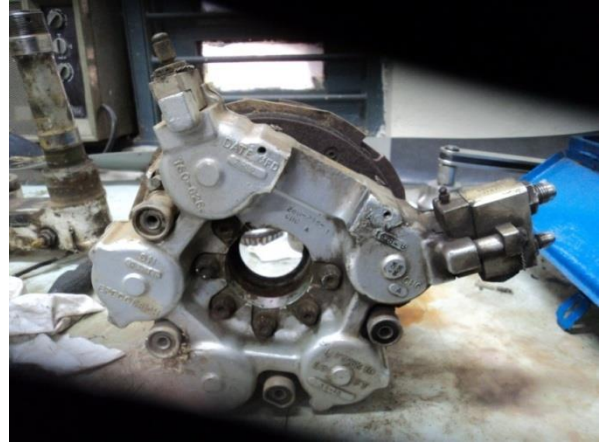
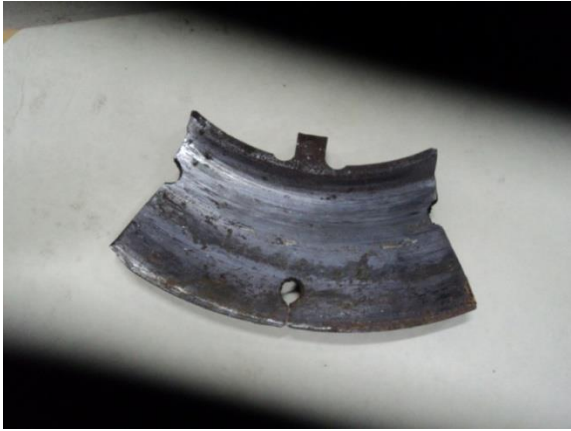
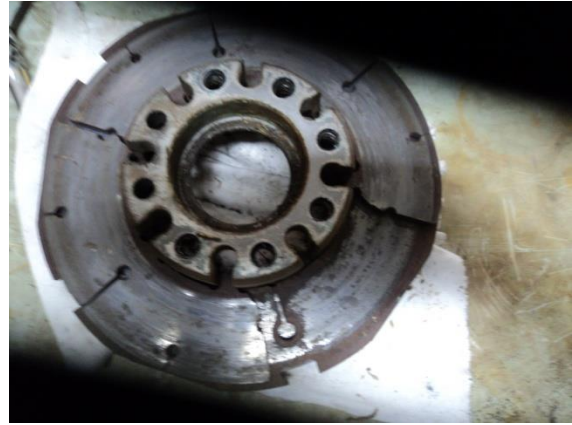
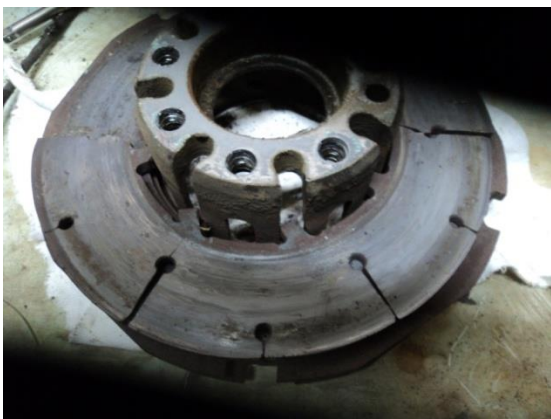
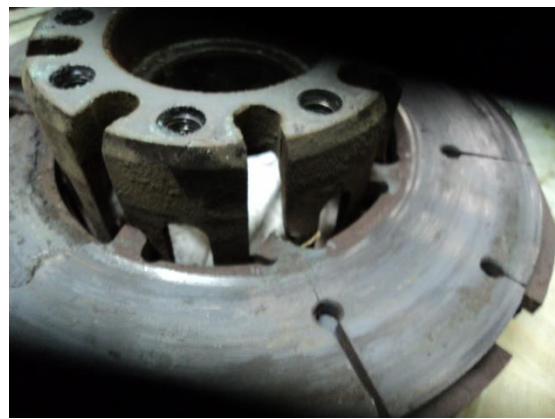
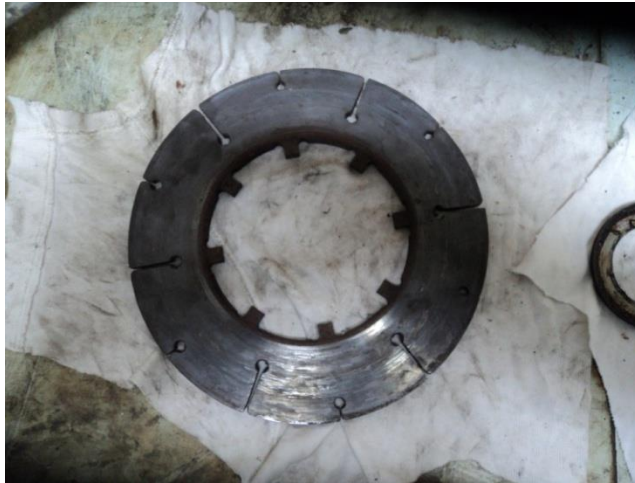
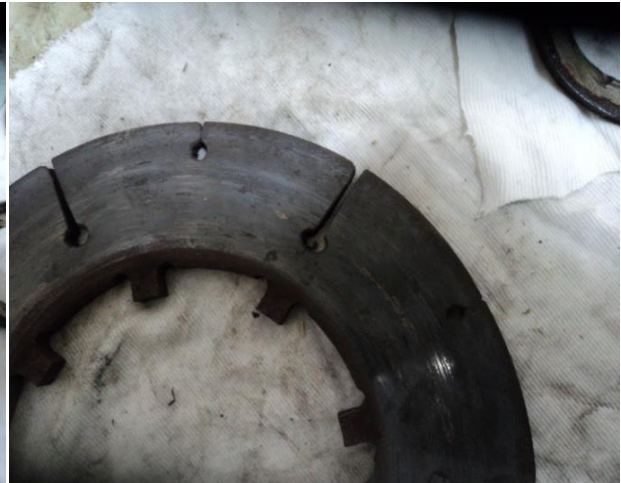
Brake Stators and rotors were found rotating and no sign of overheating observed.

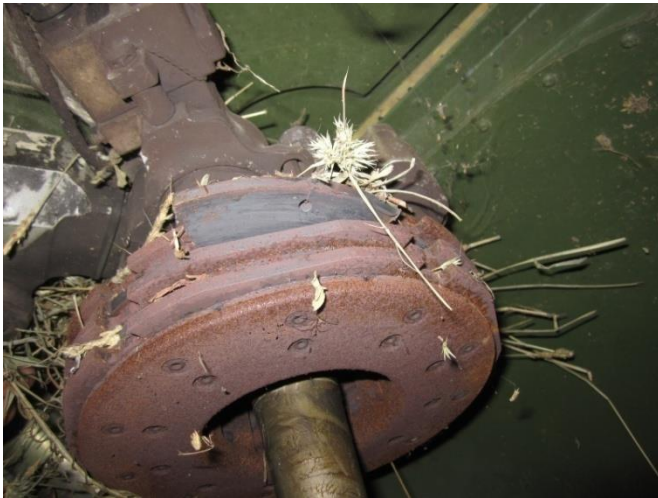
On further disassembling of the Brake assembly, One stator disk ( towards the piston housing assembly) was found into 4pieces out of which one piece of nearly one inch was found missing as shown in fig.3&4. One torque lug on this stator was found badly bent and other torque lugs found to be slightly bent. One slot on torque plate also observed as slightly damaged. The other stator (which was towards the torque plate assembly) was witnessed with crack just developed on it (fig.7&8). Both the discs the part number and serial number could not be witnessed on the discs. Further, on microscopic inspection, it was observed that the on the broken piece ends, lip shape also formed.

BA-13 (insitu' condition)

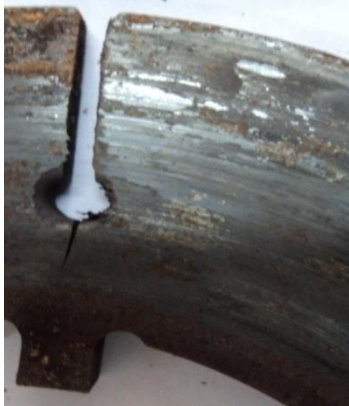
BA-15 (stator disc crack developed)

On further disassembling of the Brake assembly, one stator towards pressure plate was found broken into four pieces in which one piece of about one inch was found missing. One torque lug on this stator was found badly bent and other torque lugs found to be slightly bent. One slot on torque plate observed as slightly damaged. This shows that that stator was trying to move due to missing piece of the stator. Another stator (Not broken) also found with a minute crack at one Thermal Expansion Slot.

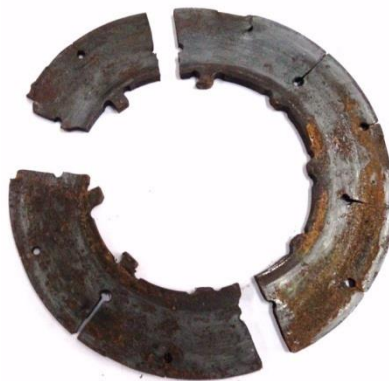
BA-16 (other stator disc in pieces)

Hence, there is a lapse on maintenance inspection observed. As the discs found broken and in pieces, the broken piece might have stopped the free rotation of the wheel as identified by the Goodrich SB.
