**FINAL REPORT ON ACCIDENT TO
GOVT. OF MAHARASHTRA
SIKORSKY S-76C++ HELICOPTER
VT- CMM
AT NILANGA, LATUR
ON 25/05/2017**

**A X Joseph
Deputy Director, AAIB
Chairman, Committee of Inquiry**

1. Aircraft Type : Sikorsky S76 C++
Nationality : INDIAN
Registration : VT – CMM
2. Owner : Government of Maharashtra.
3. Operator : Government of Maharashtra.
4. Pilot – in –Command : CHPL holder on type
Extent of injuries : Nil
5. First Officer : CHPL Holder on type
Extent of injuries : Nil
6. Place of Incident : Nilanga, District Latur
7. Geographical Co-Ordinates : 18°07’34’’N, 76°44’57’’E
8. Date & Time of Incident : 25th May 2017, 0625 UTC
9. Last point of Departure : Nilanga, District Latur
10. Point of intended landing : Raj Bhawan, Mumbai
11. Type of operation : Non Schedule Operation
12. Crew on Board : 02
13. Passengers on Board : 04
14. Phase of operation : Take off
15. Type of accident : Crash landing after hitting Electrical
High Tension Cables

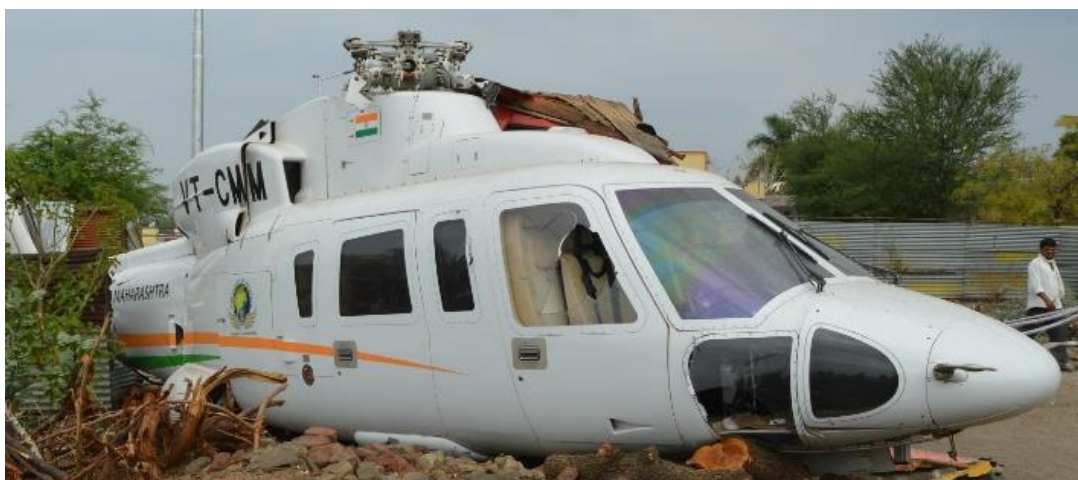
Fig:1- Main Fuselage

1. All the four main rotor blades had sheared off from its root attachment after the impact with the tree and roof of the parked truck.

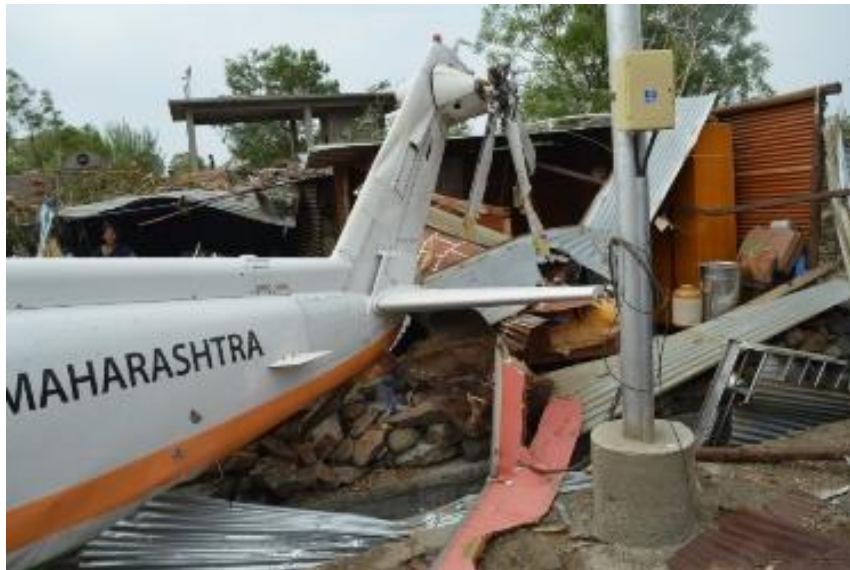
Fig:2 – Tail Portion

2. All pitch link rods for the main rotor blades were broken.
3. All the four tail rotor blades damaged after its impact with the house structure.

4. Horizontal Stabilizer (LH) was damaged at tip and punctured on upper surface.
5. The helicopter Vertical Fin was damaged at trailing edge and bottom portion.
6. A part of tree stock was found trapped at root of horizontal stabilizer

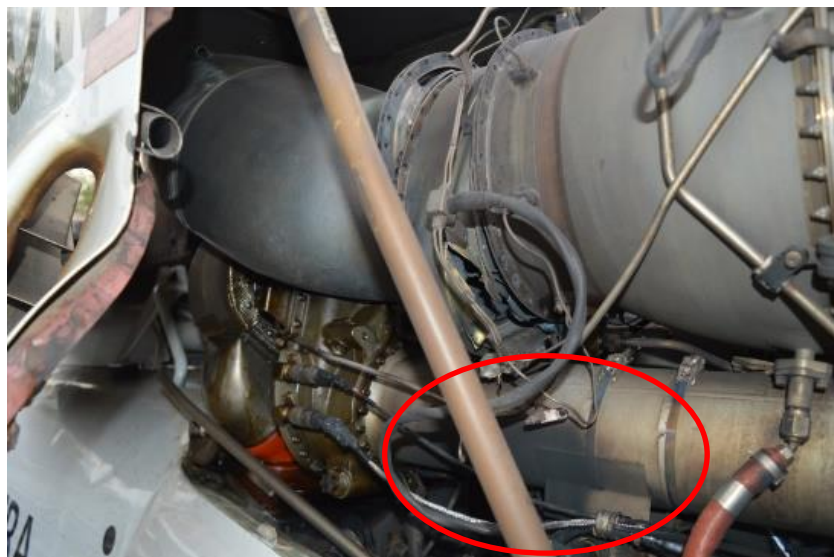
Fig:3 – Starboard Engine Power Turbine casing

7. The starboard engine Power turbine casing had burst open with local thermal damage in the surrounding area.

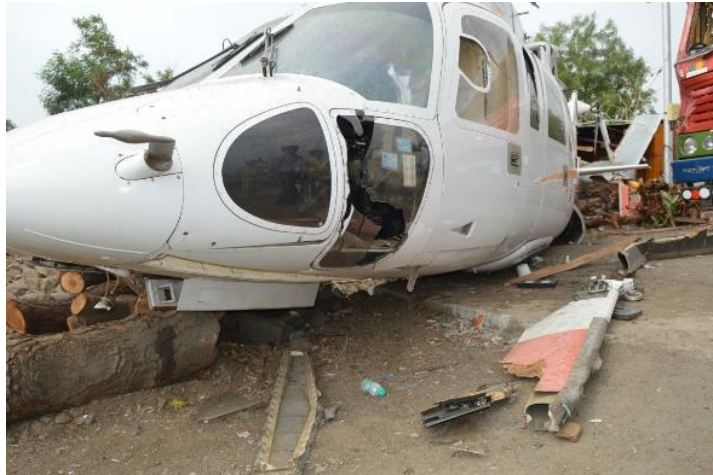
Fig:4 – Damaged Plexi window

8. Belly of tail boom had multiple dents
9. LH engine cowl was damaged
10. LH Passenger window was broken.
11. LH Cargo door was damaged.

12. Co-pilot window plexi was broken.
13. Pilot and Co-pilot wind shield were broken.

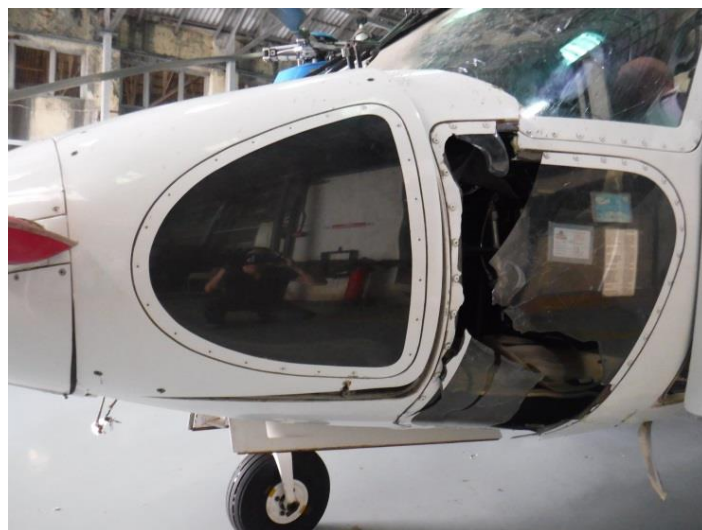
Fig:5 - Nose frame

The airframe was primarily intact. Nose frame was fractured and buckled just below the windshield on the left side, aft of the left electronics compartment access panel, through the second chin bubble at about fuselage station (STA) 60.

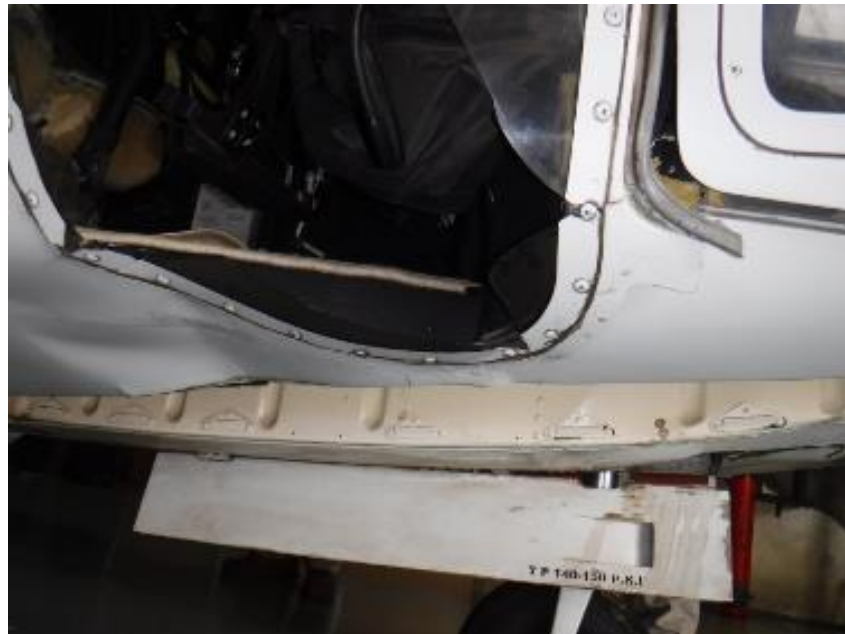
Fig:6 – RH side electronics access panel

Nose frame had damages on the right side aft of the right electronics access panel. The mounting brackets of the LRUs in the right side electronics bay were fractured.

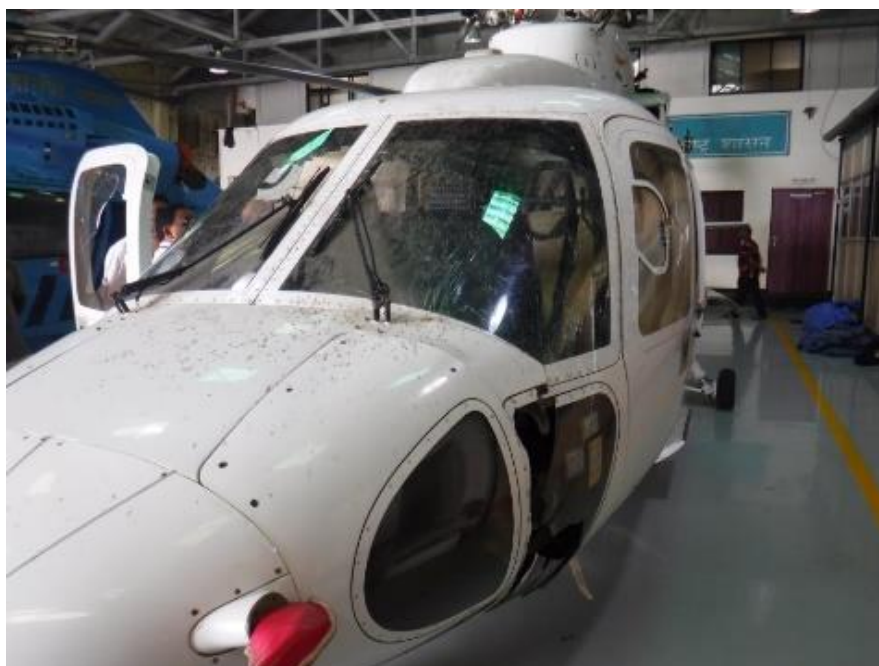
Fig:7 – LH Nose section

The left hand windshield was cracked but in place. The under-deck was buckled from STA 40 to 93. The aft right side pilot's second chin window was fractured at STA 70.

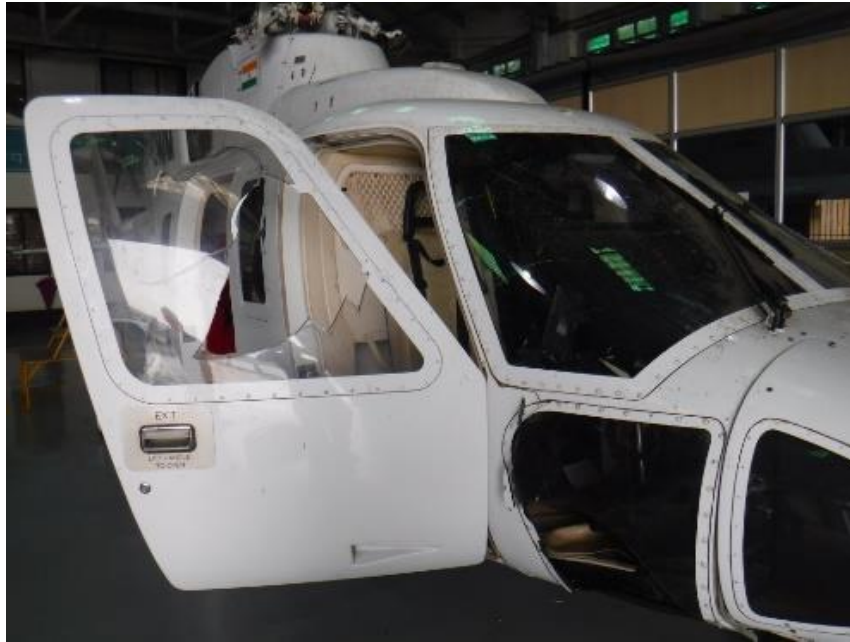
Fig:8 – RH Nose Section

The right side pilot's door and door frame were buckled near the hinge at about fuselage station (STA) 120 but the door still operated. The window in the right side door was cracked. The cockpit canopy and right windshield were intact.

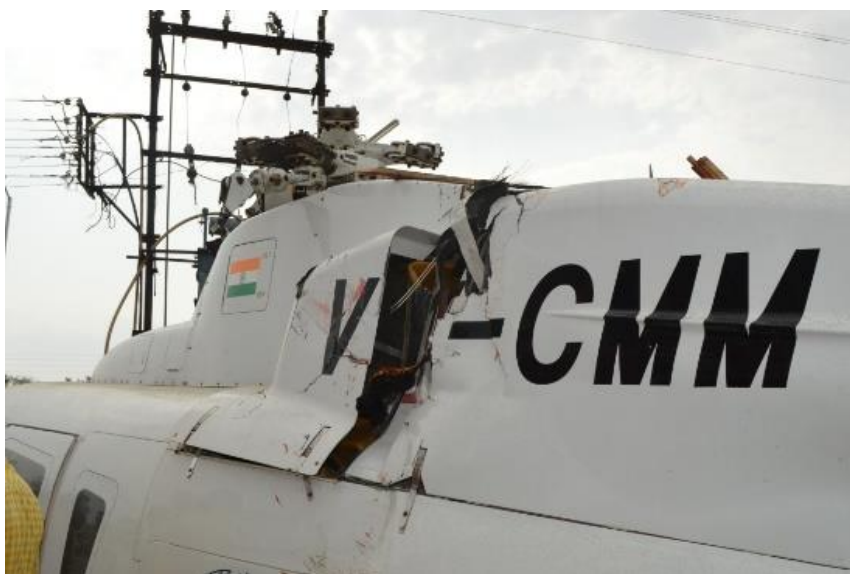
Fig:9 – LH Engine cowl

The number 1 engine inlet cowl and aft engine cowl showed impact damage and there was a vertical tear bisecting the registration number. A rod belonging to the lorry that was hit during the impact sequence pierced the left side.

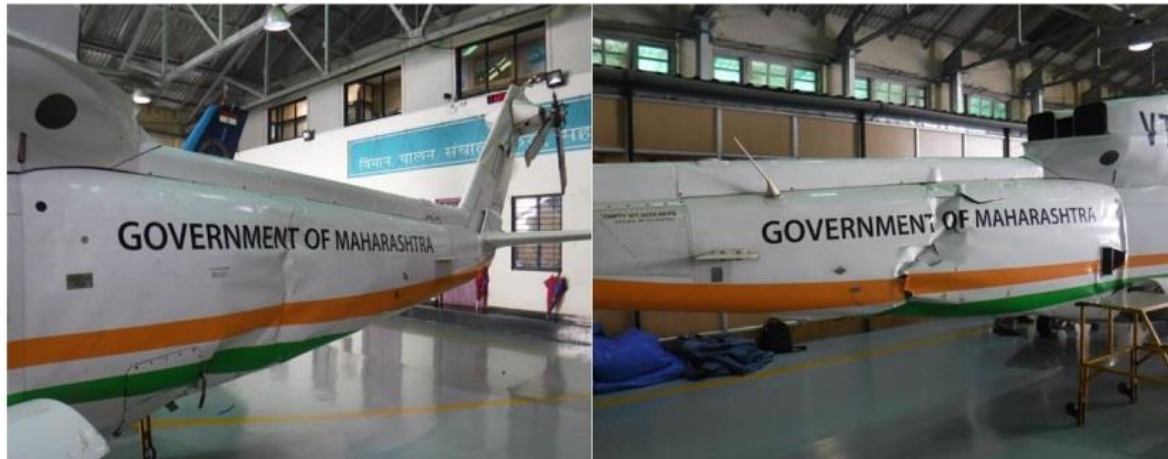
Fig:10 – Damaged Tail Section

Both the left and right sides of the tail cone were buckled just aft of the tail cone access panel and at STA 390. The horizontal stabilizer was still attached but fractured on the left attachment point. The left hand anti-collision light was broken. The vertical stabilizer fairing was fractured near the tail gearbox.

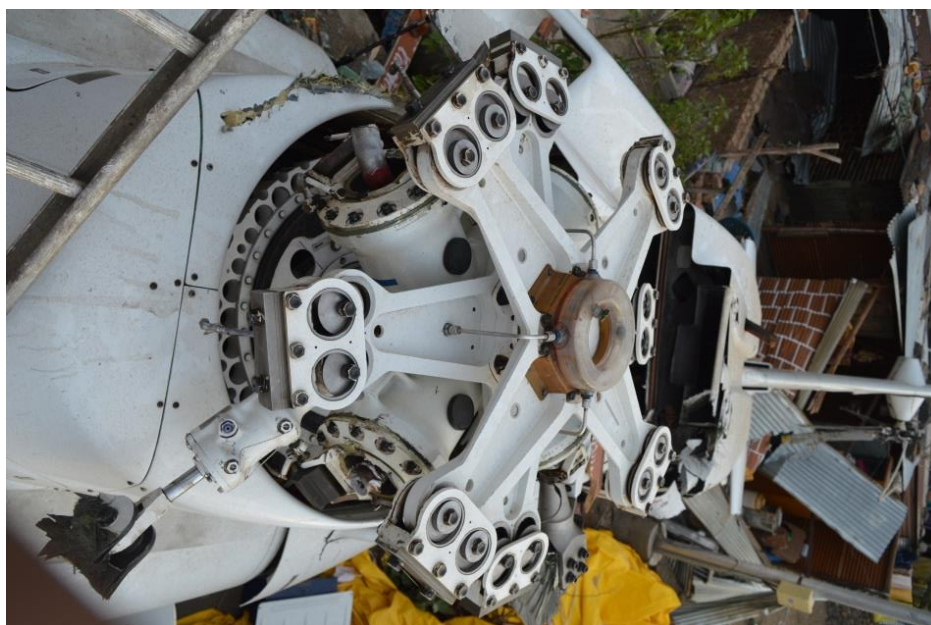
Fig:11 – Rotor Head

Three Main Rotor blades fractured at the spindle and one blade fractured at the blade cuff. The Red MRB was fractured at the spindle in the lag direction. The Blue MRB was fractured at the spindle in the lag direction about 45°. The

Yellow MRB was fractured at the spindle in the lag direction. The Black MRB was fractured at blade station BS 0 (cuff) in the lag direction.

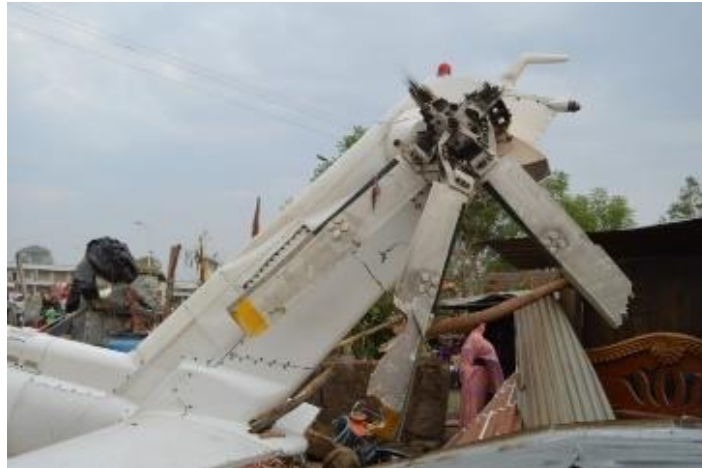
Fig:12 – Tail Rotor Head

All four tail rotor blades (TRB) were damaged during the mishap due to impact with the wires. Two blades separated at the blade root leaving only 4 inches of broom straw; A third blade was fractured just aft of the spar. The fourth blade remained attached from root to tip but was significantly damaged on the blade surface and trailing edge.

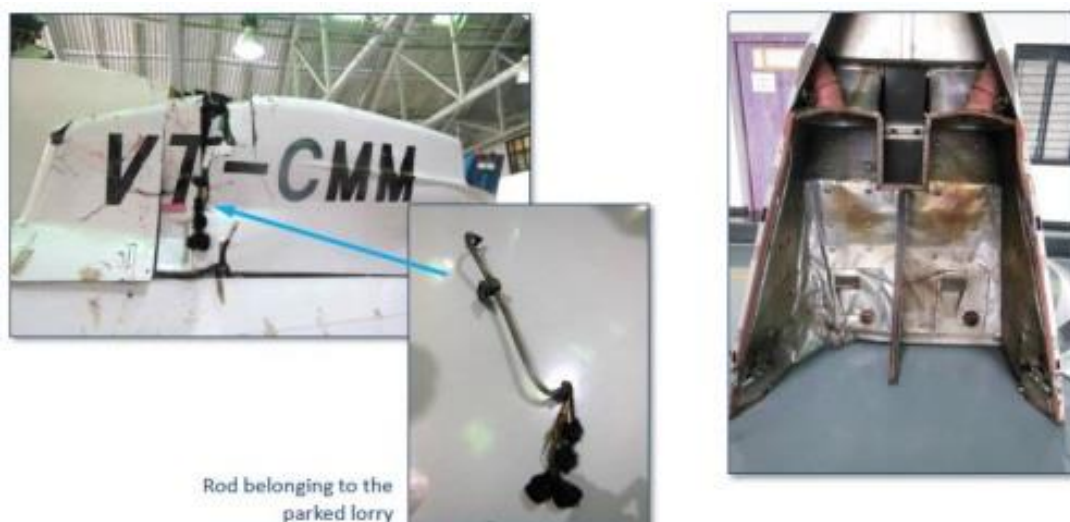
Fig:15 – Engine cowling

The engine cowling revealed impact damage to its left hand side. A rod belonging to the lorry that was hit during the crash had pierced and penetrated the cowling's left flank. The inside of the cowling was unremarkable with light heat stains (the RH one being slightly larger) in the vicinity of the engines' turbines.

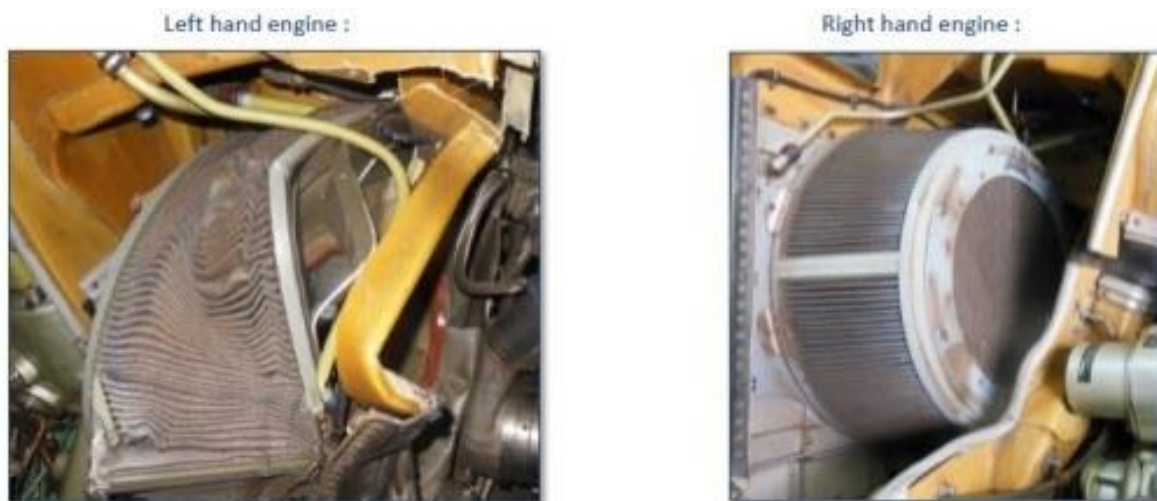
Fig:16 – Air Intake Filters

Both air intakes were fitted with sand filters which showed the presence of dust and small debris of vegetation. The RH filter was in good condition. The

LH filter was damaged during the sequence of the accident, leaving gaps that could allow debris to penetrate into the main air path.

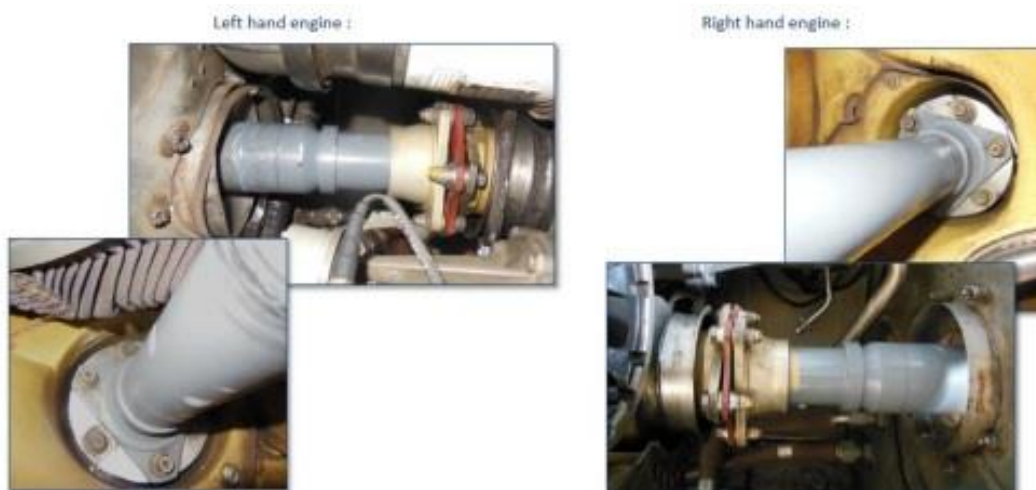
Fig:17 – Drive Shafts

The drive shafts were in place on both sides. The LH shaft showed circular traces of contact with static parts and a slightly warped flexible coupling indicative of light misalignment between the engine and the Main Gearbox as a consequence of the accident. The RH shaft did not exhibit any remarkable findings.

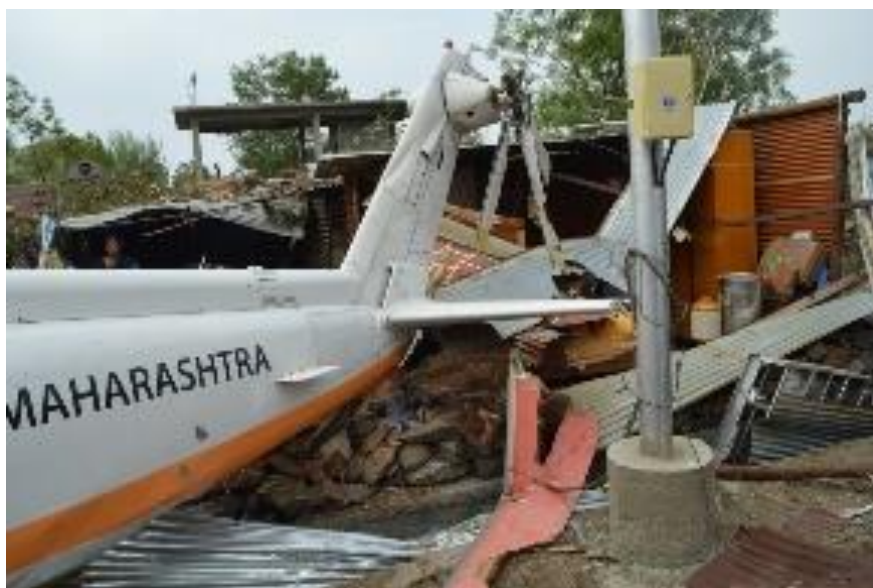
Fig:18 – Hut hit by tail boom

1.4 Other damage: The Helicopter tail boom hit a hut causing its roof and wall to collapse on the occupants.

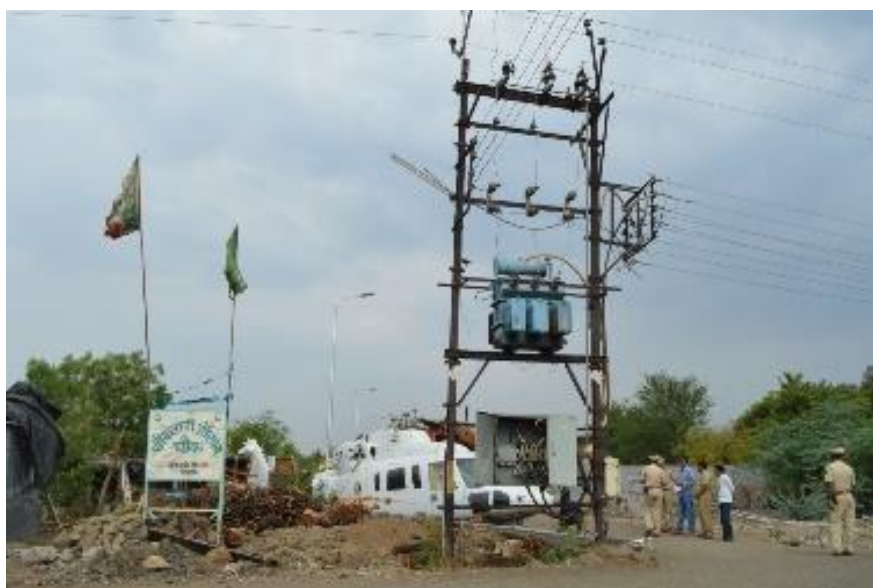
Fig:19 – 11 KV Electricity Transmission line

- The helicopter had hit a 11KV Electrical Cable, resulting in snapping of the cable. The cable had to be repaired to restore electricity supply.

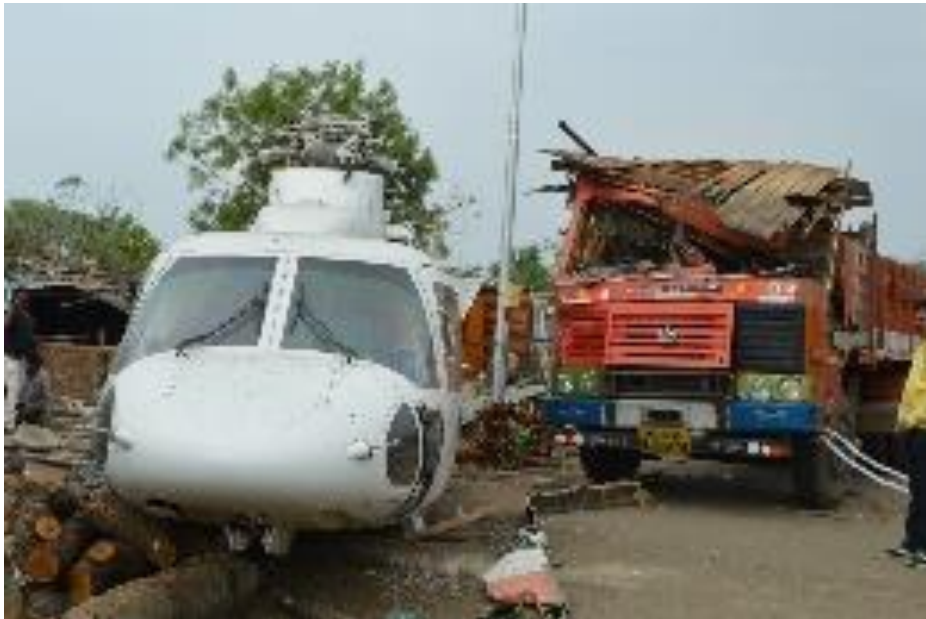
Fig:20 – Truck hit by Main Rotor

- The Main Rotor of the Helicopter had hit a tree and a truck parked nearby. The cabin of the truck was damaged by the impact of rotorblades and a steel railing from the truck got entangled in the main rotor blade.

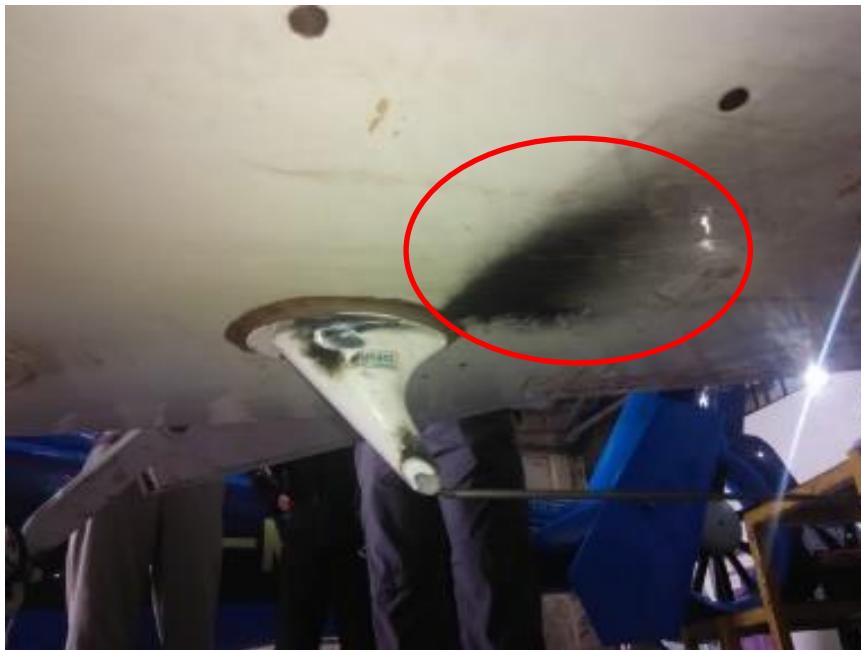
Fig:31 - Burn marks on belly

the belly of the helicopter hit the cables and caused it to snap, and the helicopter yawed to the right.

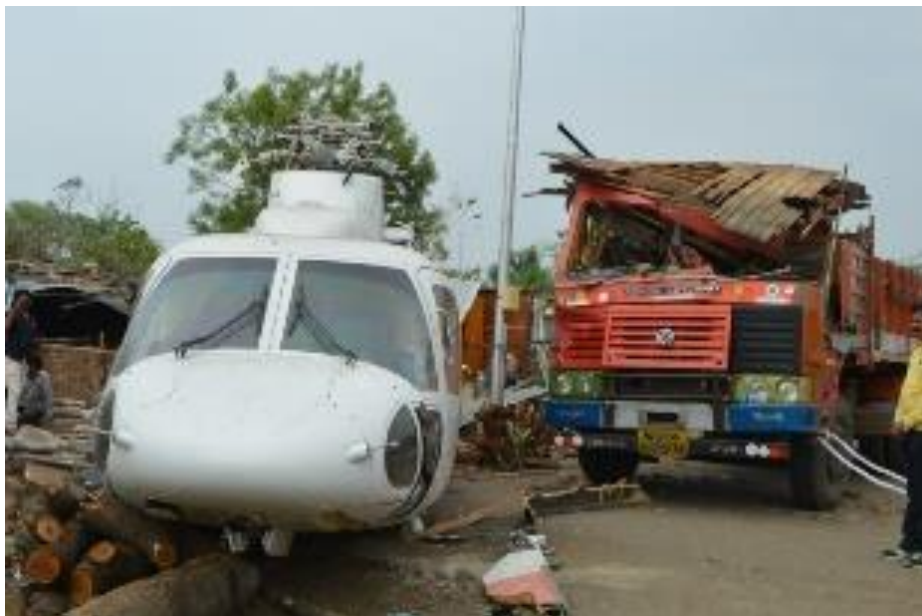
Fig:32 – Truck hit by main rotor

7. Subsequently, the main rotor blade hit the tree and blades disintegrated.
8. The helicopter there after crash landed and settled on the ground between truck and the hut.

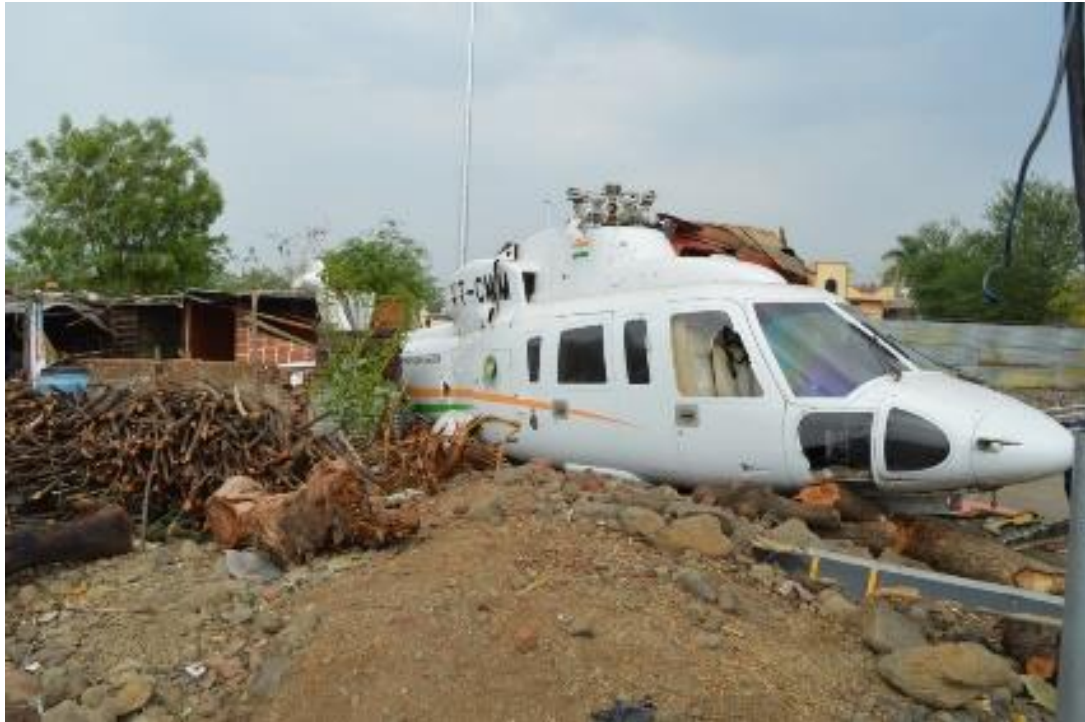
Fig:33 – Final resting position of helicopter

10. The tail boom of the helicopter hit a temporary house and damaged it and also injuring its occupants.
11. The one end of the snapped cable hit one of the person standing close to the accident side and injured him.
12. There was no fire after the helicopter impacted various obstacles before settling on the ground.

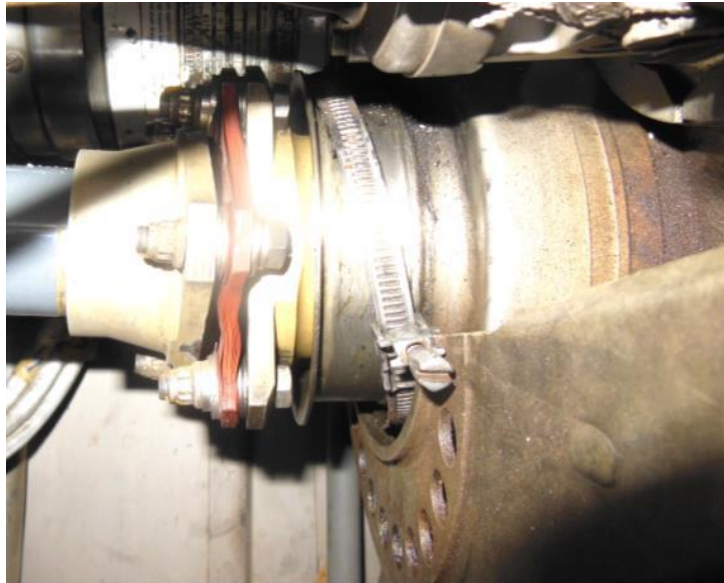
Fig:35 – LH Engine Module 1

Five fixing screws (out of 11) were sheared and were found on the engine bay floor along with their associated dowels indicating excessive lateral or vertical load at the time of impact.

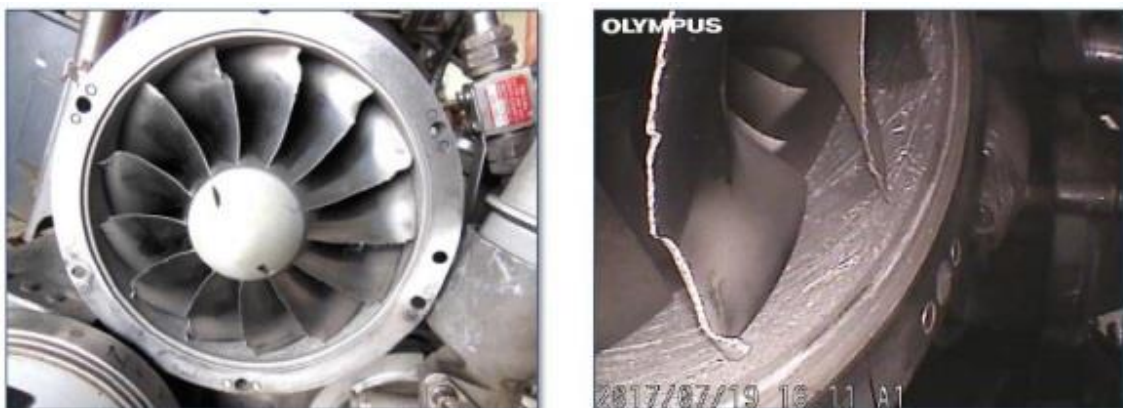
Fig:36 – LH Engine Module 2 – Axial Compressor

The casing of module 2 axial compressor was in good condition. The axial compressor exhibited significant FOD damage and deep scoring on the shroud indicating the ingestion of hard FOD. The numerous deep impacts affecting all the blades indicate that the engine was rotating at the time of the ingestion. The penetration of the FOD was made possible by the openings in the damaged LH barrier filter. As a consequence of the FOD ingestion, the Gas Generator could not be rotated by hand at the time of the examination.

The LH air intake barrier filter was damaged during the accident, leaving gaps that could allow debris to penetrate into the main air path. The compressor and the turbine exhibited significant damage consistent with the ingestion of hard metallic FOD. The findings in the HP turbine indicate that the engine was running at the moment of ingesting those FOD's made of metals with a fusion temperature close to that existing inside the combustion chamber with an established flame. Their solidification in the HP turbine and their absence in the Power Turbine indicate that the ingestion occurred shortly before the engine shut-down.

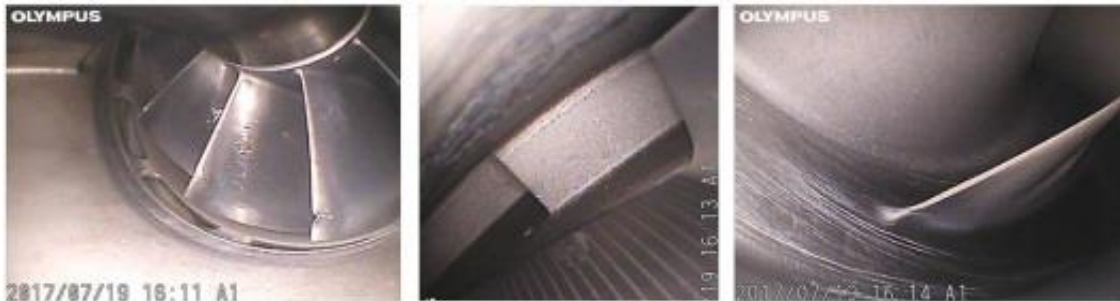
Fig:37 – LH engine Module 2 – Centrifugal Compressor

The boroscopic inspection showed FOD damage to the leading edges of the centrifugal impeller's blades. The base of the air path showed scoring marks left by hard FOD. The centrifugal diffuser's vanes were in good condition. The ingested FOD did not leave any splatter on the vanes.

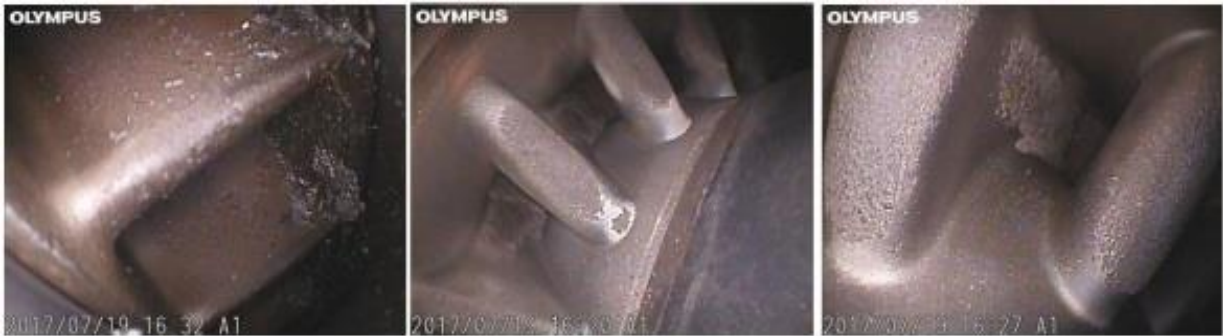
Fig:39 LH engine Module 3 – HP Turbine

The HP turbine blades too exhibited the presence of solidified metal around their tips with metal spread on the shroud. The blades' leading and top edges appeared in good condition without erosion nor corrosion.

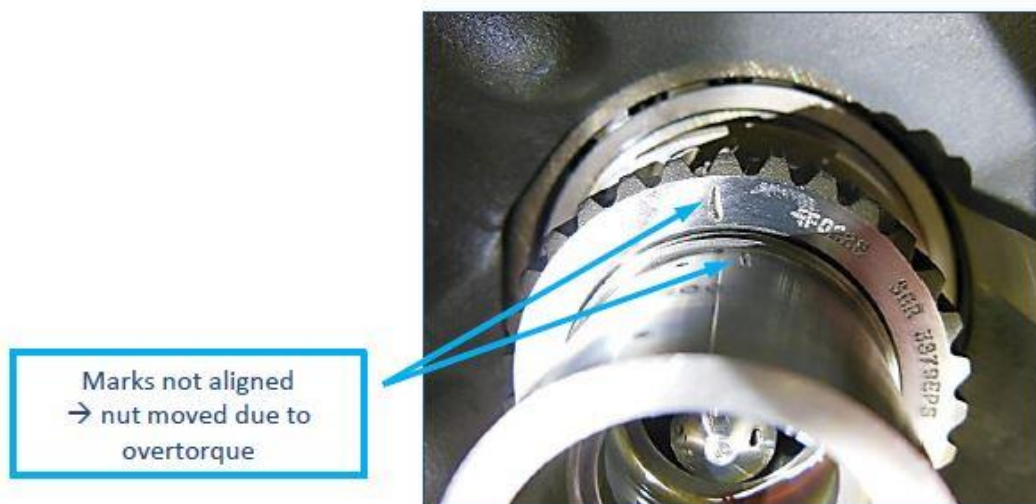
Fig:41 – Misalignment in drive nut

The module 5 was in good condition and rotated smoothly. It was separated from the Power Turbine module in order to reveal the splined drive nut on the drive gear's shaft. This nut transfers the torque delivered by the Power Turbine through the muff coupling to the reduction gearbox's gear train. Its position on the shaft is marked during the assembly process.

The drive nut's close examination revealed that the marks had moved by over 2mm indicating over torque caused by due to impediment to reduction gear box caused by rotor blades hitting obstacles during accident.

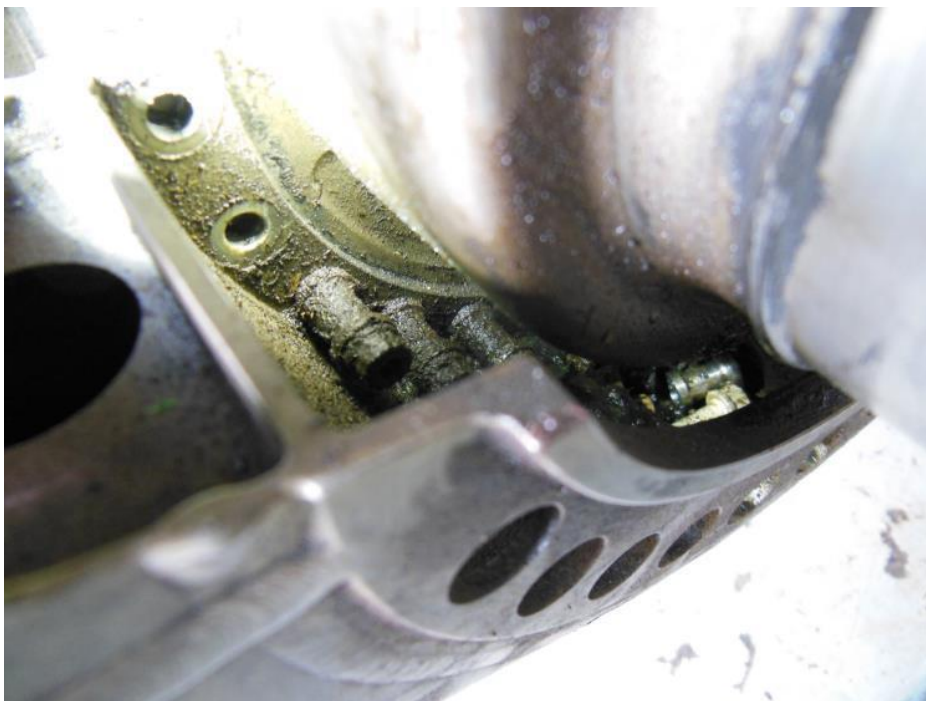
**Fig:43 - RH engine Module 1
- Module 2 (Axial Compressor)**

Two fixing screws (out of 11) were sheared and were found at the bottom of the front support along with their associated dowels thus indicating excessive lateral or vertical load at the time of impact.

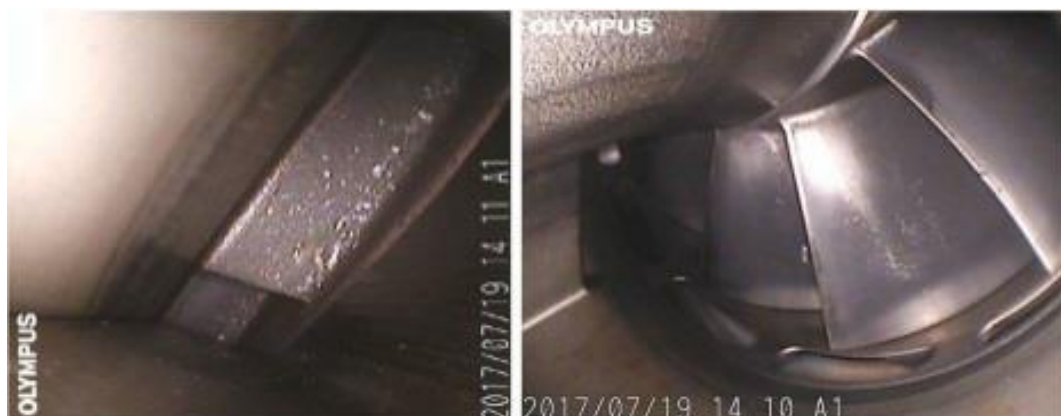
Fig:45 - RH engine Module – Centrifugal Compressor

The boroscopic inspection showed light FOD damage to the leading edges of some of the centrifugal impeller's blades (bottom left photo). Both the impeller's blades and the diffuser's vanes showed sharp straight leading edges without any significant erosion.

The centrifugal diffuser's vanes were in good condition and exhibited the presence of metallic splatter possibly caused by soft FOD and/or soft abrasable

coating being scrapped off the centrifugal impeller's cover whilst the engine was running during the accident and/or the Power Turbine blade-shedding.

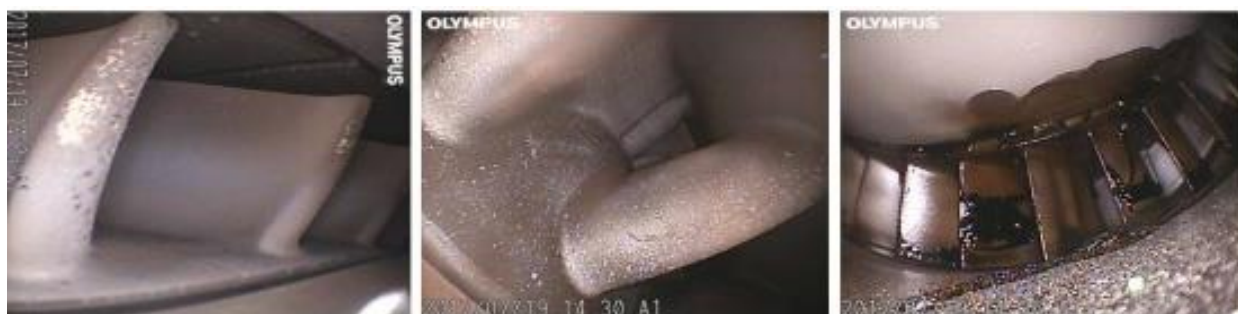
Fig:47 - RH engine Module 3 – HP Turbine

The boroscopic inspection of the Nozzle Guide Vane (NGV) showed that the vanes' leading edges were evenly covered with metallic splatter which are consistent with the compressor's condition. These deposits affected all the vanes similarly (bottom left photo).

The HP turbine blades' leading and top edges appeared in good condition without erosion nor corrosion (top right photo). The blades also exhibited the presence of metal splatter on their leading edges. All the blades were similarly

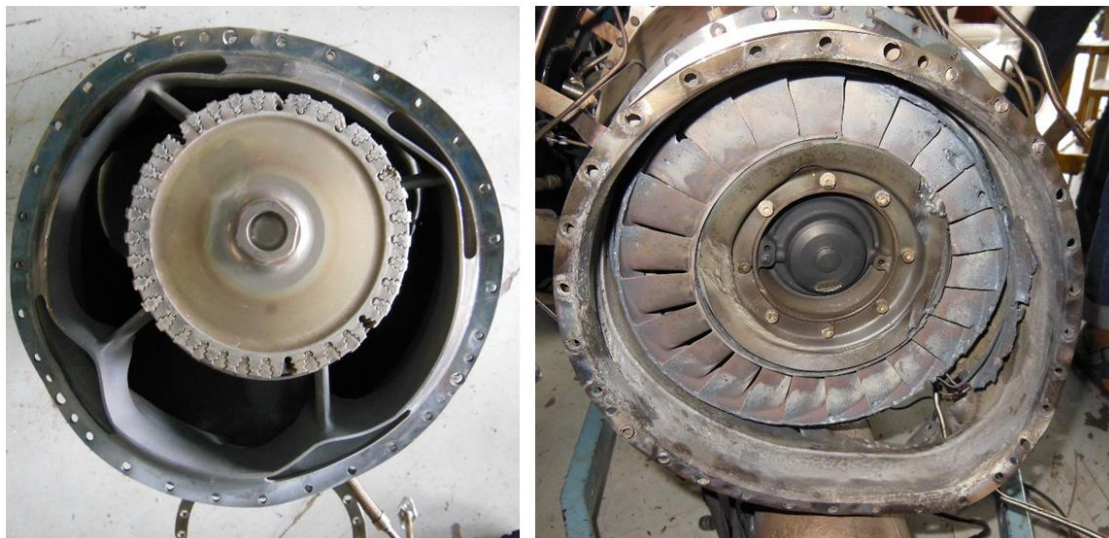
Fig:48 - RH engine Module – Power Turbine

The module 4 exhibited a deformed casing and several of the screws used to fix it to module 3 were ruptured and had fallen on the engine deck. The examination of the Power Turbine wheel revealed that all the blades had come off.

Some harnesses exhibited limited local thermal damage following the blade-shedding. The power drive chain (Power Turbine, reduction gearbox and output power drive shaft) could be rotated manually. Some rubbing was felt during the manual rotation of the Power Turbine and a sticking point was felt during the rotation of the reduction gearbox. These findings are consistent with the forces released during the blade-shedding.

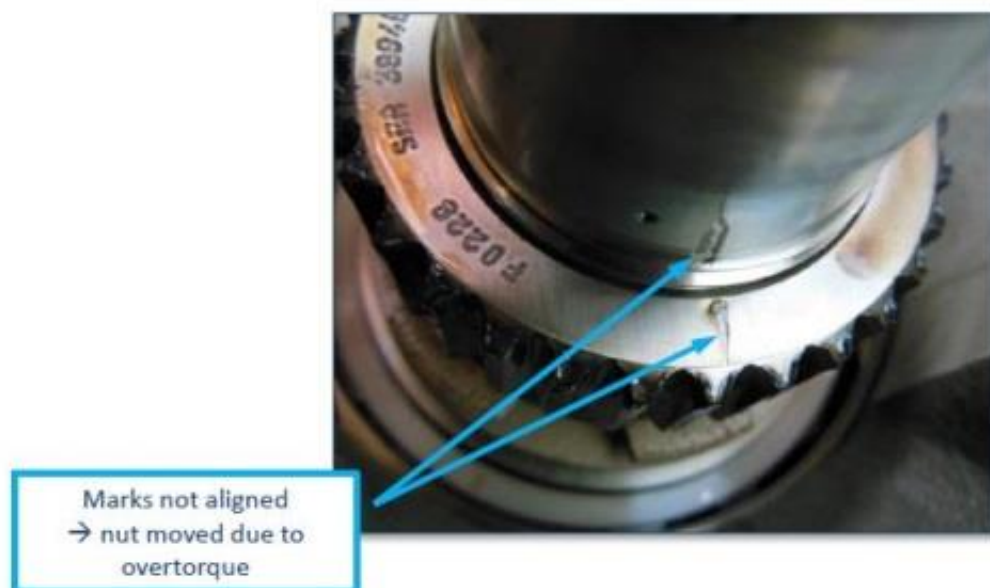
Fig:49 - RH engine Drive Nut

The module 5 was separated from the engine. A section of the casing used to centre it on the back of the module 4 was broken due to the forces released during the blade-shedding. The shafts could be rotated and a sticking point could be felt during the rotation.

Once the module was separated, the splined drive nut on the drive gear's shaft could be examined. This nut transfers the torque delivered by the Power Turbine through the muff coupling to the reduction gearbox's gear train. Its position on the shaft is marked during the assembly process. Should the rotation of the reduction gearbox's output shaft be impeded during engine operation, then the torque applied by the Power Turbine on the nut will increase. During an accident, this may lead to an over torque capable to rotate the nut on its shaft.
