No. : AV.15013/5/2008/AS

**ON ACCIDENT TO PUNJAB GOVERNMENT KING AIR C-90
AIRCRAFT VT-EHY AT VILLAGE JUGIANA NEAR
SAHNEWAL AIRPORT LUDHIANA ON 29.10.08**

**AIR SAFETY DIRECTORATE
O/o DIRECTOR GENERAL OF CIVIL AVIATION
OPP. SAFDARJUNG AIRPORT, NEW DELHI**

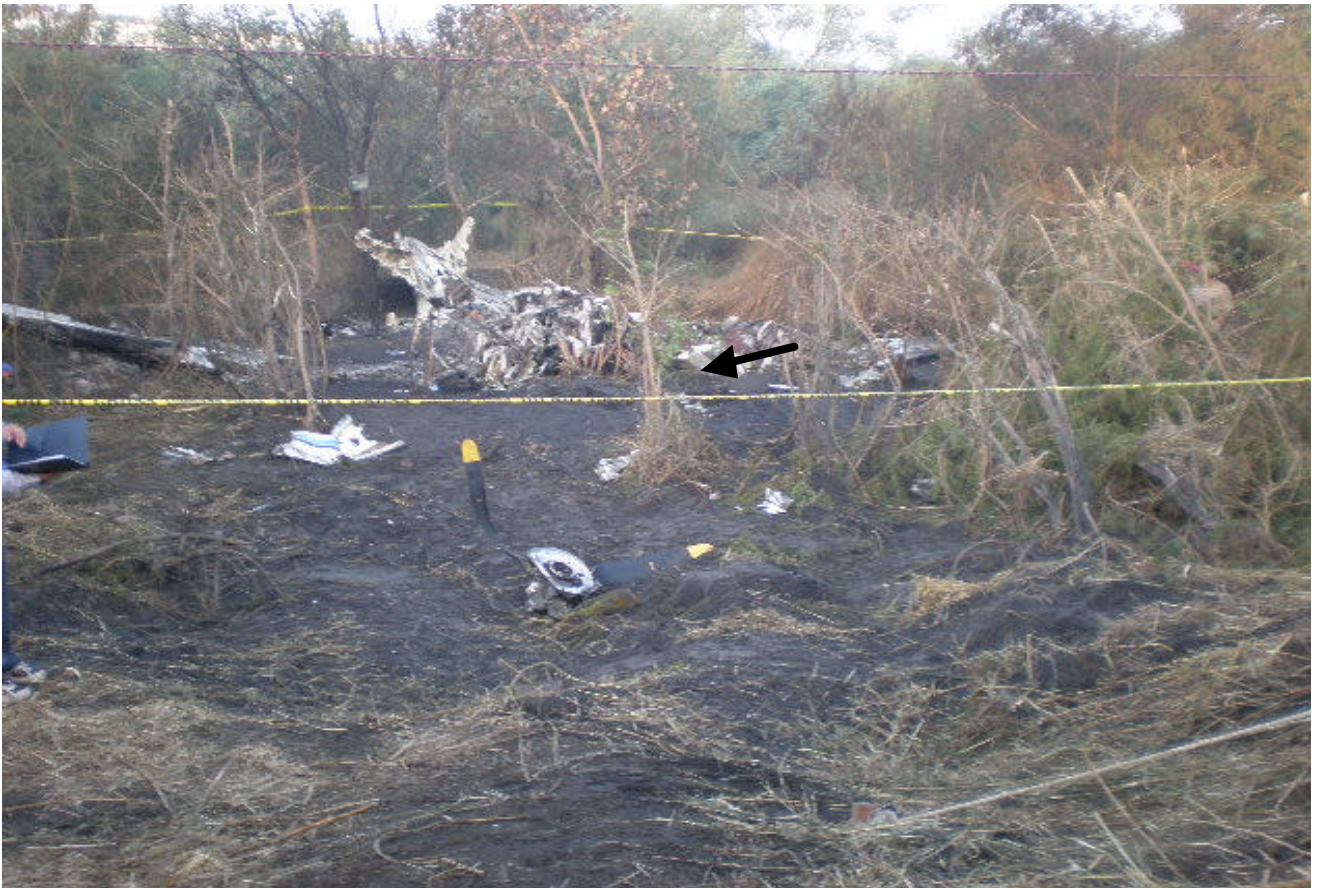
Aircraft approached the accident site in steep left bank. The left propeller impacted the ground and separated from the engine shaft due to bending and the right propeller hit the long bushes at a height of around 10.5 feet. One of the left propeller blades was found buried in the ground though attached to the hub. Aircraft finally rested at a place thirty feet away from the point of first impact. After the first impact the aircraft turned almost 270 degree and impacted the ground in nose pitch down attitude. At the point of first impact a large crater of a width of approx. 5 feet was formed. At approx. 2 ft. from the point of first impact portions of the engine bottom fairing was found in broken condition and no sign of burn were observed on it. After the second impact the aircraft caught fire and a large portion of aircraft got burnt/ melted/ fused. Before the point of first impact no aircraft part/component was recovered along the direction of flight. Detailed wreckage dig is given as appendix 'A'.

Wreckage site with direction of flight indicated

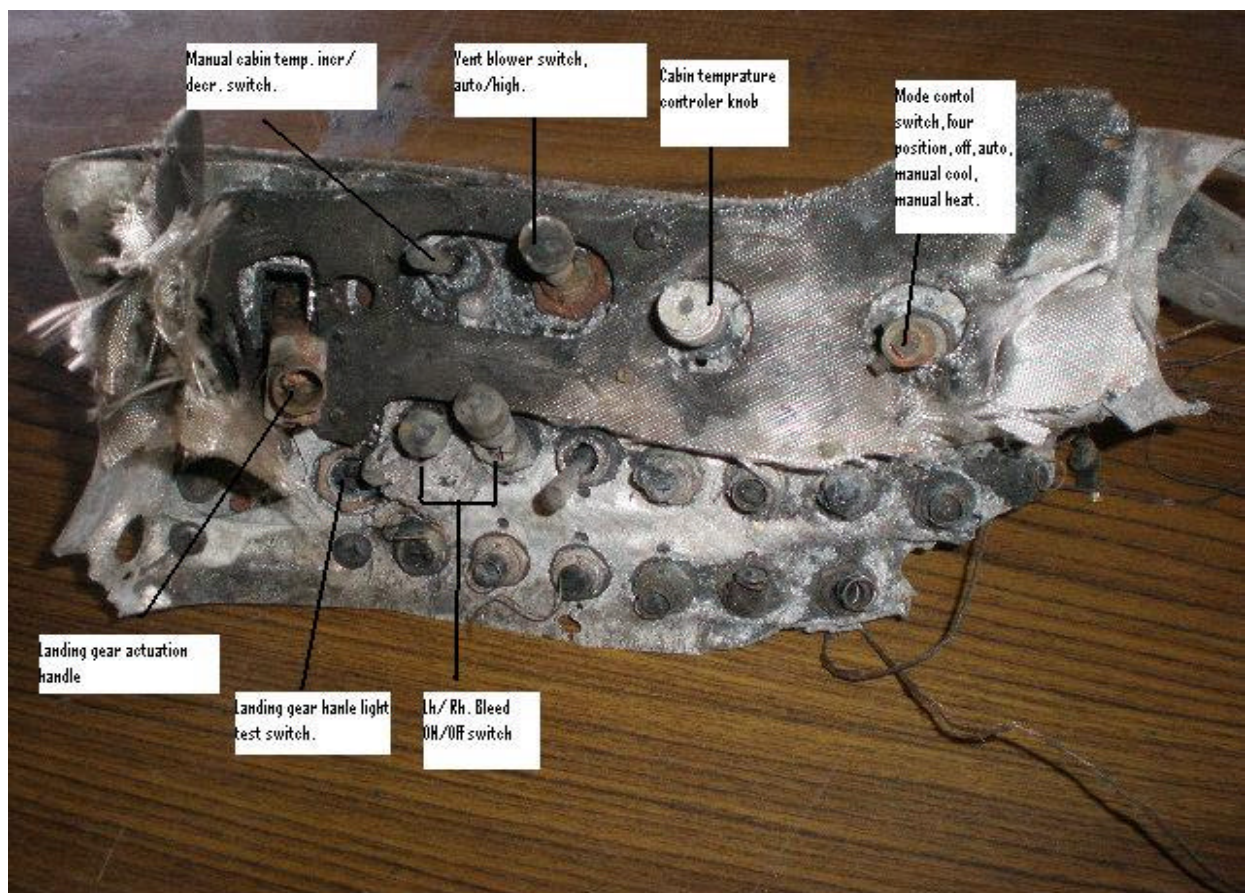
Position of switches on Landing Gear Control Switch Panel

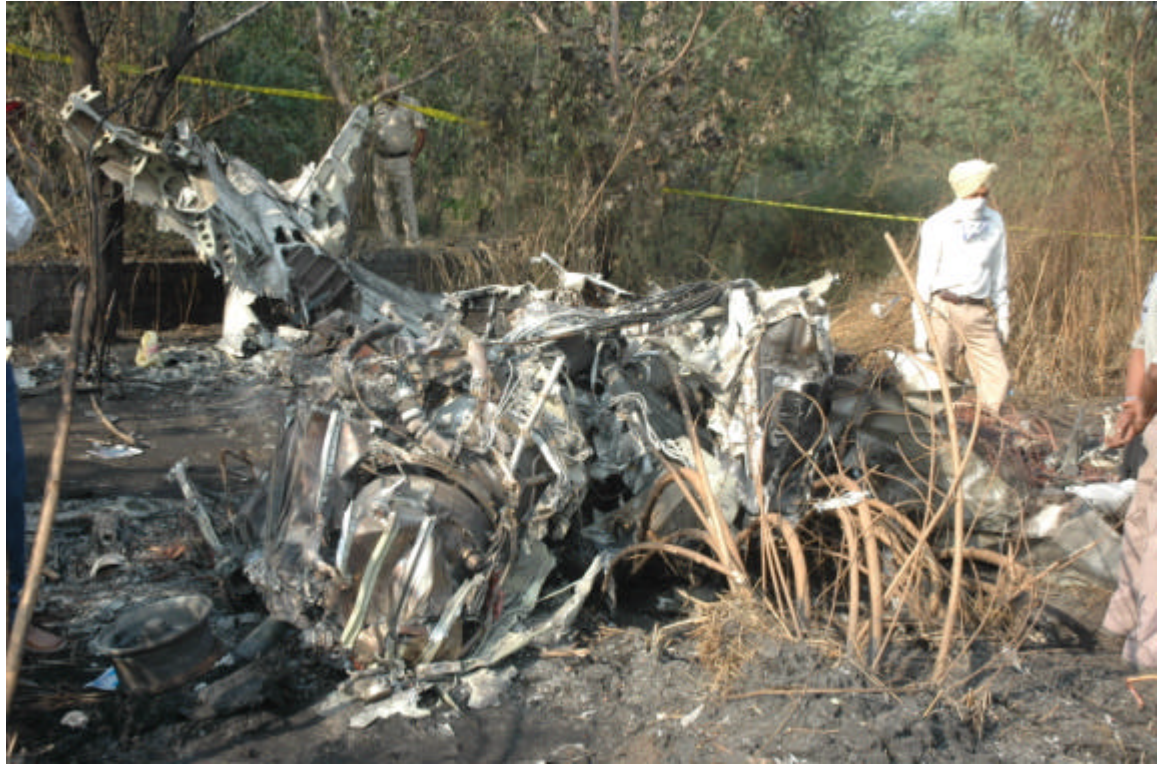
- e. **Empennage Section:**
Portion of dorsal fin and vertical stabilizer with portion of rudder attached but bent towards right, horizontal stabilizer with elevators attached, recovered. A portion of right hand side stabilizer and elevator found broken after hitting a tree and lying nearby at distance of approx. 2 feet. Complete section was discoloured due to heat. Control Linkages for rudder and elevator found intact with cables attached. At few portions molten metal puddle dropping downward observed. Anti collision light on stabilizer had separated but lying near the empennage section. Empennage section was resting on brick embankment of approx. 4 feet height. Trim Tab on elevator found slightly downward. Elevator was found in level condition.

Closer view of wreckage indicating empennage, fuselage, L/G, engine, portion of right wing

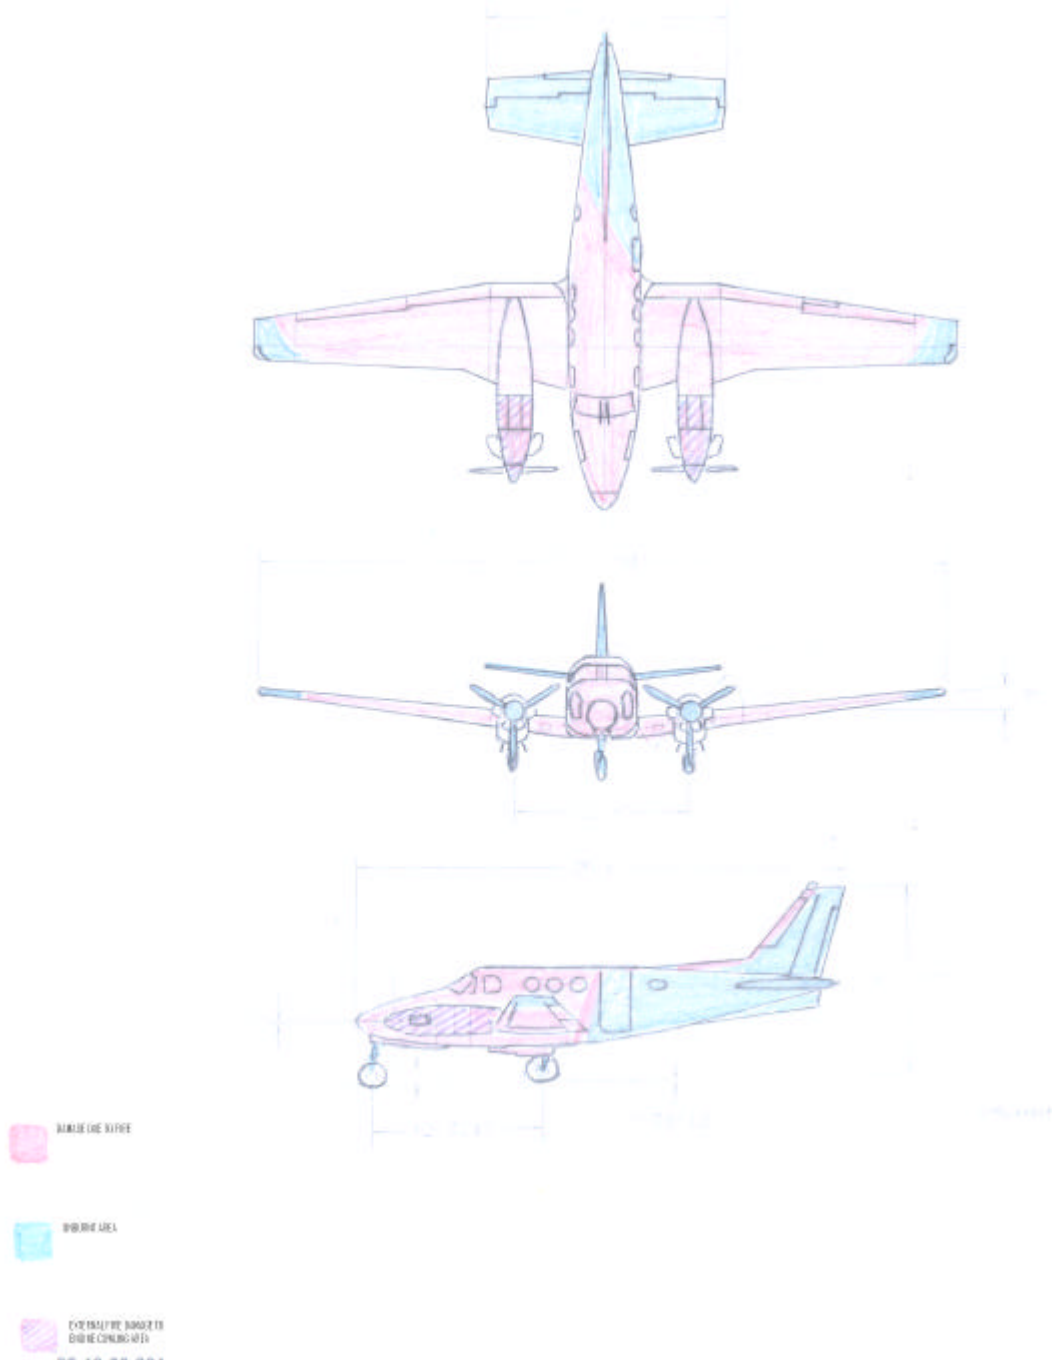
A large portion of aircraft was found burnt/ melted/ fused due to the fire. The examination of the wreckage revealed that the fire was post impact. There was no sign of in-flight fire. The eyewitness also confirmed that no fire was seen before the impact. Probably after the second impact the fire started. Due to impact the nacelle fuel tanks got ruptured. The fuel coming out of the ruptured fuel tanks came in contact with the hot engines and thus caused fire.

Description of fire damage

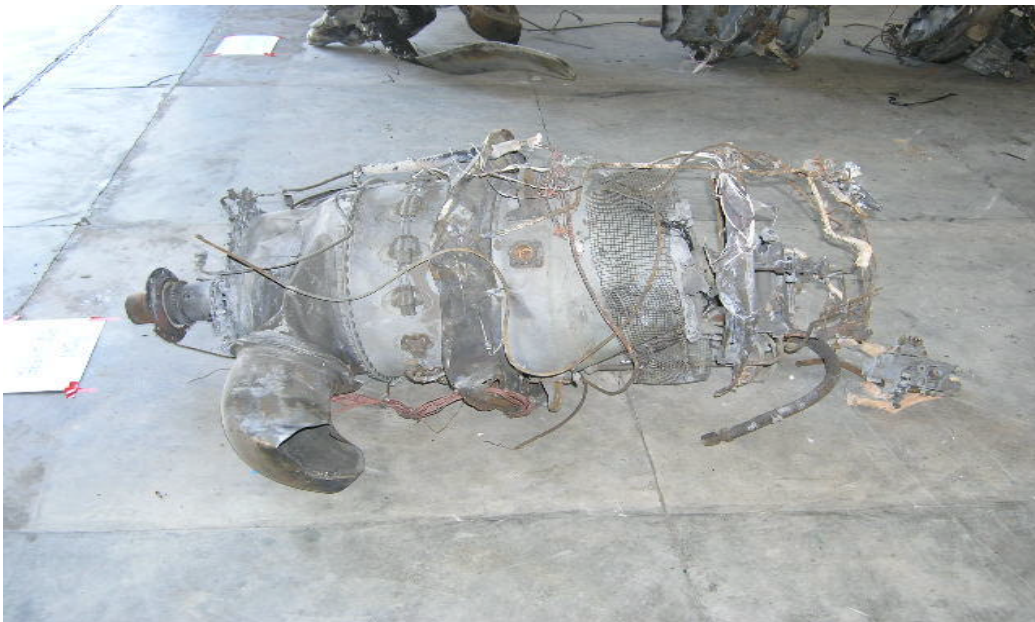
Reduction Gearbox: The housing was completely consumed by fire, exposing the reduction gearing. The propeller shaft was impact fractured immediately aft of the propeller mounting flange. The propeller governor housing was completely consumed by fire. The propeller governor input lever was continuous with the airframe linkage. The propeller governor drive shaft and flyweight assembly was

Gas Generator Case: Displayed no apparent deformation. The inlet plenum was completely consumed by fire, exposing the compressor inlet, No. 1 bearing housing, and accessory gearbox input shaft. The fuel manifold was in place. The transfer tubes were melted or consumed by fire. The compressor bleed valve was in place.

Accessory Gearbox: The accessory gearbox was completely consumed by fire. The fuel pump drive gear and the high pressure fuel pump with the fuel control unit drive assembly were recovered separately. The remainder of the fuel control unit and rest of the accessory gearbox mounted controls and accessories were not recovered or were consumed by fire.

Engine left hand view.

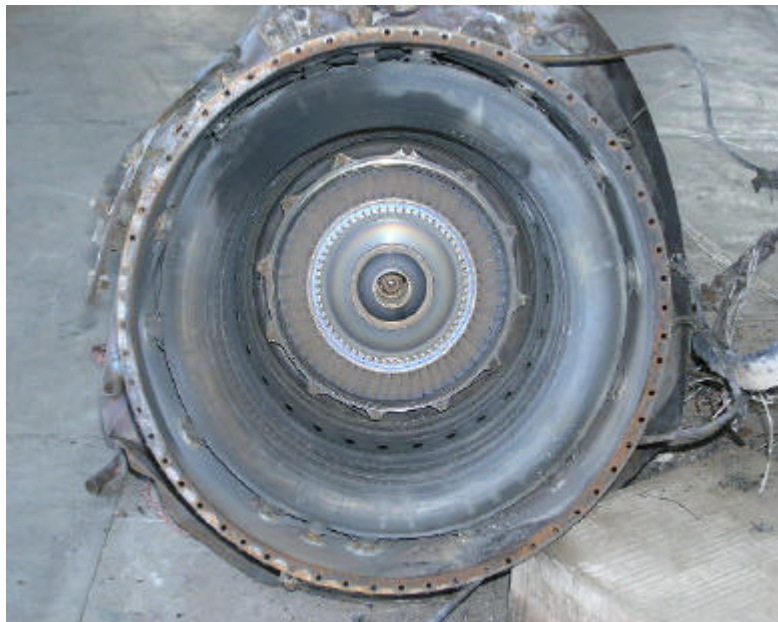
Combustion Chamber Liner: Displayed no indications of operational distress.

Small Exit Duct: Observed in-situ. Displayed no indications of operational distress.

Combustion chamber liner and compressor turbine, in-situ.

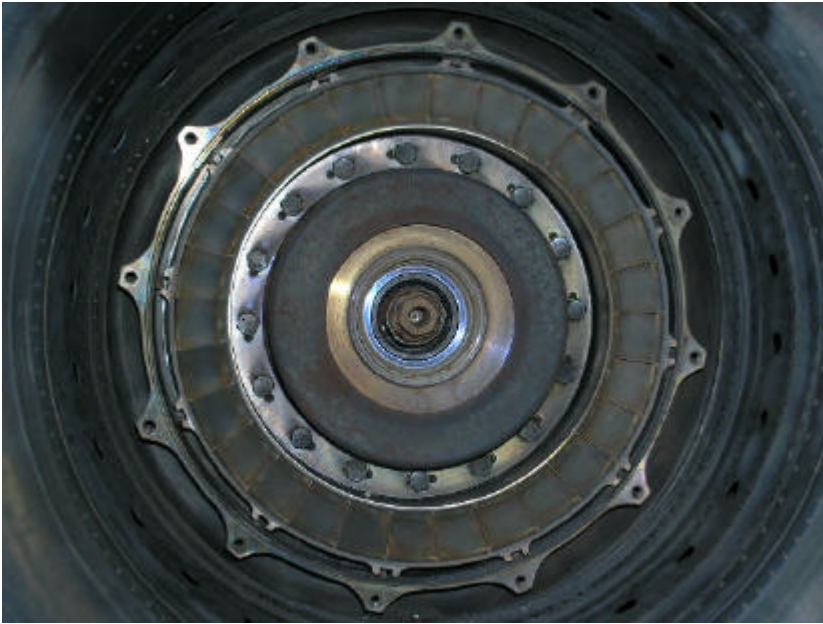
Compressor Turbine Guide Vane Ring: The vane airfoils displayed no indications of operational distress. The vane ring inner drum displayed circumferential rubbing due to axial contact with the compressor turbine.

Compressor Turbine Shroud: Displayed light circumferential rubbing due to radial contact with the compressor turbine blade tips

Compressor turbine guide vane ring and small exit duct, in-situ.

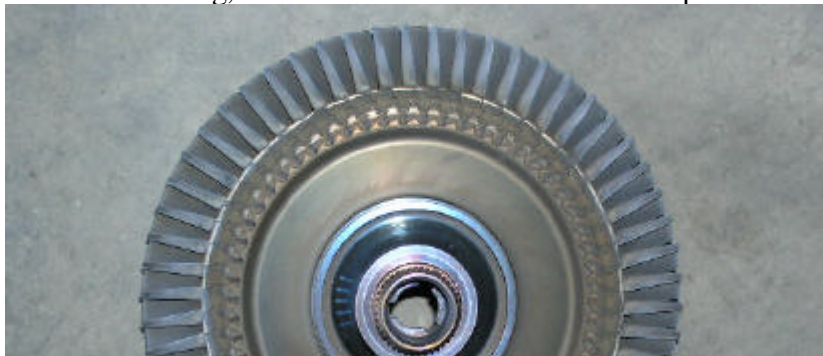
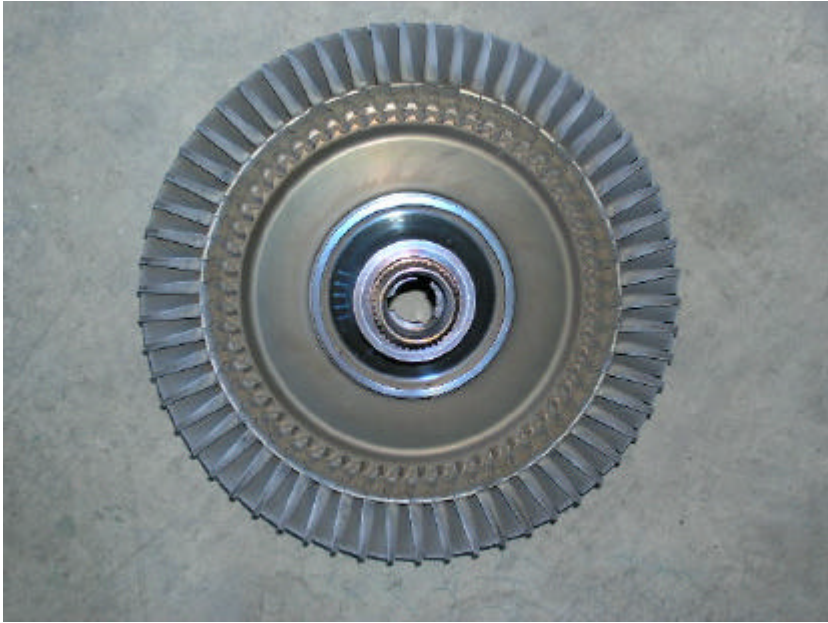
Compressor Turbine: The blade airfoils were intact. The disc upstream side displayed circumferential scoring to the blade platforms due to axial contact with the compressor turbine guide vane ring. The disc downstream side outer rim displayed heavy circumferential rubbing and machining, with frictional heat discoloration and material smearing, due to axial contact with the power turbine guide vane ring.

Compressor turbine, upstream side.

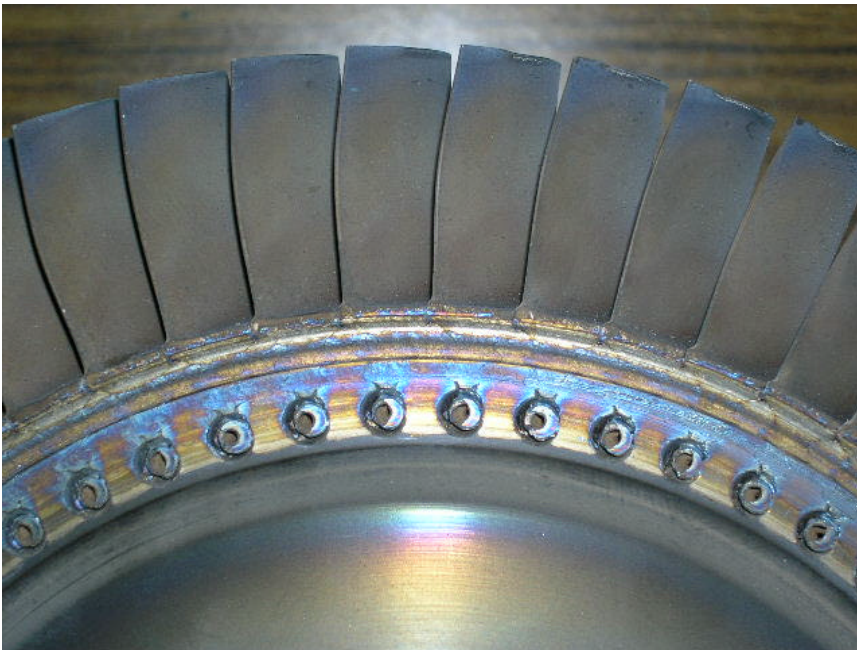
Compressor turbine, downstream side

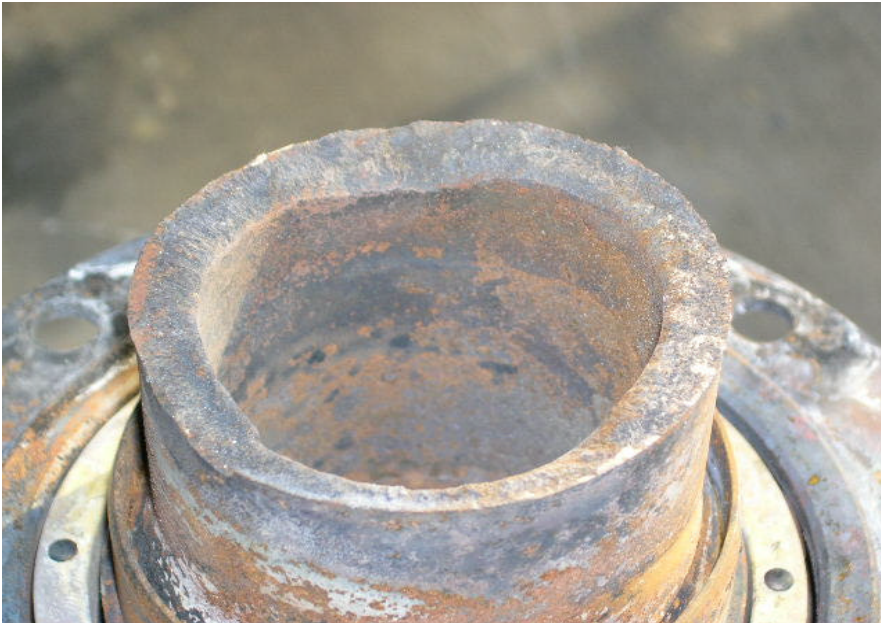
slant fracture surface and crescent shape rubbed area observed at the mating end of the propeller drive shaft, suggests that the drive shaft has failed in bending. Crescent shape area has been formed by running of mating fractured surfaces due to compression during bending. Probably the bending load has been imposed from the opposite side of the crescent shape area, on the propeller shaft causing its failure under bending overload condition. The leading edge of blades found to be clear of any dent with upper surface scratched and polished.

As per the report, the propeller drive shaft has failed under bending overload condition.

The reduction gearing was examined as exposed by the fire consumption of the reduction gearbox housing. The gearing displayed no indications of operational distress. The propeller shaft was fractured immediately aft of the propeller mounting flange. Unaided visual examination of the fracture surface displayed no indications of fatigue or other progressive fracture mechanism and indicated torsional and bending failure.

Propeller shaft, aft fracture face.

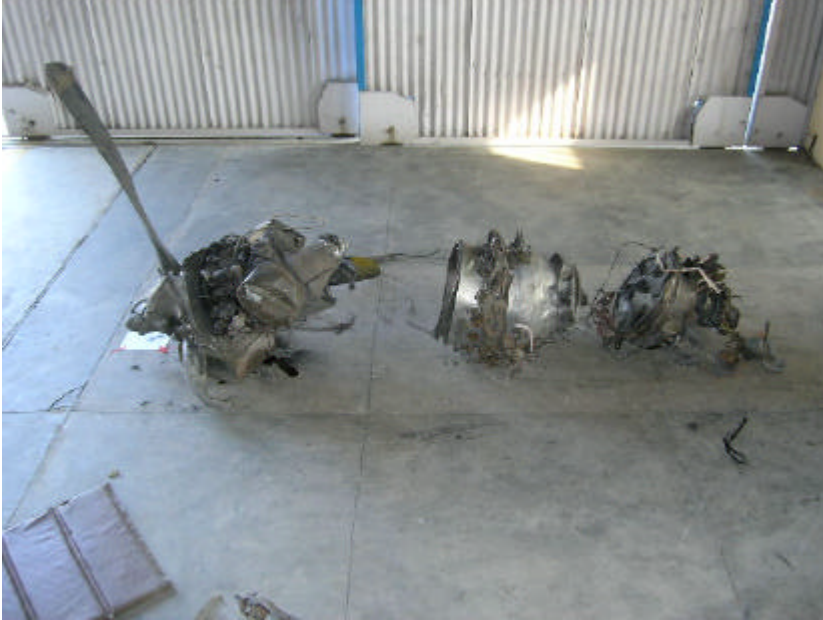
Engine left hand view.

Reduction Gearbox: Housing was essentially intact. The lower housing and chip detector mounting boss were impact fractured. The propeller shaft was intact. The propeller governor, over speed governor and the Np tacho were in place, with impact damage. The propeller governor input lever was continuous with the airframe linkage.

Exhaust Duct: The duct was torn and completely separated immediately forward of flange “C”, exposing the power turbine guide vane ring, compressor turbine, and the power turbine. The outer plenum remained attached to the gas generator case. The “C” flange retaining bolts were fractured and the flange partially separated from the gas generator case around the right hand circumference. The inner plenum remained attached to the reduction gearbox. The plenum was deformed sharply to the right and upward.

Gas Generator Case: Displayed severe compressional deformation. The inlet case support struts and plenum were impact fractured, exposing the compressor inlet and No. 1 bearing housing. The fuel manifold was in place. The compressor bleed valve was in place.

Accessory Gearbox: The accessory gearbox lower circumference was consumed by fire. The oil to fuel heater, high pressure fuel pump, fuel control unit, and ignition exciter were in place, with impact damage. The Ng tacho was not recovered.

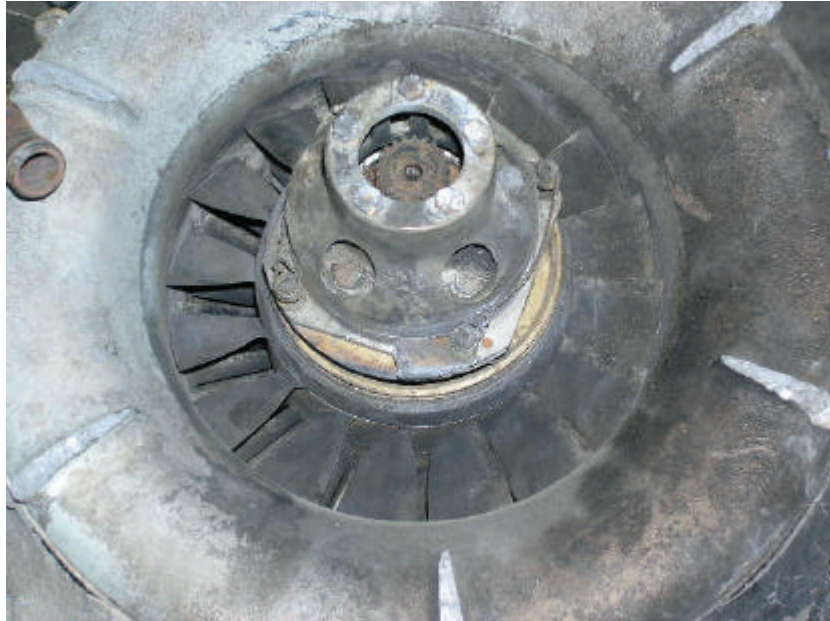
The compressor 1st stage blades, stator, and shroud were intact. The blade tips and shroud displayed circumferential rubbing, with frictional heat material smearing, due to their making radial contact. The No. 1 bearing housing was intact. The bearing could be rotated by hand.

Compressor 1st stage and No. 1 bearing housing, in-situ.

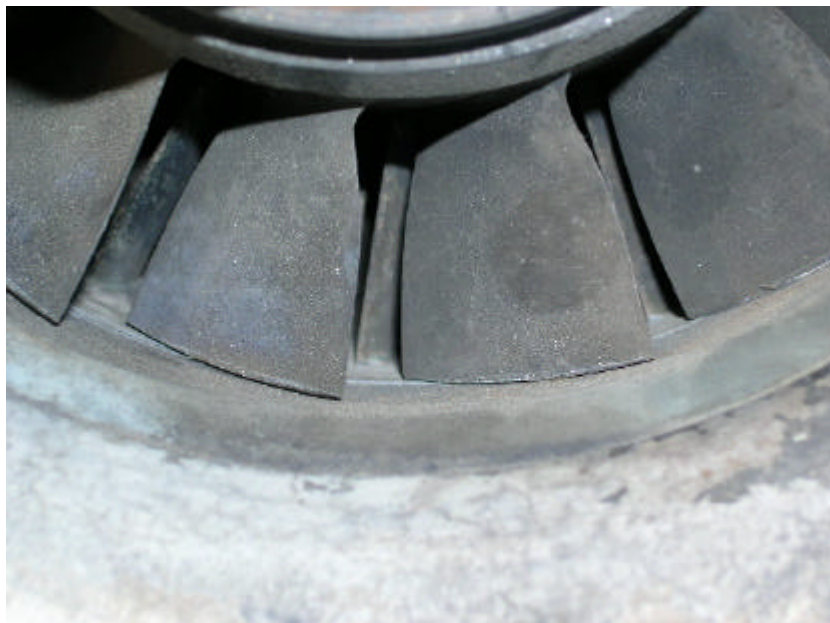
Compressor 1st stage blades and shroud, detail.

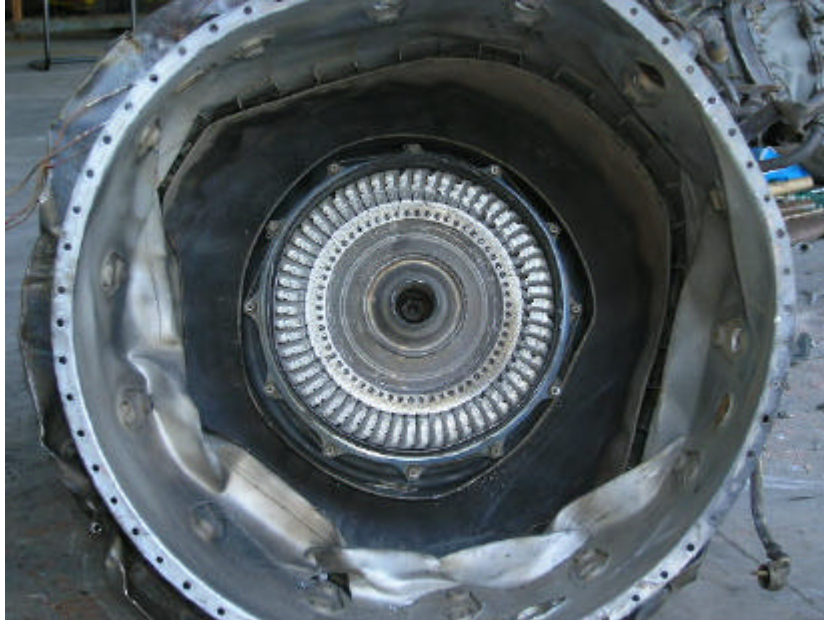
Small Exit Duct: Displayed no indications of operational distress.

Gas generator case interior, large and small exit ducts, and compressor turbine, in-situ.

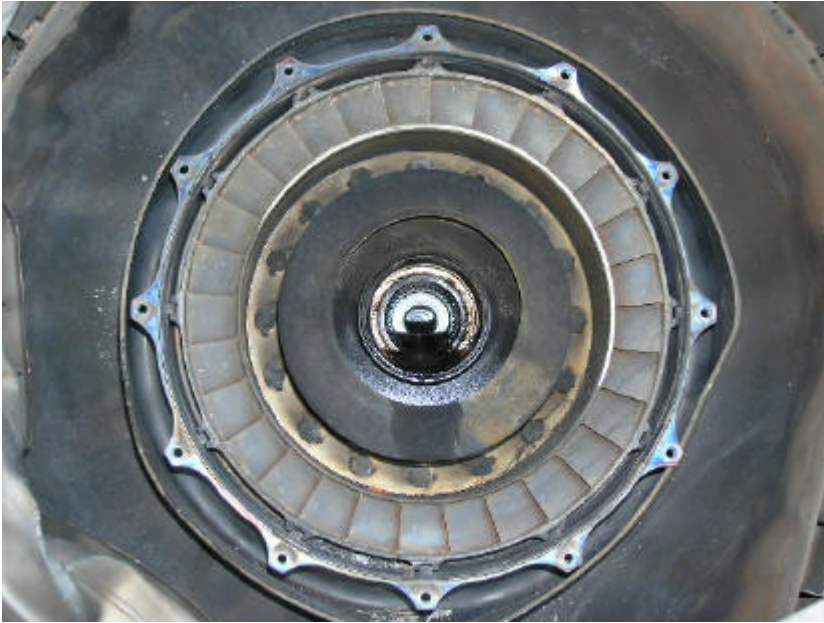
Compressor Turbine Guide Vane Ring: The vane airfoils displayed no indications of operational distress. The vane ring inner drum displayed heavy circumferential rubbing due to axial contact with the compressor turbine.

Compressor Turbine Shroud: Displayed heavy circumferential machining due to radial contact with the compressor turbine blade tips.

Small exit duct and compressor turbine guide vane ring, in-situ.

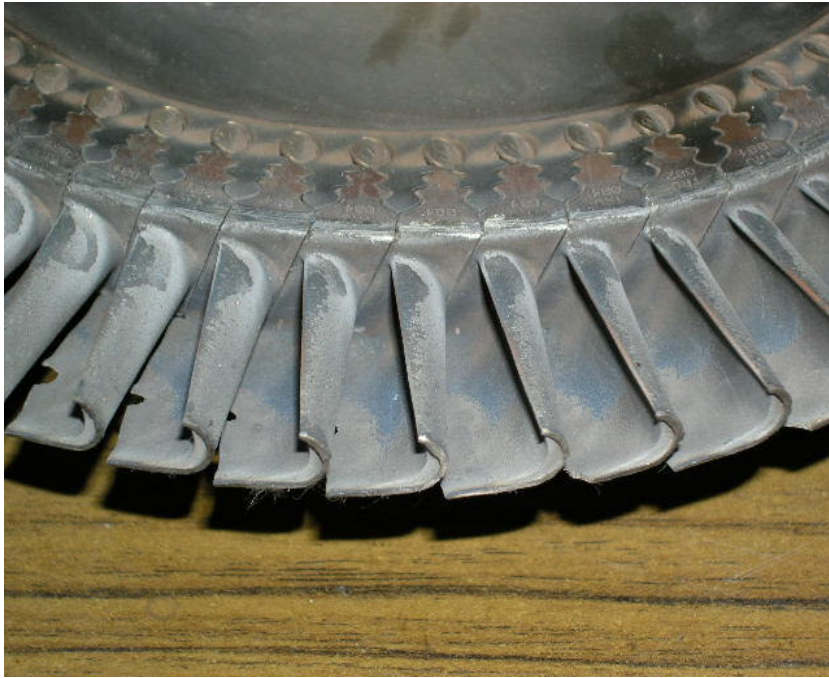
Compressor Turbine: The blade airfoils leading edges were intact. The disc upstream side displayed heavy circumferential scoring to the blade platforms due to axial contact with the compressor turbine guide vane ring. The disc downstream side outer rim and blade airfoil trailing edges displayed heavy circumferential rubbing and machining, with light frictional heat discoloration and material smearing, due to axial contact with the power turbine guide vane ring and the power turbine.

Compressor turbine upstream side, detail.

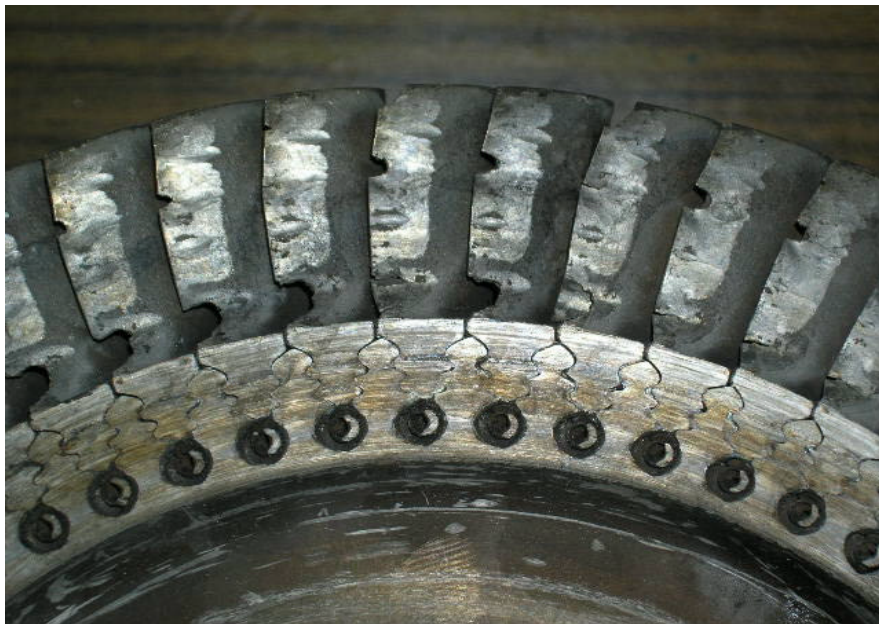
Compressor turbine downstream side, detail.

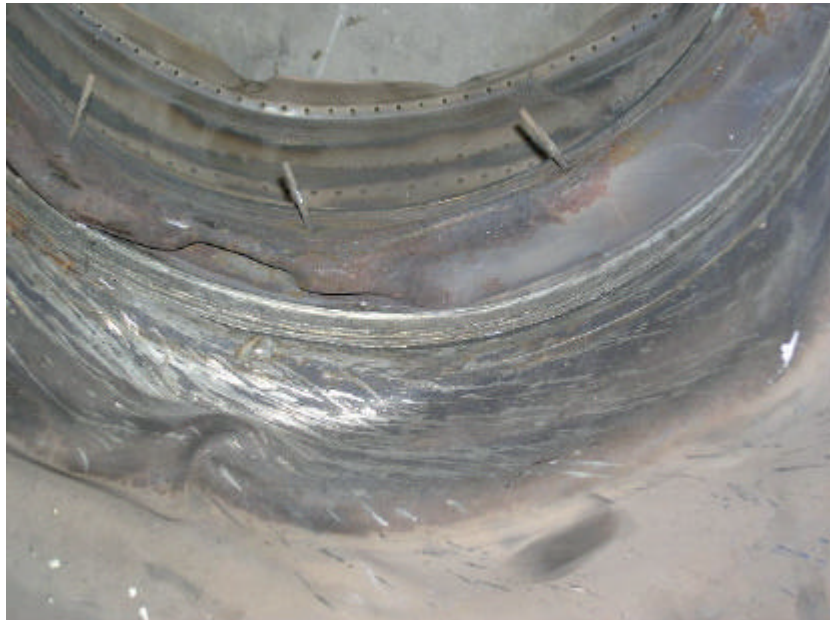
Power Turbine Shroud: The shroud and housing displayed severe circumferential rubbing and machining, with frictional heat discoloration and material smearing, due to radial contact with the power turbine blade tips.

Power turbine shroud and housing.
