**REPORT ON
ACCIDENT TO HAL ROTARY WING ACADEMY
CHETAK HELICOPTER VT-EIV AT HAL AIRPORT,
BANGALORE ON 27TH AUGUST, 2010**

**GOVERNMENT OF INDIA
CIVIL AVIATION DEPARTMENT
O/o REGIONAL CONTROLLER OF AIR SAFETY
SOUTHERN REGION, HYDERABAD AIRPORT
HYDERABAD-16**

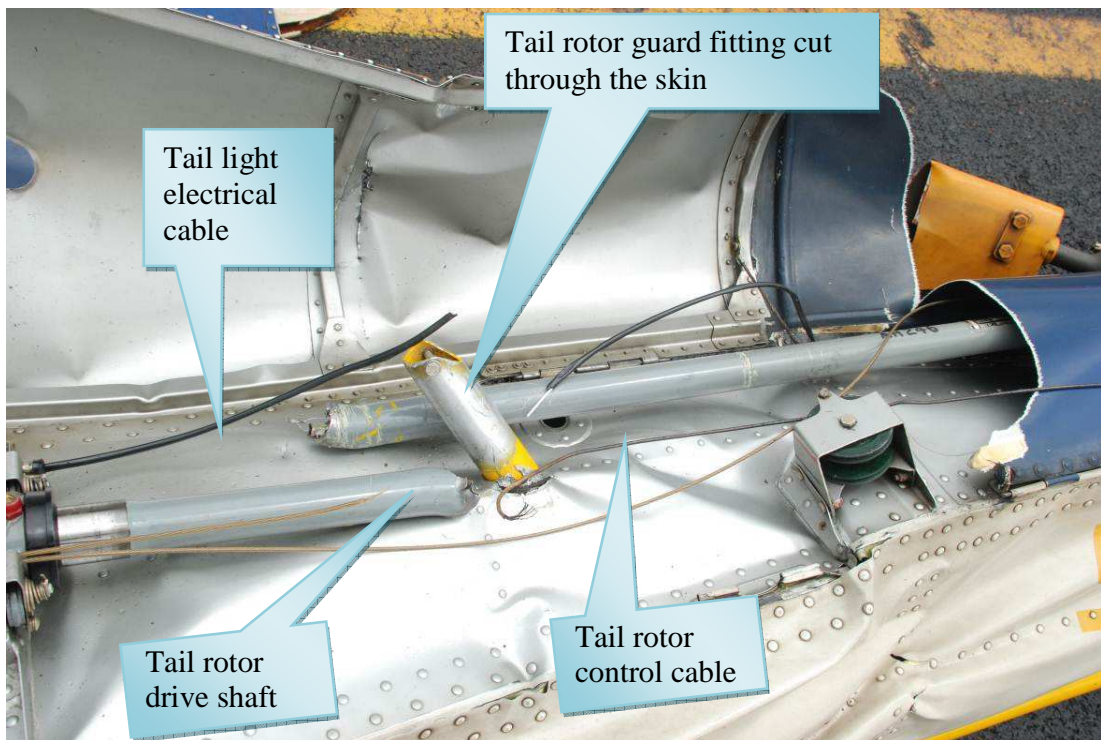
b. Tail rotor drive shaft (TGB side and MGB side):

The fracture of both the ends suggests that torsional fracture having slant fracture and marks of gauging (peeling) of protective coating of the shaft. These marks are in the folds of torsional fracture. This suggests that these marks were there on circumference of shaft before torsion occurred. The SEM factographs having shear dimples on fracture surface of tail drive shaft mating end (MGB side) indicates shear overload.

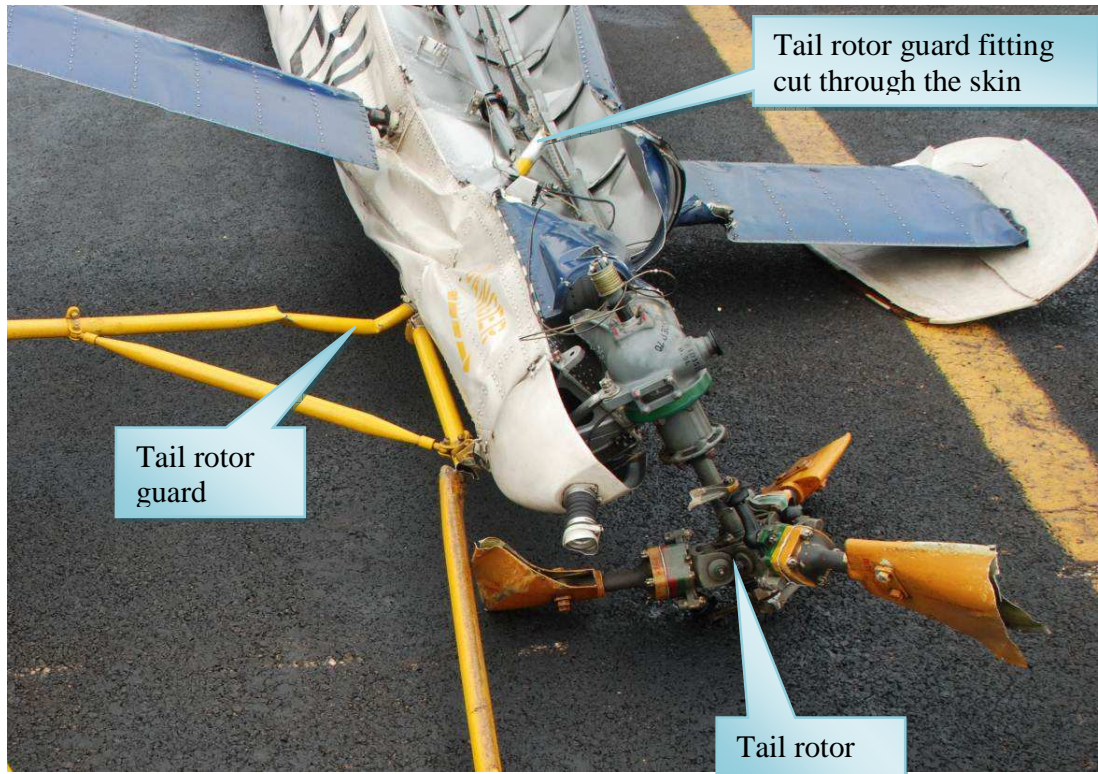
The failure of tail rotor guard upper fitting on tail boom top skin suggests that it was pushed upwardly elongating and failing both the bolt holes, cracking the top skin and probably hitting the tail drive shaft, thereby making circular marks on the protective coating of shaft. Bending of the bolt of tail rotor rod and smooth marks on its bend suggests that it is touching the rotor shaft. Top edge of the tube containing tail rotor guard also shows metal flow. The torsional force (produced by tail rotor upon hitting the ground) might have failed the shaft and buckling it torsionally.

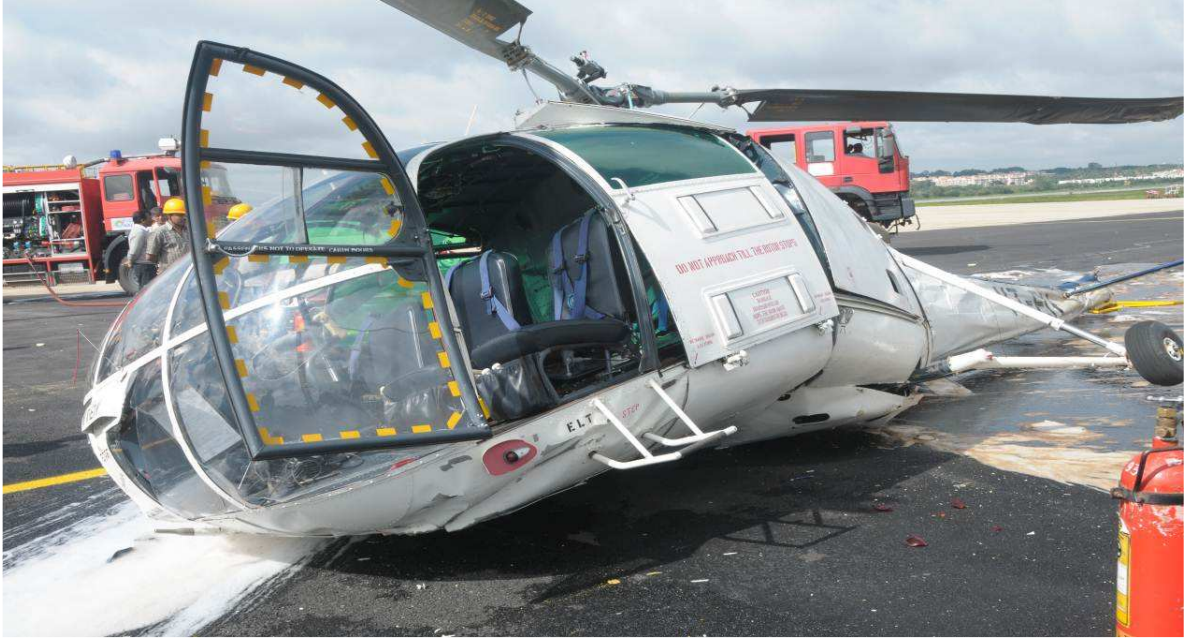
Helicopter resting on its belly in tilted condition

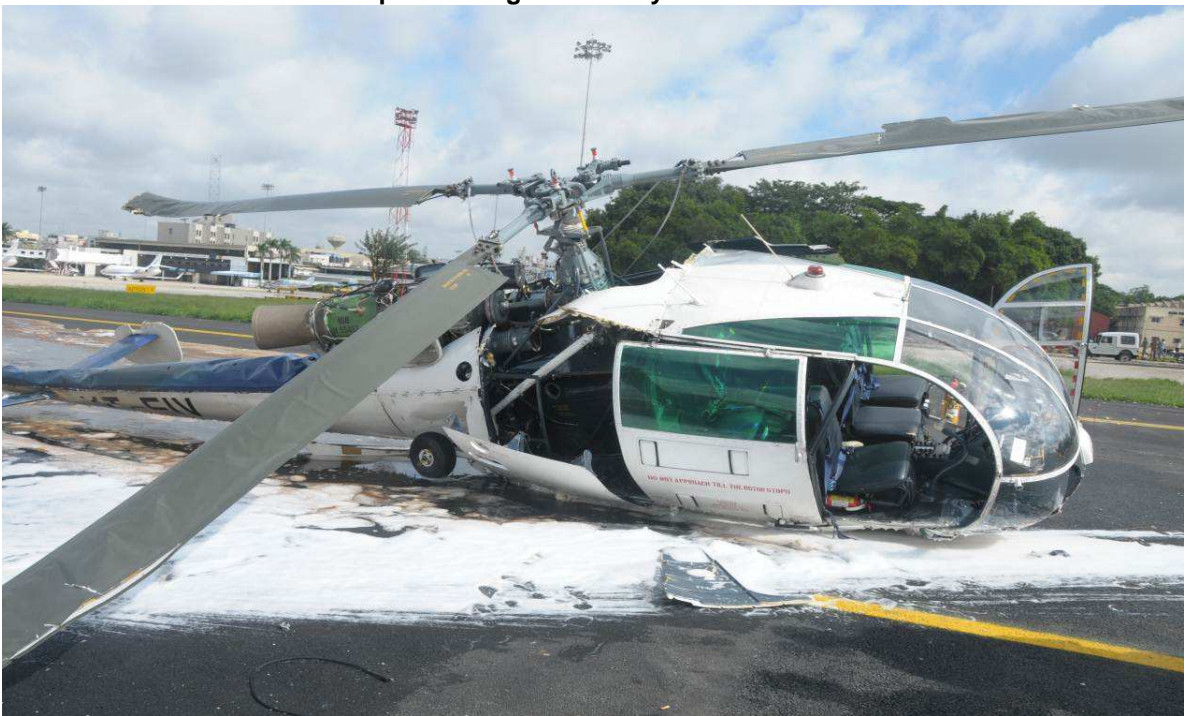
Right side view of the cockpit with right cockpit door separated

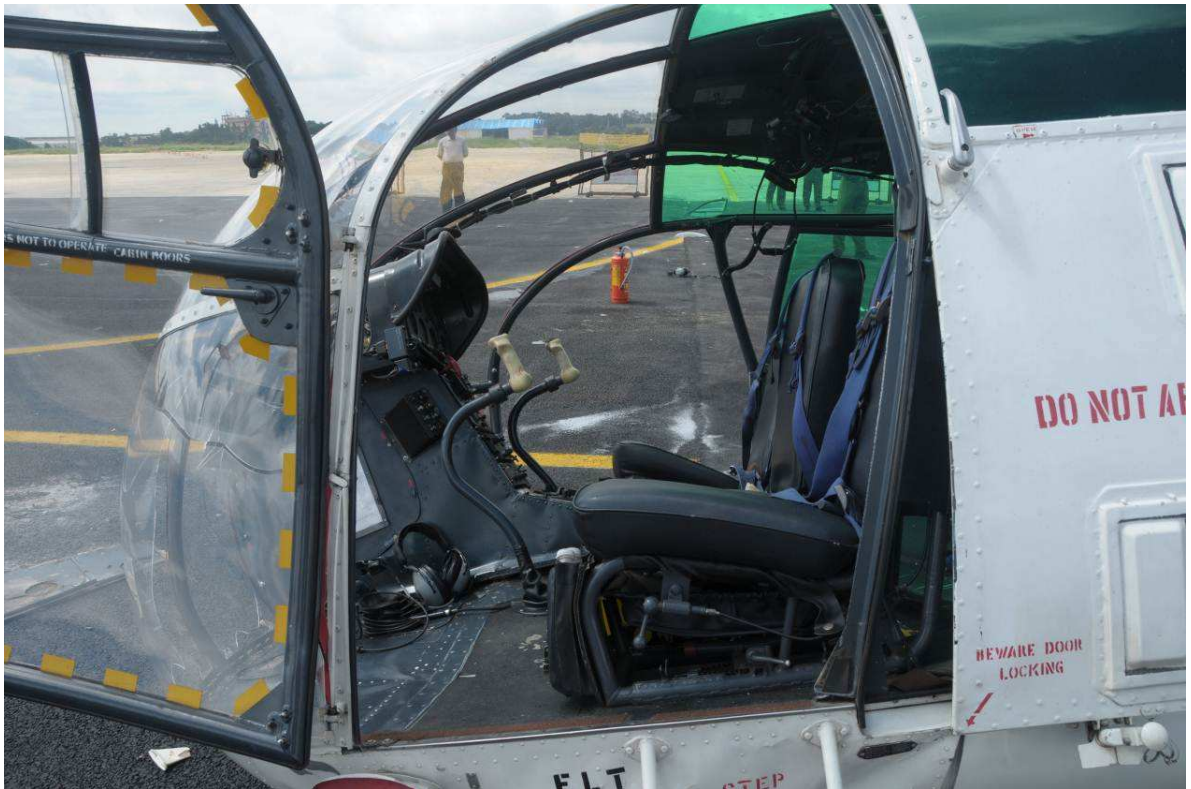
Left side view of the cockpit with left cockpit door open

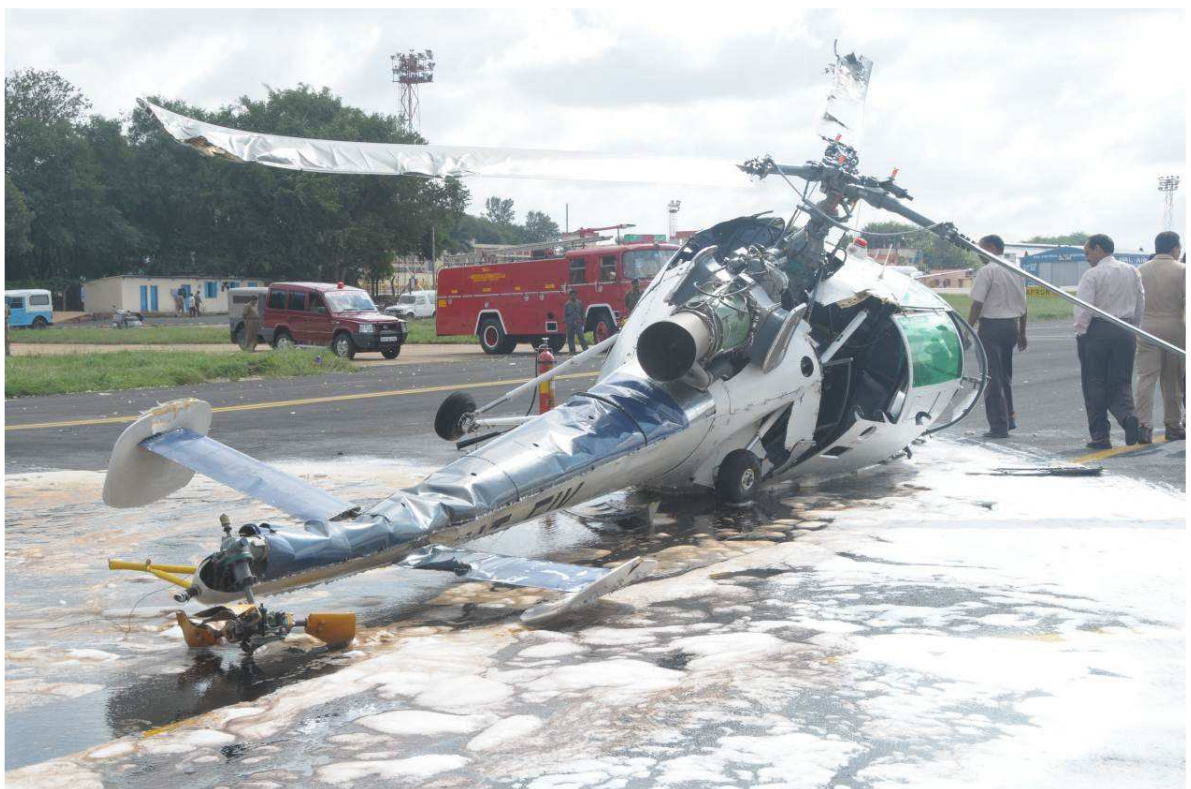
Helicopter with the foam spread on the tarmac

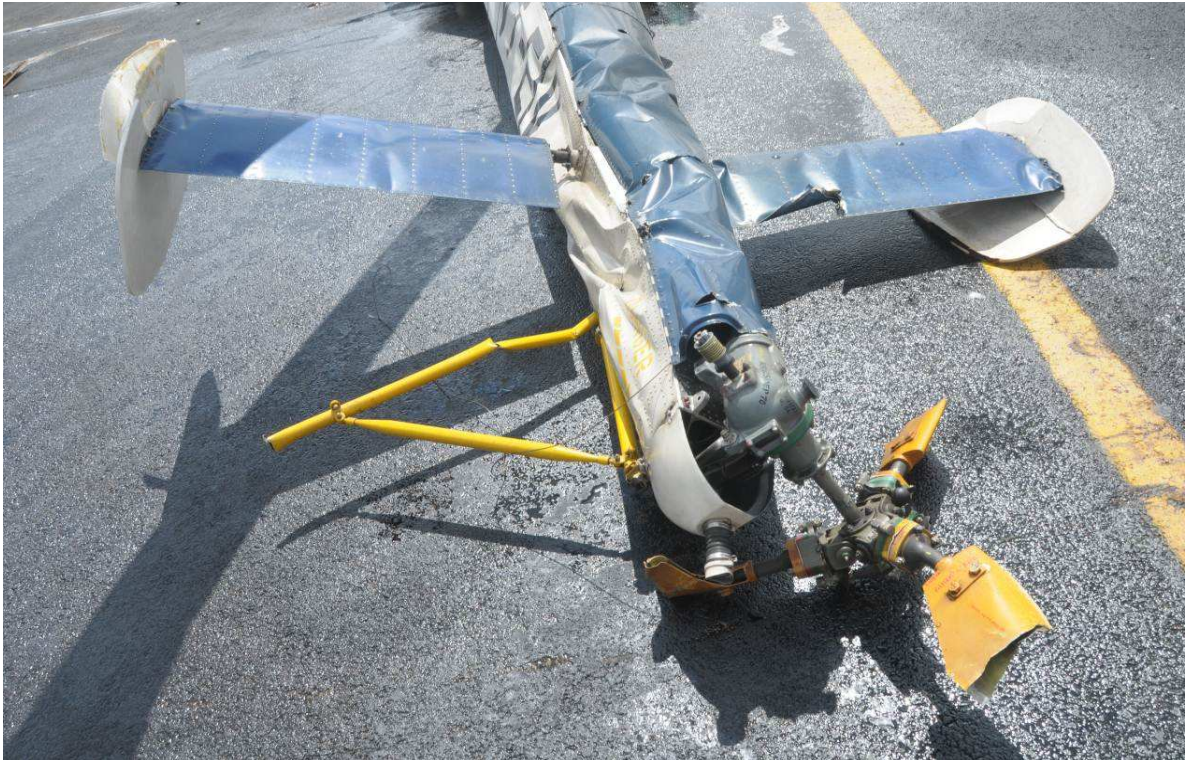
Due to steep pitch up, the tail rotor guard had hit the ground, cracking the top skin and hitting the tail rotor driveshaft causing tail rotor failure and subsequent uncontrolled yaw to the left. The tail rotor guard had also cut the tail rotor cable making the rudder pedals ineffective.

Damage to the tail rotor guard and tail rotor blades with tail boom buckled

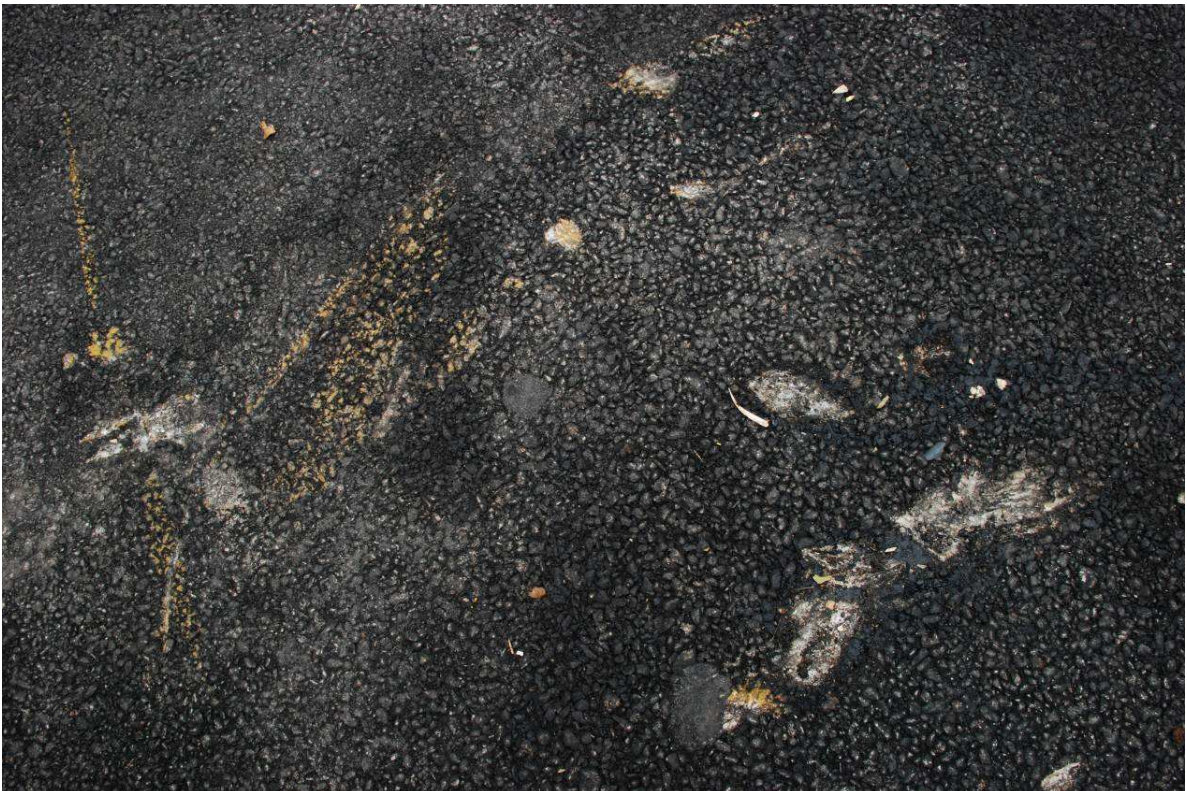
Ground marks of tail rotor guard and tail rotor blades
