**REPORT OF ACCIDENT TO VT-EQL CHETAK HELICOPTER OF BSF AT FATEHPUR VILLAGE,
NEAR MOUNT ABU, RAJASTHAN ON 13.05.2011**

- (a) Helicopter
- Type and Model : Chetak Helicopter
Nationality : Indian
Registration : VT-EQL
- (b) Owner/Operator : Border Security Force,
New Delhi
- (c) Date of Accident : 13.05.2011
- (d) Time of Accident : 0945 UTC
- (e) Last Point of Departure : BSF base, Gandhinagar, Ahmedabad
- (f) Point of intended Landing : Mandore, Jodhpur, Rajasthan
- (g) Geographical Location of Accident : Lat. 24°32'33" N
Long. 72°38'35" E
- (h) Type of Operation : Non-scheduled
- (i) Phase of Operation : Cruising

SYNOPSIS

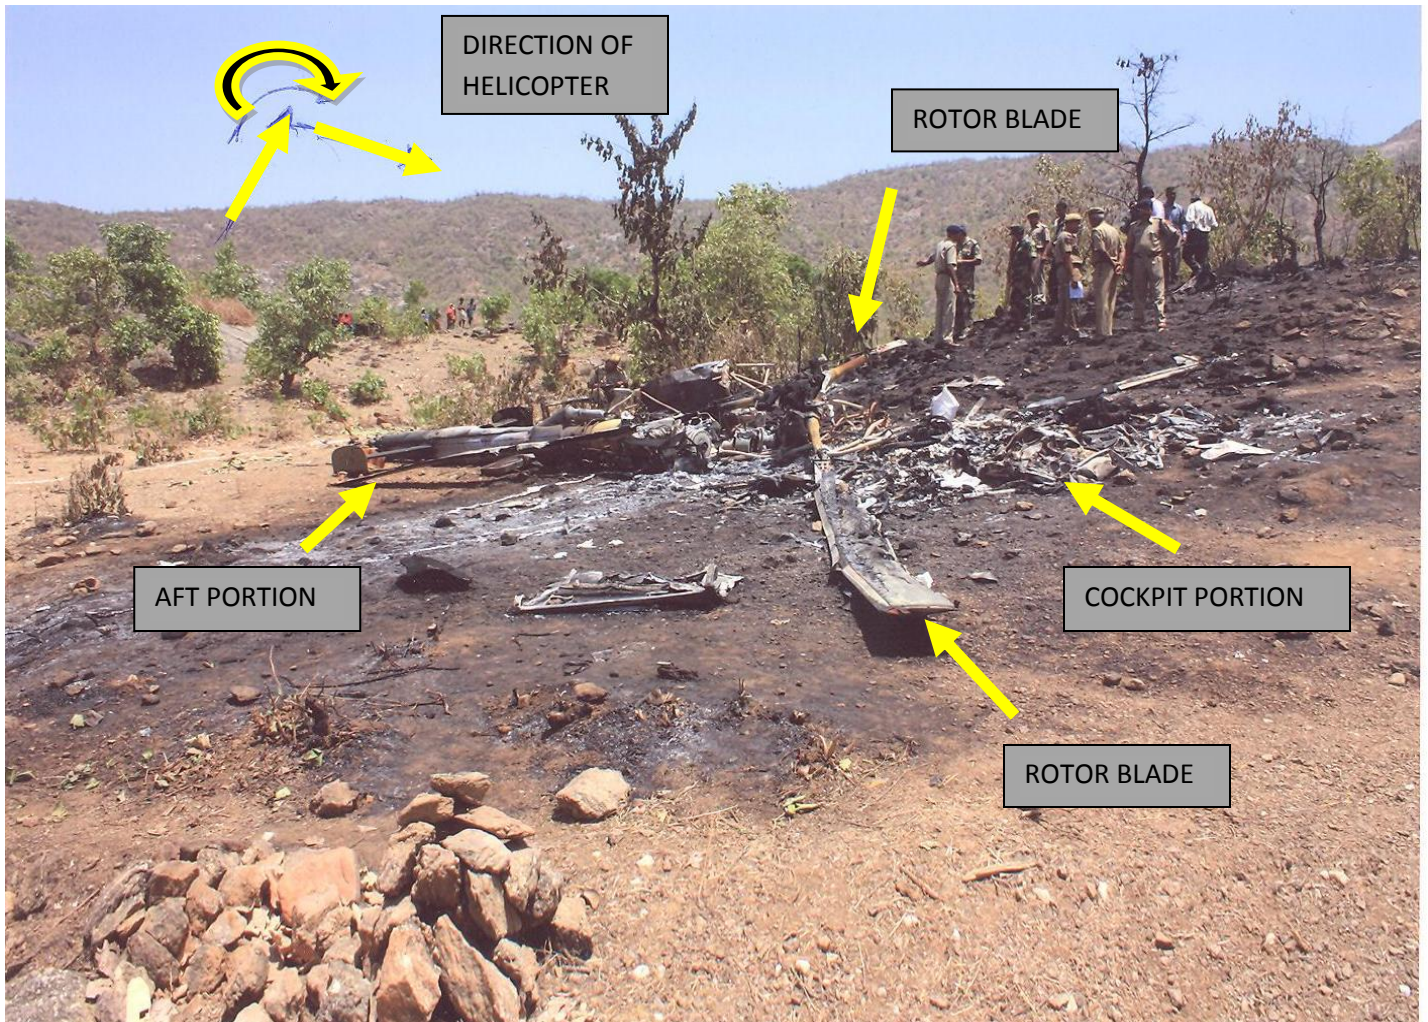
Fig.No 2 View of the Accident Site with the Direction of Approach to the site

The accident site is a hilly barren land with slight slope and embedded with stones. As per the Eye witness No. 1 helicopter made a right turn before impacting the ground at approximately 40 meters from the flight path. The helicopter impacted the accident site in a squarely manner i.e. vertically. There was no forward motion of the helicopter after the impact. Wreckage of the Helicopter was found confined at one place approximately in a radius of 20 feet. Due to impact its fuel tank burst and fuel spread all over the area, resulting in fire which consumed entire cockpit area. Observations made at the accident site are as given below:

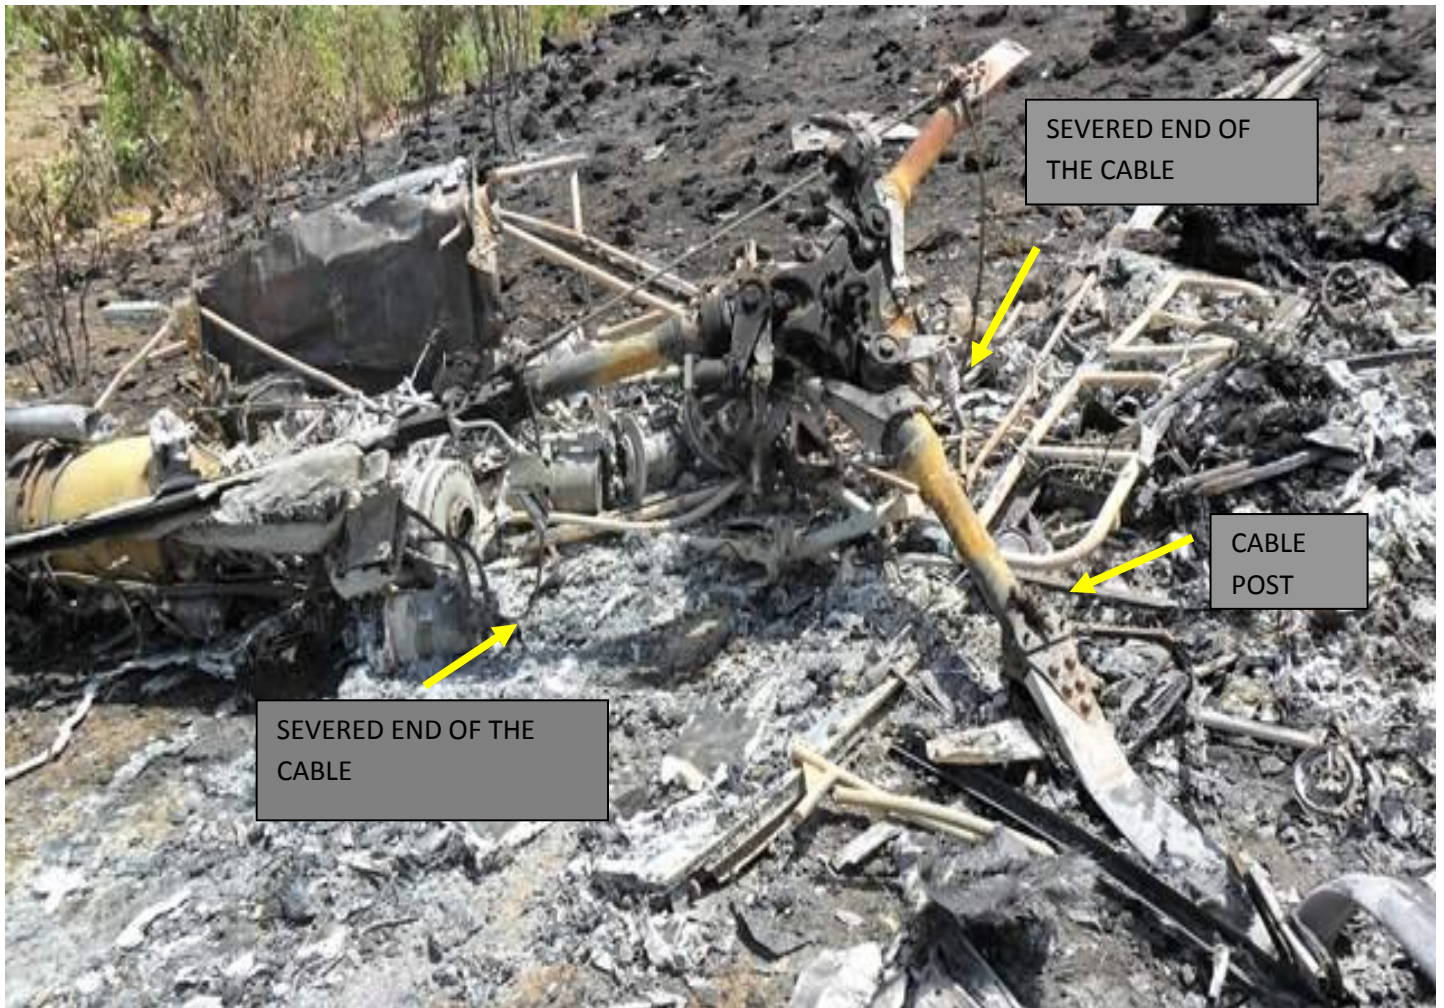
Fig-3 Main Rotor Hub Assembly with the severed spacing cables

- ✚ One of the Spacing cable was found attached to its Posts on both sides (Fig.3). The two other Spacing cables, though anchored to one end of their respective Cable Posts, had got detached from the link chains attached to the third Cable Post (Fig.3). The Attachment bolt of one Chain Link had sheared off and the free end of the detached cable was found near the engine RG casing end. The Attachment bolt of its second Chain Link though still intact had been pulled out from its nut end. The link had opened outwards thereby, letting the Spacing Cable end to come out. This free end of the second Spacing cable had lost its bush insert and was found lying beneath the Rotor Assembly.
- ✚ One of the three Hydraulic Drag Dampers had got burnt and the other two were found badly damaged due to impact.

One Attachment Bolt was found to have sheared off, and the link bent outwards, thereby letting the Cable to get disengaged from the post. The second Attachment Bolt was found to have come out of the Link after bending the Link outward through 90 degrees and disengaging the cable end from the post. Deep scoring marks were found on the swaged end of the cable Sr. No. 30172. The inner bushes of eye-ends of the cables Sr. No. 30172 & 30324 were missing.

Examination of wreckage at the accident site revealed that one of the spacing cables was attached to its Posts on both sides. The two other spacing cables, though anchored to one end of their respective Cable Posts, had got detached from the link chains attached to the third Cable Post. The Attachment bolt of one Chain Link had sheared off and the free end of the detached cable was found near the engine RG casing end. The attachment bolt of its second Chain Link though still intact had been pulled out from its nut end. Both the links had opened outwards thereby, letting the Spacing Cable ends to come out. This free

The above result of the metallurgical examination lends credence to the fact that there was excessive tension in the Spacing Cables which led to the failure of the Attachment Bolts. As one of the cables was released from the post, it became free and started hunting thus caused failure of the pitch change rods. Failure of the Pitch Change Rods was probably due to the hit by the Spacing Cable end.

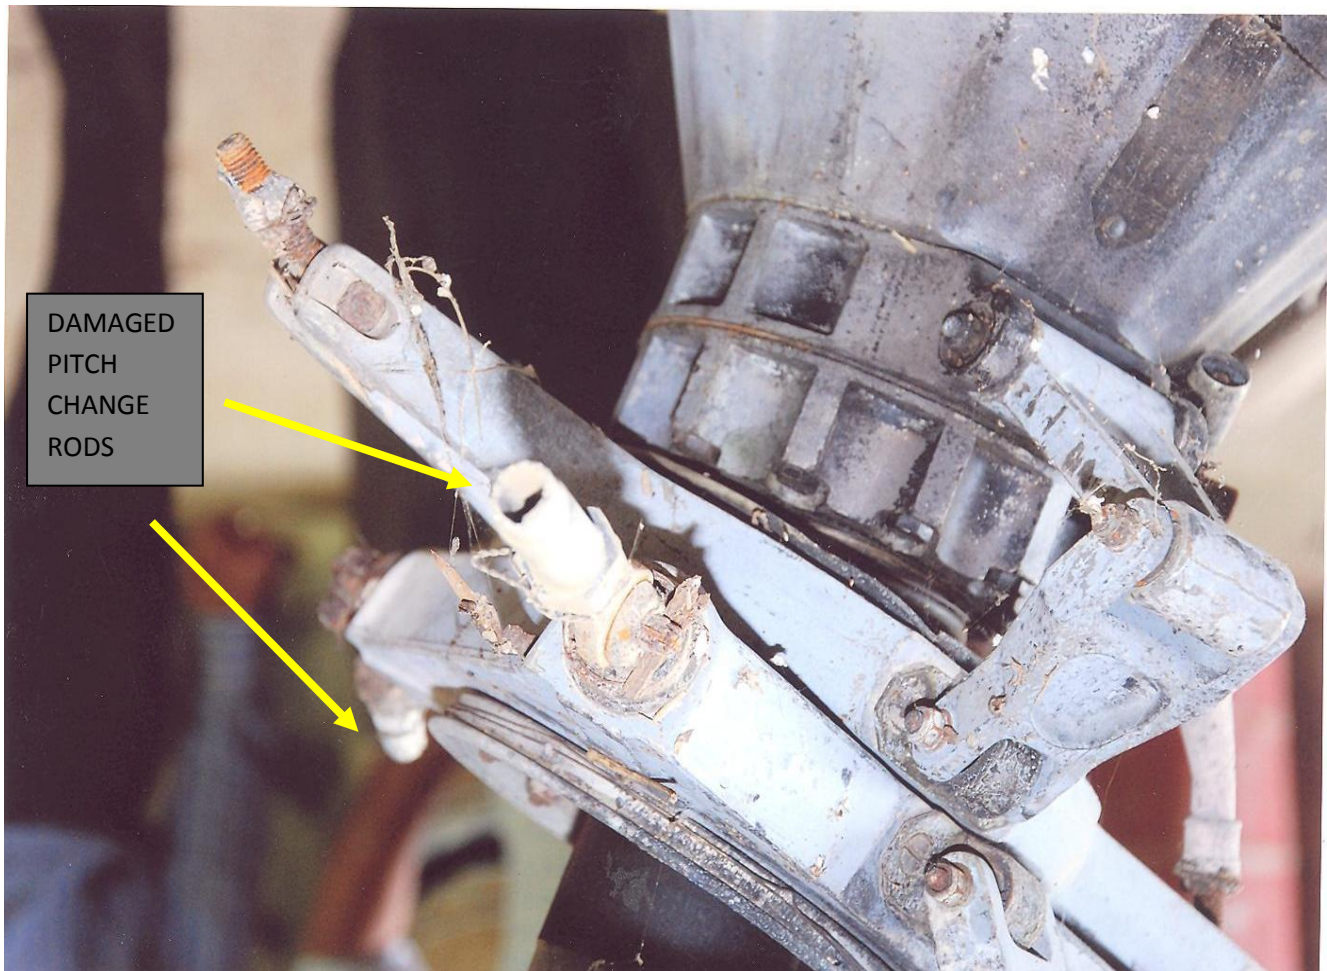
Fig.4 MGB Transmission showing the damaged pitch change rods

Examination of pitch change rods revealed bending of the pitch change rods preceded the fracture. This indicates that rods were acted upon by bending load during the fracture. There were no evidences of progressive failure such as fatigue or stress corrosion or cracking in any of the pitch change rods.

Examination of pitch change rods revealed bending of the pitch change rods preceded the fracture. **This indicates that rods were acted upon by bending load during the fracture. There were no evidences of progressive failure such as fatigue or stress corrosion or cracking in any of the pitch change rods.”**

3.1.4 Pitch change rods were acted upon by bending load during the fracture imposed probably by hitting of the released spacing cable. There were no evidences of

progressive failure such as fatigue or stress corrosion or cracking in any of the pitch change rods.

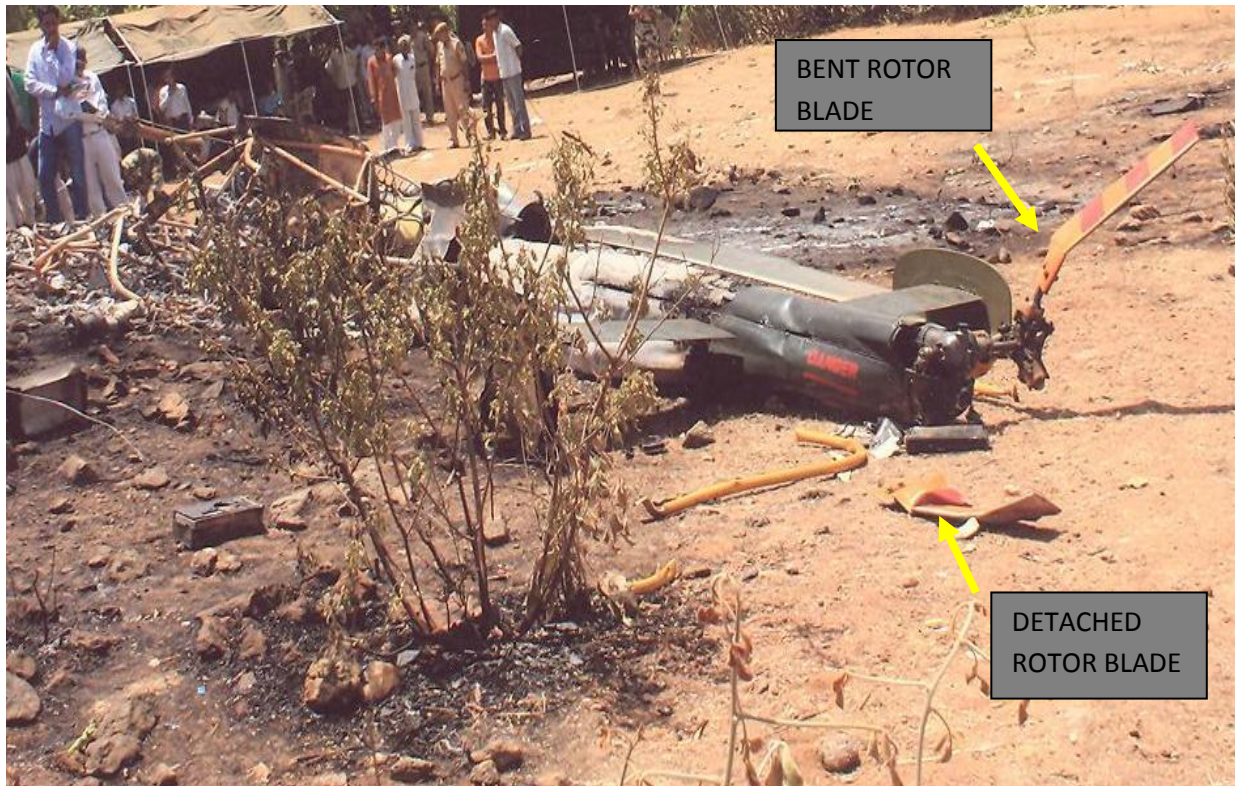
Fig. 5 Tail Portion of the Helicopter showing the Tail rotor Blades

Forward portion completely destroyed in fire. Tail section including horizontal stabilizer was intact. Vertical fin was damaged due to impact. Tail rotor had broken. Tail rotor (TR) guard had

broken. Tail Gear box was intact with two TR blades, and was bent due to impact. One TRB sheered off at the cuff due to impact. No grazing of TRB tips on ground indicating either they were freely rotating at a very low rpm or had stopped rotating.

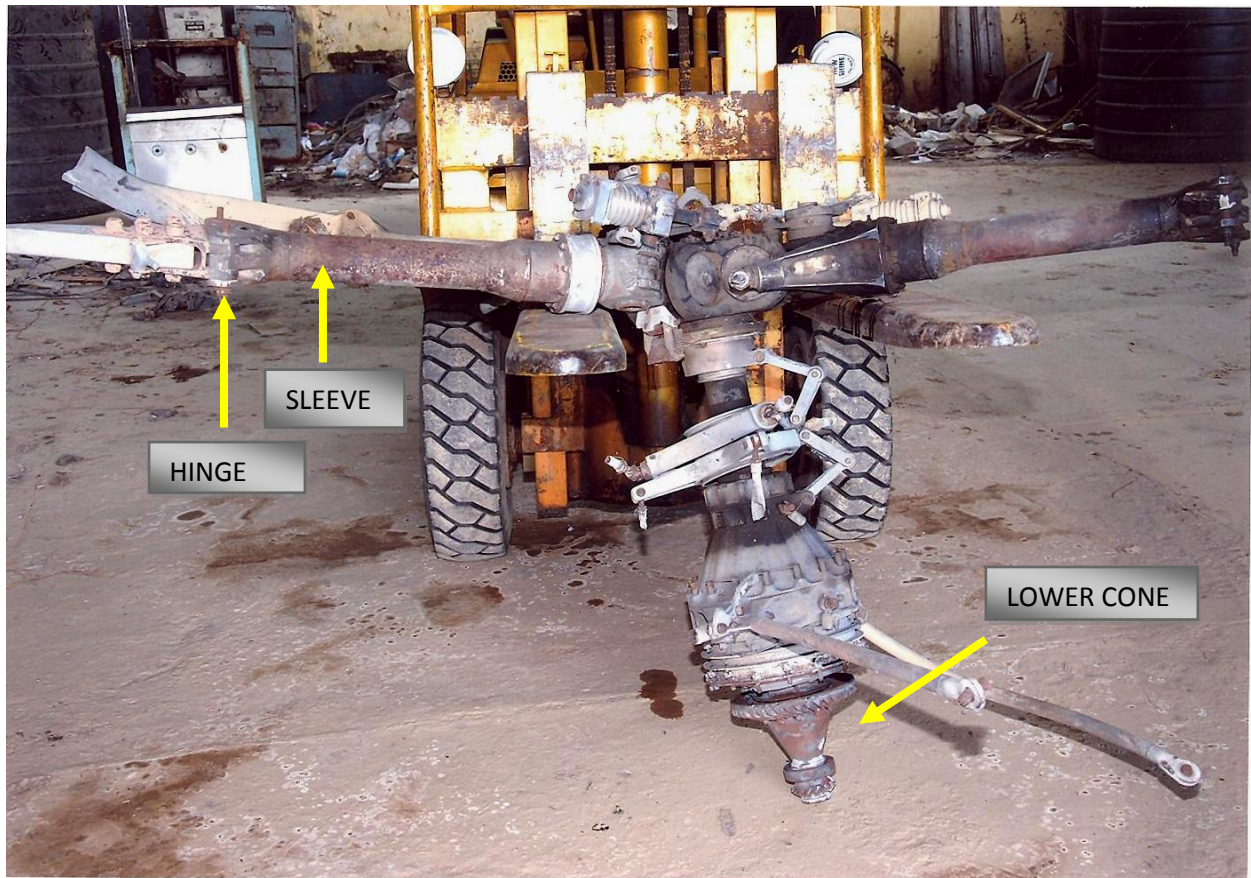
Fig. 6 View of Transmission

✚ No damage was observed on the upper portion of Main Gear Box (MGB), Main Rotor Shaft and Main Rotor Head Assembly. The lower portion (Magnesium casting) of MGB was completely burnt /melted away exposing the Crown and worm gear.

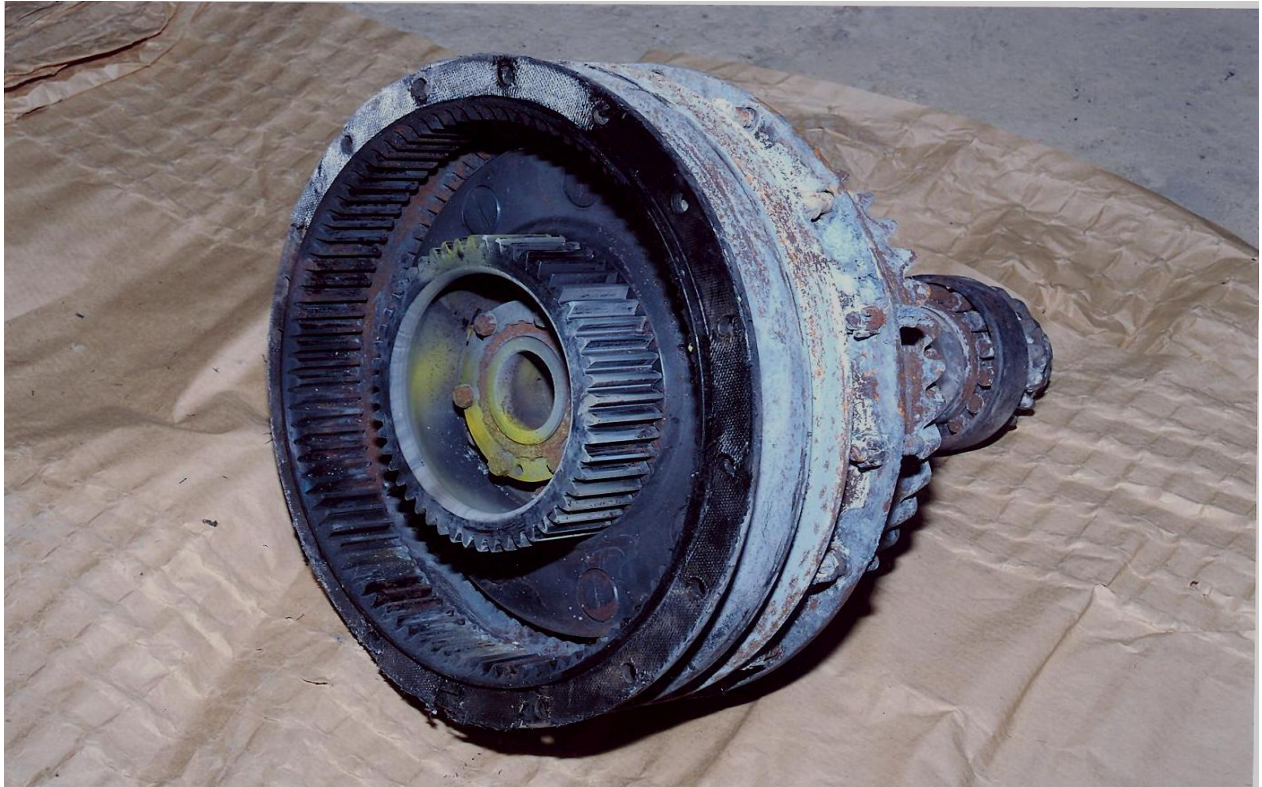
Fig. 7 Ring Gear

The Ring gear together with Planetary gears were found undamaged and freely rotating even after the huge impact and the violent fire. All the eight gears were intact (Fig. 7). They were freely rotating with no sign of seizure or breakage of teeth. Central gear was intact. No signs of abnormal wear or breakage of teeth were observed. The Crown & Worm gear teeth also did not exhibit any damage, galling or pitting.

The transmission gears were in good condition. No breakage, pitting, galling was observed. The gears in the transmission were capable of smooth transmission of power.

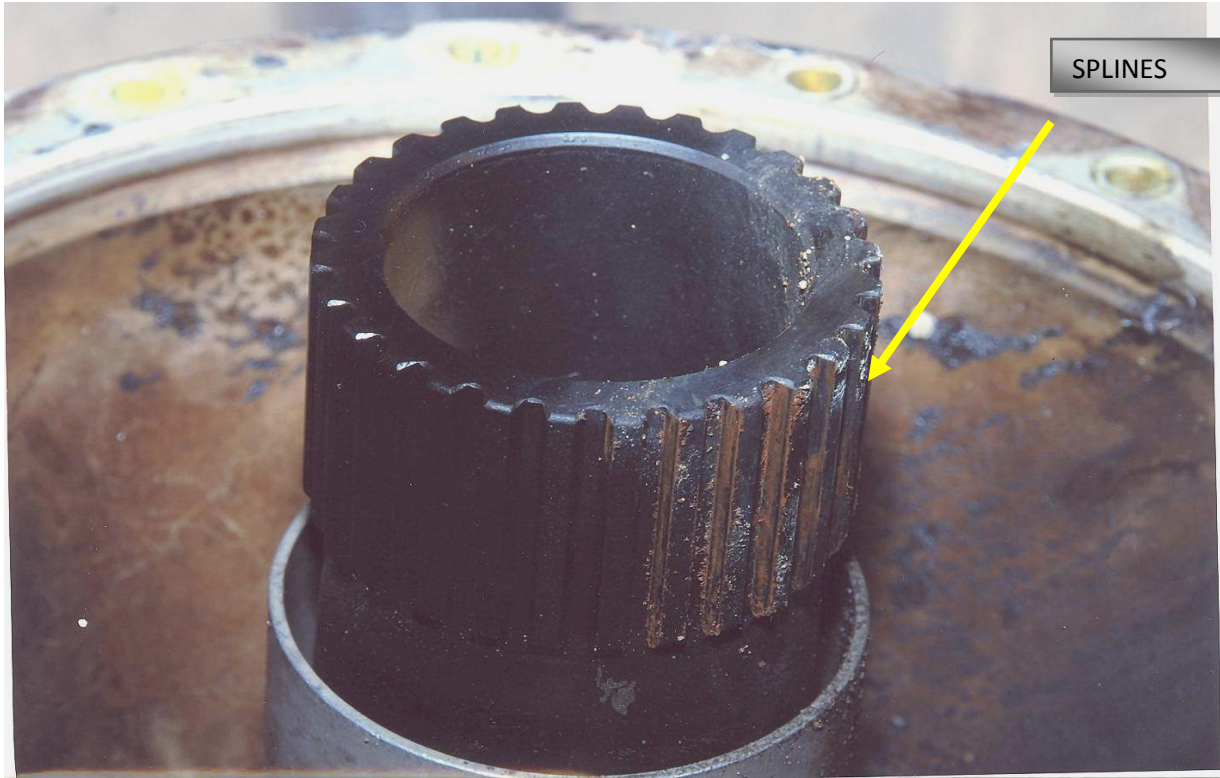
Fig. 8 Main Rotor Drive Shaft

No damage was observed to the shaft.

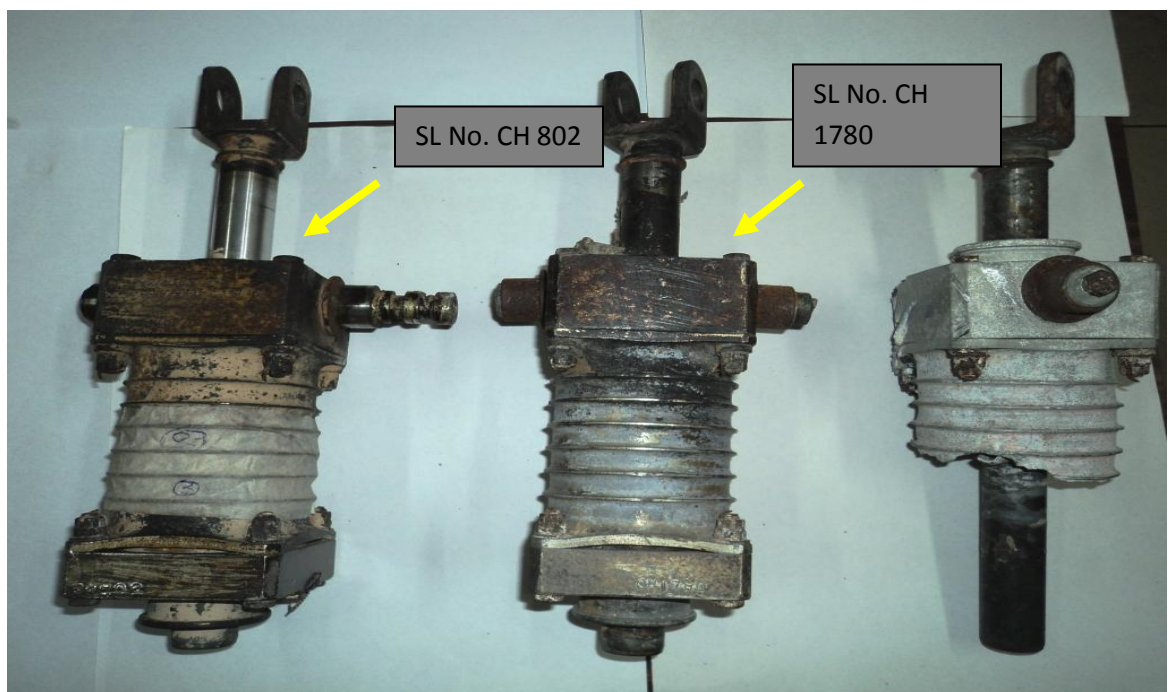
Fig. 10 Hydraulic Drag Dampers

Damper SI No. Ch 802 & 1780 were found mounted on the Drag Hinge Pins of MRH. The sight gauges were found to have broken and pistons of two dampers had ceased. The body of the third Damper was found to have burnt off. Therefore, the serial no. of the third damper could not be ascertained.

The metallurgical examination has indicated excessive tension in the spacing cable. This excessive tension in the spacing cable may be due to the malfunction of the hydraulic drag damper. The set of drag dampers recovered from the accident site were installed on this helicopter on 22/12/2008. These were installed after the previous set was found to have “Timing out of limits”. The set had been overhauled at HAL on 06/12/2005 and matched. Two of the Drag dampers recovered from the site were identified while the third drag damper due to damage could not be identified as its body had got burnt. However due to the damage, the three drag dampers could not be subjected to bench check.

The Hydraulic Drag Damper malfunction in flight would cause severe vibrations that could not be dampened. The imbalance or hunting movements of the advancing / retreating Blades would cause transmission of excessive tensile loads from the Rotor Blade System to the Spacing Cable Posts. This would result in excessive tensile load which might cause failure of Attachment Bolts /Links.

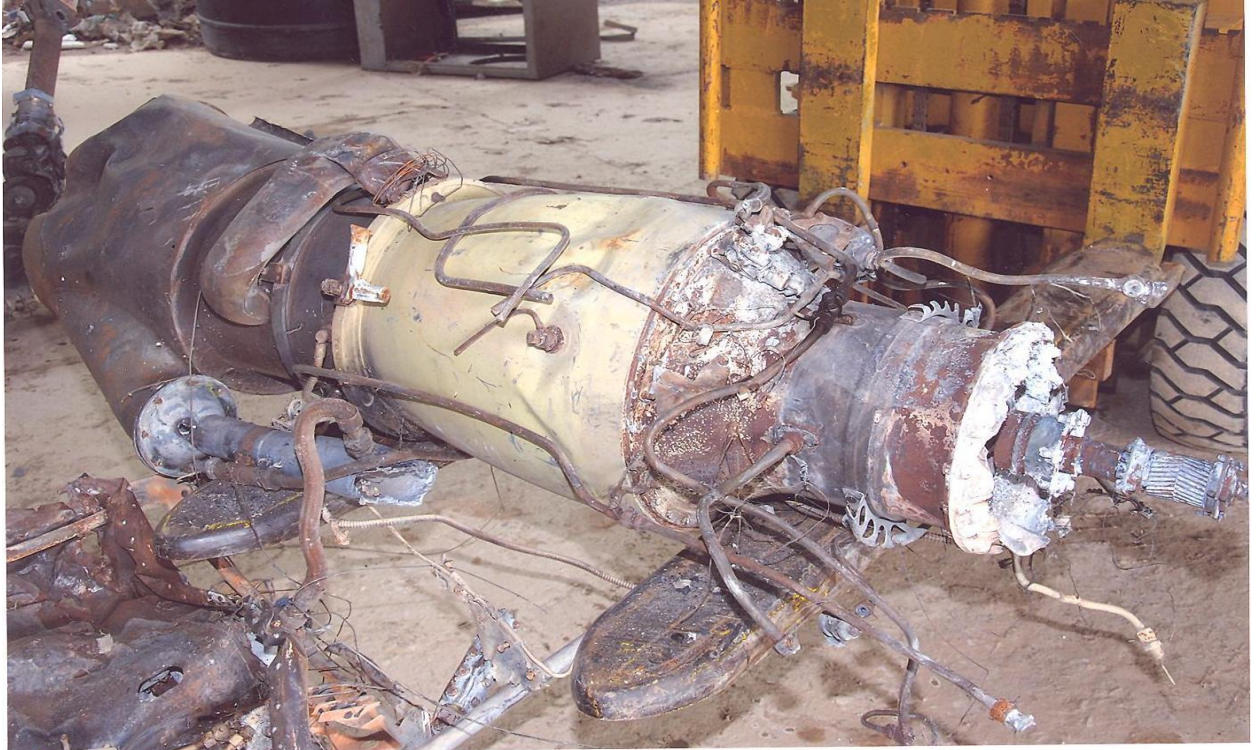
Fig. 11 Right Side view of the engine

The Artouste IIIB Aero Engine Sr No.H-55484 was found intact. It exhibited impact and fire damage.

- ✚ The Magnesium Reduction Gear Casing of the Engine had got completely burnt /melted, with all the gear train in position. The Fuel Pump, Governor Assemblies etc had partially got melted.
- ✚ The Compressors & its housing, Combustion Chamber, the Turbine discs were found to be intact.(Fig. 11)
- ✚ None of the blades of 1st stage centrifugal compressor exhibited breakage, impact or foreign object damage. (Fig. 12)
- ✚ There was no evidence of the Turbine blades having grazed the turbine casing. (Fig. 13)
- ✚ The exhaust section of the engine was found unburnt and attached to the Engine Turbine casing.

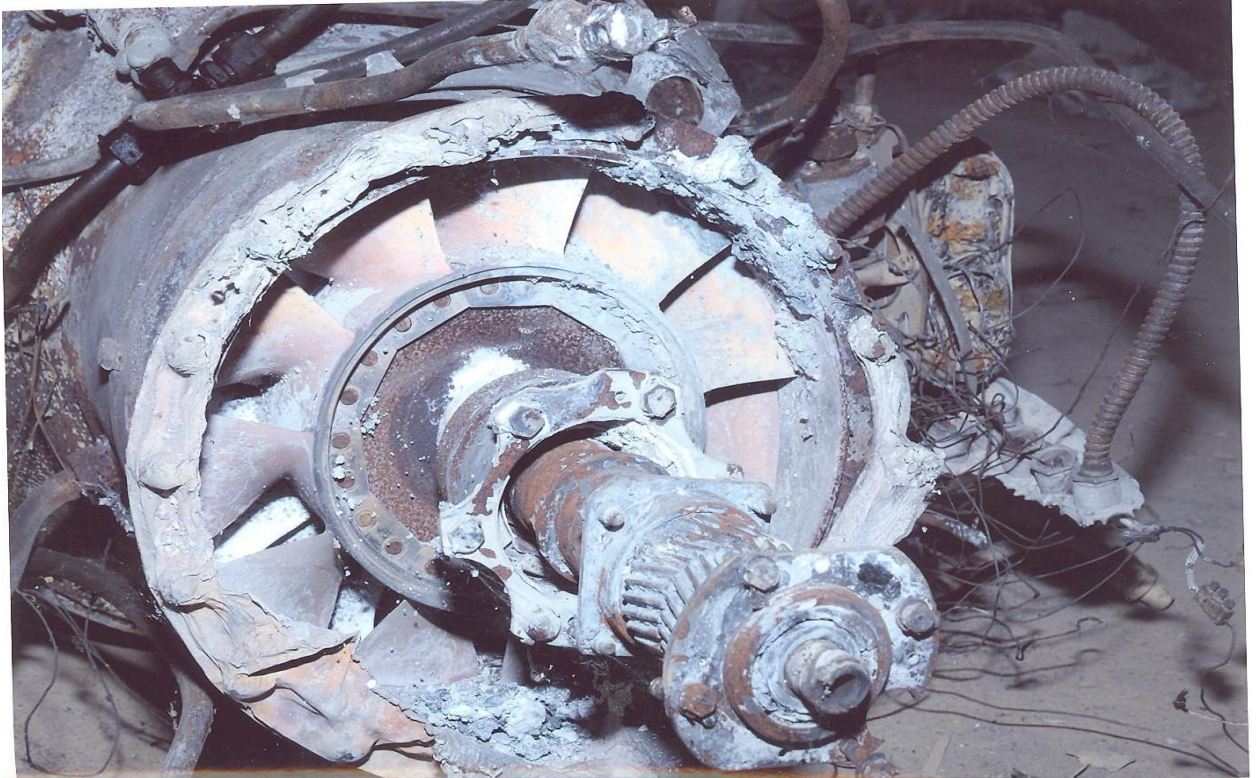
Fig. 12 Inlet to 1st Stage Compressor

- The Magnesium Reduction Gear Casing of the Engine had completely melted with all the gear train in position. The Fuel Pump, Governor Unit etc had partially got melted.
- None of the blades of 1st stage centrifugal compressor exhibited breakage, impact or foreign object damage.
- There was no evidence of the Turbine blades having grazed the turbine casing.

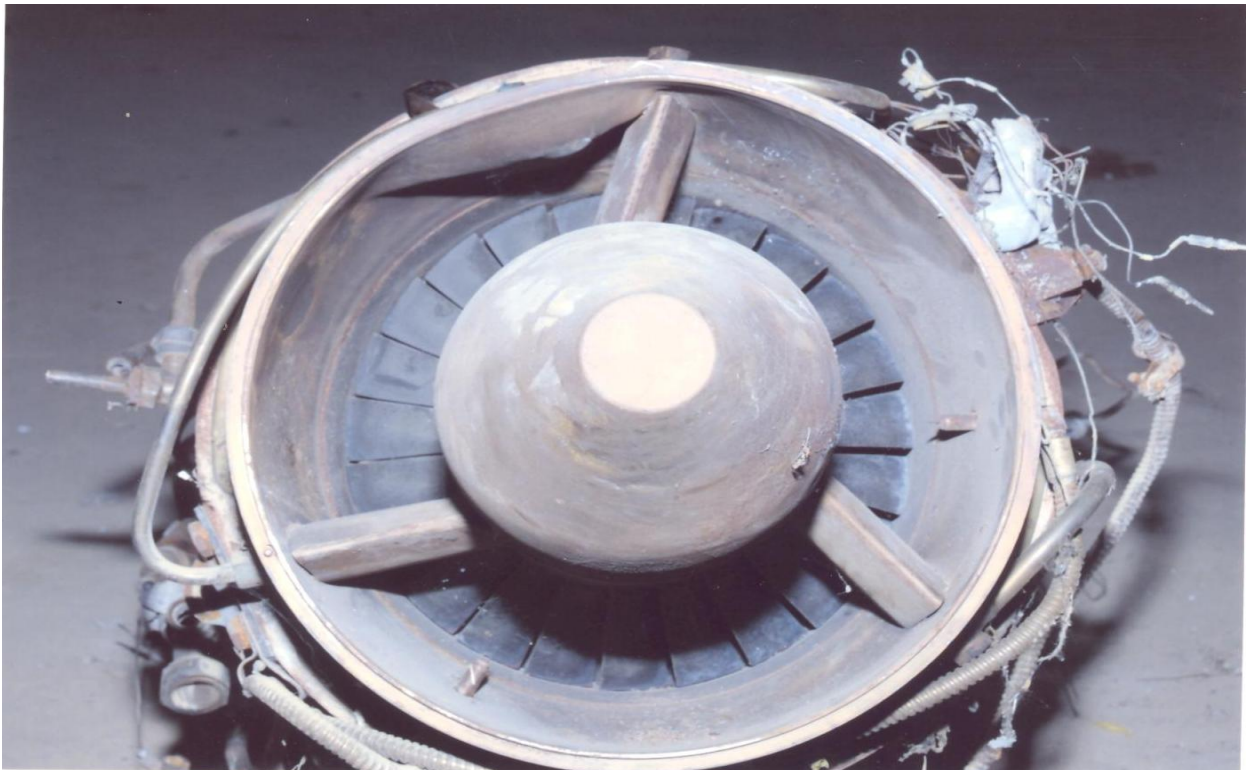
Fig. 13 Last Stage Turbine Blades

It indicates that there was not any failure of the engine or the bearings.
