**GOVERNMENT OF INDIA
MINISTRY OF CIVIL AVIATION**

**FINAL INVESTIGATION REPORT ON ACCIDENT
TO AIR INDIA AIRBUS A-320 AIRCRAFT VT-ESH
AT JAIPUR ON 05.01.2014**

**AIRCRAFT ACCIDENT INVESTIGATION BUREAU
SAFDARJUNG AIRPORT
NEW DELHI – 110003**

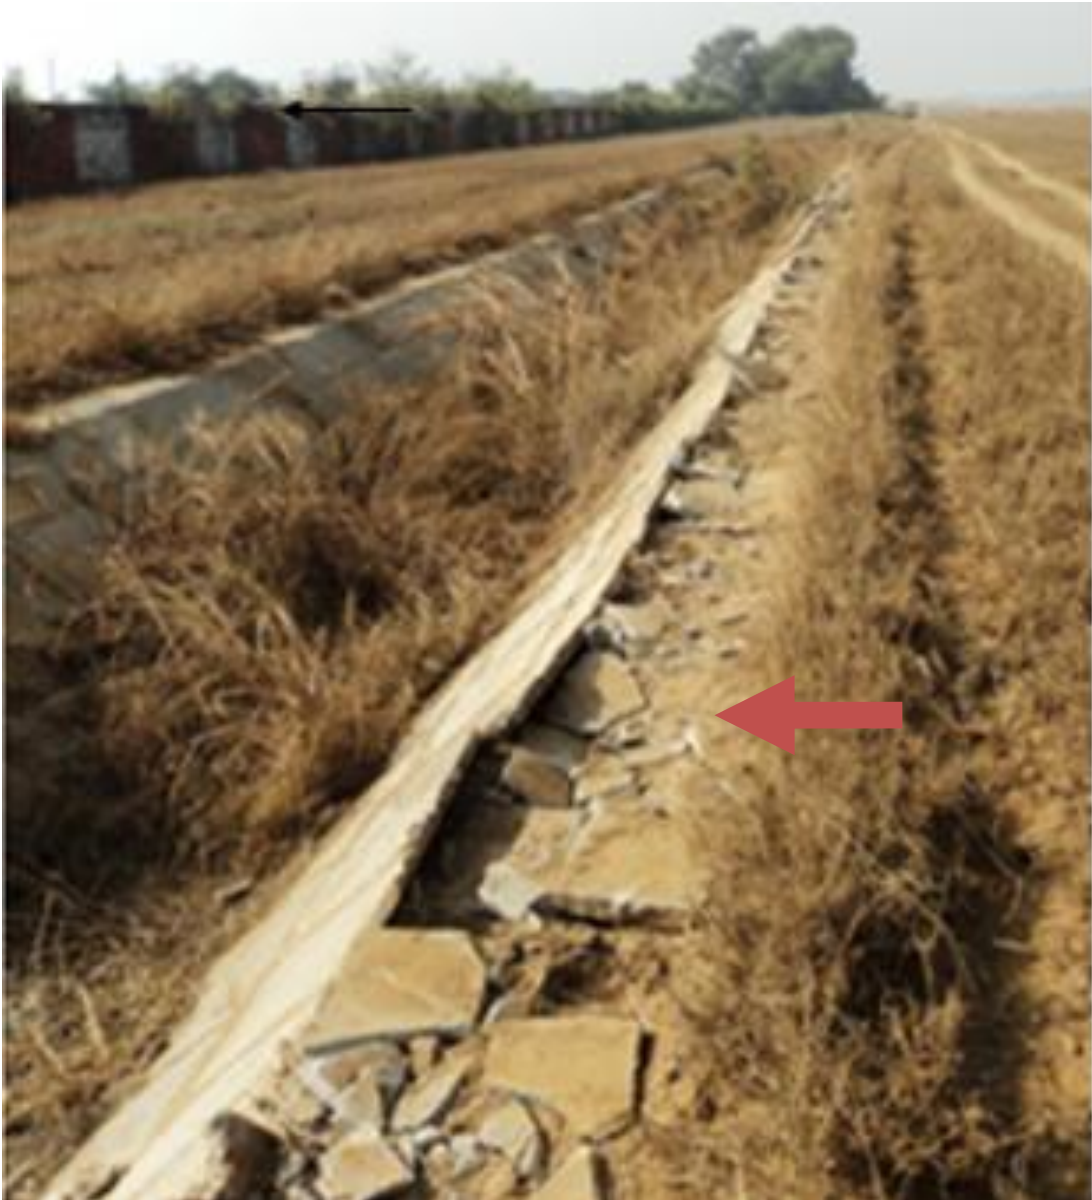
Left main wheel rolled over the drain boundary area

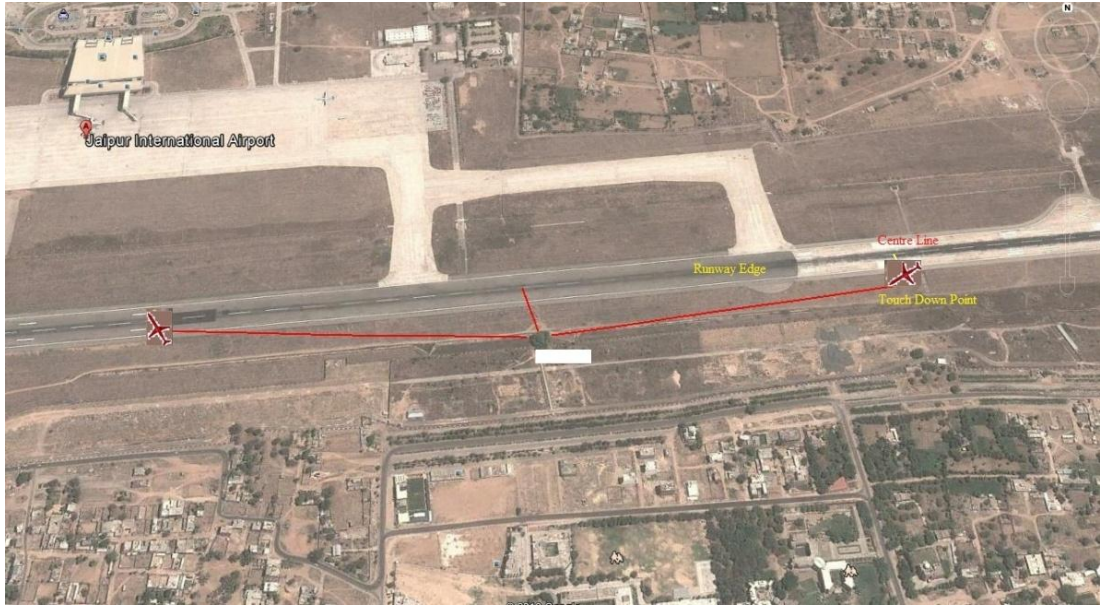
The aircraft continued to roll/ skid on the unpaved surface and during this period the left wing impacted trees causing damage to the left wing. Thereafter aircraft turned right and entered the runway finally coming to a halt on the LH side of runway. There was no fire.

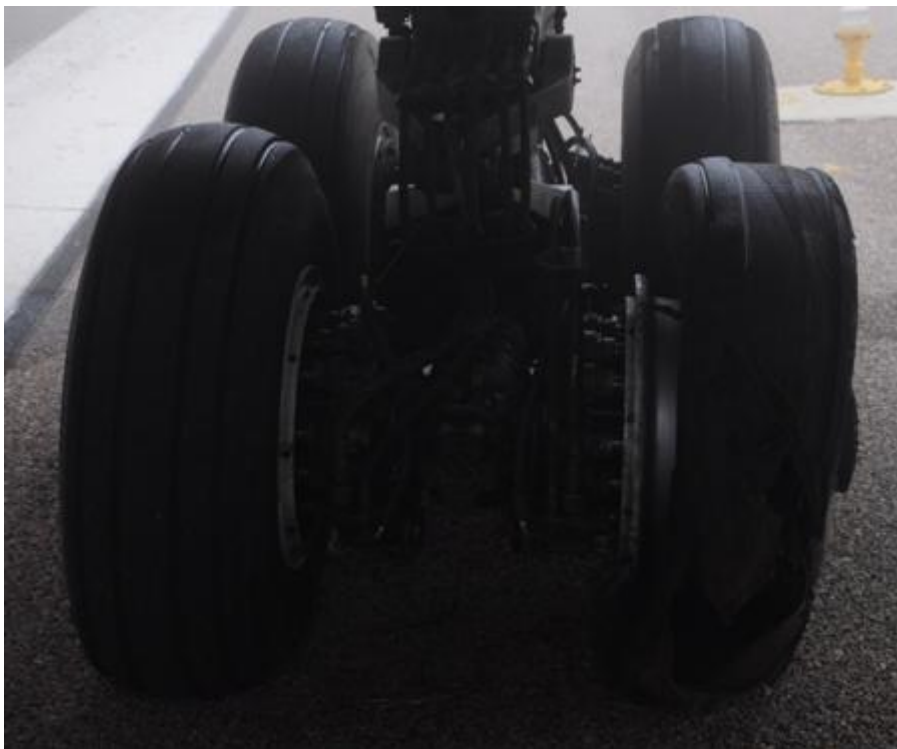
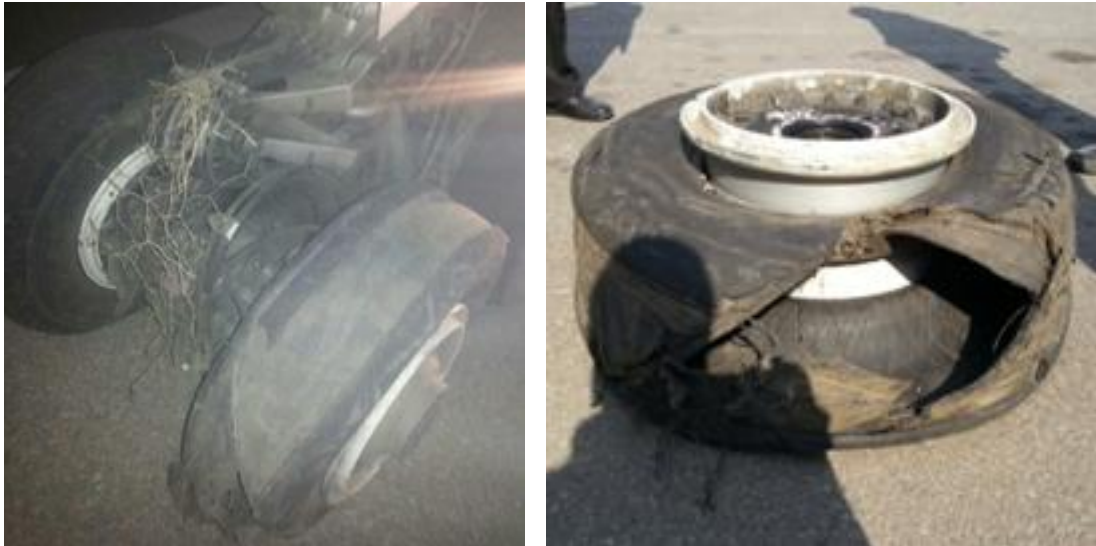
The aircraft had touched on the left side of the runway on soft ground. There was no damage to the aircraft on its first impact with the soft ground. The aircraft had rolled and then the left wheel had gone over the drain boundary area. The left main wheels got de-capped / damaged during this roll over/ skidding and during final stoppage with application of brakes.

Thereafter the aircraft turned right but at the same time hit trees wherein the left wing leading edge structure got damaged from rib 23 onwards. Outboard wing spar box including upper skin, lower skin, front spar, rear spar and ribs got sheared off from a distance of about 5 ft from the wing tip.

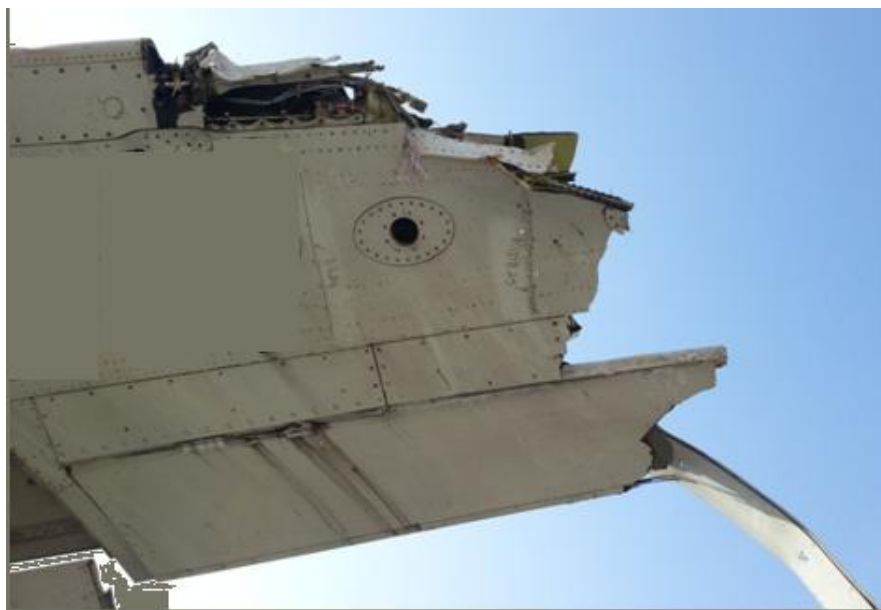
- Wing tip and wing tip fence area sheared off and found in drain.

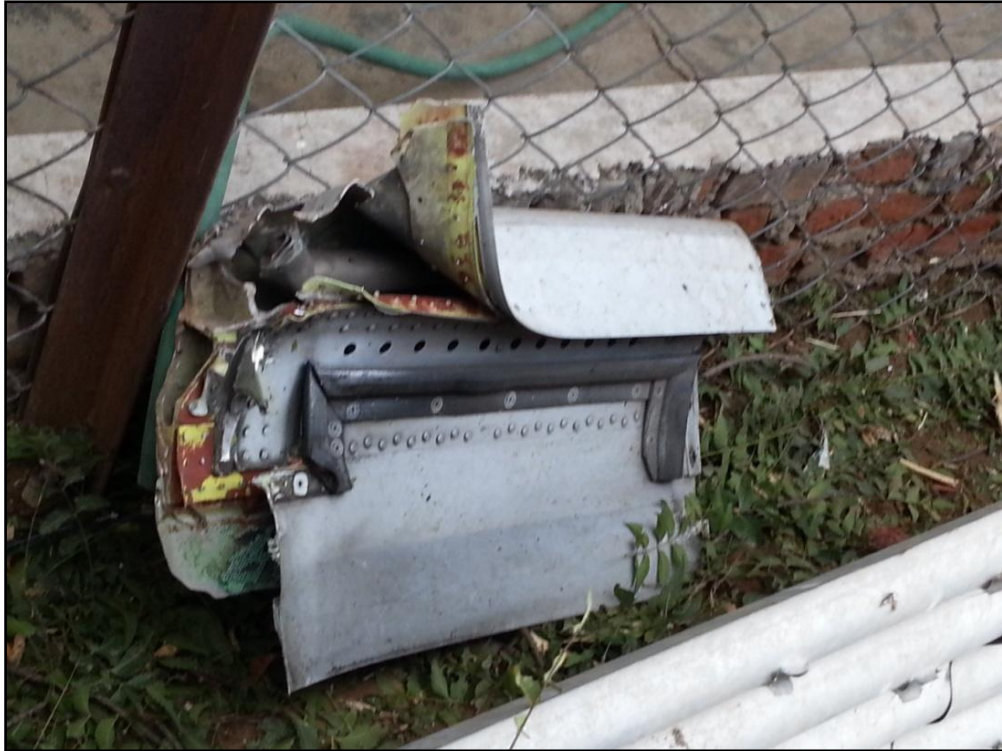
- Slat #3 and #4 found damaged.
- Slat #5 broken and found near drain.

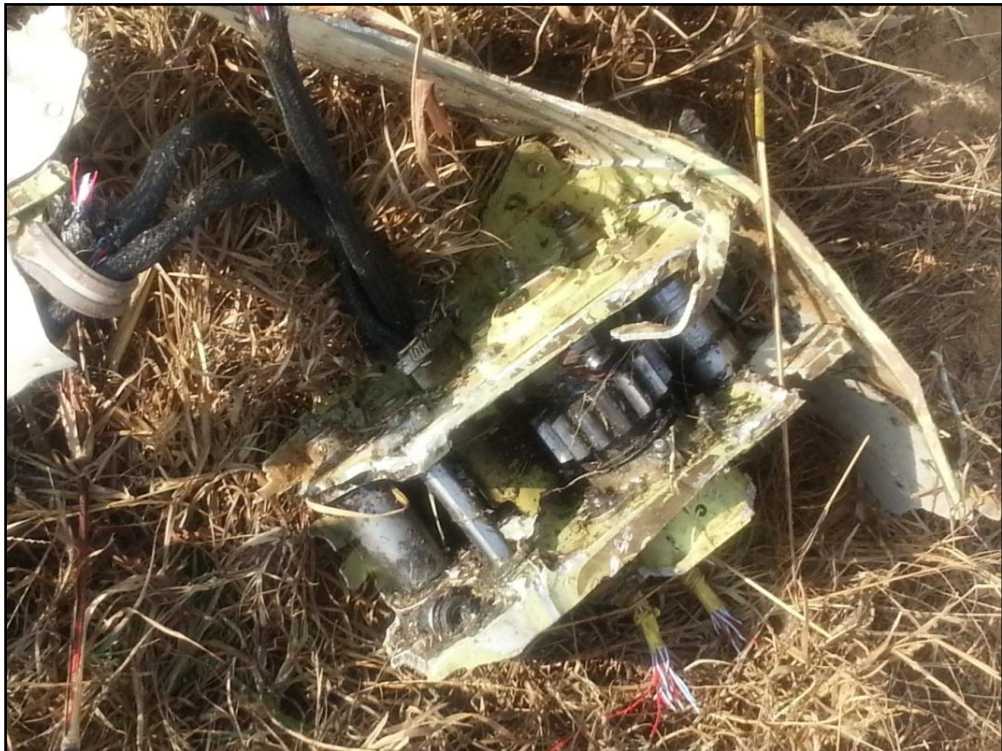
- Wing leading edge structure was found damaged from rib 23 onwards.
- Slat wing tip brake and hydraulic lines damaged at front spar.
- Rear spar sheared from rib 25.
- Upper flange of rear spar cracked outboard from rib #24.
- 1/3rd portion of aileron outboard area sheared off.
- Left outboard flap damaged near outboard tip lower surface.
- Aileron upper and lower access panels damaged.
- Wire bundle on front spar pulled/damaged/snapped outboard of rib #23.
- No. 1 main wheel found decapped.
- Observed multiple cuts and rubs on main wheel #5.
- Grass straws observed on fan blades of both the engines.
- Blue system loss due hydraulic line ruptured in slat 5 area.

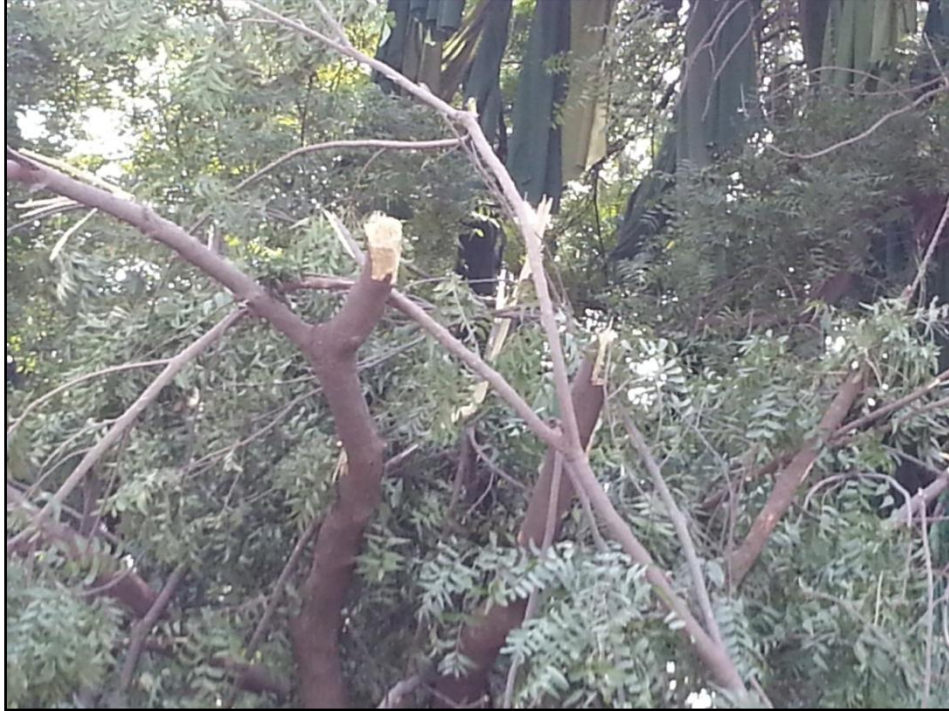
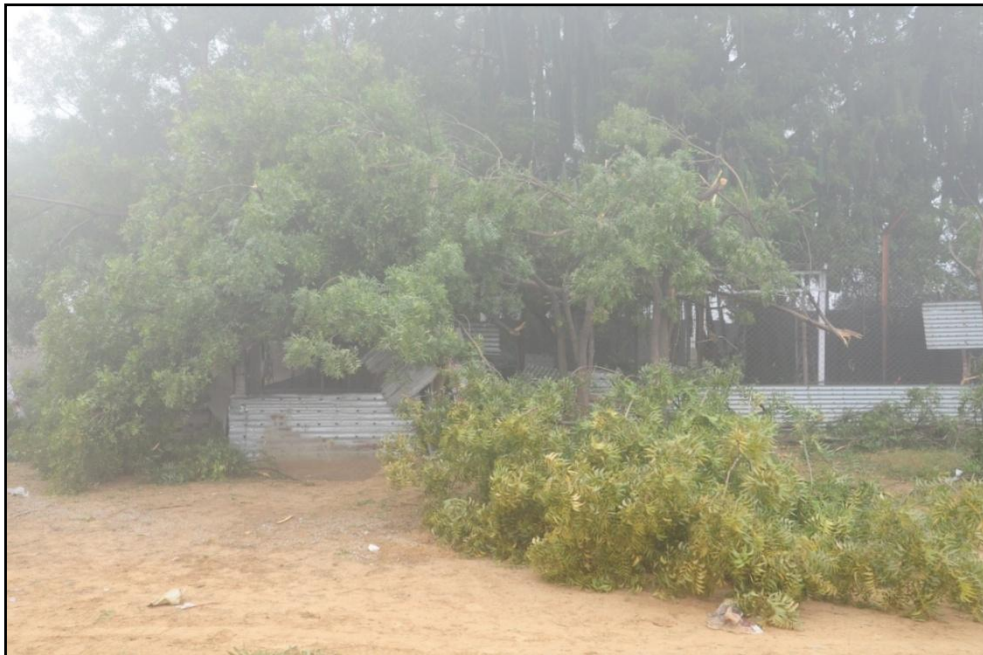
There was no damage to either runway or lights etc. Branches of trees on the side of the runway were cut by the left wing.

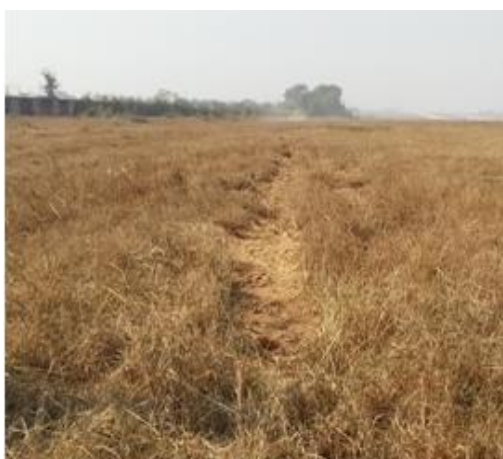
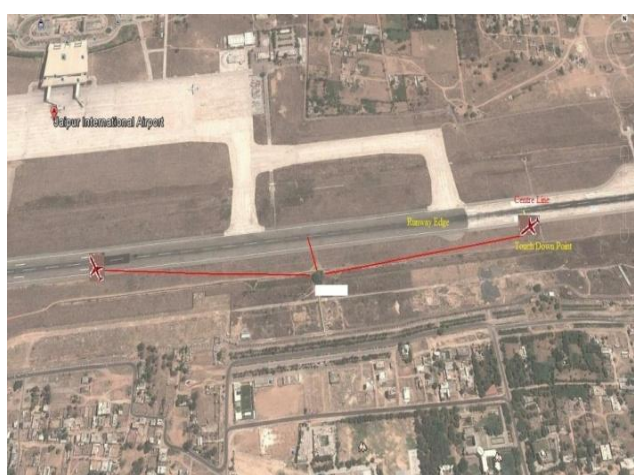
The PIC disengaged the auto-pilot at 200 feet. At 75 feet RA on the longitudinal axis, the Captain applied two successive back stick inputs (5.5° and 7°). The pitch increased up to 5.5° . On the lateral axis, aircraft was aligned with runway axis, left roll was commanded on captain stick leading left roll to increase. In the meantime, a progressive right rudder pedal input was applied.

The decision of PIC to disengage the autopilot was the last inappropriate act which caused the aircraft to deviate to left from localiser resulting in the aircraft landing (with both landing gears) on the soft ground.
