AIRCRAFT ACCIDENT INVESTIGATION BUREAU

FINAL INVESTIGATION REPORT ON ACCIDENT TO BEECH-CRAFT KING AIR B200 AIRCRAFT VT-HRA AT CHANDIGARH AIRPORT ON 27th MARCH 2014

AAIB (India) Report No. : 2014-ACC-0

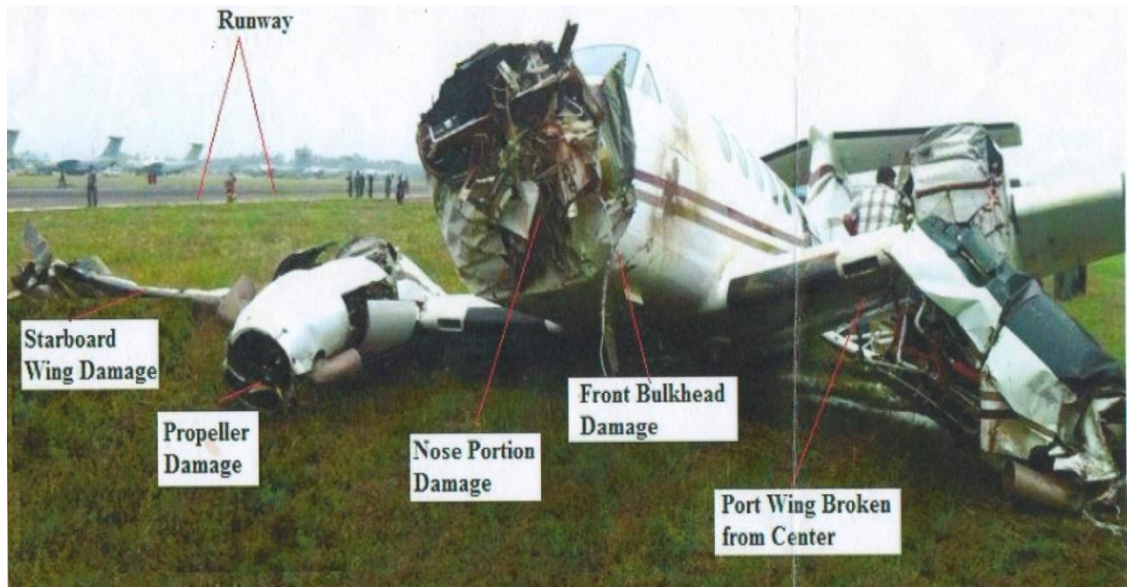
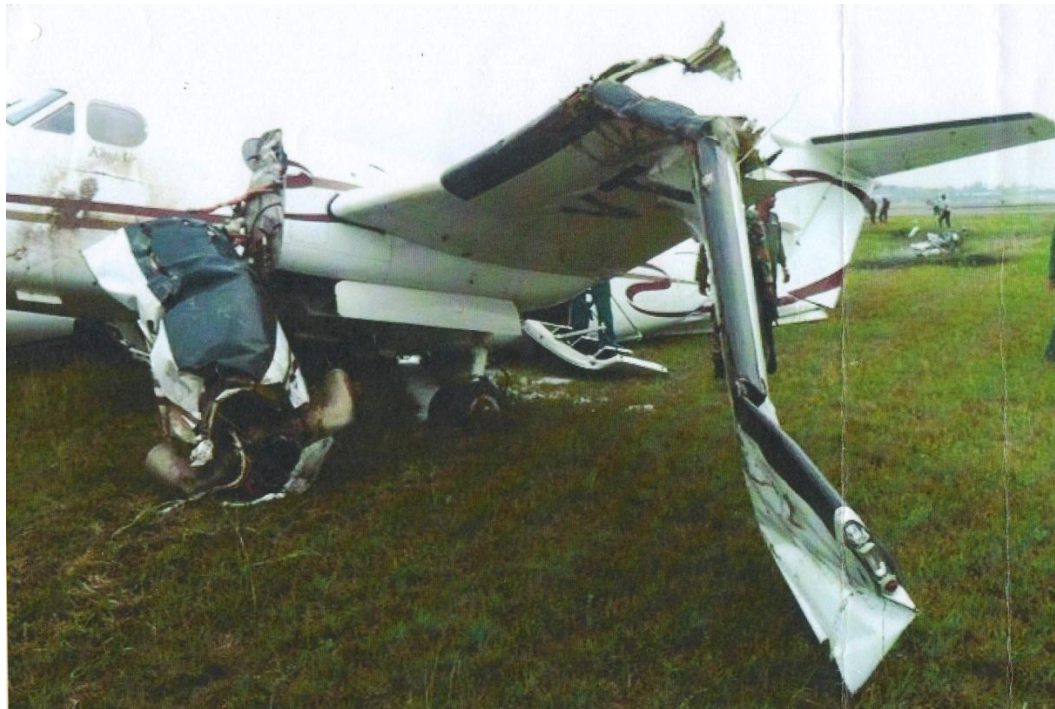
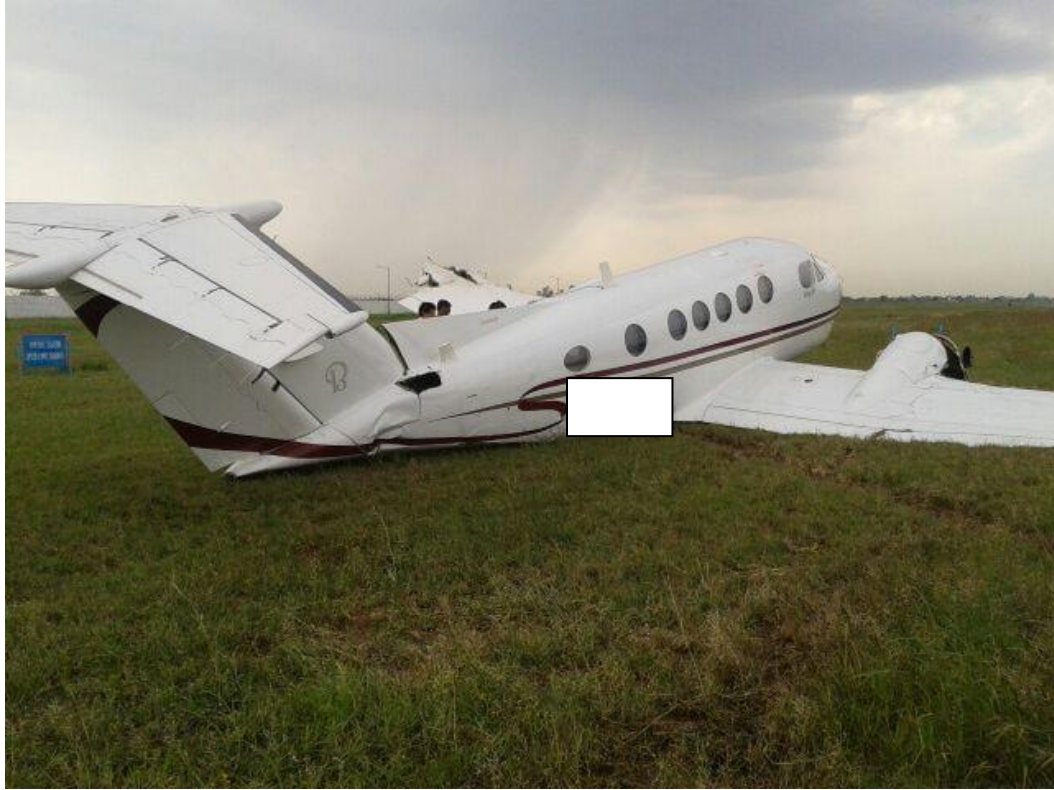
Within 3-4 seconds of getting airborne the aircraft impacted ground in left bank attitude. The initial impact was on pucca (tar road) and the left wing has taken the first impact loads with lower surface metallic surface rubbing on ground.

On the ground, there were marks of the propeller. The propeller blades of the left engine had made cut marks on the ground and then skidding of the aircraft. On the way both the propeller hub assemblies have got detached from the main structure. The nose section also got separated from the aircraft and was lying at a distance of 30' from the final position of aircraft.

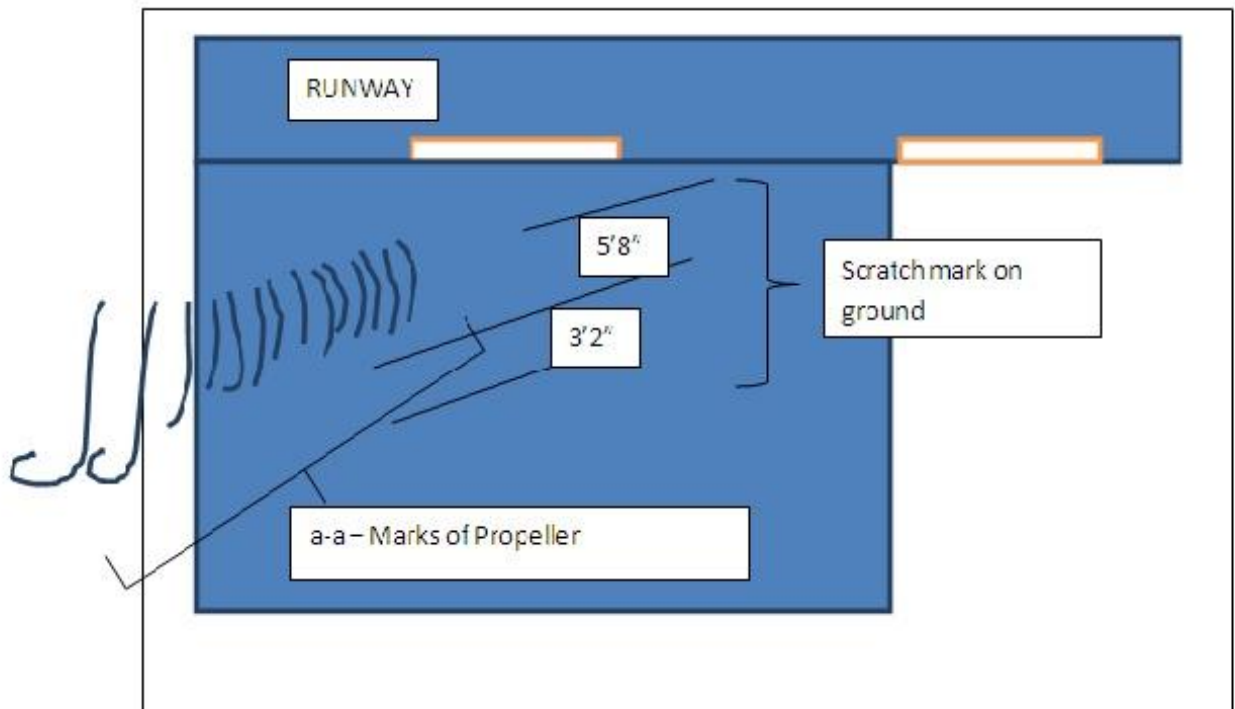
Rubbing marks observed on the ground are as in the drawing below:

a-a : Mark of Propeller Striking the ground in running condition.
Dimensions (starting at 1 from right)

1-2	:	10"	8-9	:	17"
2-3	:	10"	9-10	:	17"
3-4	:	12"	10-11	:	22"
4-5	:	12"	11-12	:	22"
5-6	:	14"	12-13	:	26"
6-7	:	17"	13-14	:	31"
7-8	:	16"
