FINAL INVESTIGATION REPORT
ON ACCIDENT TO
JET AIRWAYS BOEING B-737-800 AIRCRAFT VT- JBG
AT GOA ON 27.12.2016

Rajinder Singh Passi
Chairman, Committee of Inquiry

FINAL INVESTIGATION REPORT ON ACCIDENT TO JET AIRWAYS
BOEING B-737-800 AIRCRAFT VT- JBG AT GOA ON 27.12.2016

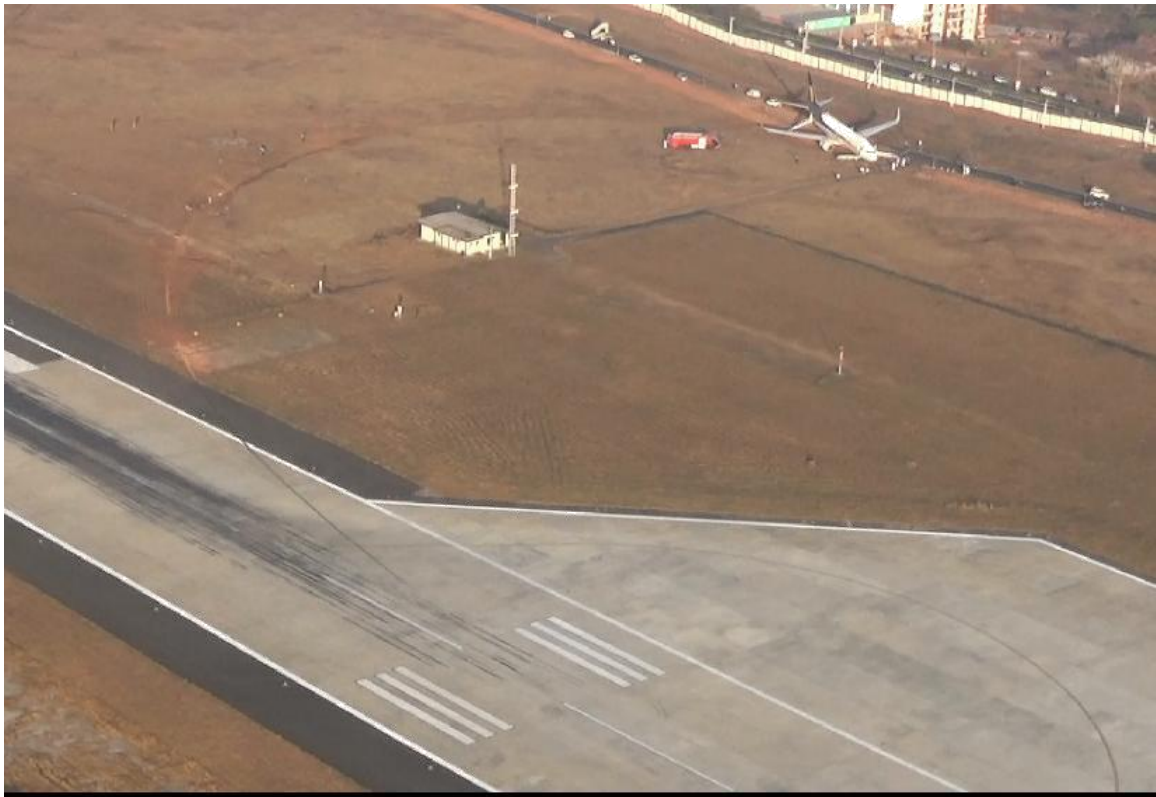
TRAJECTORY FOLLOWED BY THE AIRCRAFT

As soon as TOGA was pressed, the aircraft started drifting towards right. Within 10 to 12 seconds of pressing TOGA, the aircraft went into unpaved surface. As per the crew, they tried to apply brakes, rudder and use NWS to

steer the aircraft, but due to heavy bumps could not apply control effectively. The aircraft went out of control and continued into unpaved surface.

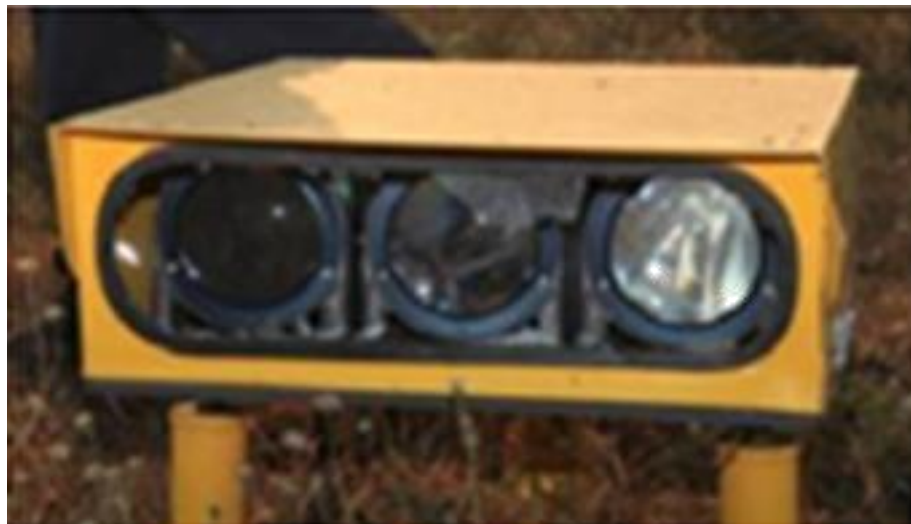
PAPI LIGHTS

The aircraft stopped at a distance of 219 m from the runway edge and just short of periphery road. During this trail it had hit PAPI lights.

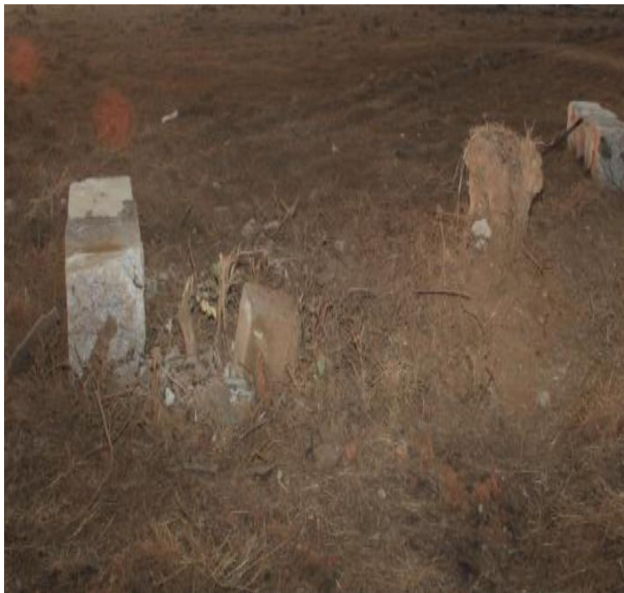
PILLARS (after aircraft impact)

Engine had hit vertical pillar of 2.3 m height, located at 92.3 m abeam center line of Runway 26. The pillar has also damaged the left bottom portion of the fuselage.

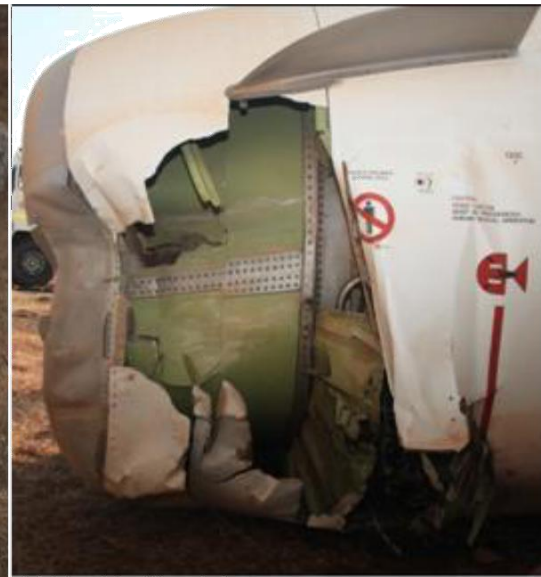
Engine damaged due hitting pillar

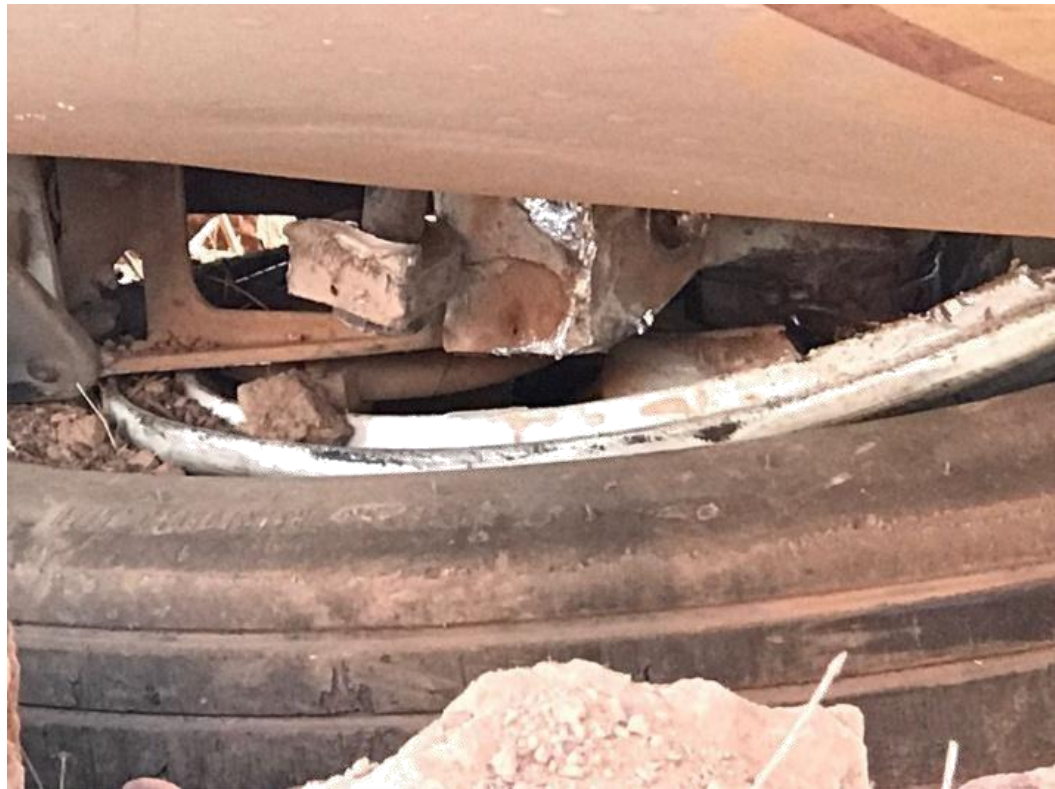
- Nose landing gear oleo got damaged and found completely buried under the aircraft nose.

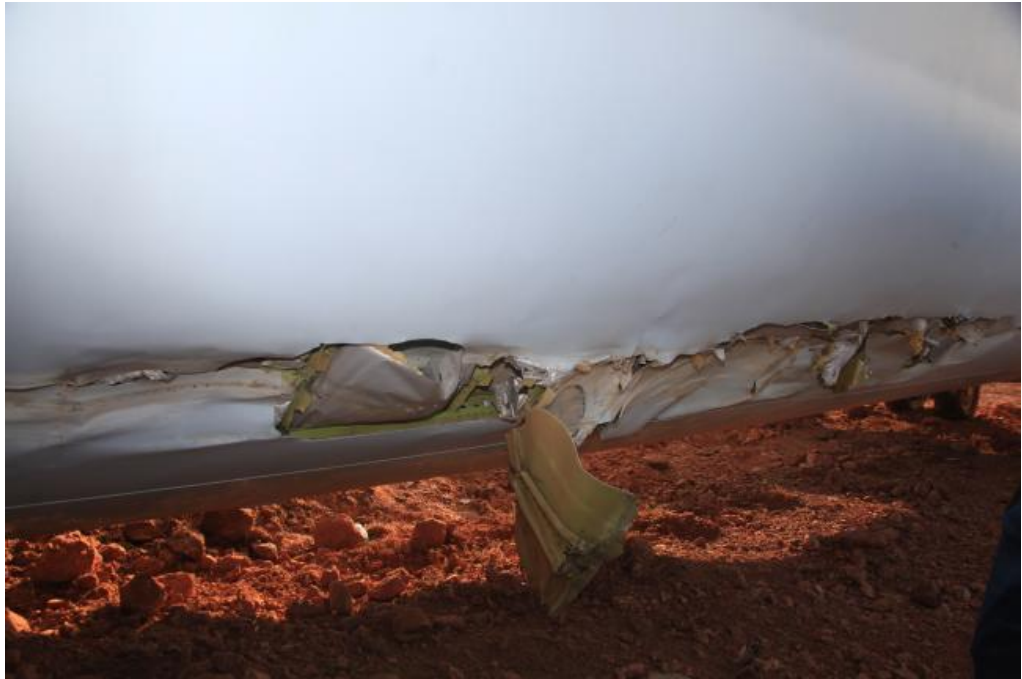
- Damage to LH side fuselage rearwards of aft of the front LH main door.

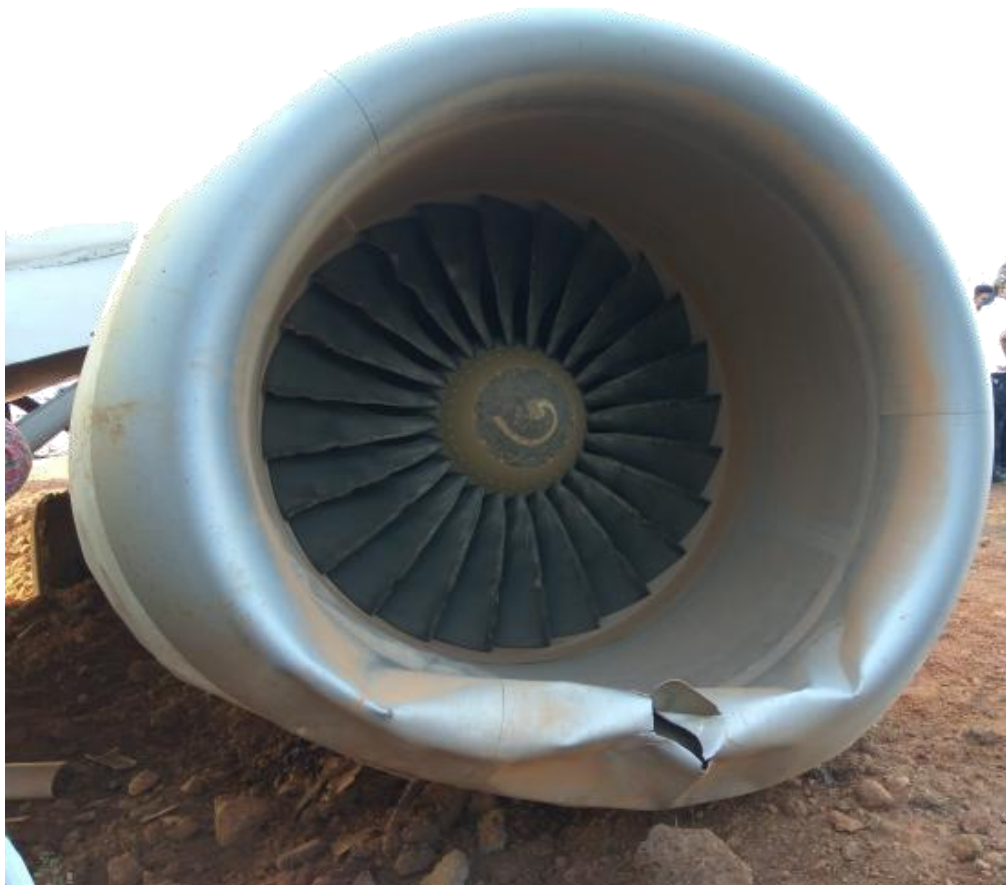
- Damage to LH engine cowling.

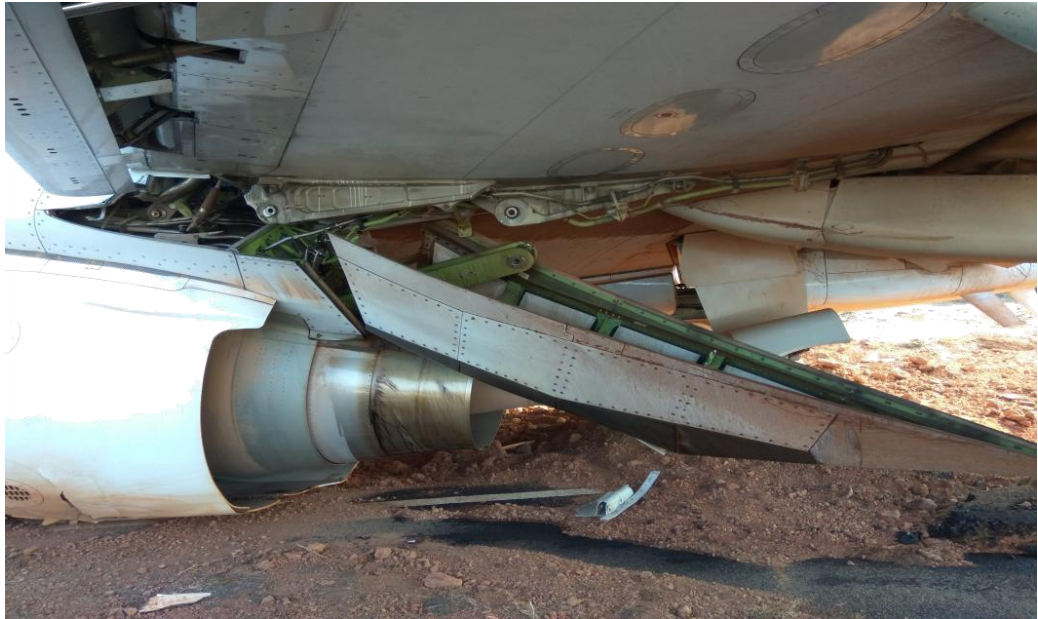
- LH engine pylon attachment broken.

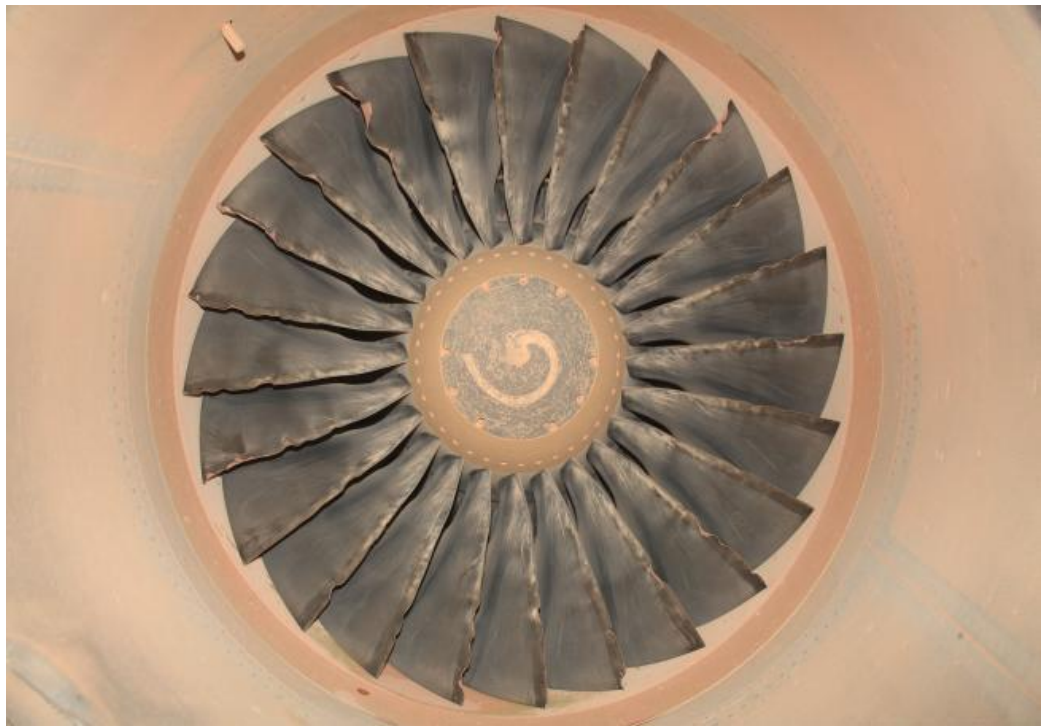
- Damage to LH engine fan blades.

- Air starter housing had a dent and crack.
- All the fan blades had nicks and tears. The fan Case lining was completely missing with parent metal exposed.

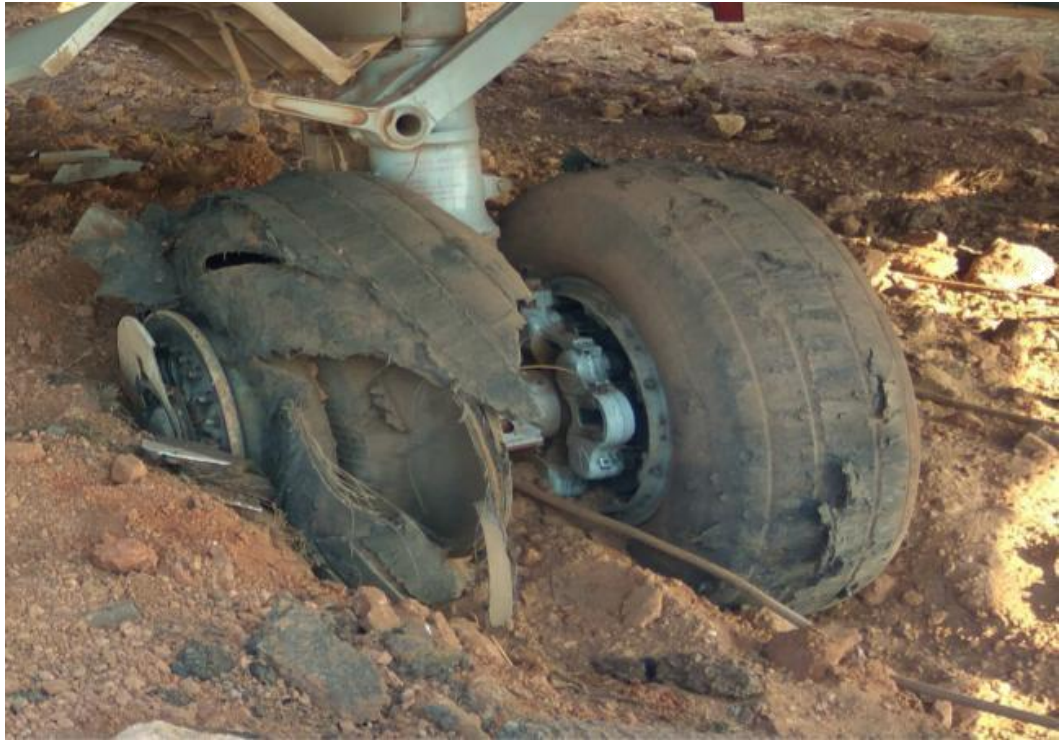
- Damage to LH landing gear wheel & Tyre.

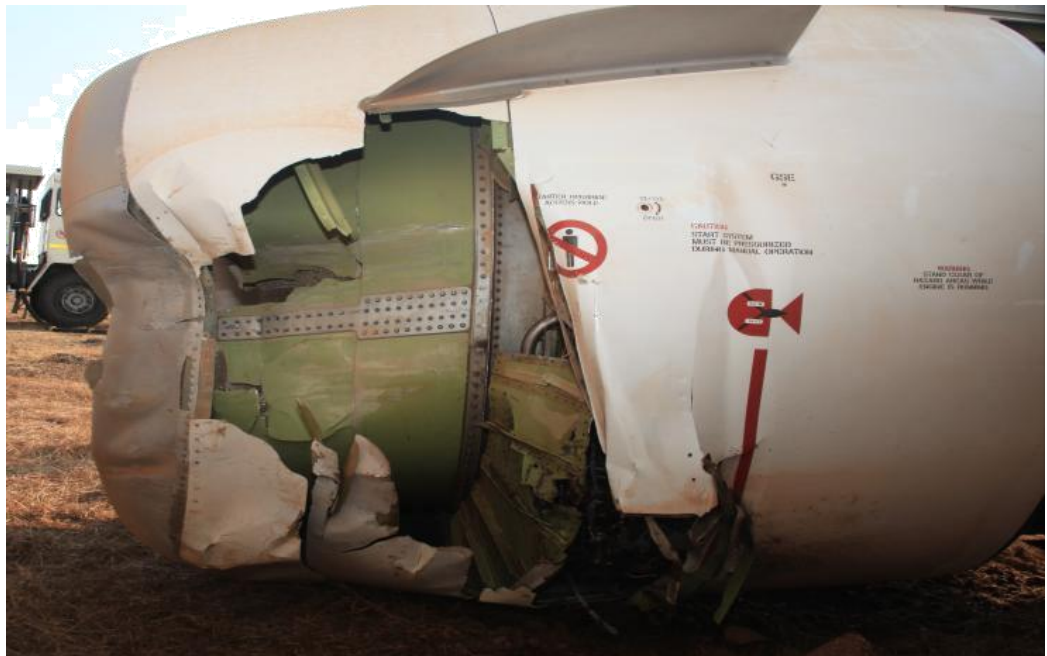
- Damage to RH engine.

- Impact damage was seen on the IDG.
- AGB was broken
- Servo Fuel Heater was broken.
- TGB shaft housing was bent.
- Leading edge distortion was observed on one of the Fan Blades.
- Fuel Filter, Oil Supply Filter and Scavenge filter condition was satisfactory.
- All Magnetic Chip detectors and Scavenge screens were removed, inspected and found satisfactory.

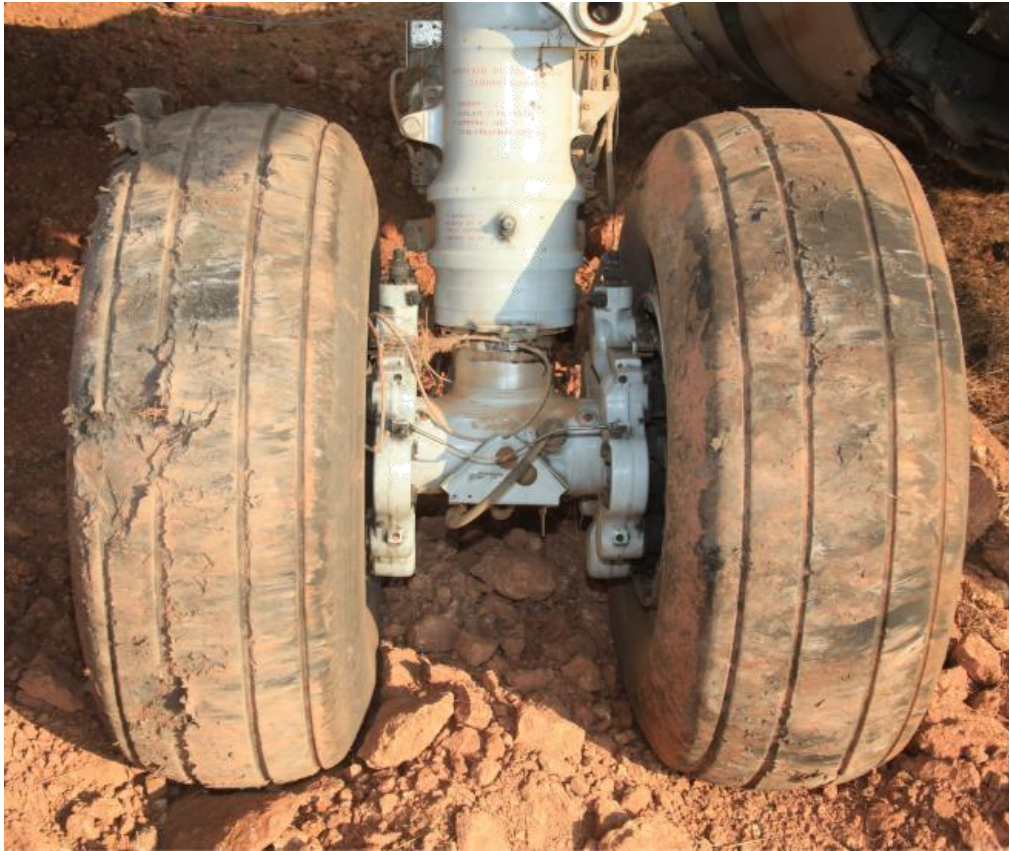
- Damage to RH Wheel & Tyre.

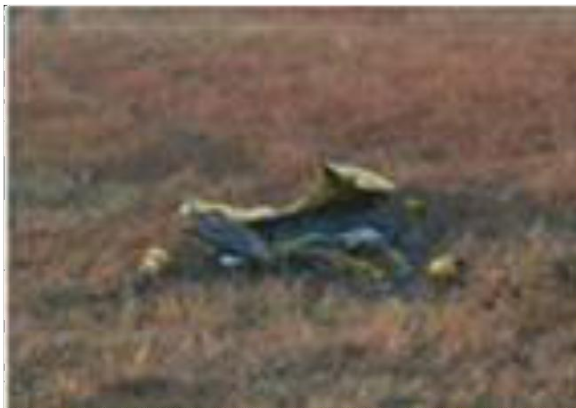
The aircraft had hit a PAPI light and damaged glass of another PAPI light.

Broken PAPI Light

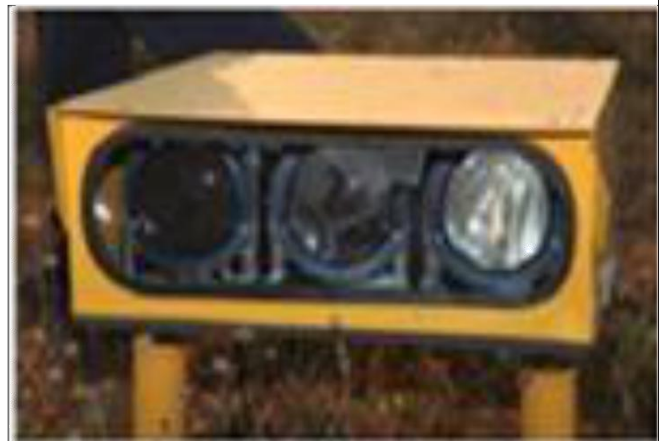
Broken glass of other PAPI Light

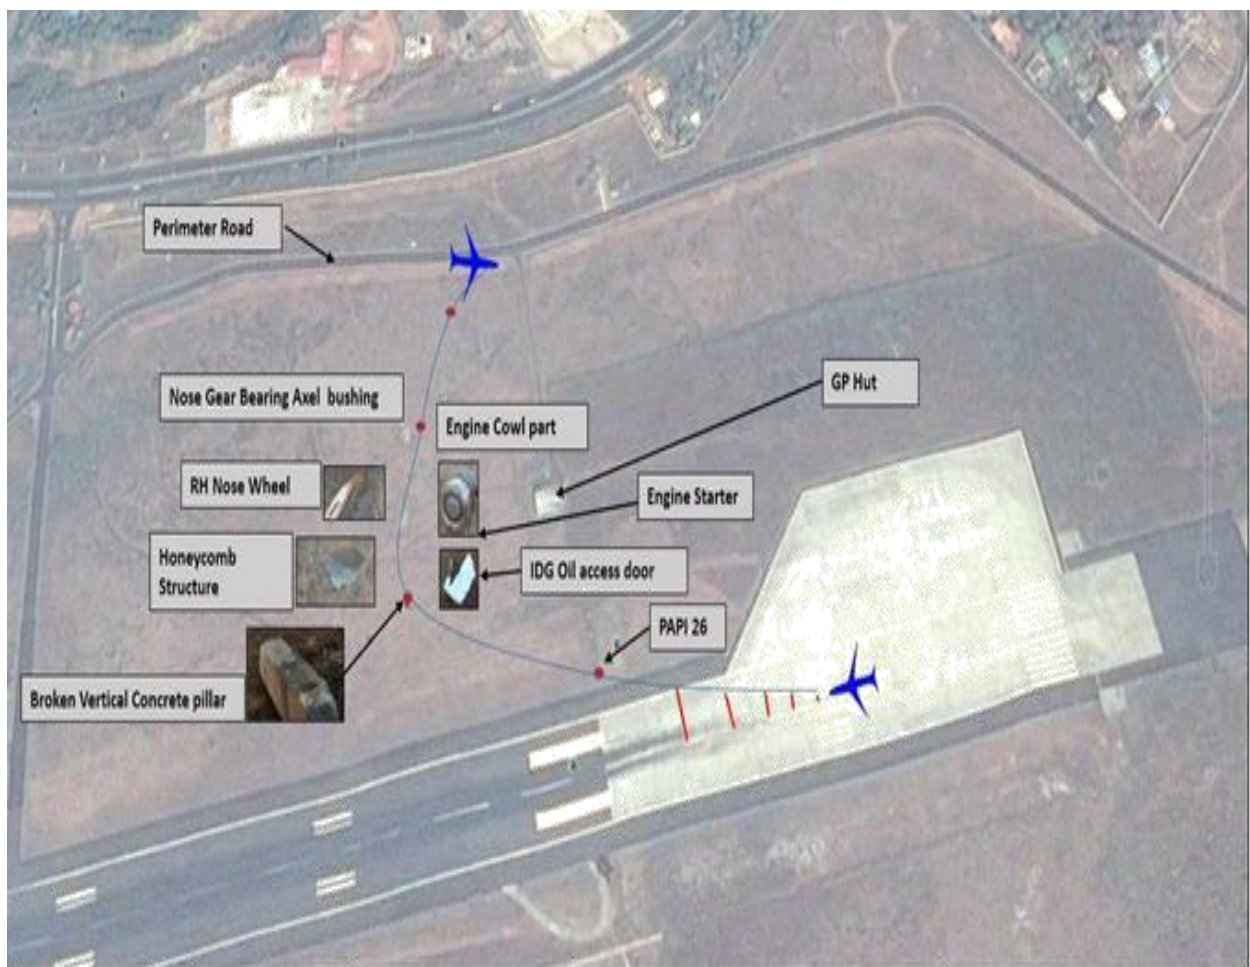
WRECKAGE DIAGRAM

The crew could not control the aircraft and it went into kutchra. The aircraft stopped at a distance of approximately 219 m from the Rwy centre-line, just short of periphery road. There were some unused RVR observation vertical cement pillars of approx 2.3 m height in the path traversed by the aircraft. Though the aircraft stopped and the wreckage was self contained, there were following structural damages due high speed travel on the undulated ground

- ✚ LH and RH forward lower fuselage (from STN 360 to forward lower Nose compartment)
- ✚ LH engine
- ✚ Tread and sidewall of both tyres of RH MLG were badly scrapped.
- ✚ Nose gear was folded backward into area between E/E compartment and wheel bay.
- ✚ RH Engine inboard side
- ✚ LH MLG No. 1 wheel hub and both tyres.

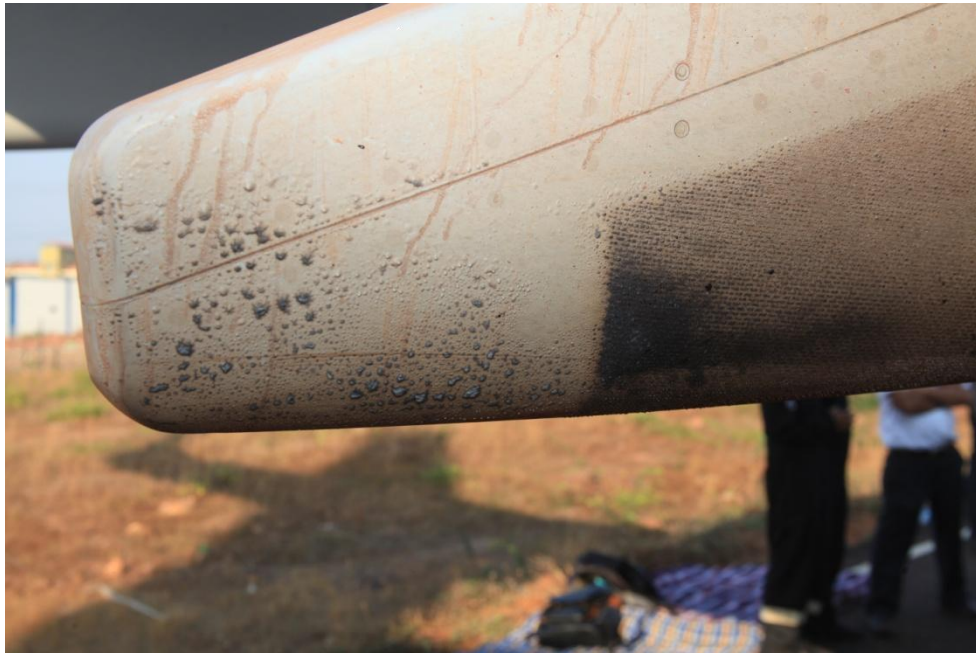
There was no fire barring that one of the flap track fairing had burn marks.

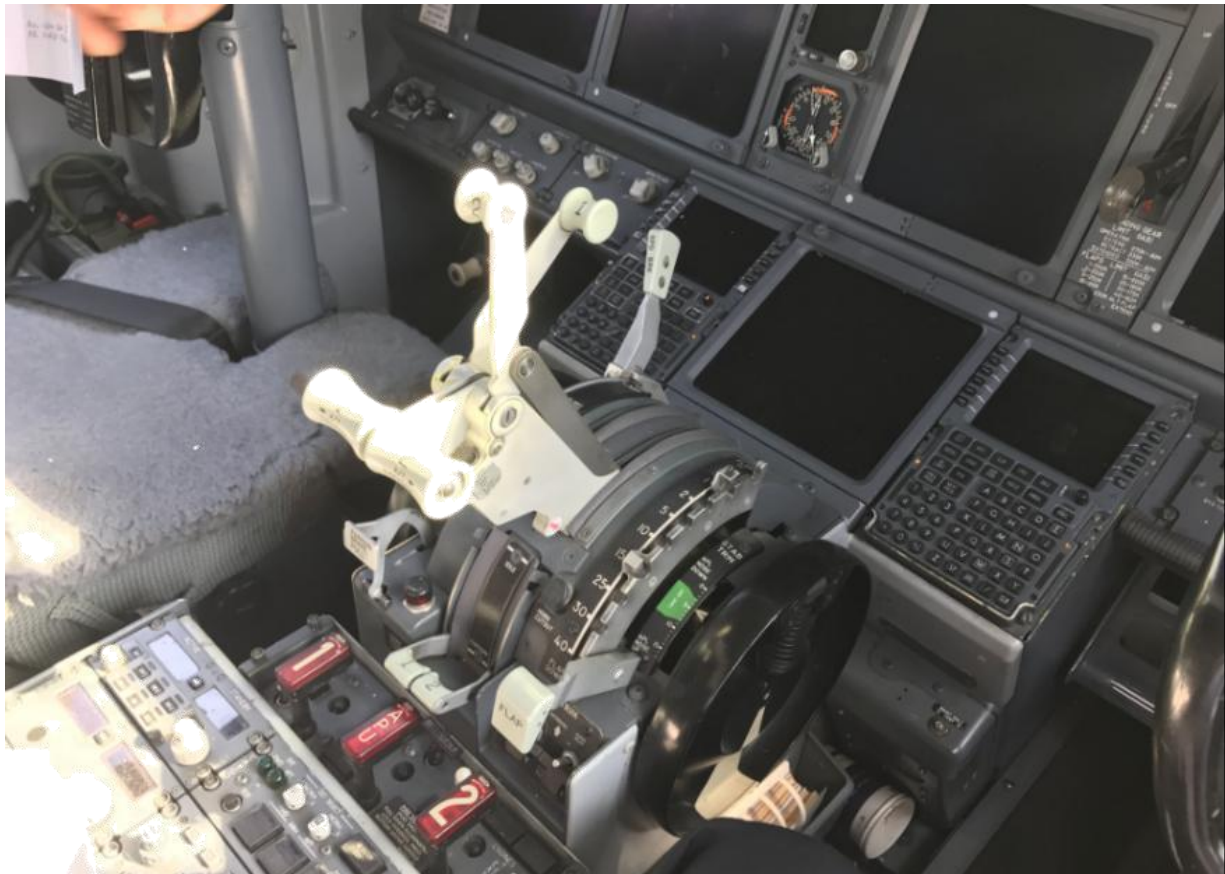
- The number two reverse thrust is fully deployed and the number one thrust lever is in the interlock stop position.
- The parking brake has been set and the speed brake lever is in the down detent

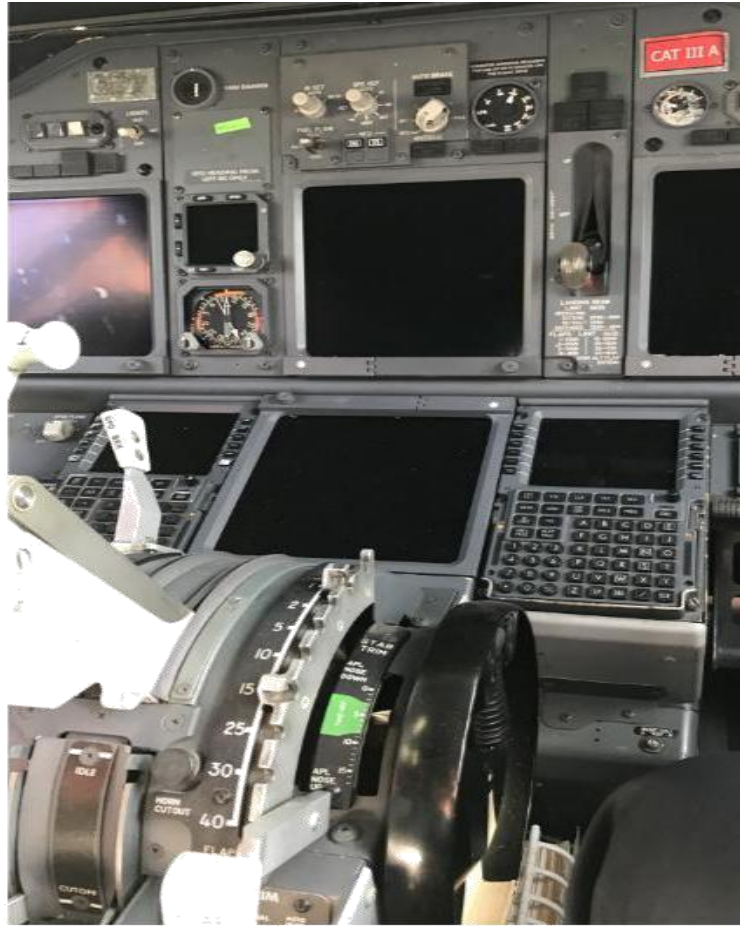
- The flaps lever is in the 40 position.
- The flaps indicator shows flaps 5.
- There is damage to the brake pressure indicator on the top right side

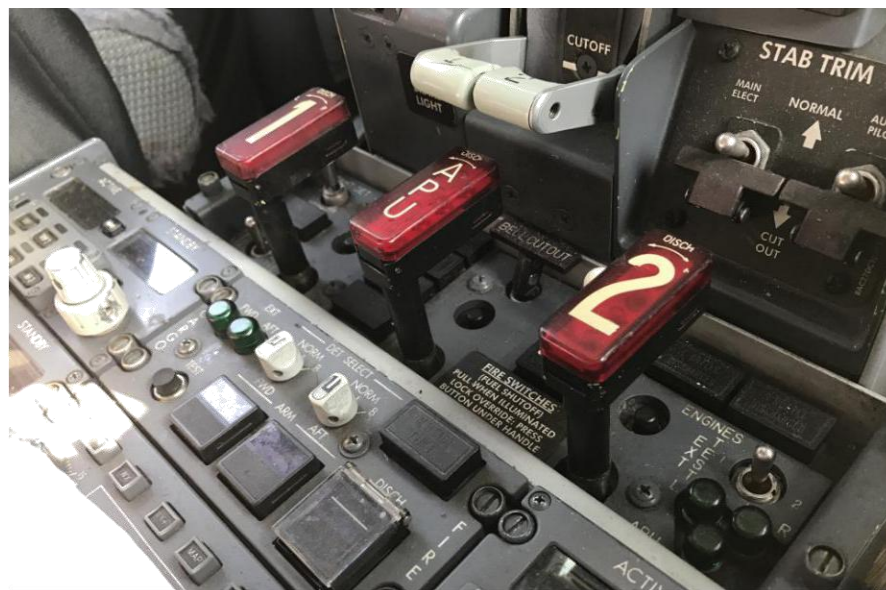
- Both start levers are moved to cutoff.
- The two engine fire switches and the APU fire switch have been pulled. These are in concurrence with the evacuation checklist
