**FINAL REPORT OF ACCIDENT
INVOLVING
M/s JET AIRWAYS ATR 72-600 AIRCRAFT
VT-JCX
AT INDORE
ON 07TH MAY 2016**

FINAL REPORT ON ACCIDENT TO M/s JETAIRWAYS ATR 72-600

AIRCRAFT VT-JCX AT INDORE ON 07/05/2016

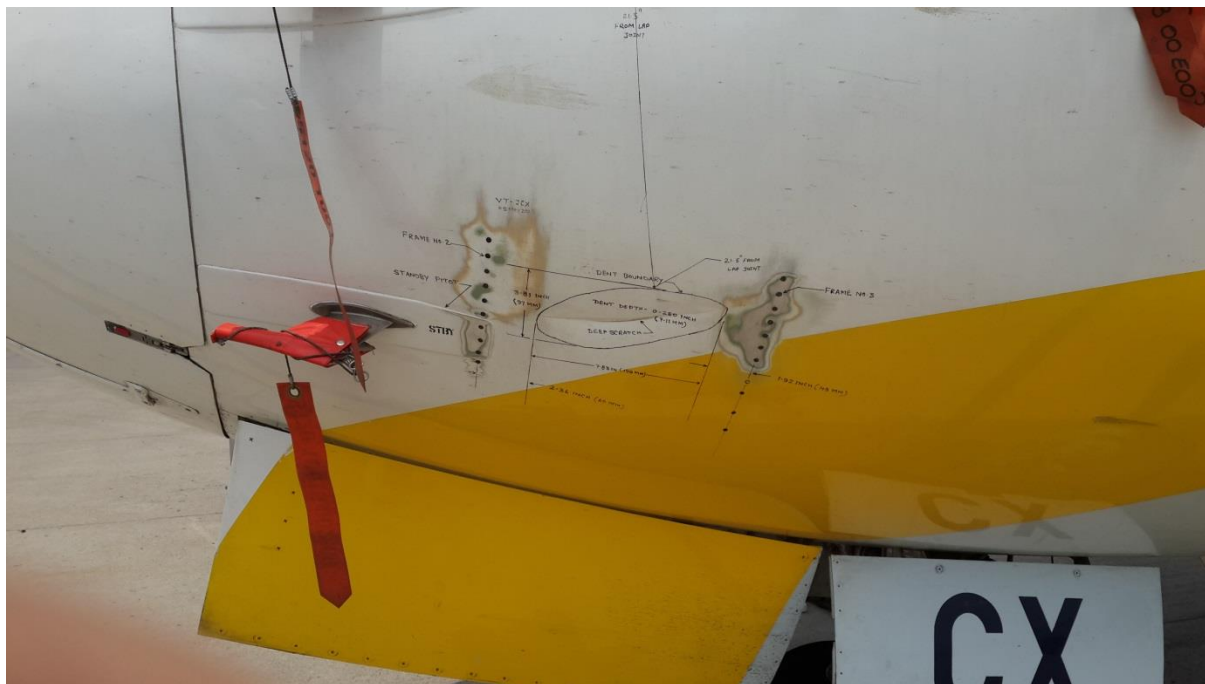
Fig 1

Aircraft sustained substantial damage while moving over uneven and unpaved surface and was grounded for necessary repairs and maintenance. Deep scratch and dent was observed near Standby pitot probe SEC 11.

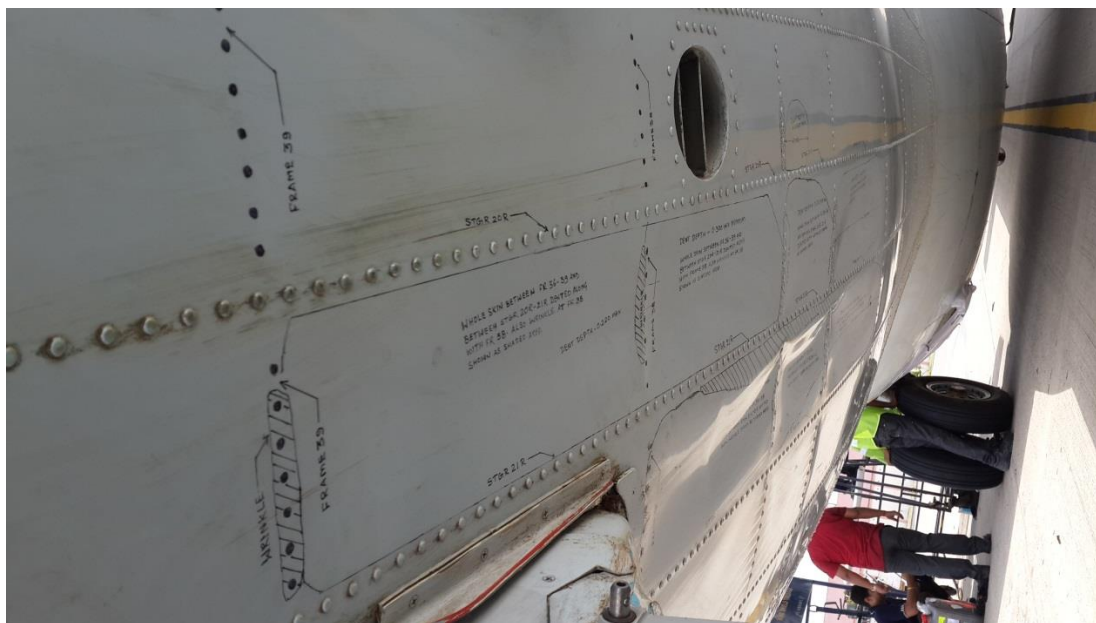
Fig 2

Lower fuselage belly skin was scratched, buckled and dented ahead of SEC 16.

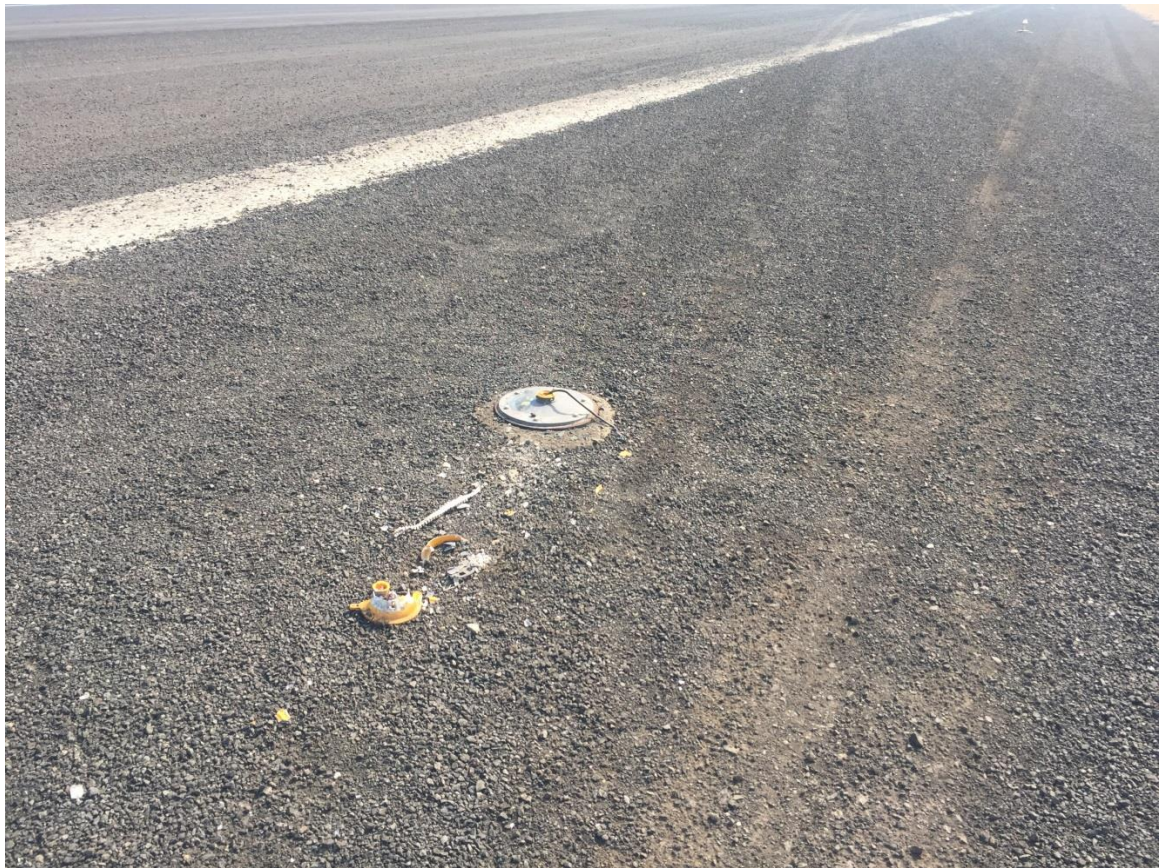
Fig 7

The DGCA had conducted last surveillance of Indore Airport on 26.11.2014. As per the non-compliance report *“Surface condition of runway is very bad. Loose pebbles are observed throughout the runway. There are depression and pot holes at many places on the runway, It is safety hazard to aircraft.”* The picture below shows the surface condition of runway near area where aircraft exited the runway

As per the Action Taken Report provided to the COI, both the non-compliances were still open, as on 31.03.2016. The tender for resurfacing was awarded, but the work was under progress, and in the meanwhile regular removal of gravels was being done through runway cleaning contract. The potholes were also being repaired as per operational requirement. The expected date of completion was stated as 30.11.2016.

It is evident that from the photographs, inspection report and statements of pilot that, condition of the runway had deteriorated and was a contributory factor in accident.

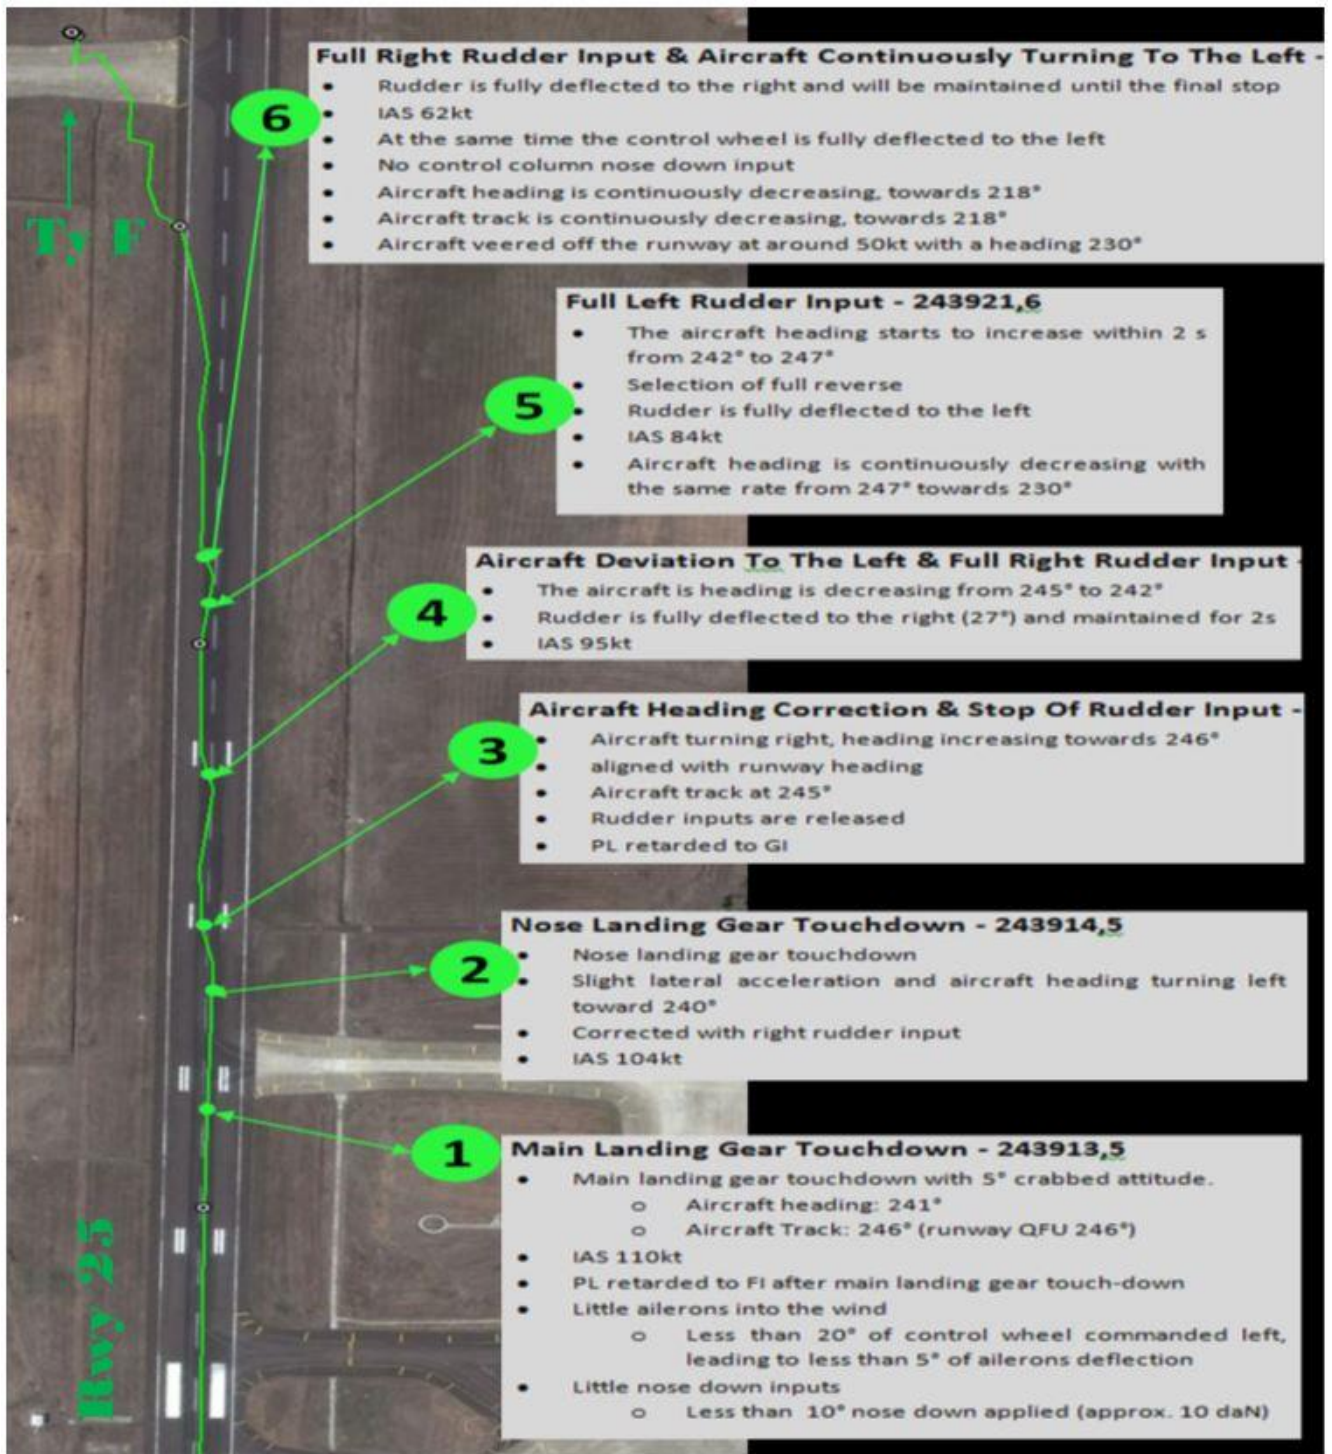
Fig 8

Main events vis-a-vis travel of aircraft on runway and off the runway after landing as per the report provided by BEA, France are appended below.

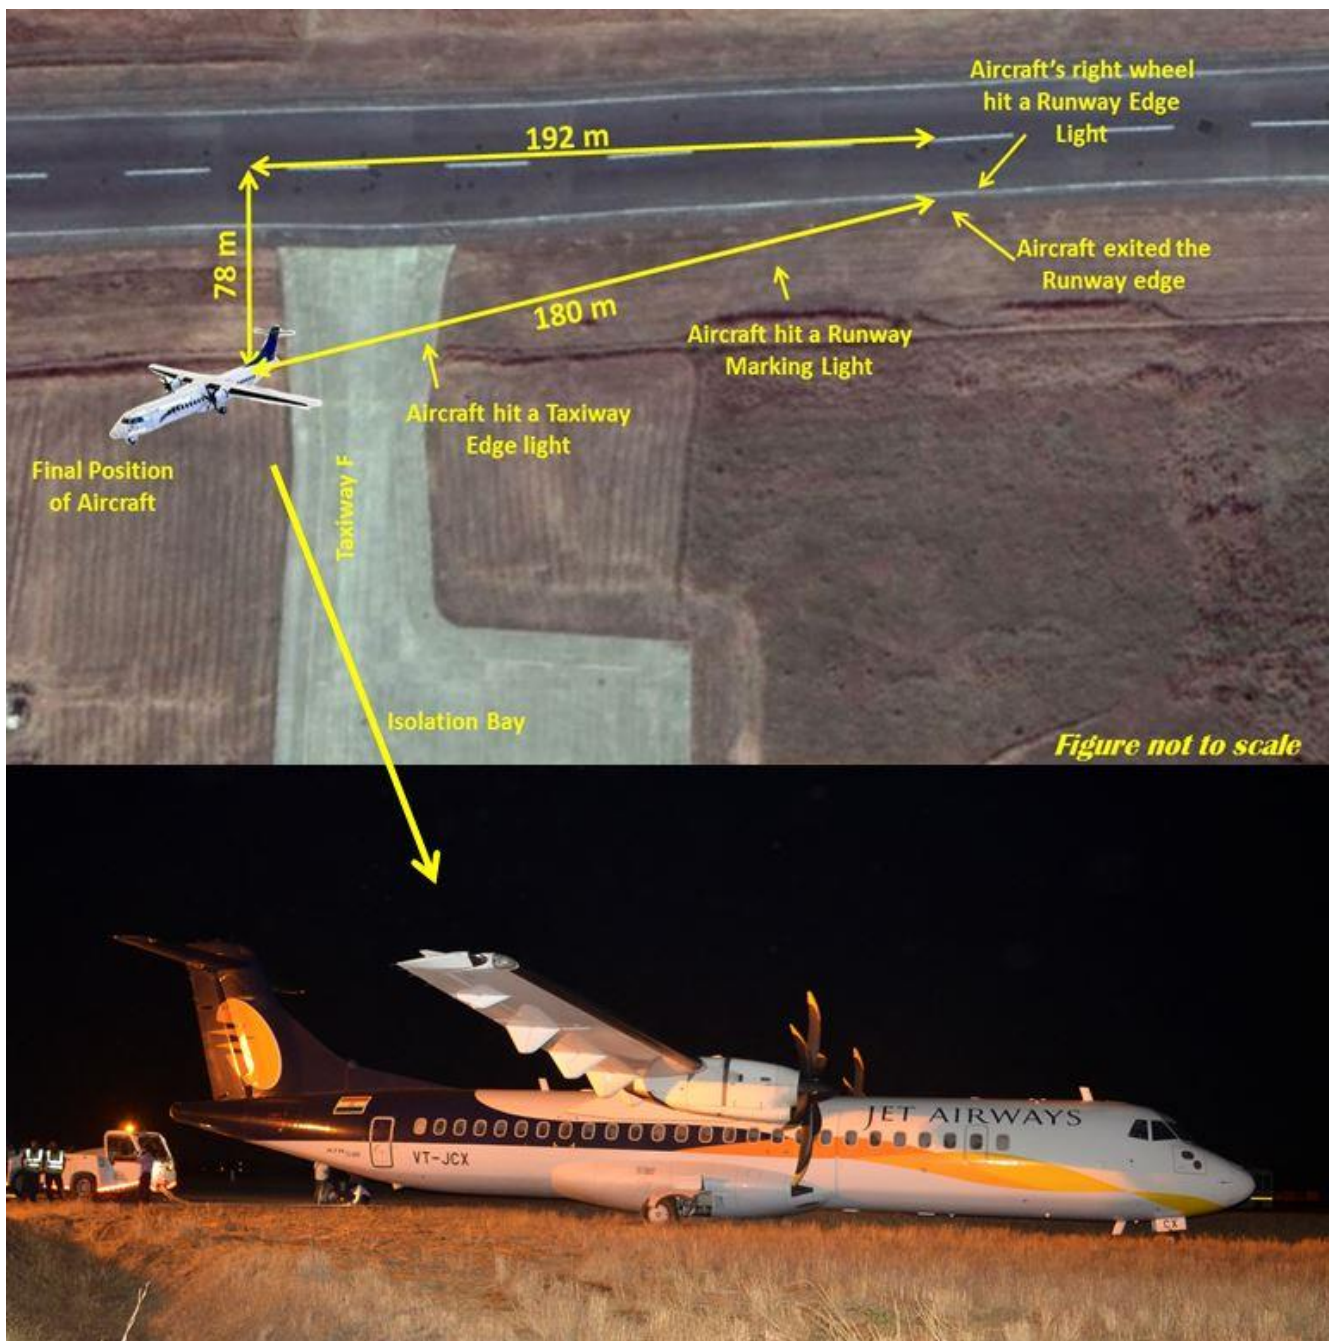
Fig 9

The aircraft exited the runway on the right at a distance of approximately 1300m from Rwy 25 threshold.
