**FINAL INVESTIGATION REPORT ON ACCIDENT TO
CESSNA-152, VT-MMM OF M/s YASHAIR LTD. AT
SHIPRA RIVER, KALYANPURA, UJJAIN, MADHYA
PRADESH ON 19.05.2010.**

Office of Director of Air Safety, Mumbai
Directorate of Air Safety,
Directorate General of Civil Aviation, New Delhi.

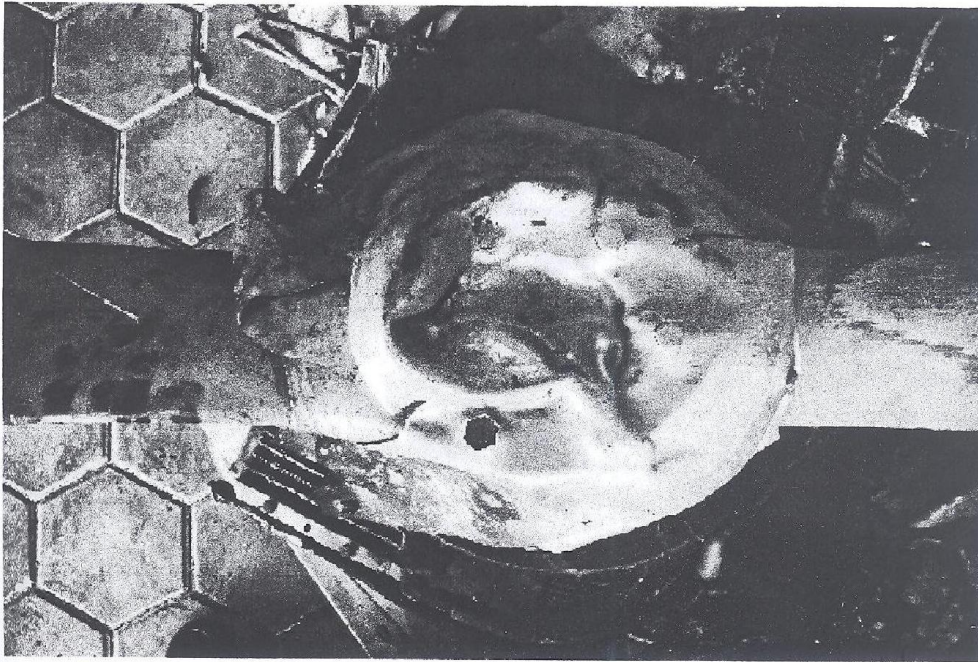
Spinner mark exhibit low power impact on nose with river bed

The propeller has the marks of electric cable on the leading edge and the spinner. The rubbing marks pattern indicates that the propeller was on power at the time of impact with the electric cable. The nose landing gear strut is also having a rubbing mark of the electric cable thereby peeling the white paint coating on the frontal surface.

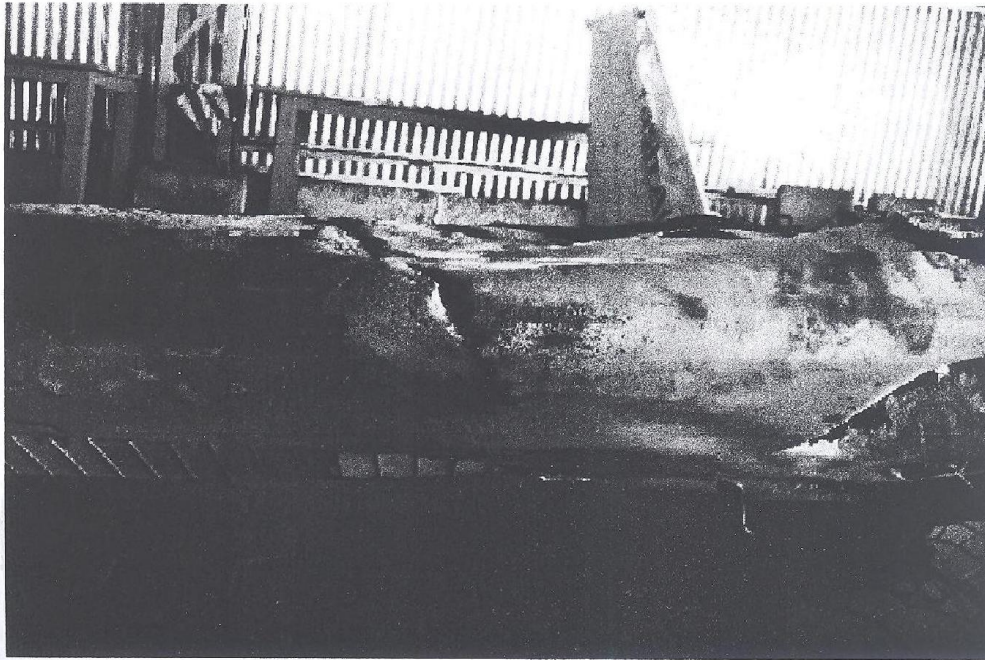
The main landing gear struts also has the rubbing marks on the frontal surface. The RH wing has a cut of approx 60 degree indicating the bank of right after hitting the first cable. The second cable must have cut the wing RH leading edge.

The electric cable sliced the RH leading edge of the wing

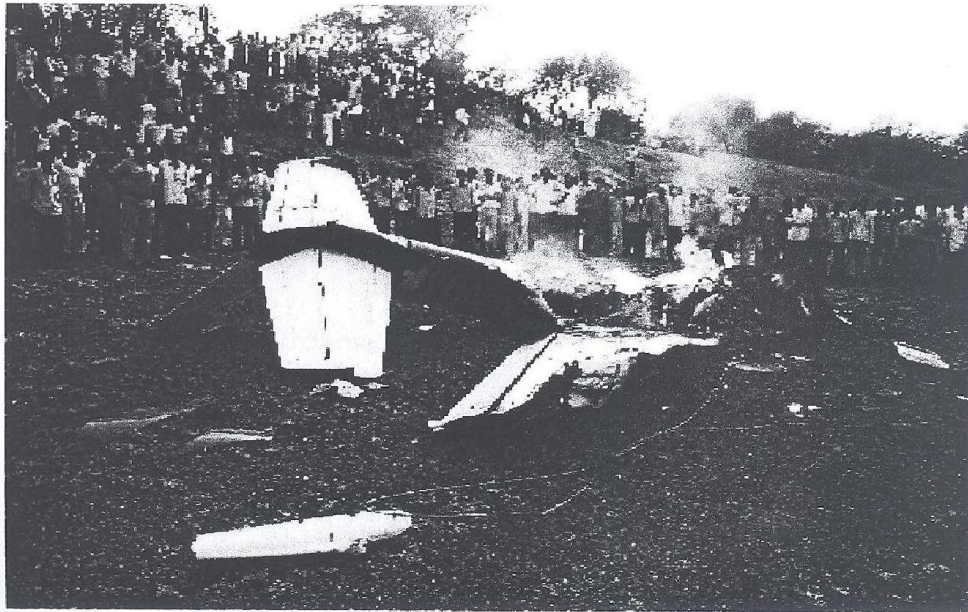
The beginning or initiation of the fire was the impact on ground. This could be said with good degree of certainty because the electric cable of 33KV was inspected and did not reveal any fire traces. The fire was confined to the aircraft and the 11KV cable which was found along the wreckage.

The fire initially began on impact with ground due to the breaking of carburetor and the AVGAS getting sprayed on to the hot section of the engine. The carburetor is at the bottom of the engine and just ahead of the exhaust manifold. The exhaust manifold is hot and any fuel or fuel vapour on to it can cause immediate fire. This has caused the complete engine to catch fire. Hence the complete engine cowling melted. This fire had spread to the wing tanks situated right above the cockpit and engulfed the whole cockpit. There was no indication of inflight fire as no trail of fire or fuel could be observed on the rear of the fuselage.

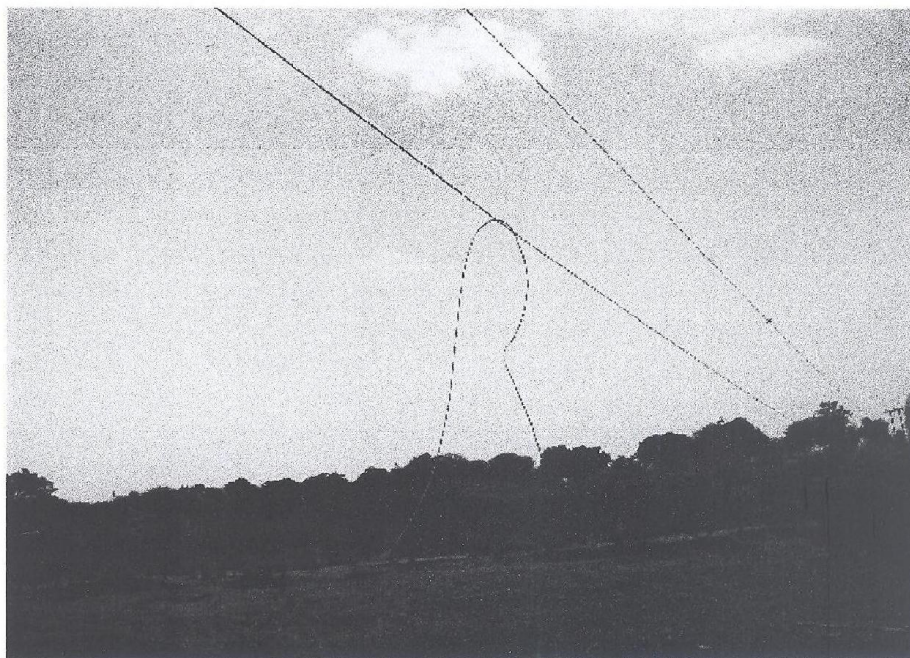
The 33 KV line wires were plying across the river Shipra from electric pole to pole. The R phase of these 33kv wires had broken due to aircraft impact and was found near the wreckage. Thereafter the aircraft had also impacted 11KV 3 wires and even these cables were found near the wreckage.

The broken cable of 33KV electric line across Shipra river

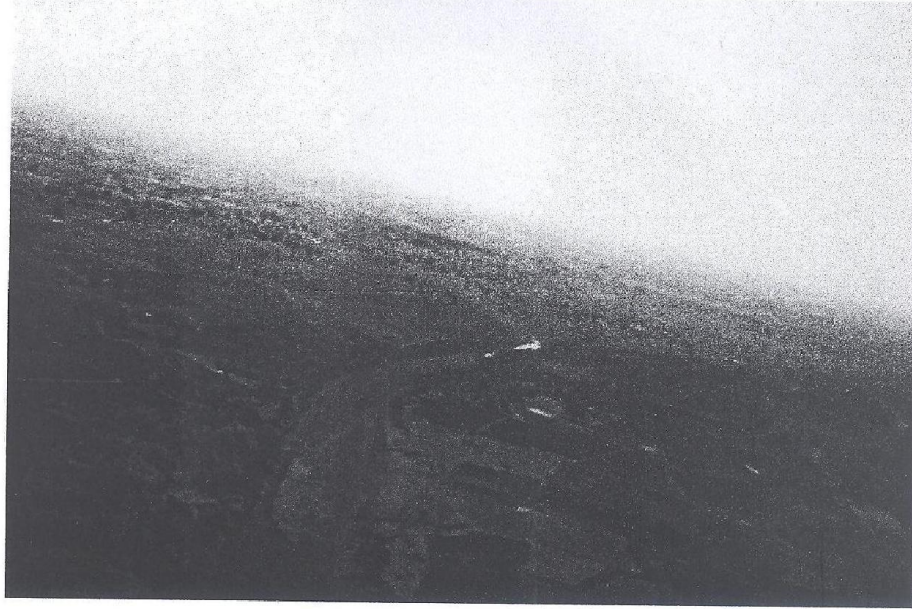
The aerial view at the beginning of downwind left hand circuit

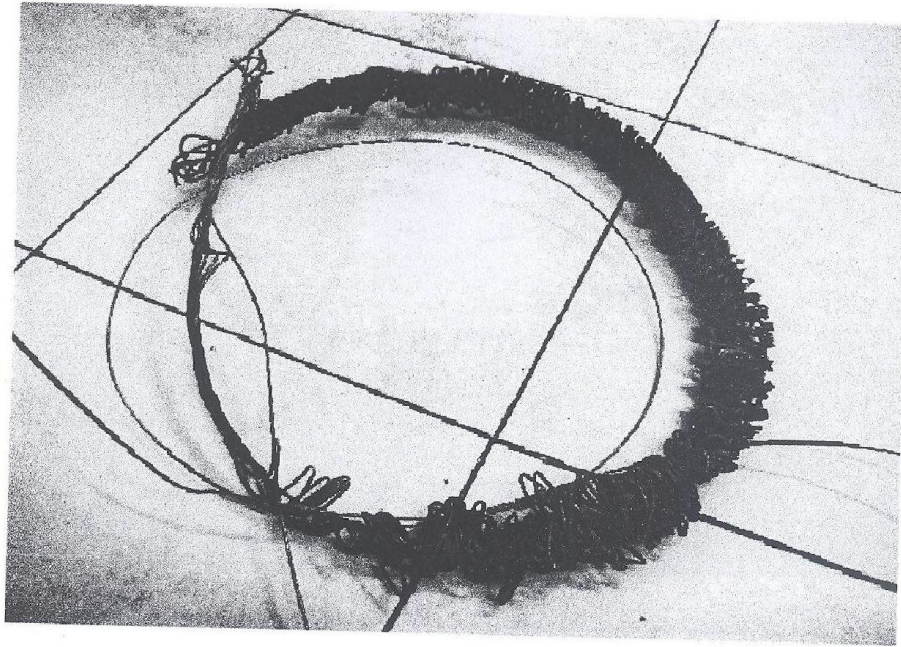
The Assistant Engineer, State Electricity Board stated that the 33KV electric line had three cables. It is 750 ft long from pole to pole across the river. One of the cables of 33KV measuring 300 ft broke and wherever it has broken it has formed a lump of rings. Thereafter the aircraft went into 3 electric cables of 11KV, which were 1050 ft long from pole to pole across the river. The aircraft broke these cables into 3 pieces of 450 ft and the aircraft was enmeshed into it. However there was no electric power in these cables during the accident.

Condition of the 33 KV cable found with wreckage

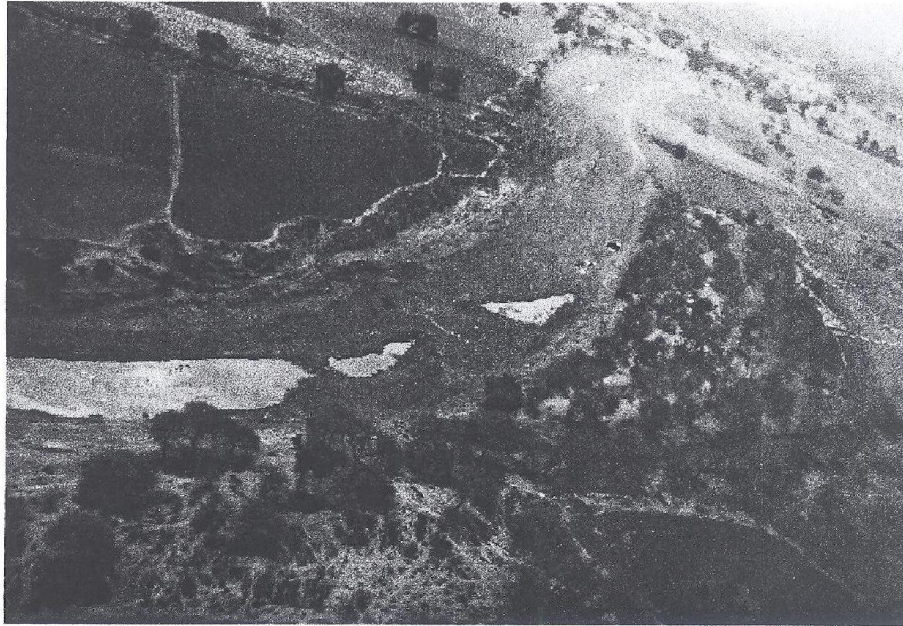
In view of the above statement and facts it could be stated that the aircraft was low when it was on crosswind. Further it came low by reducing the power to fly low over the river. Just before the crash site two water bodies could be seen and attempt was made by the pilots to have a closer look of water bodies (Photo).

The crash site just ahead of water bodies in shipra river
