**FINAL INVESTIGATION REPORT OF ACCIDENT TO M/S NORTH
EAST SHUTTLES PRIVATE LIMITED CESSNA CARAVAN 208B
AIRCRAFT VT-NES AT LENGPUI AIRPORT ON 04.05.2011.**

Cessna caravan 208 B aircraft VT-NES operated by M/s North East Shuttles Private Limited was involved in a runway overrun accident at Lengpui airport while landing on 04.05.2011 at approx 1045 Hrs IST.

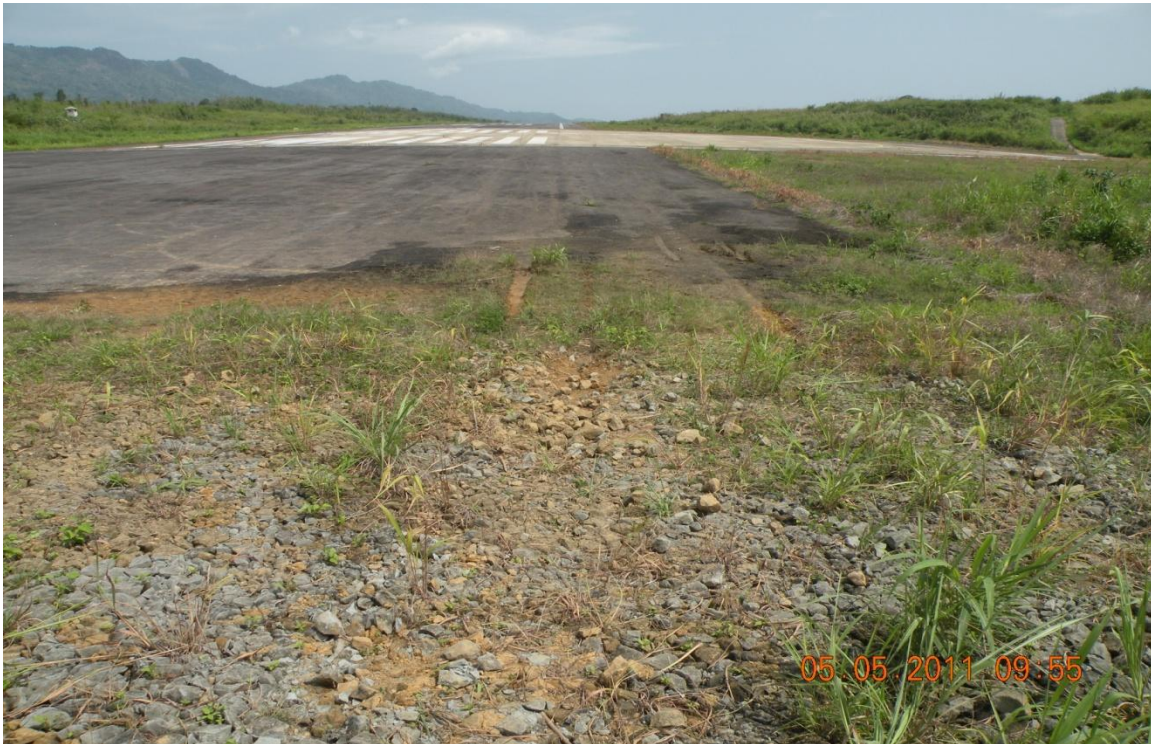
Runway End Safety Area (90Mts X 90Mts) is yet to be declared. RESA will be provided on RWY17 and RWY 35 side on completion of the proposed runway extension (Fig 1 shows no RESA).

Fig-1: View of the runway from RWY 35 with no RESA.

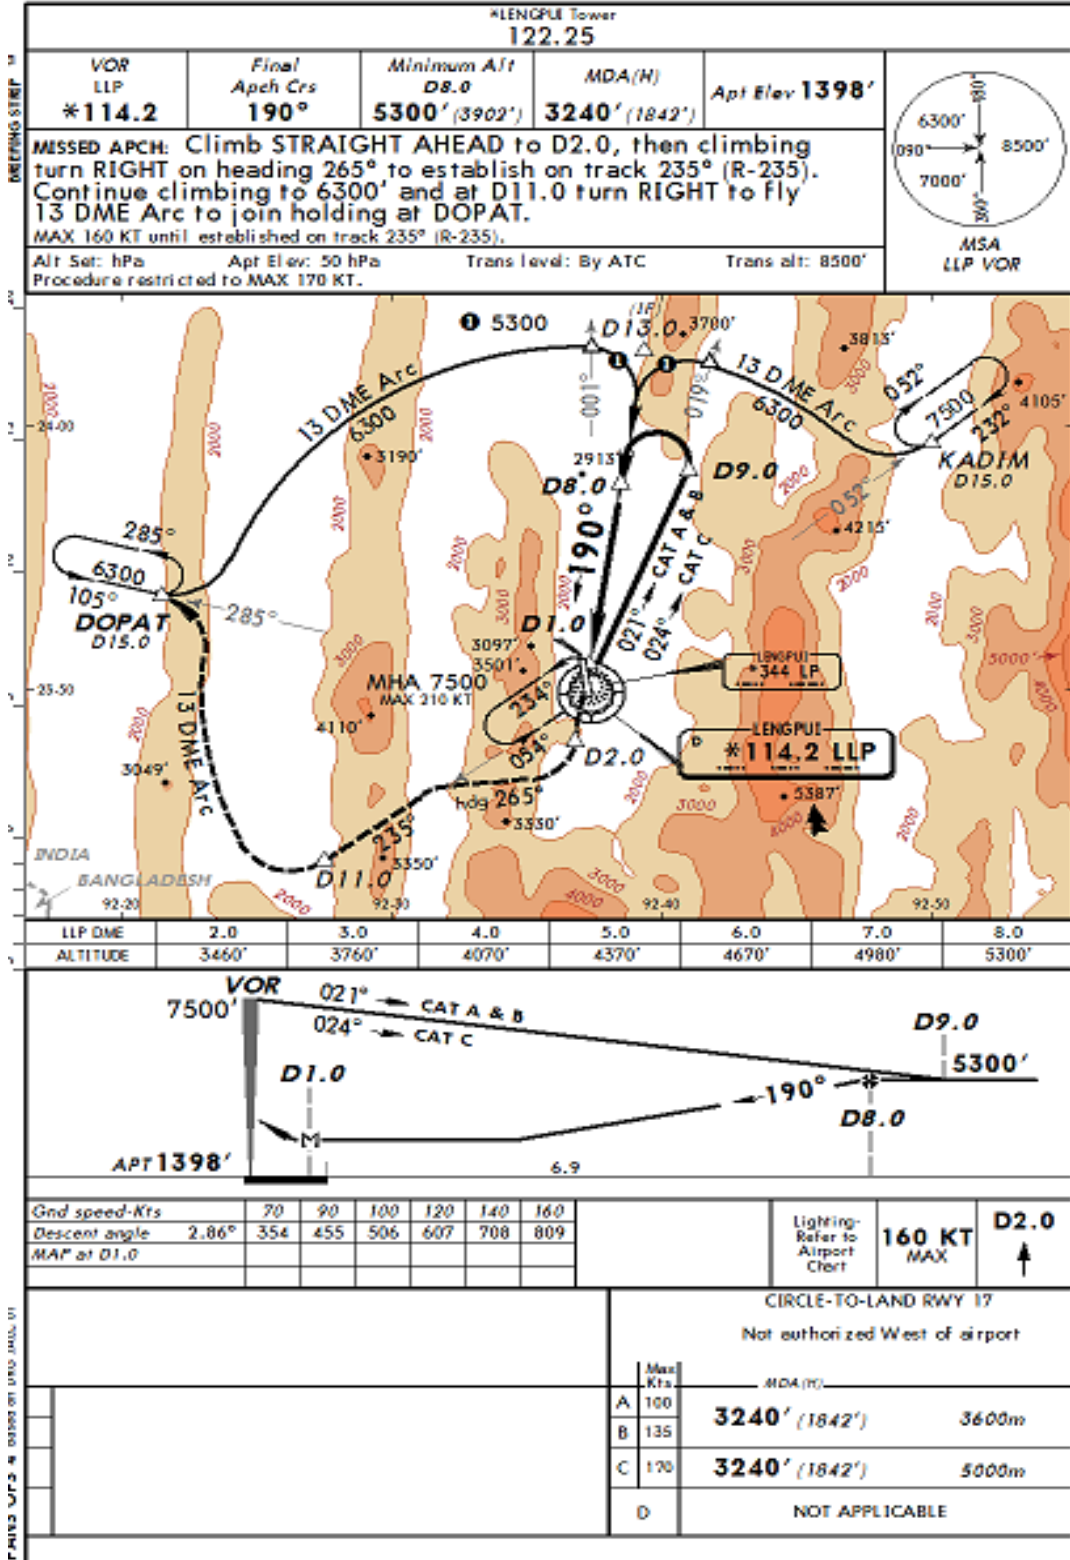
**LENGPUI, INDIA
CIRCLING VOR DME**

Airport is equipped with NDB and DVOR and DME. It has a published VOR DME circle to land approach for RWY 17 with a minima of 3600m for this category of aircraft (refer Fig 2)

Fig-2: Published VOR DME circling approach.

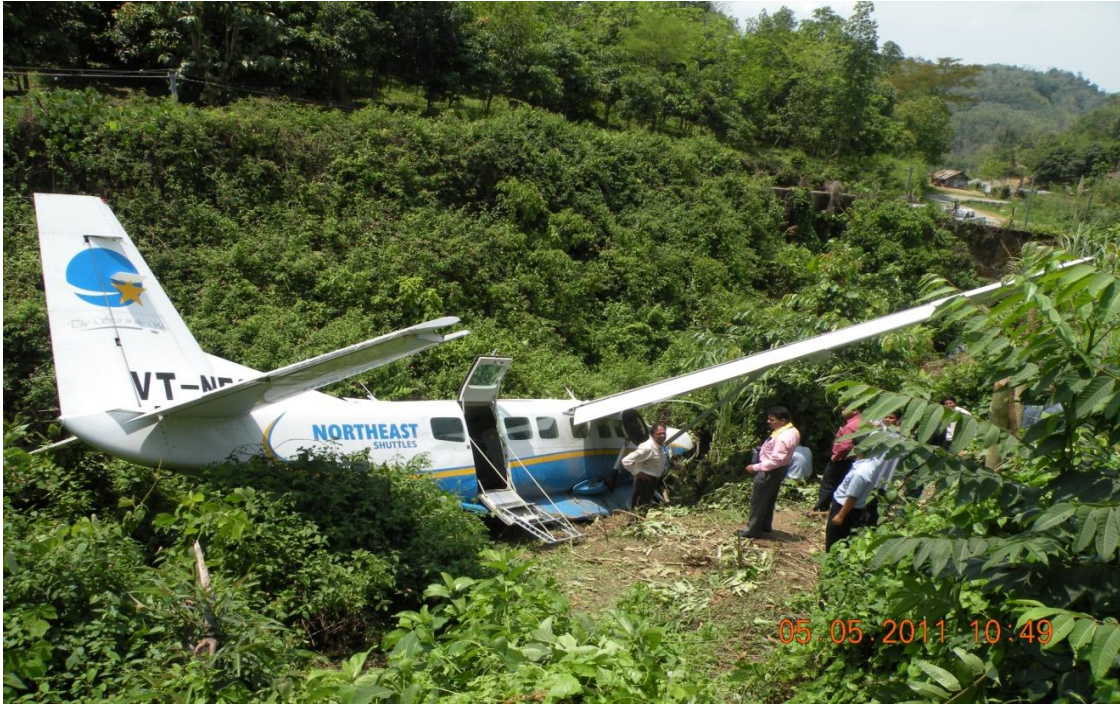
The wreckage of the aircraft was found in the 60 feet ravine at the end of runway 17 (Ref Fig 3). No parts/component found disintegrated from the main wreckage of the aircraft, however the brief details of the damage sustained by the aircrafts are appended below:

Fig-3: View of the wreckage seen from the top of ravine.

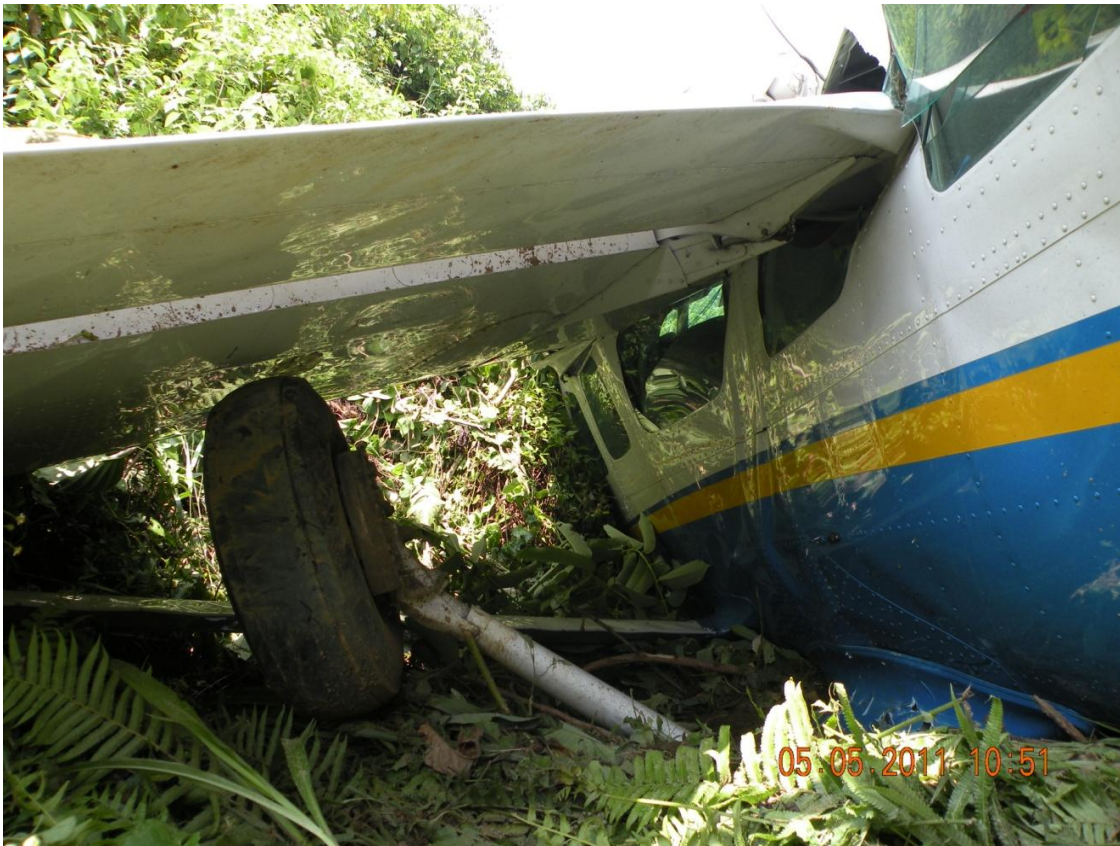
RH Wing top attachment got distorted and wing strut damaged. RH Flap leading edge got damaged. LH wing attachment area aft side caved in the cabin (Ref Fig 4). LH wing was substantially damaged. LH wing strut totally damaged. LH aileron substantially damaged. All the three undercarriage were broken. Belly of the fuselage was ruptured Propeller blade totally damaged including spinner. Engine mounts were found broken and substantial damage found around exhaust and cowling area.

Fig-4: Broken undercarriage and caved in wing portion in the cabin.

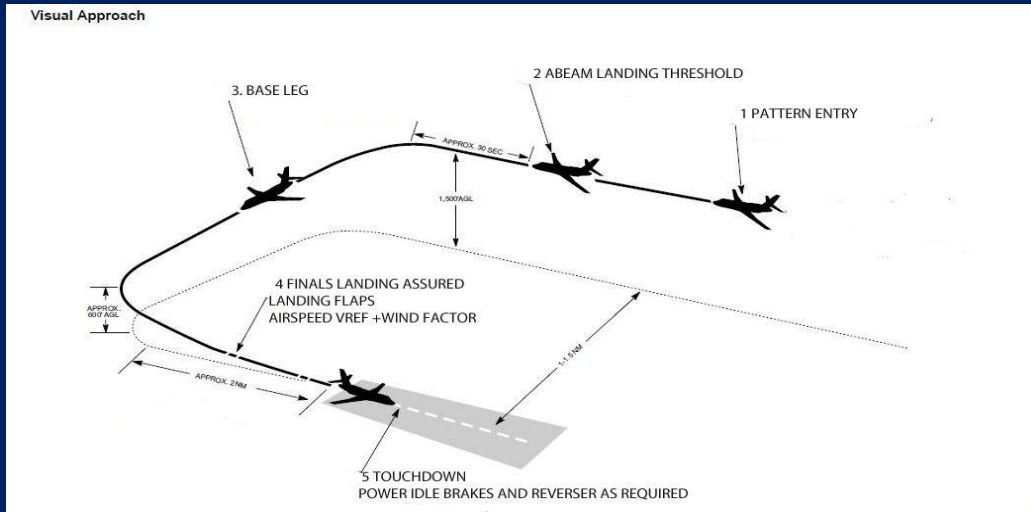
STANDARD VISUAL PATTERN

It is clear that seeing weather on downwind the pilot turned for base leg before reaching the end of the downwind leg, with this early turn by the time the pilot rolled out for finals he had crossed the landing threshold for runway 17. This non standard visual pattern resulted in the aircraft crossing the landing threshold high and fast. The aircraft touchdown took place well beyond the touchdown point of the runway at a higher than normal speed with a remaining distance in which it was not possible to stop the aircraft from overshooting.

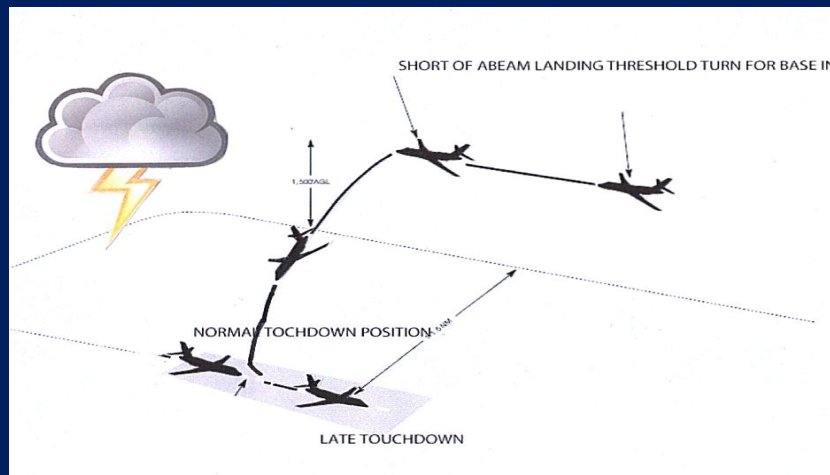
NON STANDARD PATTERN FOLLOWED BY THE AIRCRAFT

The pilot did not adhere to a visual circuit pattern the airplane was not stabilized but the pilot at no stage considered a go-around and continued to land in an unsafe condition. The Pilot was also not aware of his landing distance requirement. M/s NES as an operator did not provide it's Pilot with clear and consistent guidance and training regarding company and DGCA policies and procedures in several areas, including calculation of Landing Field Length. Mandatory Go Around policies, weather Radar usage.
