**INVESTIGATION REPORT ON ACCIDENT TO  
AGUSTA AW 119 MK II HELICOPTER  
VT- NRK ON 10-06-2017  
AT  
BADRINATH JI HELIPAD, UTTARAKHAND.**

**GOVERNMENT OF INDIA  
MINISTRY OF CIVIL AVIATION  
AIRCRAFT ACCIDENT INVESTIGATION BUREAU**

**Final Investigation Report on accident to M/s Kestrel Aviation Pvt. Ltd. Agusta  
AW119 MK II Helicopter VT-NRK Near Badrinathji Helipad on 10.06.2017**

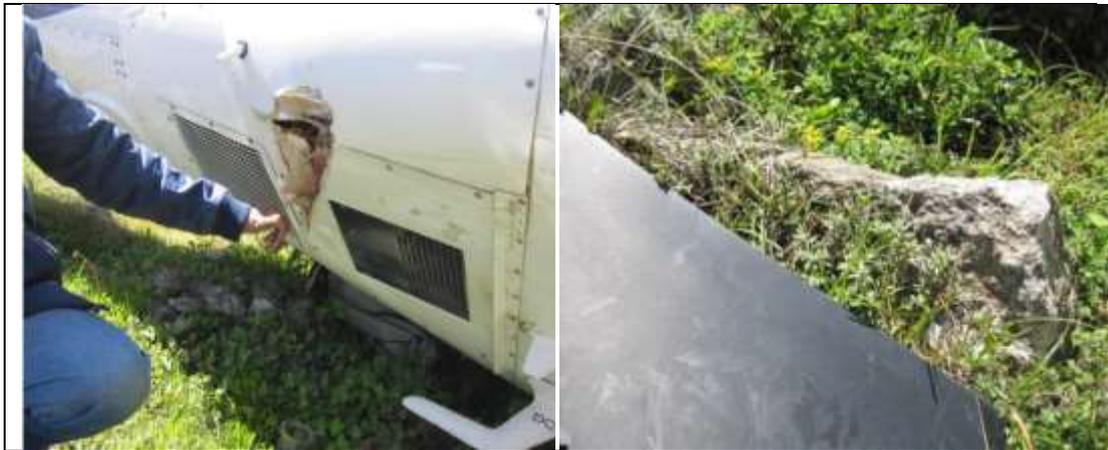
- The helicopter sank just after take-off during which it hit the ground/ terrain in nose up and a slight left bank condition. The helicopter first impacted a hard rock imbedded to the ground with the rear portion of right skid hitting the ground which got severed from the main structure. A significant impact mark was found on the rear part of the Fuselage, just below the Baggage Compartment due impact with a sharp rock.

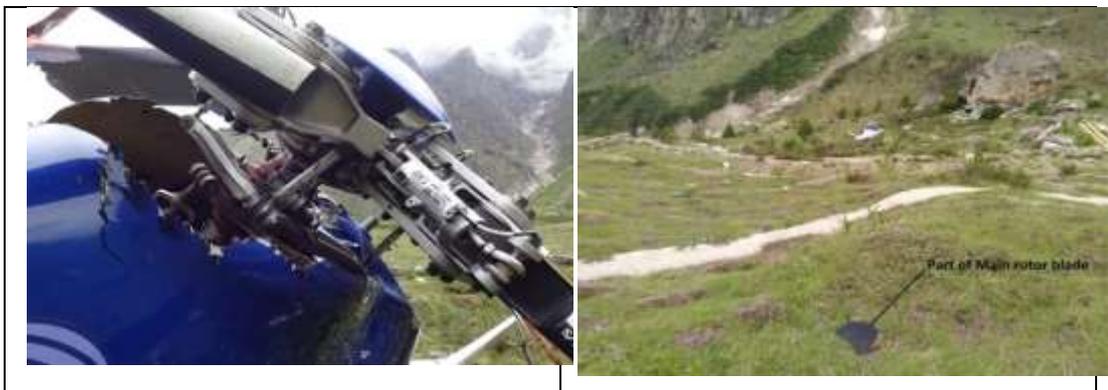
- Broken pieces of the main rotor blades were found scattered around the main wreckage. A piece was found at a distance of about 80 meters from the main wreckage. The roots of the blades were found attached to the hub. Marks of main rotor blades impacting the ground were observed.

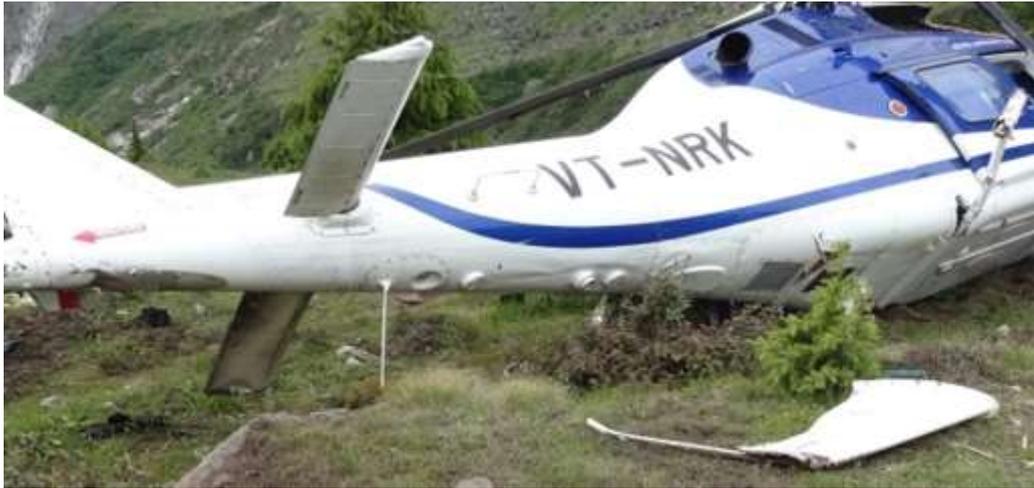
- The lower vertical fin/ tail rotor guard impacted the ground and was found separated from tail boom. The tail rotor blades were sheared off up to mid span due impact with hard rocks and trees.

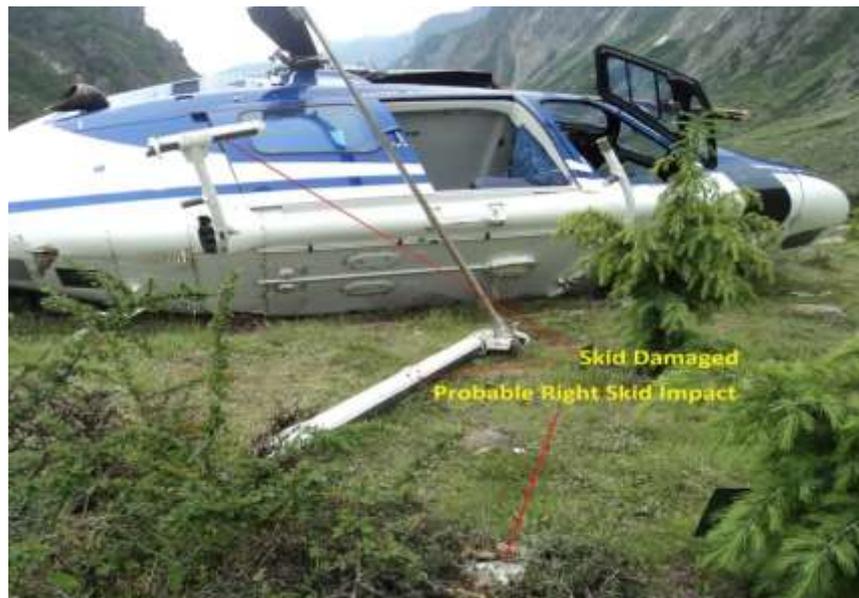
- As the ground had a downward slope towards left of the helicopter, the helicopter rolled towards left (though remained almost at the same point), resulting in left skid impacting the ground. The cross tubes of the skids were found tilted approximately 180 degrees upwards.

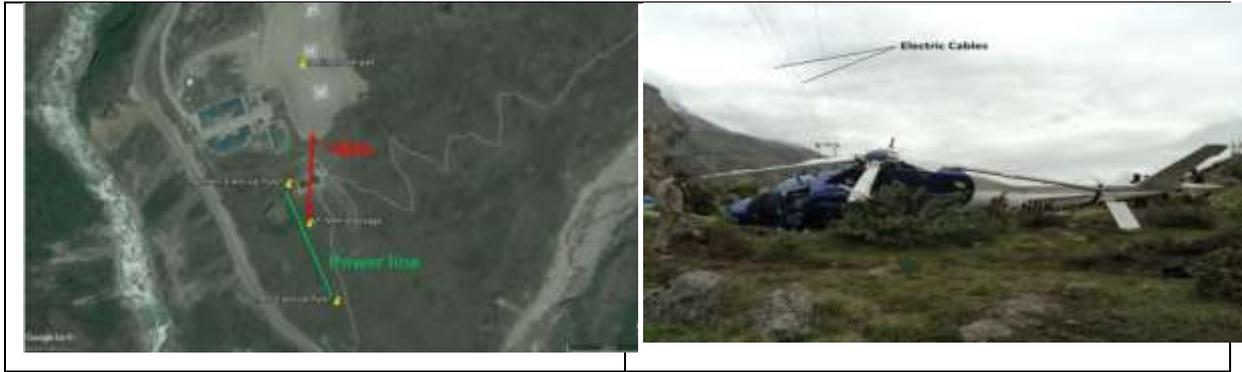
- The helicopter finally came to halt in a left bank attitude resting on the ground on its broken left skid and fuselage with the support of rocks & bunch of small trees. The final position of helicopter was approximately 150 m south of the take-off point and directly below the electric cables (power line) passing in the area.

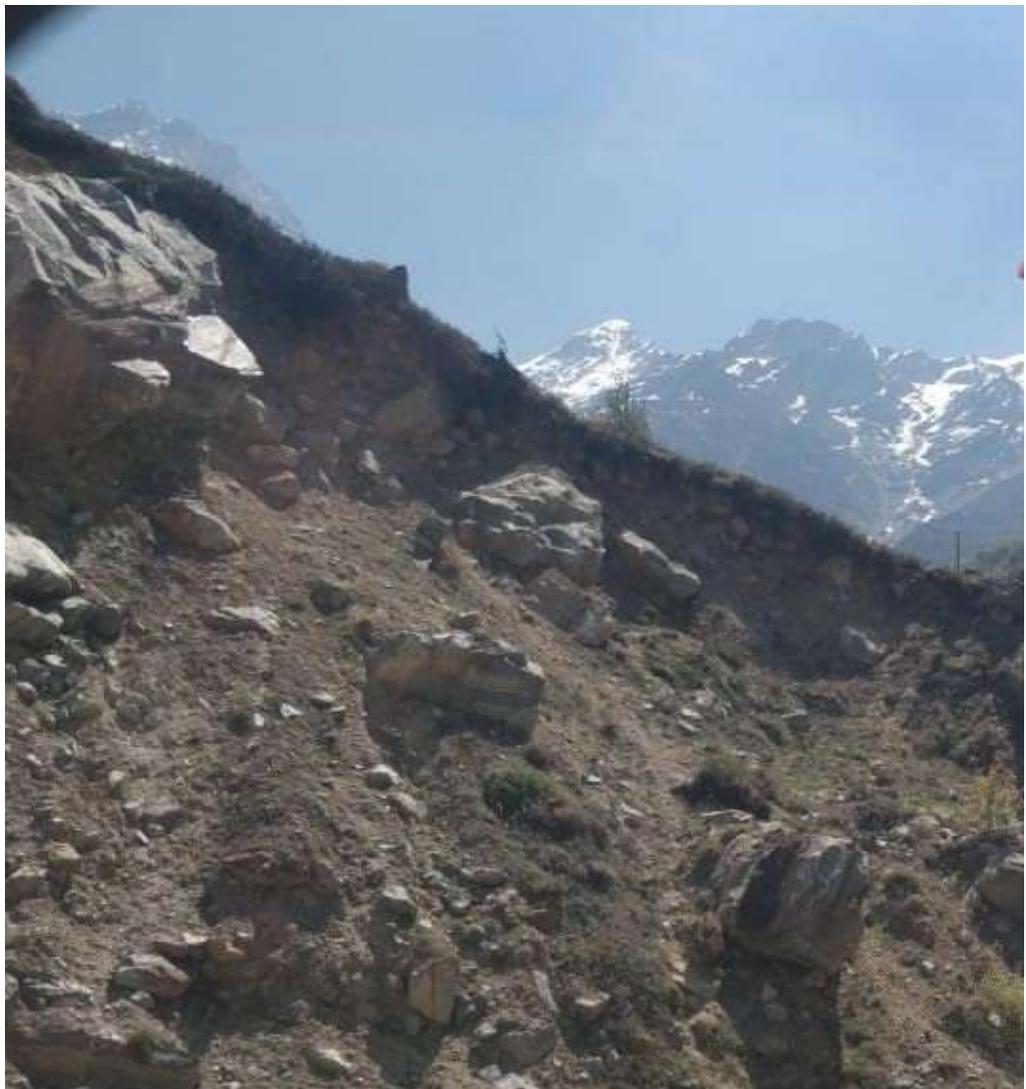
Ledge at the helipad end (towards take off direction)

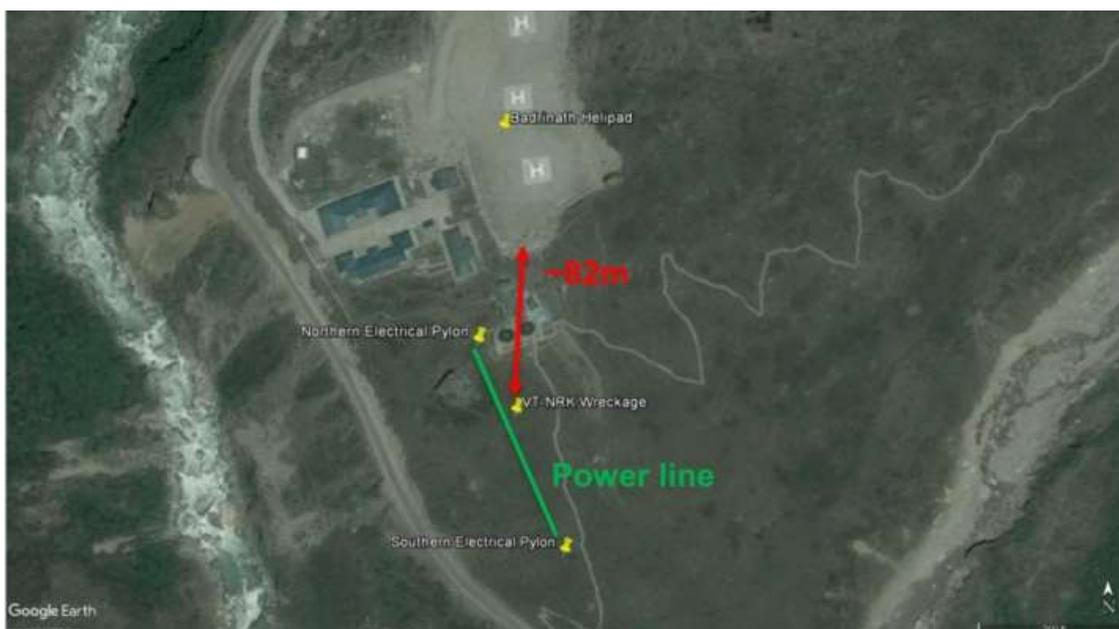
Power line (crossing flight path) above the wreckage

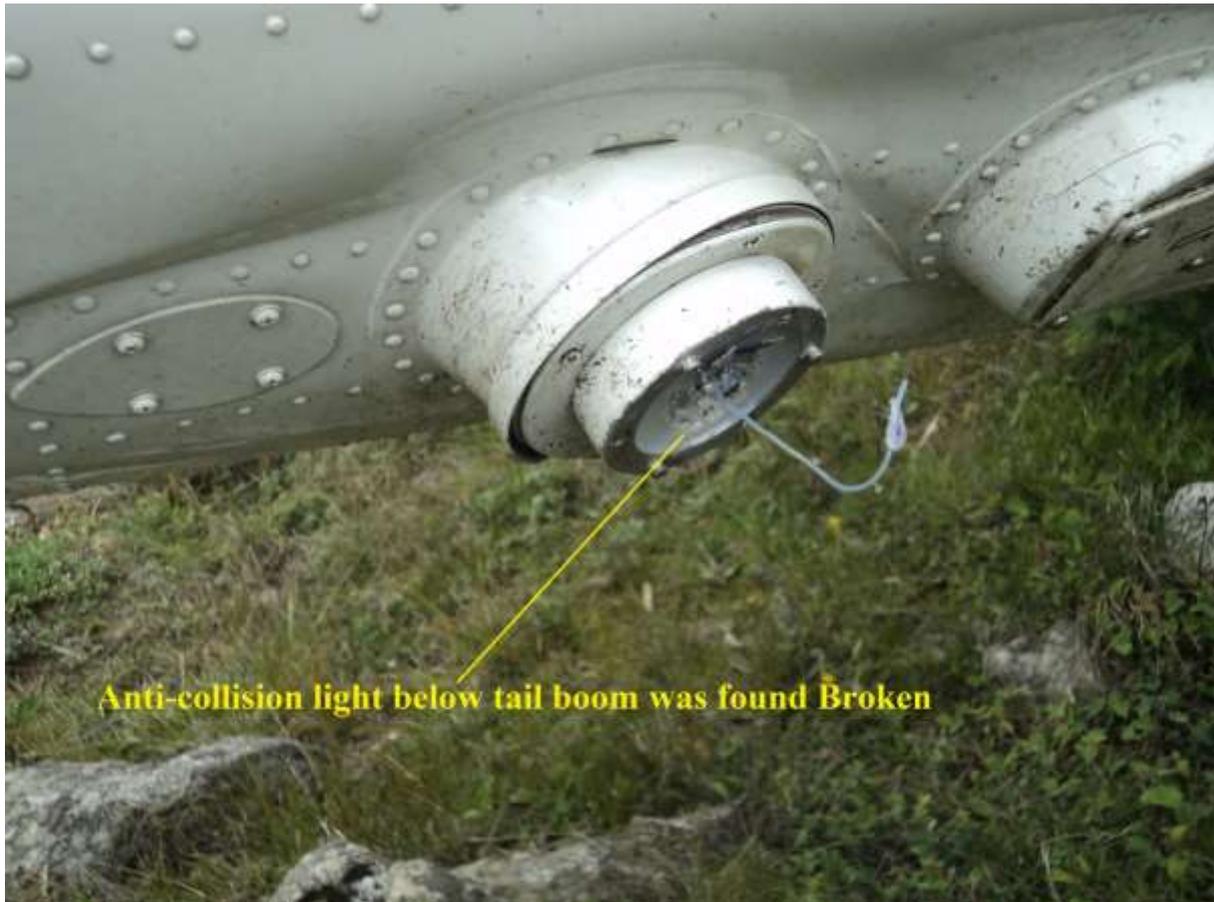
**Anti-collision light below tail boom was found Broken**

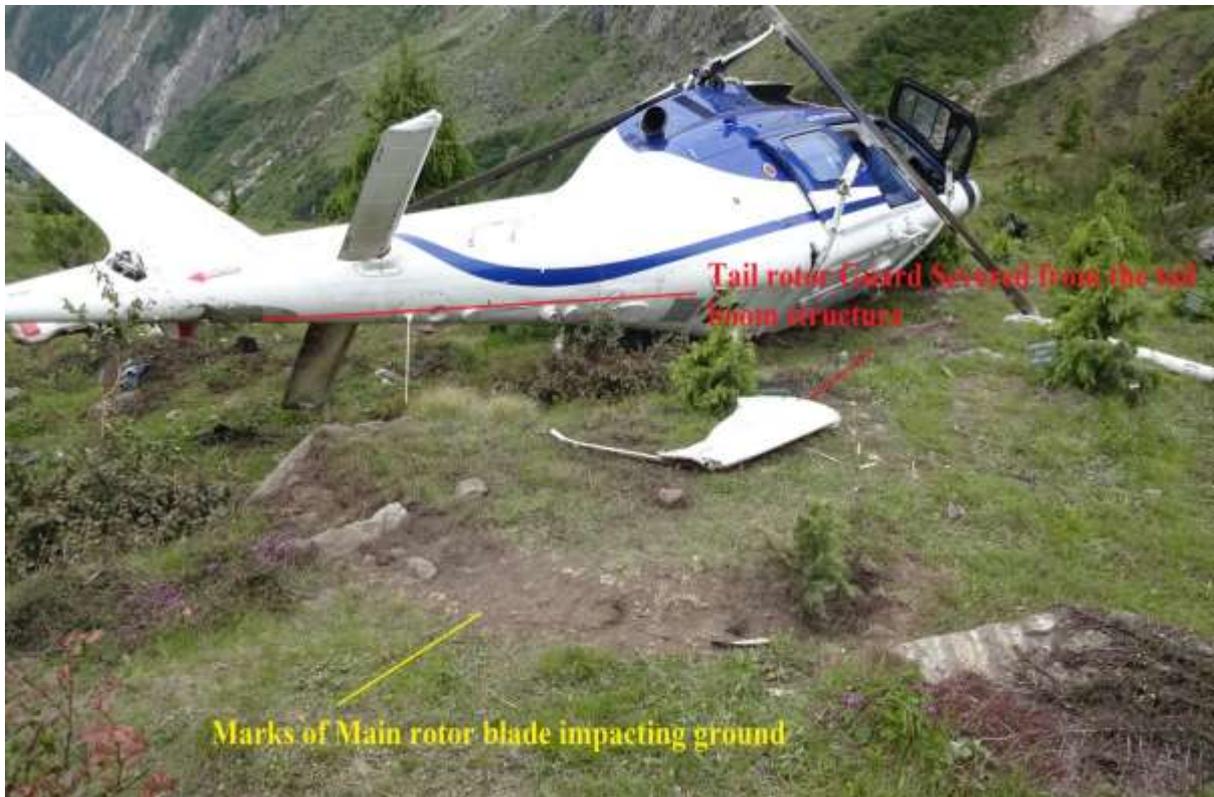
**Tail rotor Guard Severed from the tail boom structure**

**Marks of Main rotor blade impacting ground**

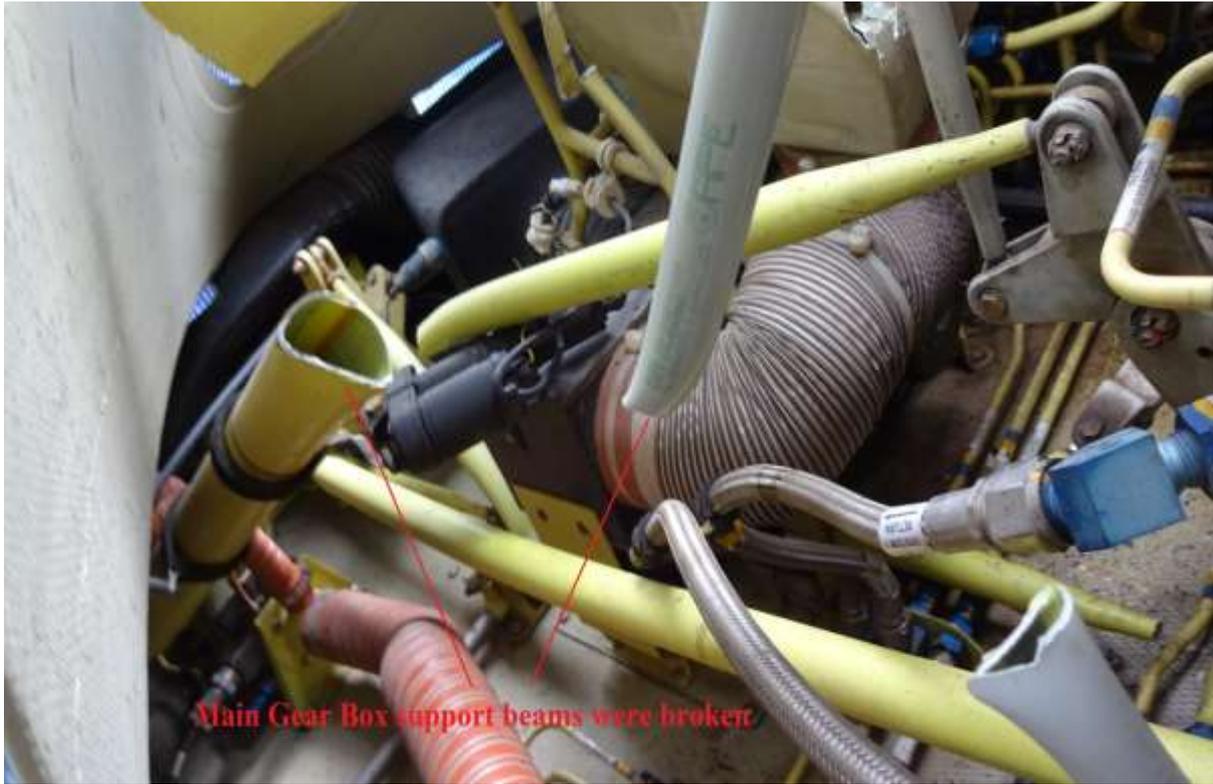
**Main Gear Box support beams were broken**

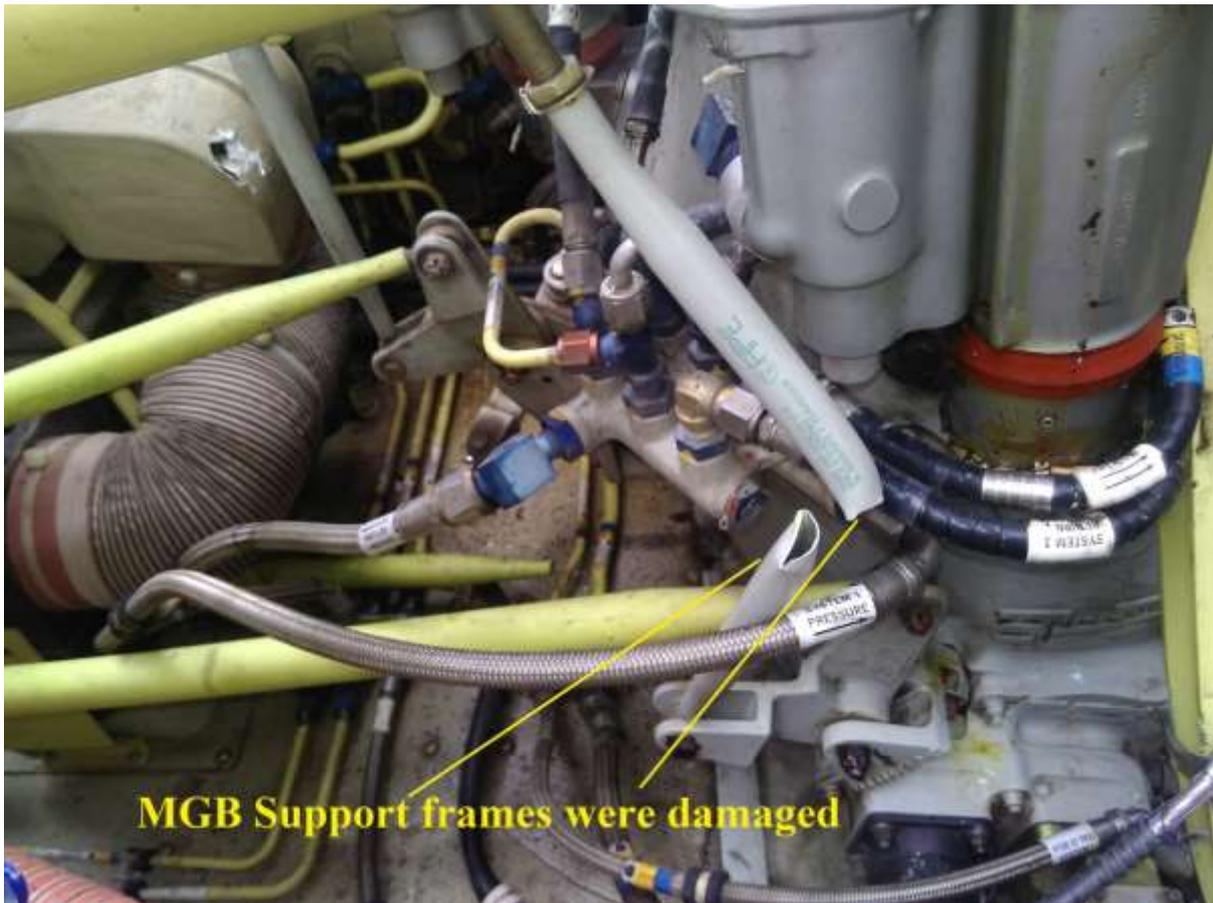
**MGB Support frames were damaged**

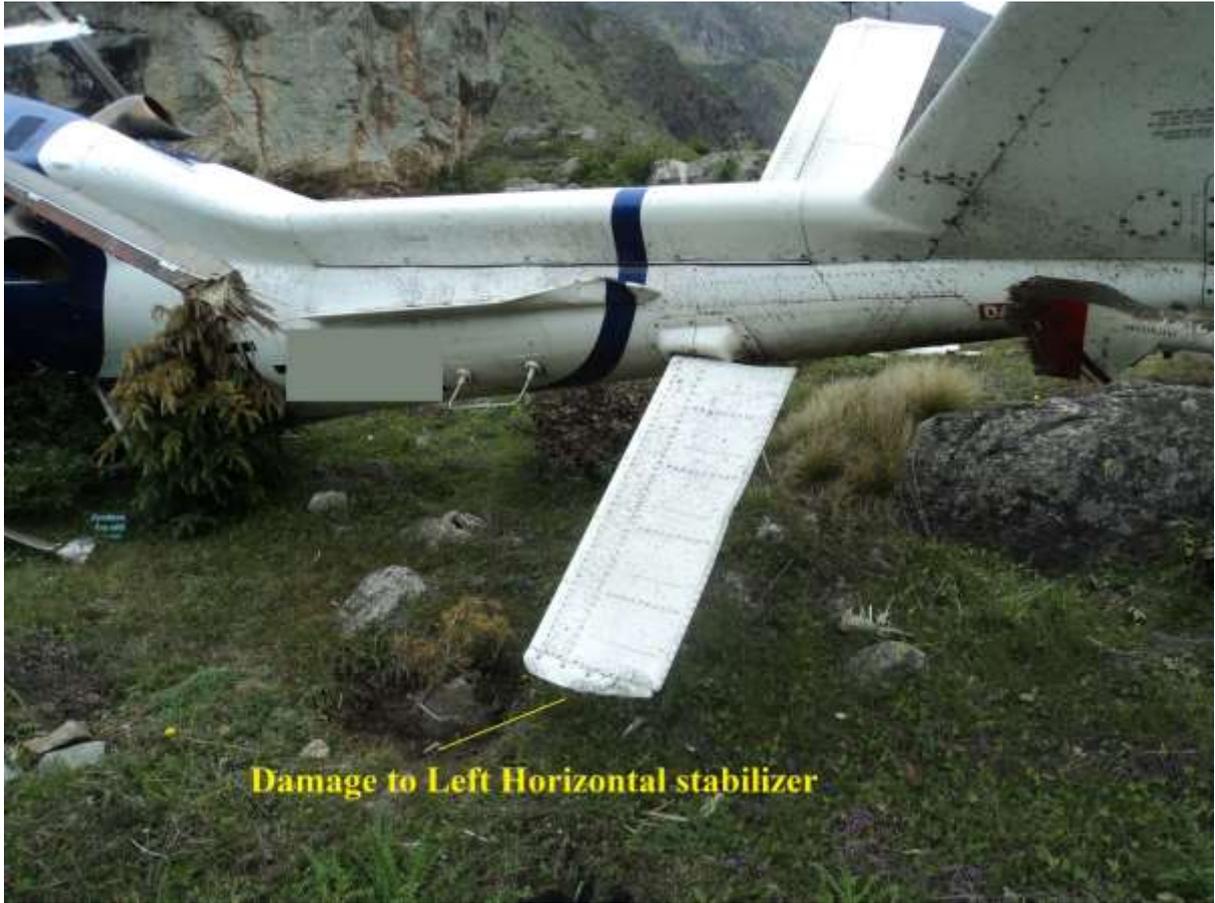
**Damage to Left Horizontal stabilizer**
