**FINAL INVESTIGATION REPORT ON ACCIDENT
TO AMAN AVIATION & AEROSPACE
SOLUTIONS (P) LTD.**

**ROBINSON R-44 HELICOPTER VT-PHB
ON 11-12-2016 NEAR JUHU, MUMBAI**

**AIRCRAFT ACCIDENT INVESTIGATION BUREAU
MINISTRY OF CIVIL AVIATION
GOVERNMENT OF INDIA**

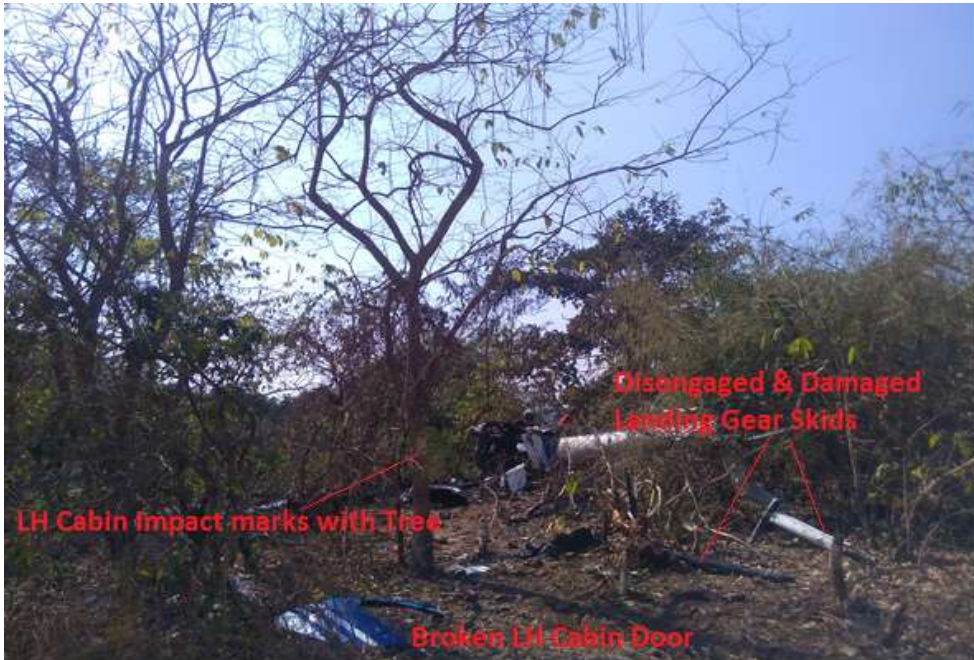
As per the evidences collected and inspection of the accident site the helicopter impacted the trees. The helicopter left side cabin hit one of the trees as evident from the glass pieces found stuck on the tree and a broken part of the cabin door was found lying alongside the tree.

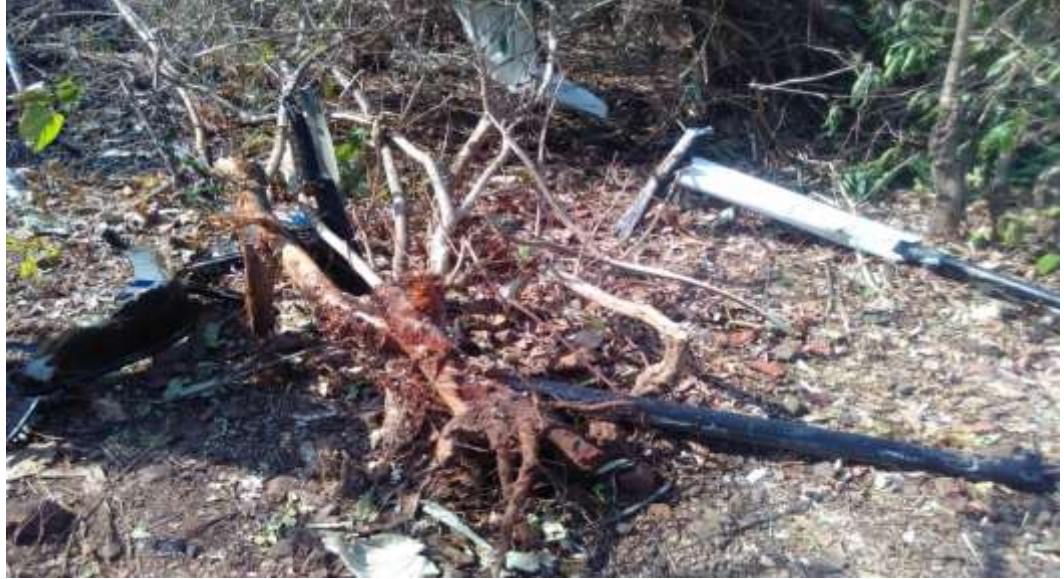
The helicopter turned to its right side after hitting trees as landing gear skids impacted the tree. Finally, the helicopter impacted the ground on its right and immediately caught fire.

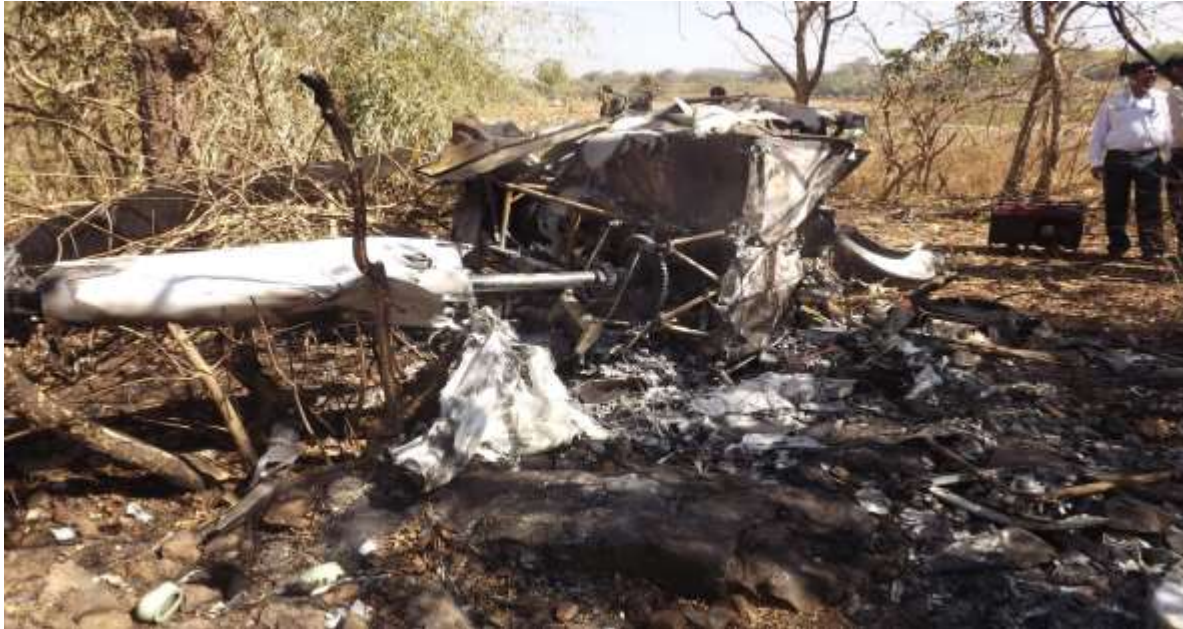
Front part (Cockpit/Cabin) of the helicopter completely burnt.

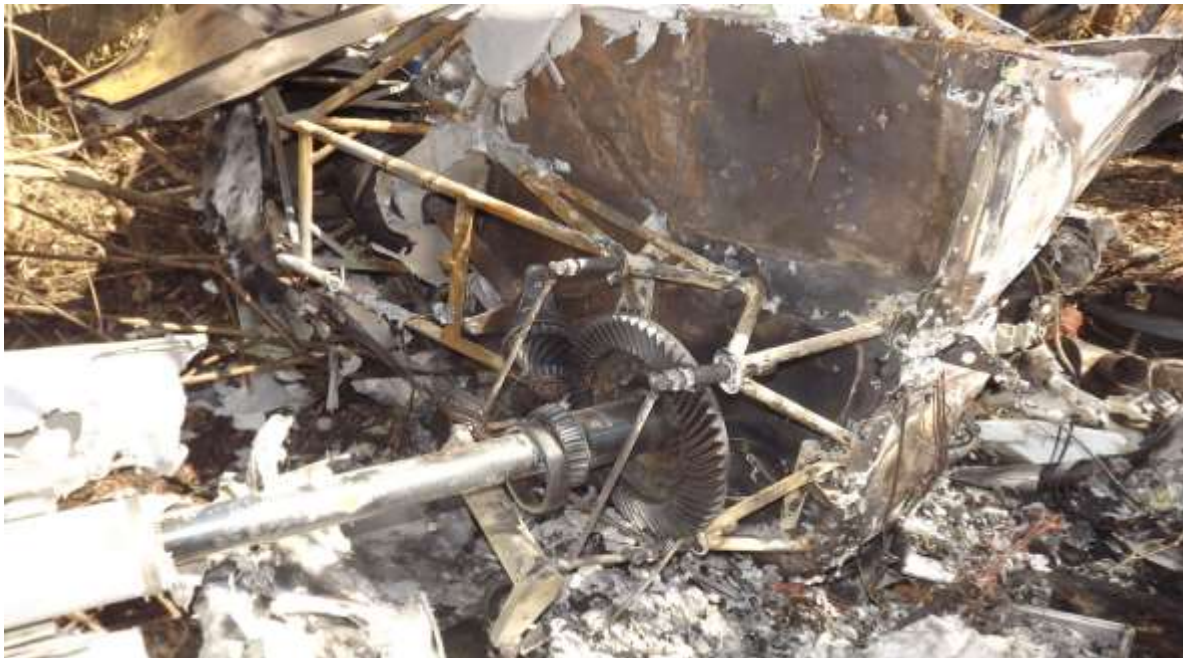
- ✚ Passenger and crew deck area of the helicopter found burnt and missing.
- ✚ Small pieces of wreckage found scattered all around.
- ✚ Parts of the trees found burnt due to wreckage fire.
- ✚ MGB cowling melted and gears visible.

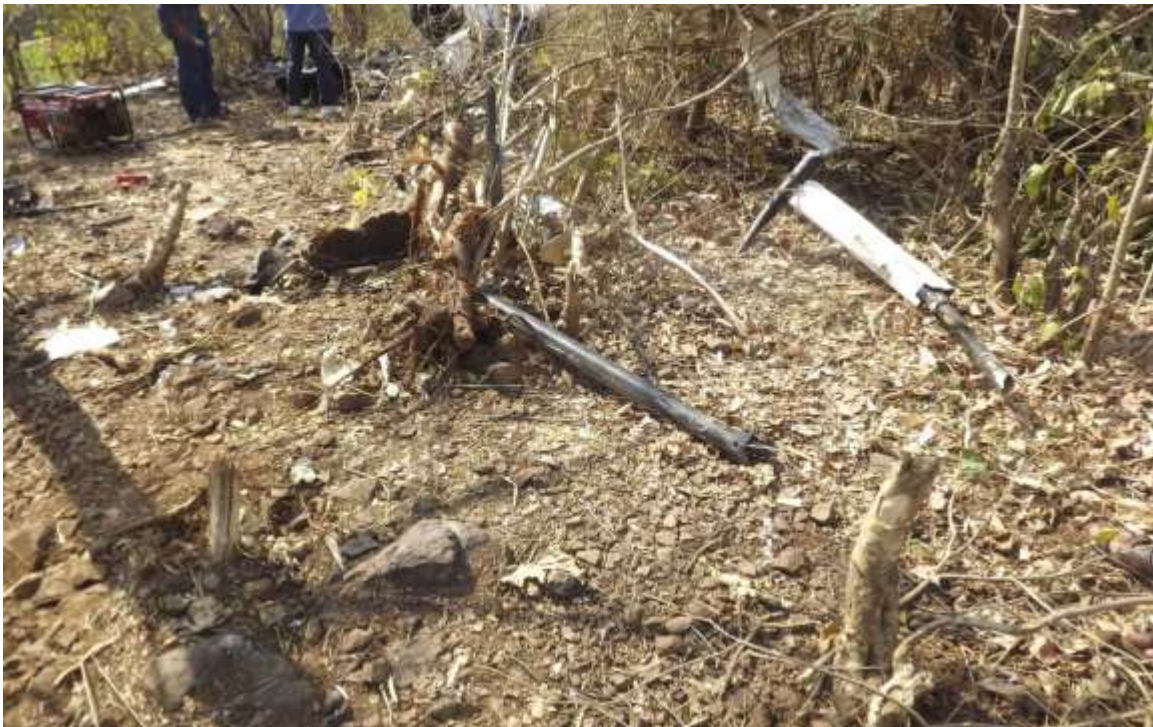
- ✚ All airframe parts, doors, panels, exhaust pipe, induction tubes, carburetor broken & separated from the airframe and engine.

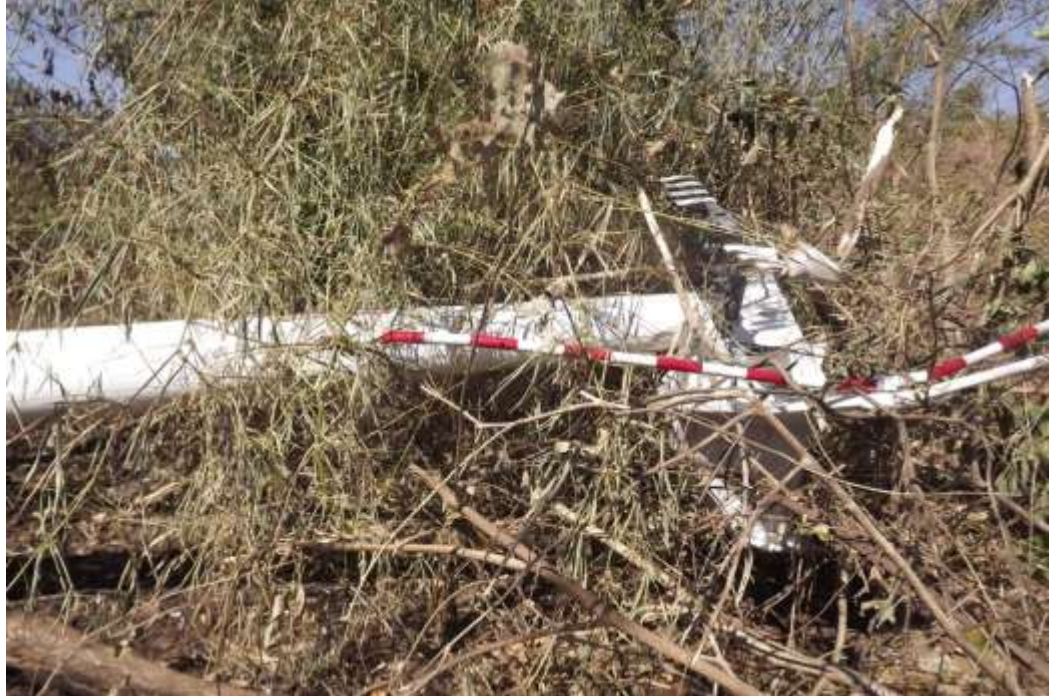
- ✚ Landing gear skids broken and separated in pieces due to impact with ground/trees.
- ✚ Tail rotor gear box & tail rotor hub found intact on tail boom with no apparent signs of damage.

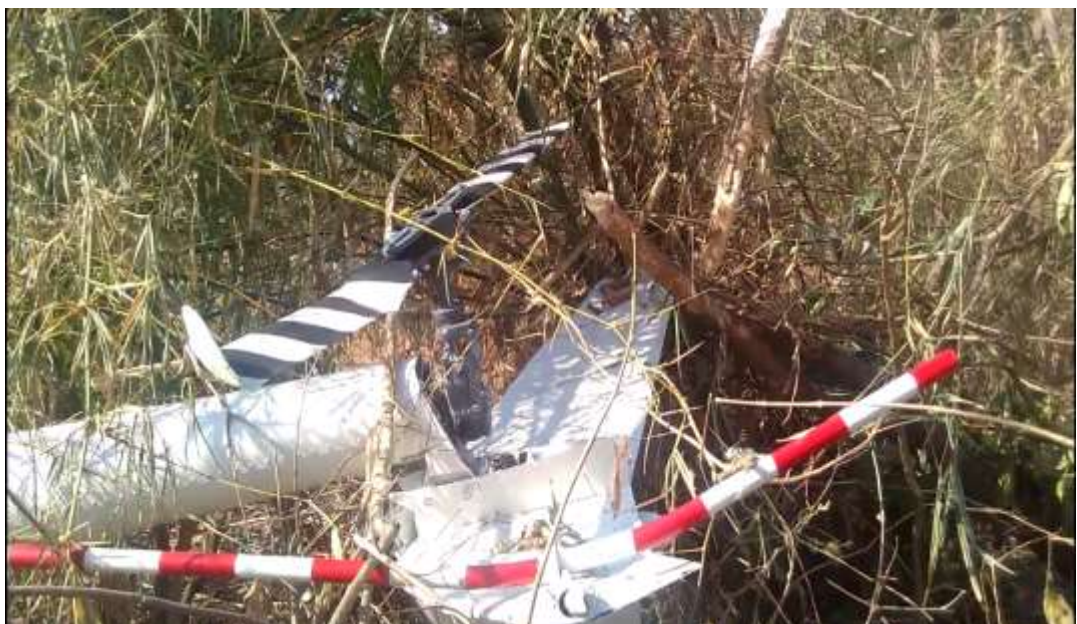
- ✚ One Tail Rotor Blade (TRB) found intact and undamaged, second TRB found intact with bent on the tip due to impact with tree.

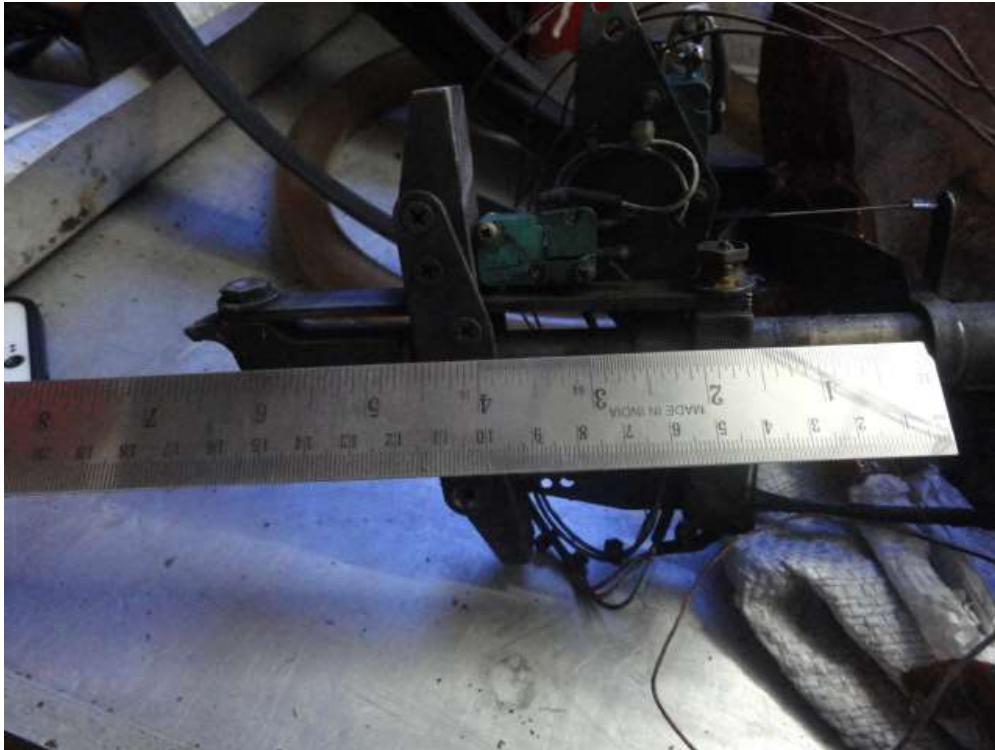
2.4.4 Clutch mechanism

The clutch unit (actuator mechanism) was found separated from the helicopter after the accident. The actuator was stuck at the last position before the impact which was measured and was found 1.60 inches which corresponds to the fully extended position which also indicates there might not have been any relative movement between the V-belts and the pulley.
