Final Investigation Report on Accident to
Pawan Hans Helicopters Limited (PHHL)
Bell 407 Helicopter VT-PHH on 30-12-2012
at Katra Valley, Jammu & Kashmir

COMMITTEE OF INQUIRY VT-PHH

| Final Investigation Report on Accident to Pawan Hans Helicopters Limited (PHHL) Bell 407 helicopter VT-PHH on 30/12/2012 at Katra valley, Jammu & Kashmir | | | |

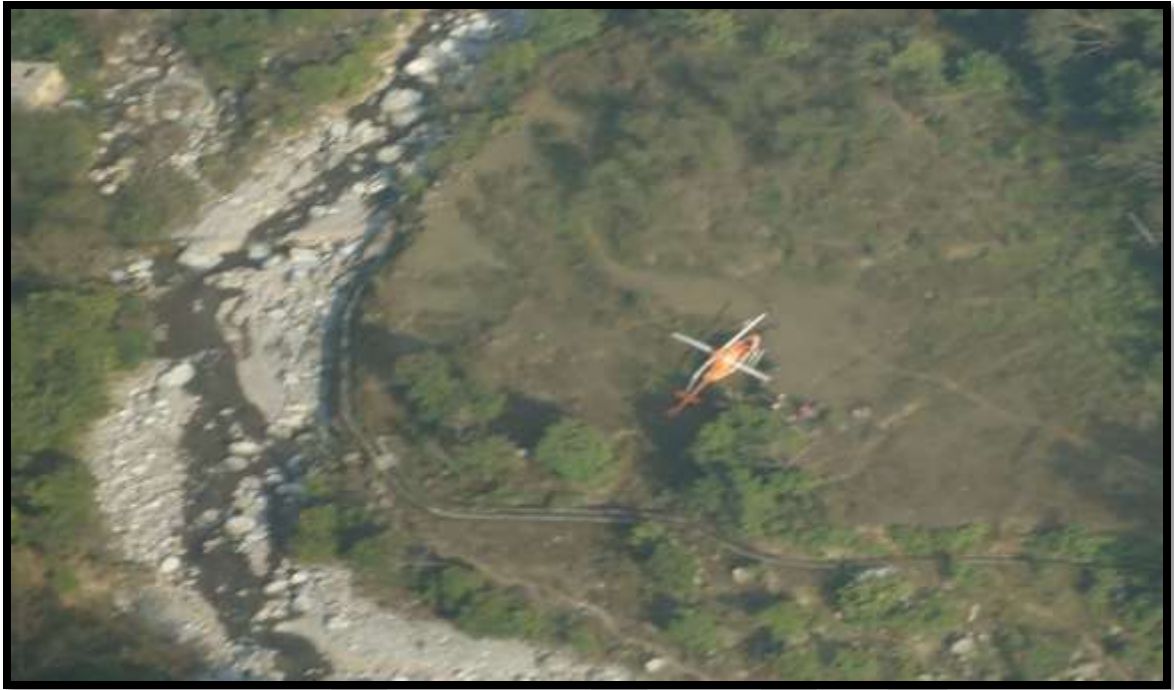
Landing of Helicopter at River Bed short of flat Ground

Due to heavy landing, helicopter received substantial damage. The fuselage exhibited extensive vertical impact damage. The cross tubes bent and landing skids were spread but not fractured. The tail rotor had hit the ground and subsequently the tail drive shaft had failed in torsional overload, and tail rotor blades were severed approximately mid-span consistent with sudden stoppage of the tail rotor blade impact with terrain. The tail boom exhibited no evidence of contact by the main rotor blades. The vertical fin was found fractured near its attachment point due to ground contact. The tail rotor gear box and vertical fin attachment casting exhibited a large crack consistent with vertical fin ground contact.

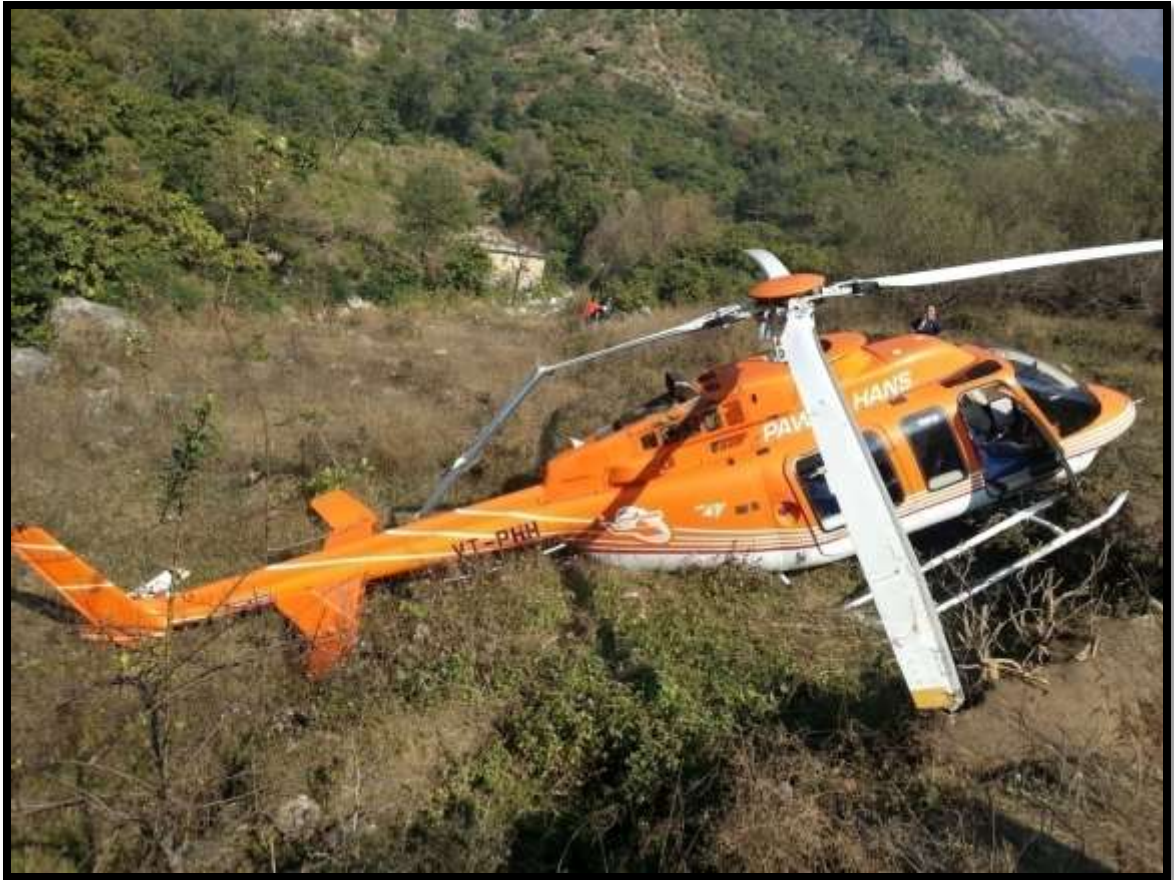
Out of four main rotor blades, the blue main rotor blade exhibited maximum damage due to impact with ground. The blue blade tip was fractured and bent back opposite the direction of normal counter-clockwise rotation. Both upper and lower magnetic chip detectors (MCD) were removed for inspection. On lower MCD, minor contamination (light fuzz or paste) was observed, and upper MCD shows contamination chips (silvers and a few small less than 1mm) were observed.

Landing of helicopter on sloping surface

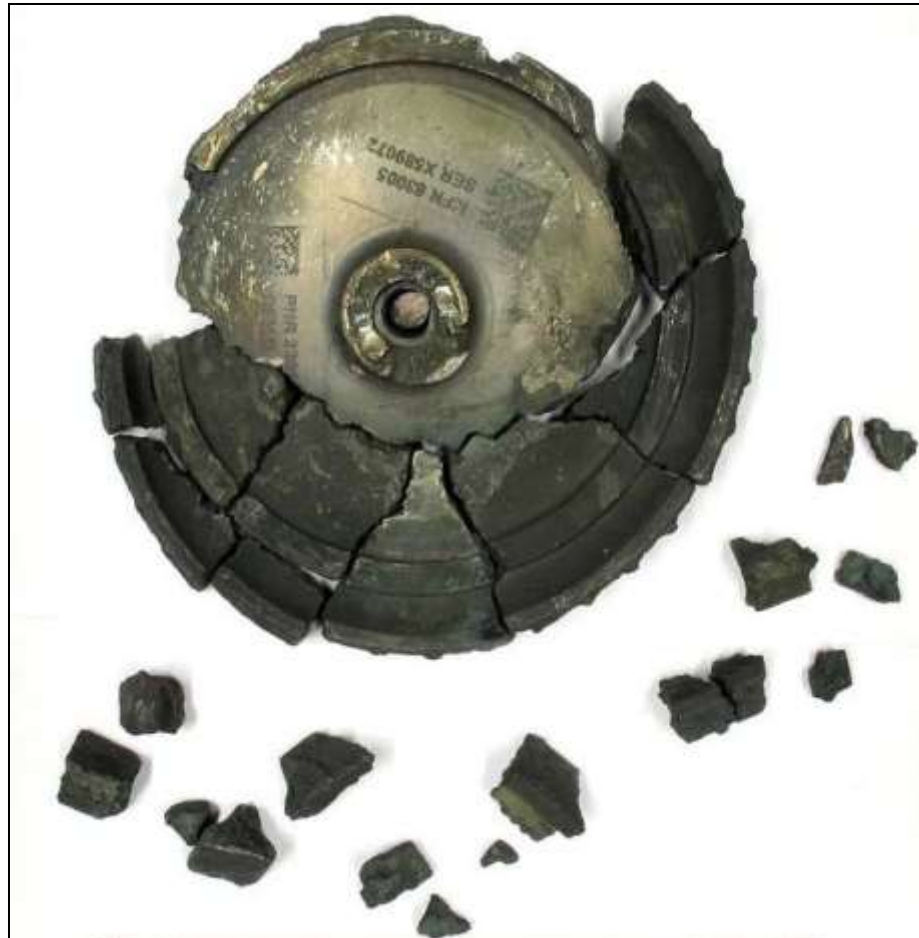
First Stage Turbine Wheel

The 1st Stage Turbine wheel was fragmented into multiple pieces from an apparent overspeed burst, which is consistent with a decoupling of the gas generator turbine from the compressor. The 1st stage turbine Energy Absorption Ring was bulged from contact by the 1st stage turbine wheel. The gas-producer turbine support was bulged and fractured axially at the 12 o'clock position.

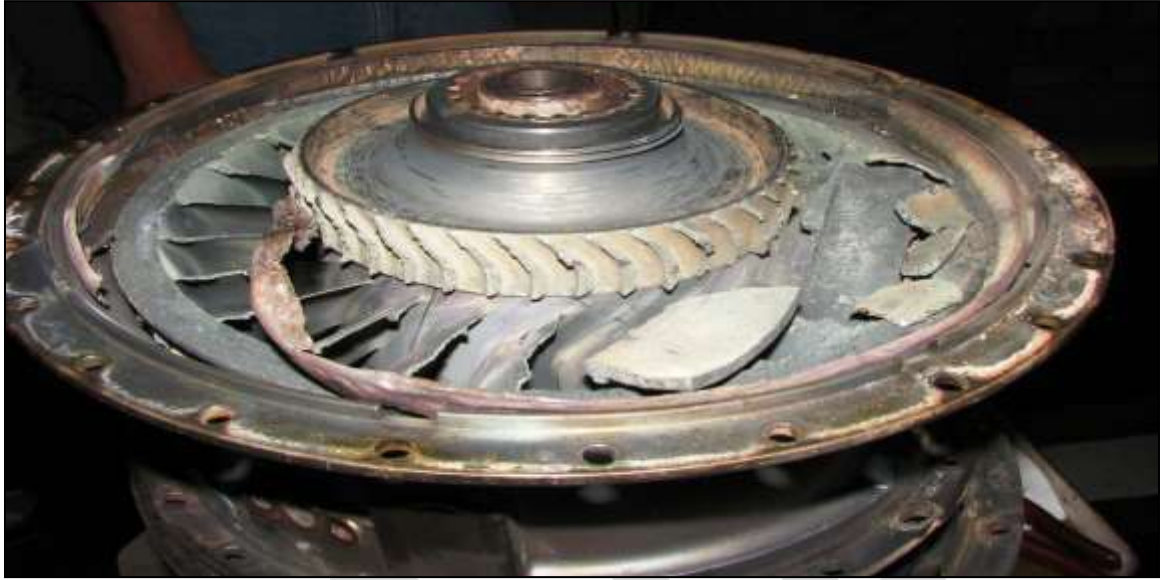
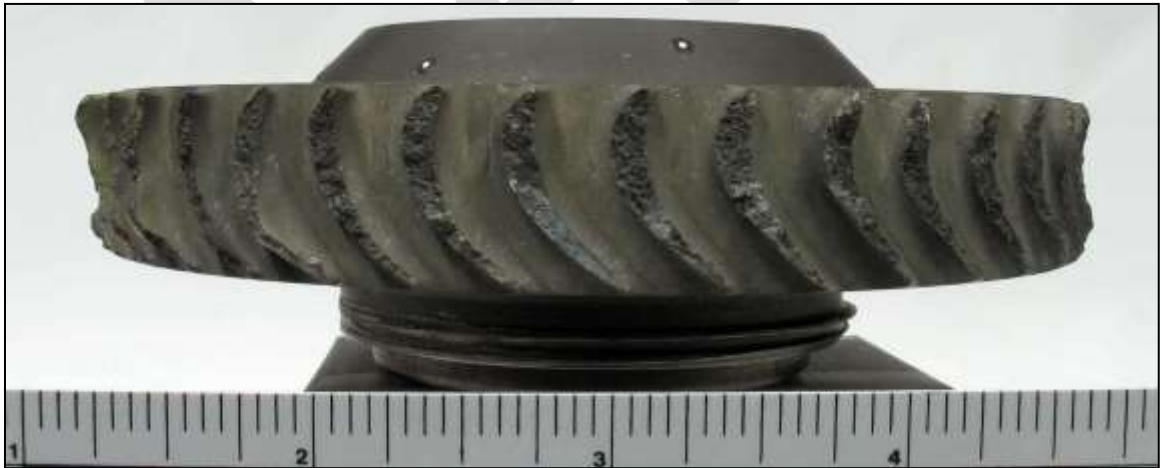
3rd Stage Turbine Wheel

The 3rd stage turbine wheel had liberated all of its blades at the root. Detailed examination of the 3rd stage turbine blade fractures revealed a single blade had failed in high cycle fatigue (HCF). All other blades had fractured in overload. The high cycle fatigue fracture of the single 3rd stage turbine blade was determined to be the initiating event of the engine failure.

Metallurgical examination of the fatigue-fractured blade revealed the fatigue crack progressed approximately 0.48 inch from the trailing edge before final fracture and separation of the blade in overload. The total cross sectional area of the blade measured approximately 0.0593 square inches, and the cross sectional area of the overloaded portion of the fracture measured approximately 0.0308 square inches

Scanning Electron Microscope (SEM) examination of the fatigue fracture revealed rub damage on the suction side and a Stage I fatigue facet on the pressure side of trailing edge. No surface anomalies were noted on the walls of the blade near the facet. These fracture features are consistent with high cycle fatigue initiation and propagation of the crack.

During investigation it was found that that 3rd stage turbine wheel blade fractured in high cycle fatigue at the trailing edge hub location due to operation of one or more natural frequencies of the wheel. Failure of first blade led to a rapid failure of turbine wheel as remaining blades fractured in overload.

Rolls-Royce has issued an alert Commercial Service Letter (CSL) A- 6144 in June 2013 regarding operations in the Power Turbine speed avoidance range (Keep Out Zone) and time restricted overspeed zones to minimize the possibility of power turbine failure. Also as mentioned in report, Rolls-Royce plans to release two design changes that will increase the operating speed natural frequency margin on the initial change and further increase the frequency margin and also improve the vibration margin on the second design change.

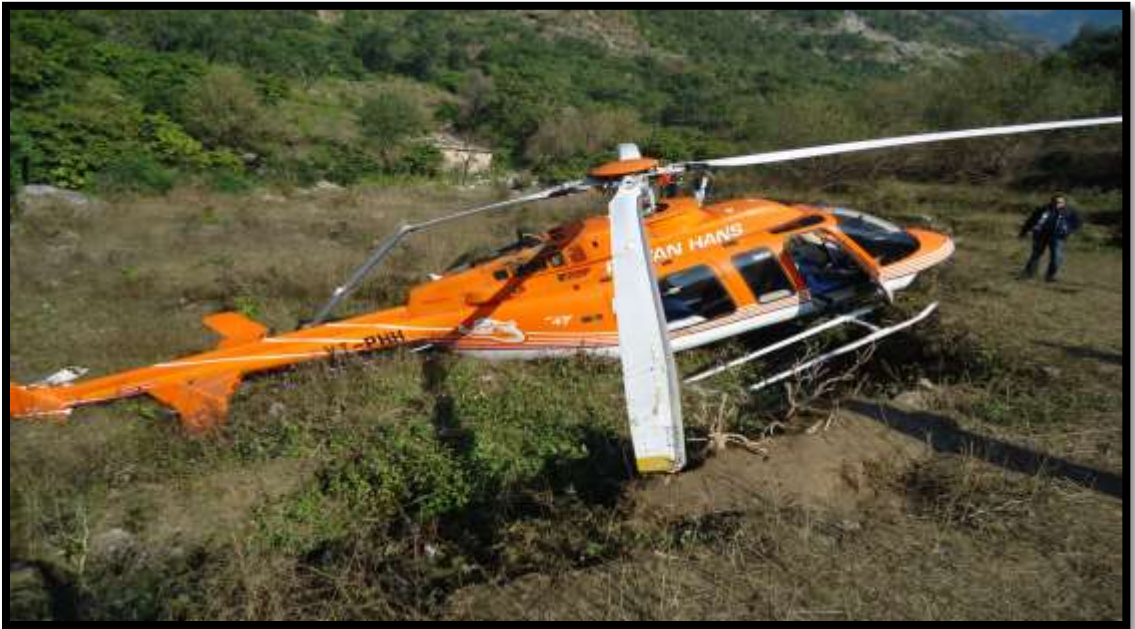
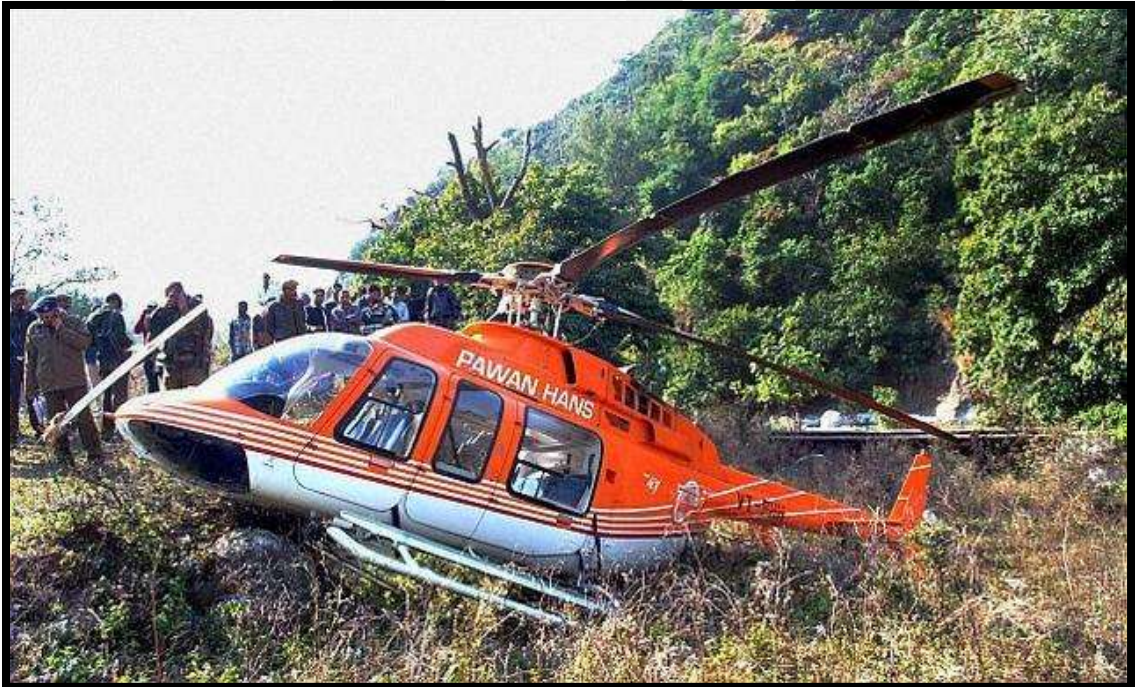
1. Main Rotor Hub Assy: Main rotor Yoke found in damaged condition.
2. Wind shield: Both LH & RH wind shield and Bottom plexi glasses found in broken condition.
3. Exhaust Duct: Duct found in damaged condition with crack and burnt hole.
4. Turbine module found burnt and damaged at few places.
5. Combustion chamber mounting at turbine assembly was found splitted at the top.
6. Air duct from engine fairing and compressor were dislodged and clamps fallen inside deck.
7. Vertical fin lower part was fully damaged.
8. Both Tail Rotor blades were fully damaged.
9. RH side of the belly portion was having multiple cracks below PIC door, pax door and above pax door.
10. LH side below pax cabin, belly structure found depressed.
11. VHF antenna at belly section found broken
12. The cross tubes were bend and both the skids spread due impact force.

Damage to Helicopter

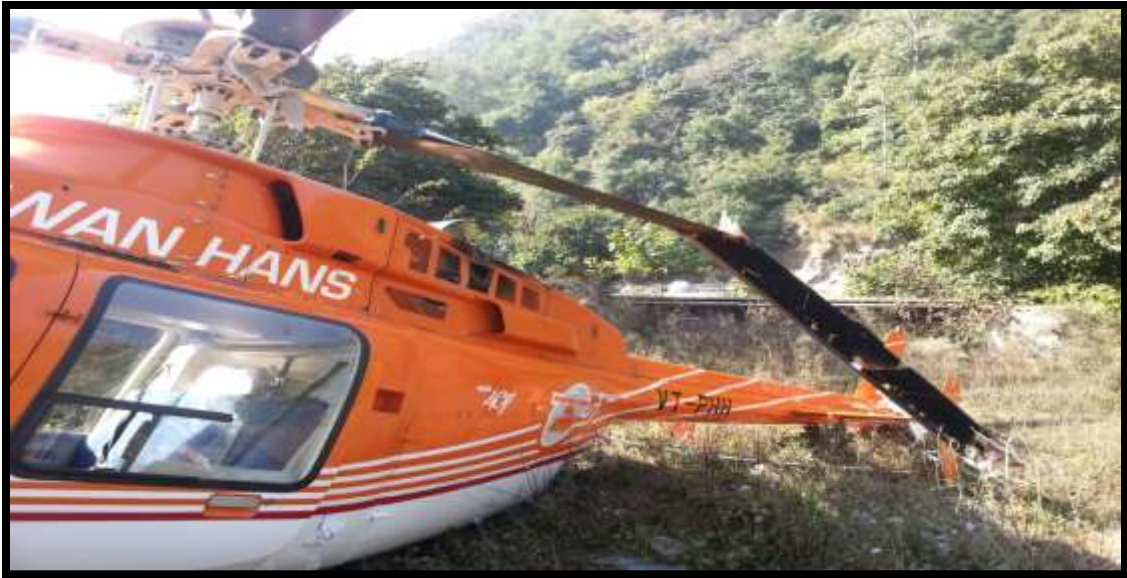
Damage to Main Rotor

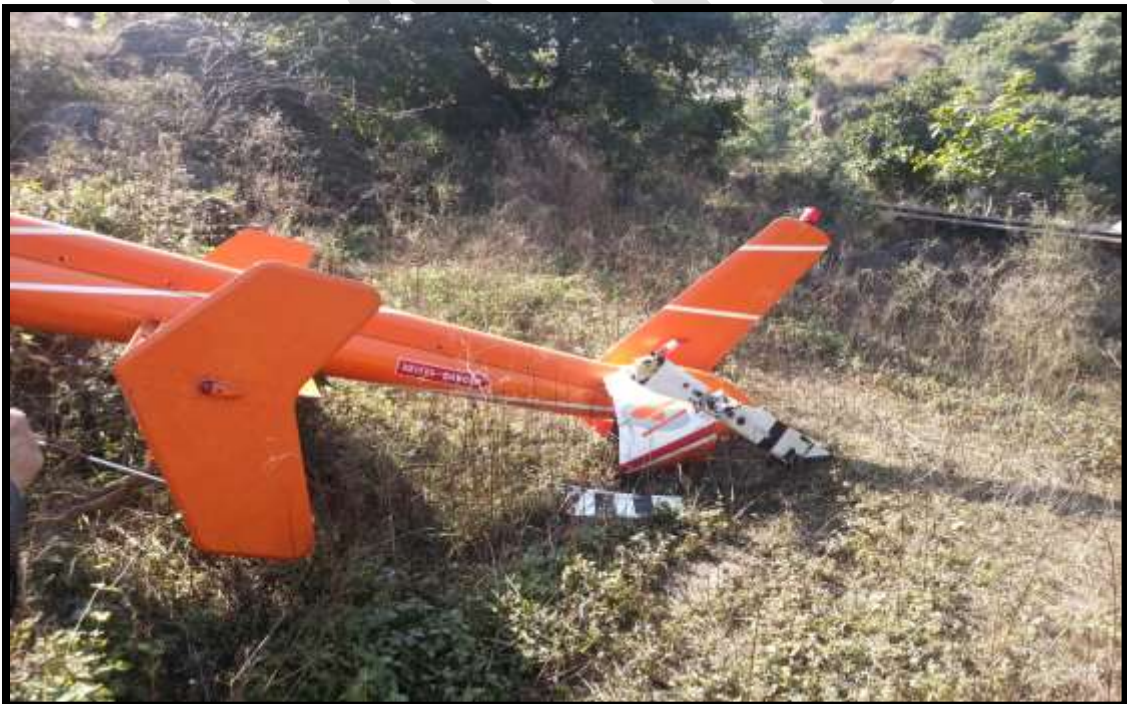
Damage to Tail Rotor

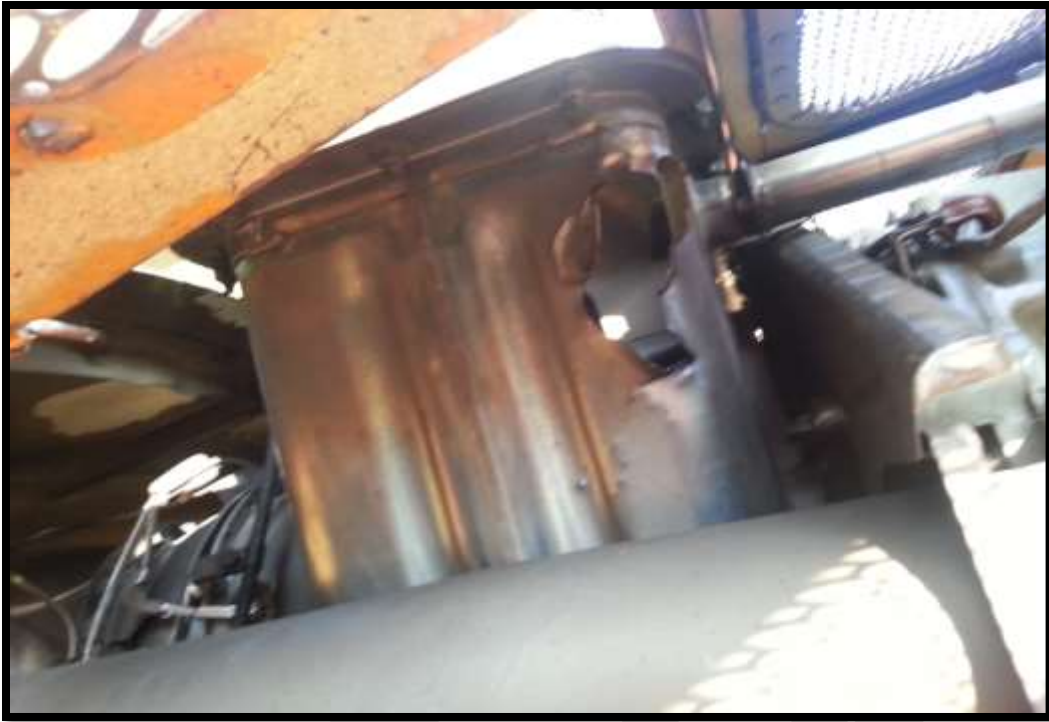
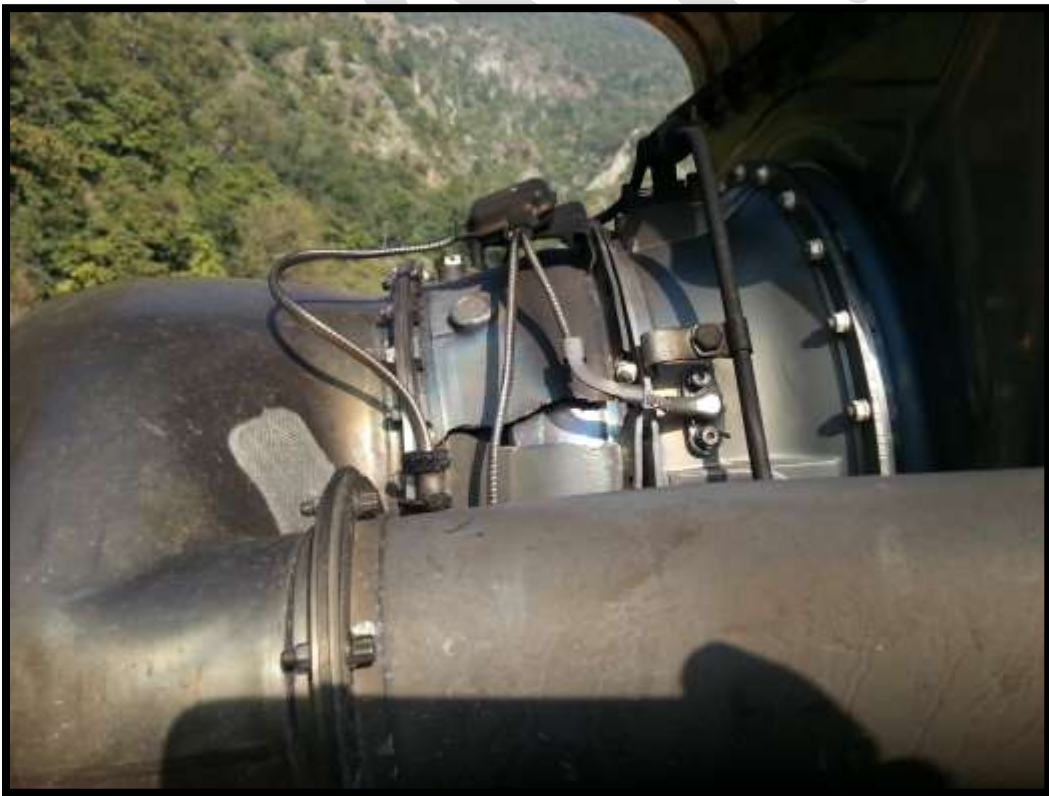
Inspection of the engine exterior didn't revealed any obvious signs of damage from ground impact but exhibit evidence of uncontained turbine burst. Fractured pieces of power turbine wheel and turbine outer shroud were observed.

Damage to Engine
