**GOVERNMENT OF INDIA
MINISTRY OF CIVIL AVIATION
AIRCRAFT ACCIDENT INVESTIGATION BUREAU
NEW DELHI INDIA**

**REPORT ON
ACCIDENT TO M/s PAWAN HANS
DAUPHIN N3 HELICOPTER VT-PHK
AT KHONSA
ON 04/08/2015**

**REPORT ON
ACCIDENT TO DAUPHIN N3 HELICOPTER VT-PHK
NEAR KHONSA (ARUNACHAL PRADESH) ON 04/08/2015**

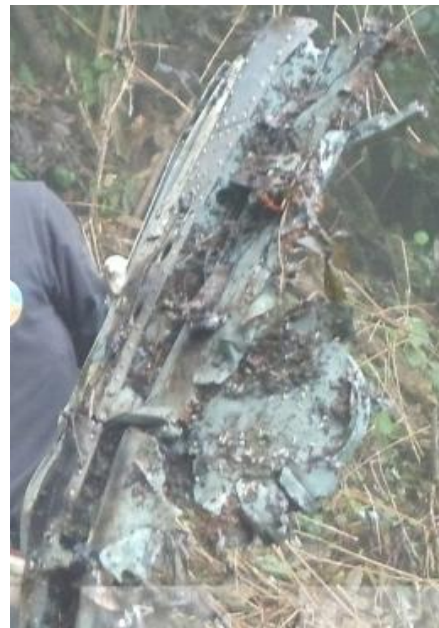
BROKEN PANELS & CONTROL RODS

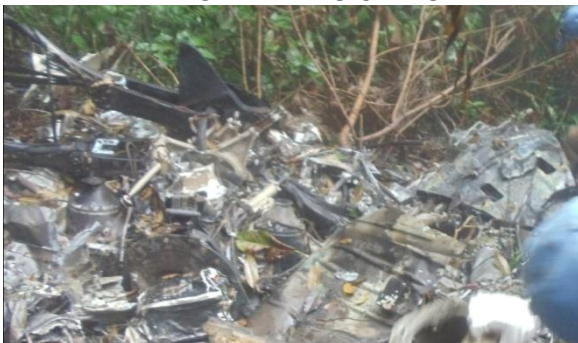
DAMAGED PARTS OF MGB

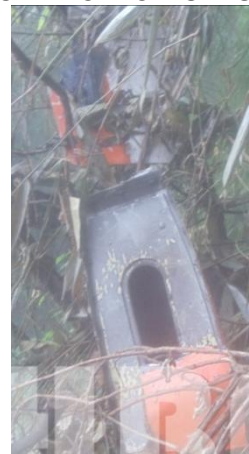
DAMAGED BOTTOM STRUCTURE

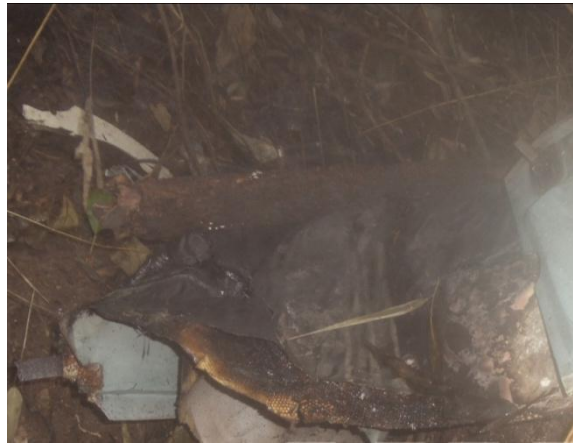
PANELS WITH FIRE DAMAGE

As observed from the photographs of the crash site the wreckage has caught fire after impacting with the hills.

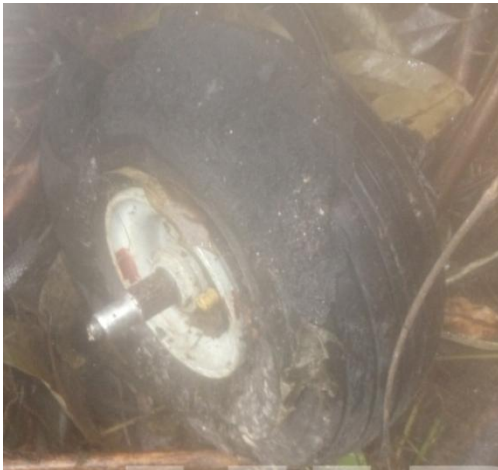
DAMAGED NOSE WHEEL

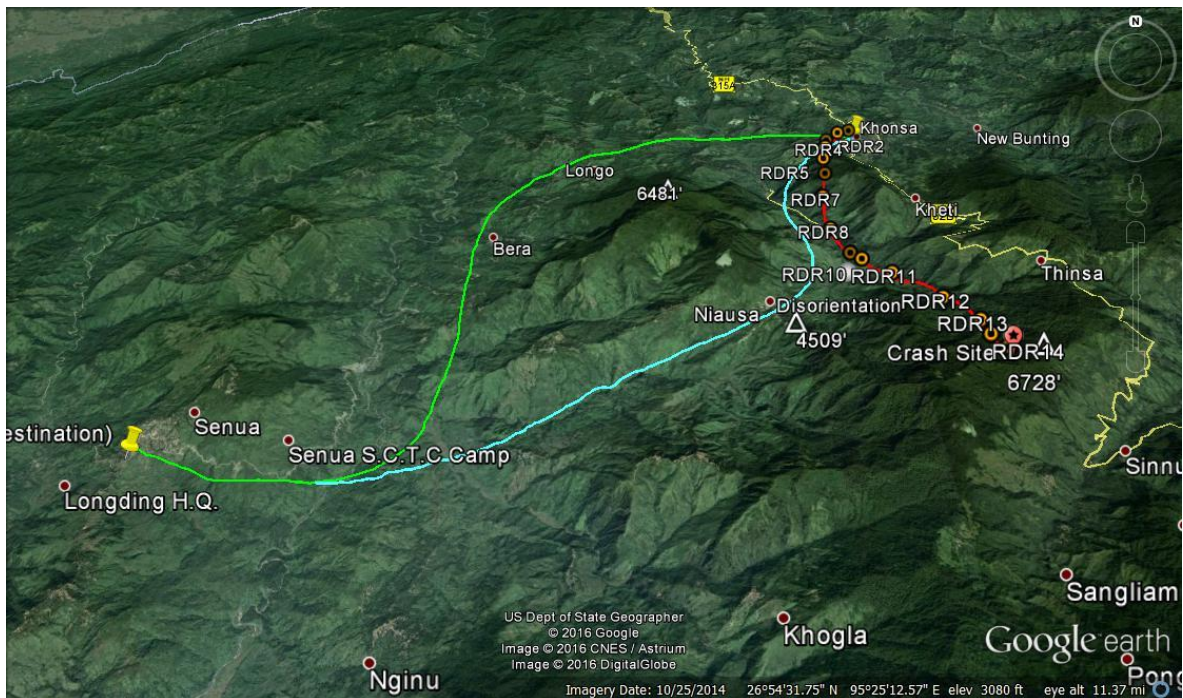
The above picture gives out the terrain very clearly and attempt has been made to depict the planned, alternate and actual flight paths taking into account

the data available from Radar plots, Flight plans, terrain study and Radio Calls given by the Pilot. The green path is for the probable planned route, blue path is probable alternate path which the PIC tried to follow due weather on the planned path and Red is the actual path followed by the helicopter.

As per flight Plan the level filed for the sector 3500 ft, which based on the average heights of the hills in the area implies that the planned route was that after take-off from Khonsa fly West towards Luthong, up till Longo and then turn Southerly towards Bera up till Senua where the PIC would have once again turned west and landed at Longding. The highest point in this route is approx 2400 feet, so with 1000 feet clearance, he had planned to fly at 3500 feet level (as given in filed flight plan by the flight crew). No other routing has terrain less than 2500 feet.

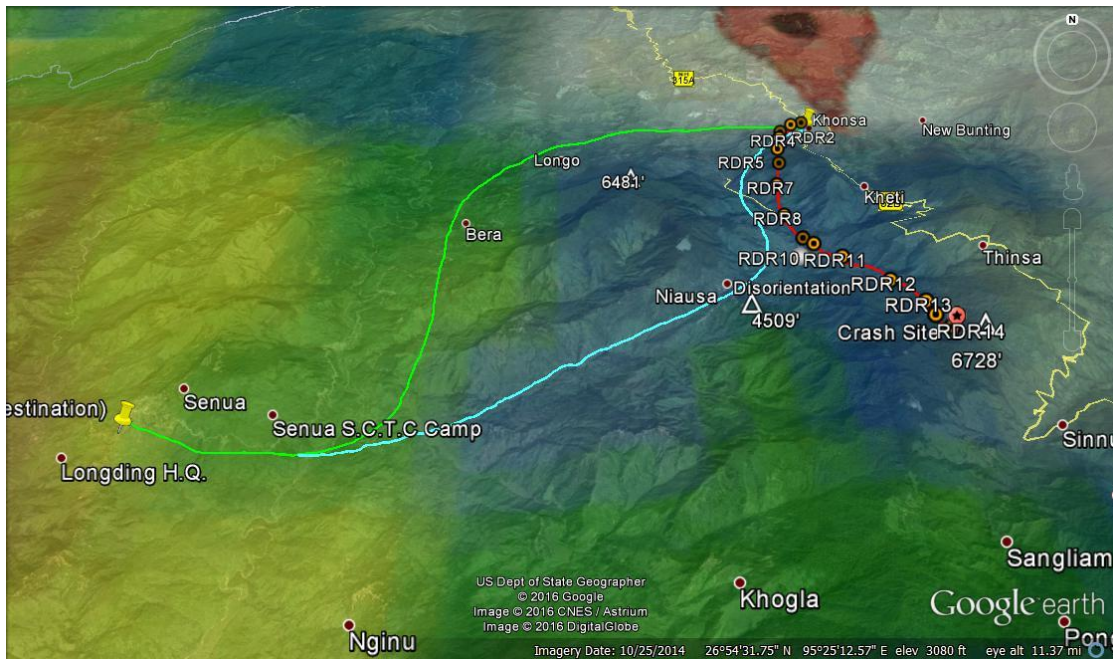
Flight Paths with Cloud Picture overlay

Cloud picture overlay of Satellite imagery, clearly gives out that there was widely spread low cloud cover and same is corroborated by weather reports and statements of people on ground. The clouds were thick and dark as per the statements of people on ground. As in the present case the weather was very bad in the area of planned routing, alternate routing available was via Niausa, for which initially the helicopter should fly south after take-off uptill Niausa and climb to 5500 feet, as altitude of Niausa is 4500 feet, there after turn right (west) and fly towards Senua and continue descending to land at Longding.

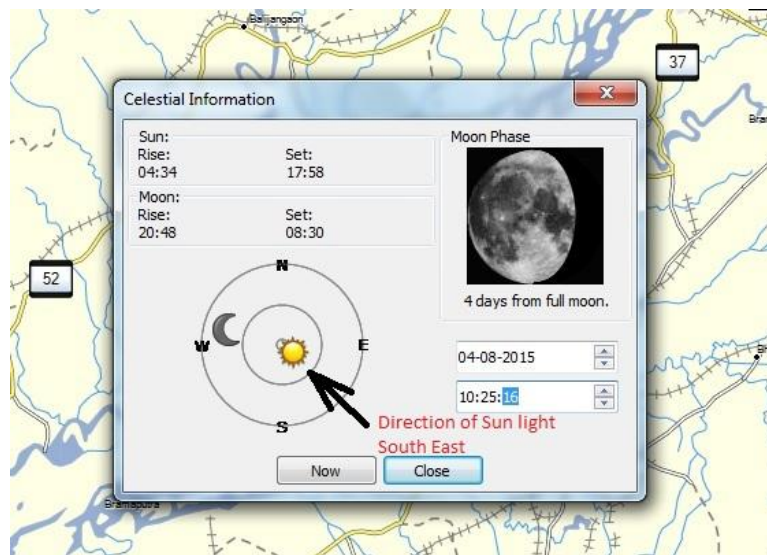
Sun Position

One more reason for pilot not taking the planned route and trying out alternate route comes out from the direction of sun (light) during the flight. Position of Sun was in South East direction. When sky is completely covered with thick clouds, in the direction of Sun, because of strong sun rays, the clouds seem to be lighter and give a feeling of less cloud thickness and reciprocal direction looks darker. This phenomenon, makes the pilot feel that it's better to fly in the direction where clouds are less and might get a clear area very soon and in the present case the direction was SE. This could had been the reason for Pilot to fly on the alternate route. The last radio call given by the pilot was of "Climbing to 5500 feet" which indicates that he was following the route via Niausa, and was
