FINAL REPORT OF ACCIDENT TO PAWAN HANS
ECUREUIL AS 350 B3 HELICOPTER VT-PHT AT
LUBUTHANG, ARUNACHAL PRADESH ON 30th APRIL 2011

1. Helicopter Type : Ecureuil AS 350 B3
Nationality : INDIAN
Registration : VT - PHT
2. Owner/ Operator : Pawan Hans Helicopters Ltd.
3. Pilot – in –Command : CHPL holder
Extent of injuries : Fatal
4. Co-Pilot : CHPL holder
Extent of injuries : Fatal
5. Place of Accident : Near Lubuthang, Arunachal Pradesh N 27⁰ 34' 05''
E 92⁰ 12'03''
6. Last point of Departure : Tawang
7. Intended place of Landing : Itanagar
8. Date & Time of Accident : 30th April 2011, 0500 Hrs approx
(exact timing not known)
9. Passengers on Board : 03
Extent of Injuries : Fatal
10. Phase of operation : In flight
11. Type of Accident : A case of Controlled Flight into terrain

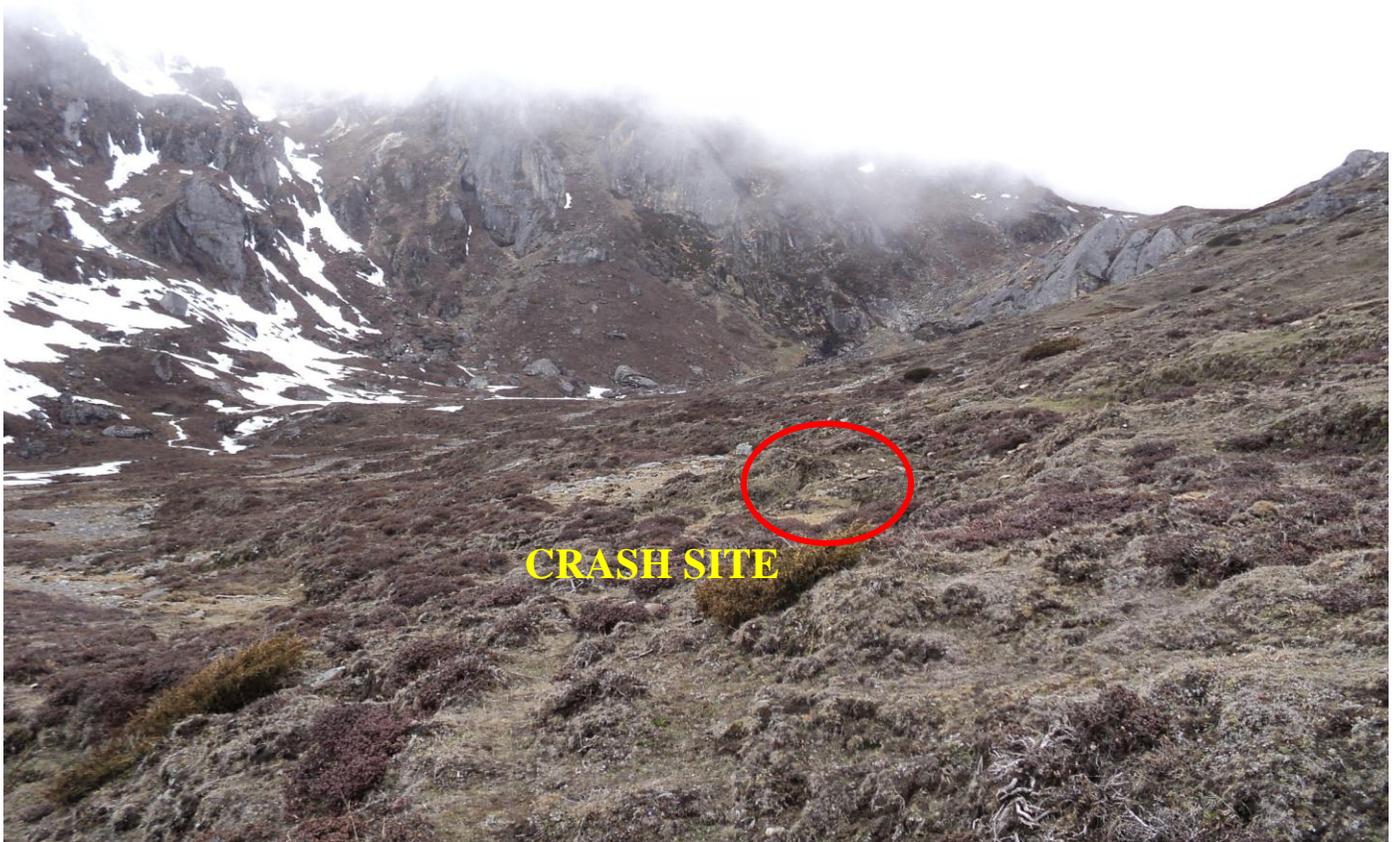
PHOTOGRAPH SHOWING THE TERRAIN AND CRASH SITE

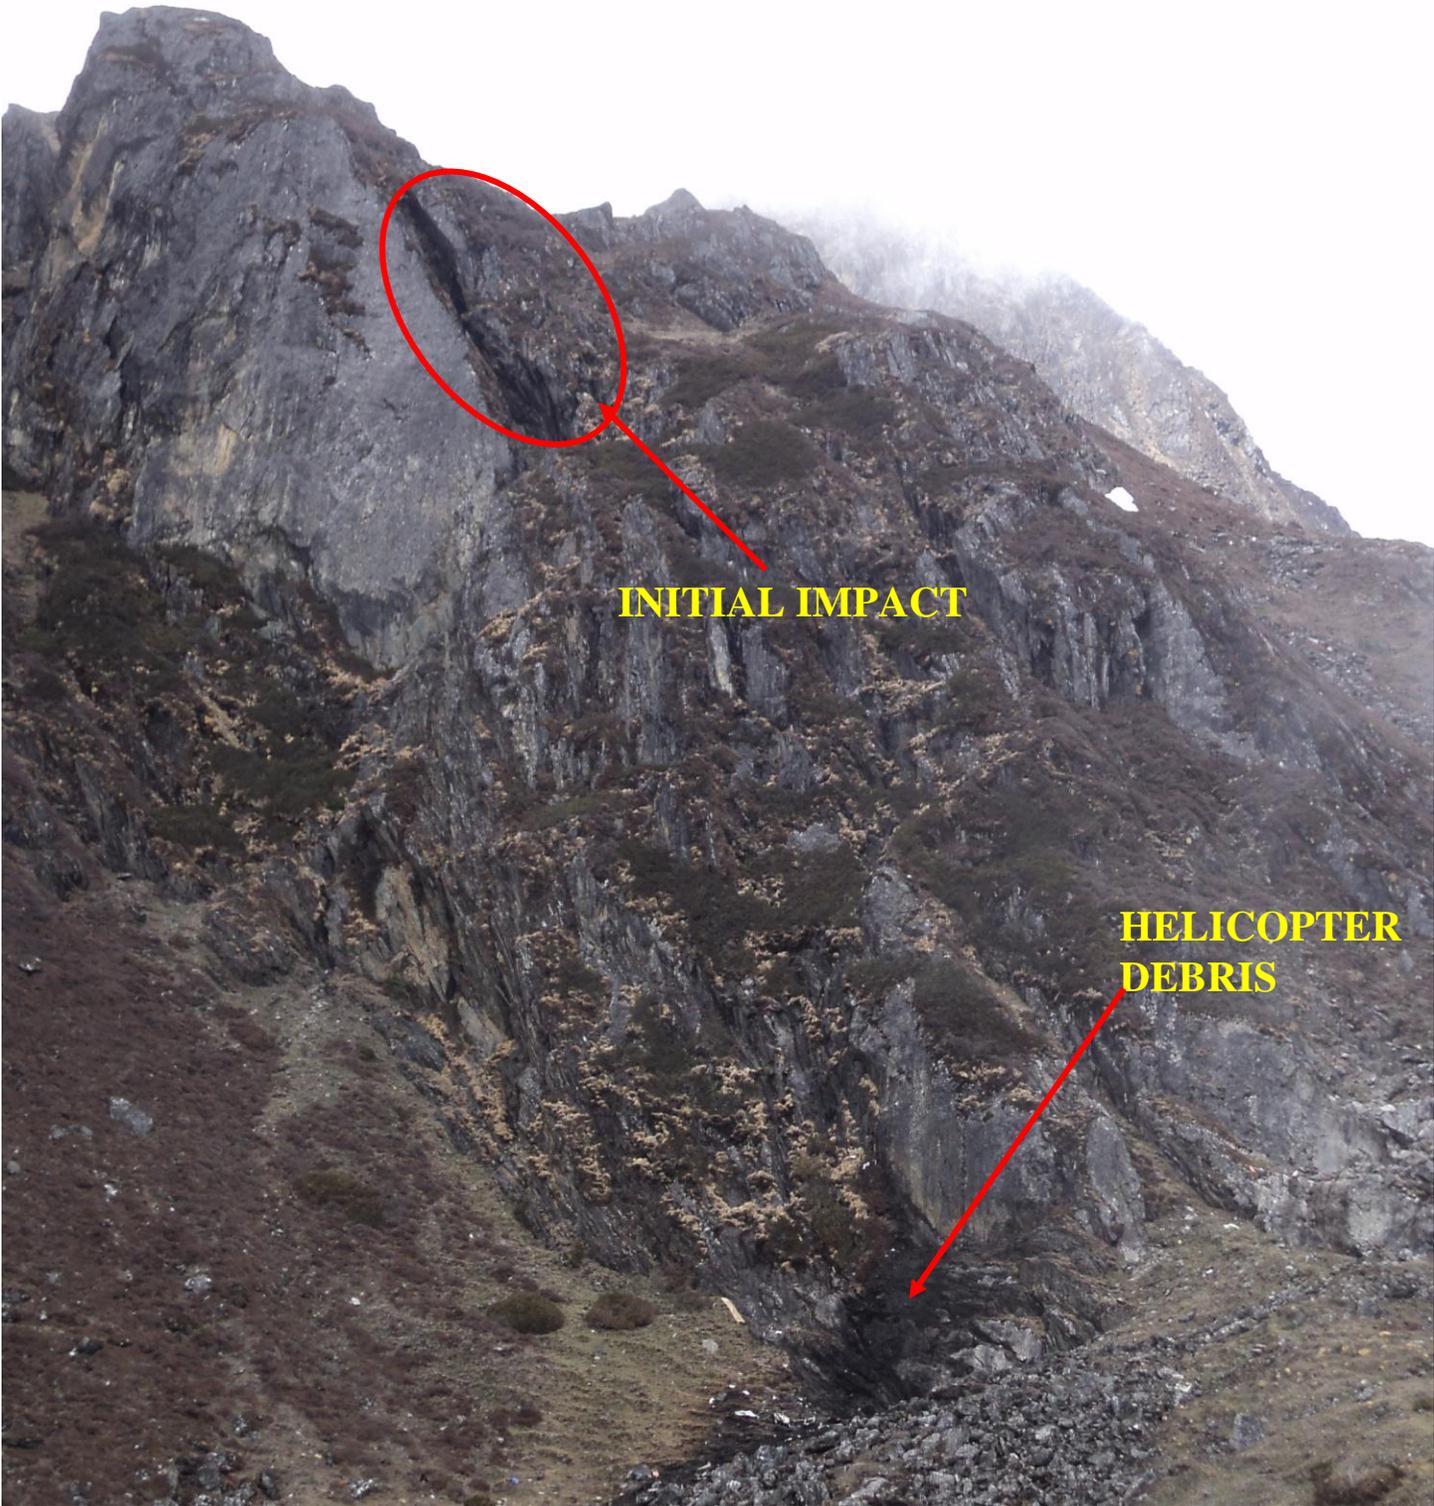
RIDGE WHERE THE HELICOPTER IMPACTED

The wreckage was mainly concentrated at one point. The helicopter after having impacted at a point about 100 to 150 feet below the top of the ridge has fallen along the steep face of the cliff and rested at a place of relatively lesser gradient approximately 600 feet below. The helicopter has thereafter caught fire due to the availability of almost full fuel. The burn marks indicate the spread of fire in the rocky terrain. The fuselage has broken into a number of small pieces and most of it has burnt to ashes. The engine and a few other components were recovered from the crash site and was sent for further examination at the OEM site in France. The ECU was found in a burnt and damaged condition. The control columns were found

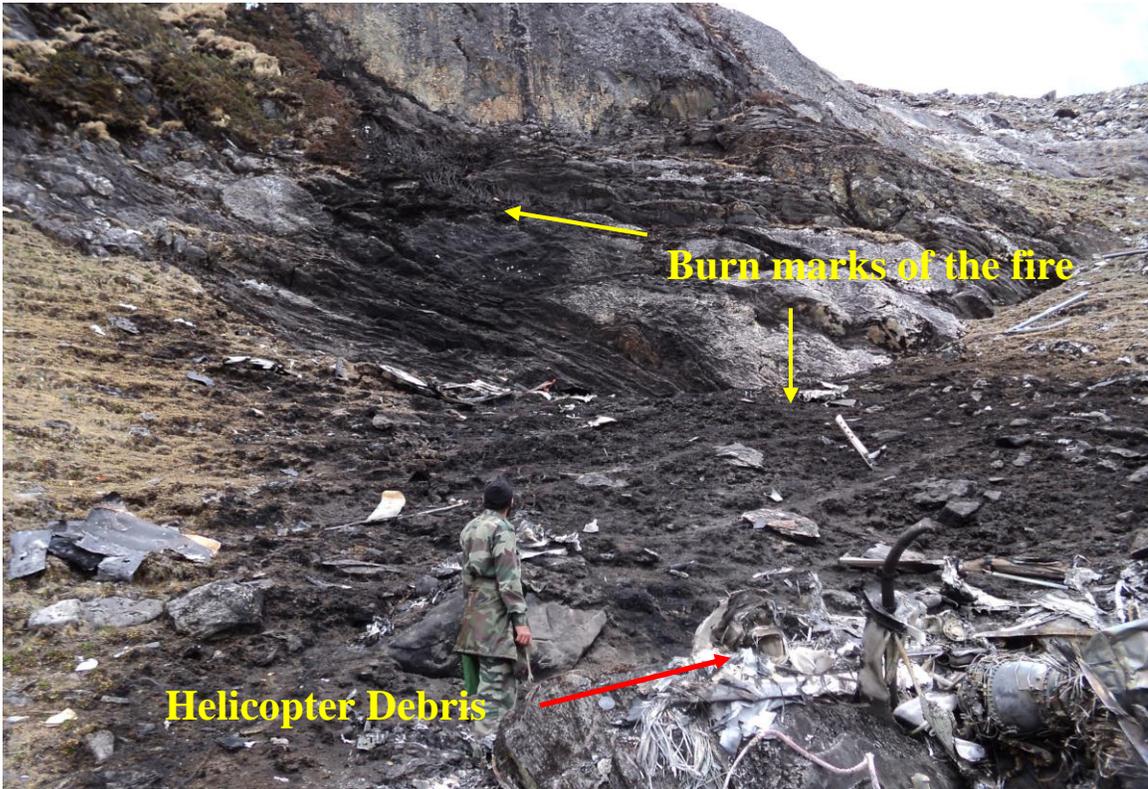
HELICOPTER DEBRIS AT THE CRASH SITE

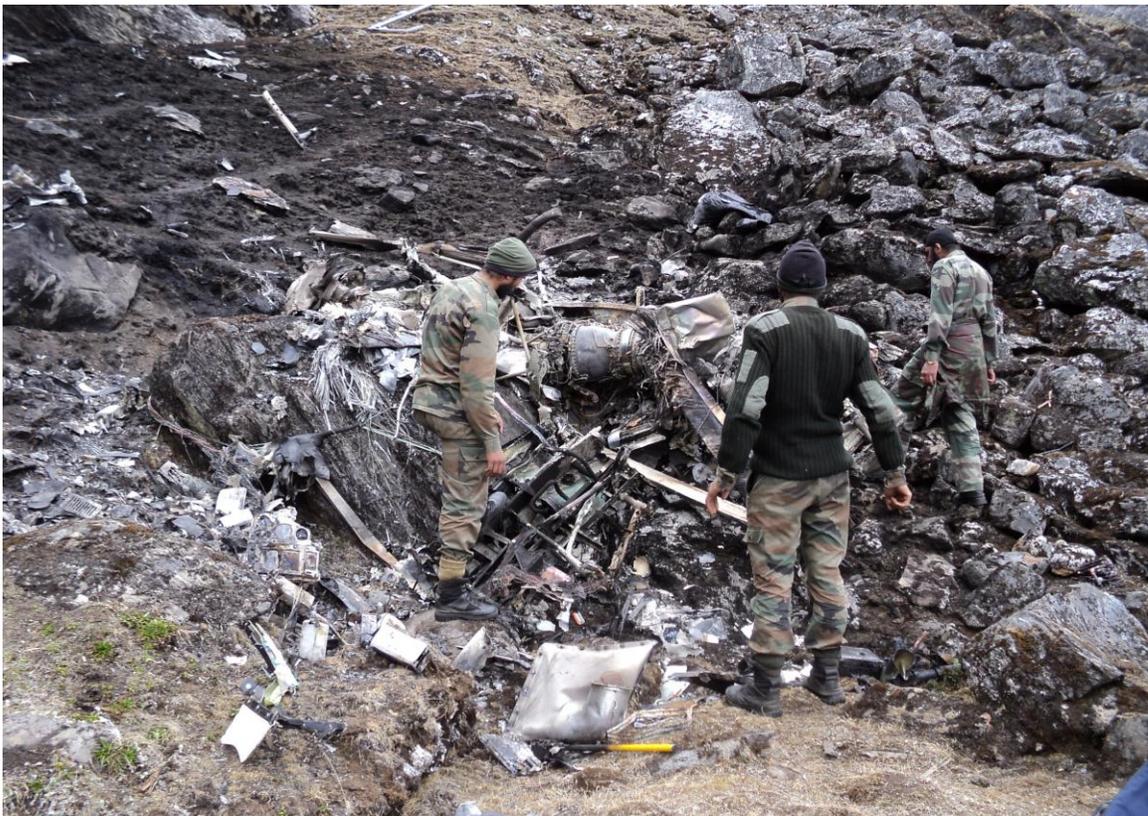
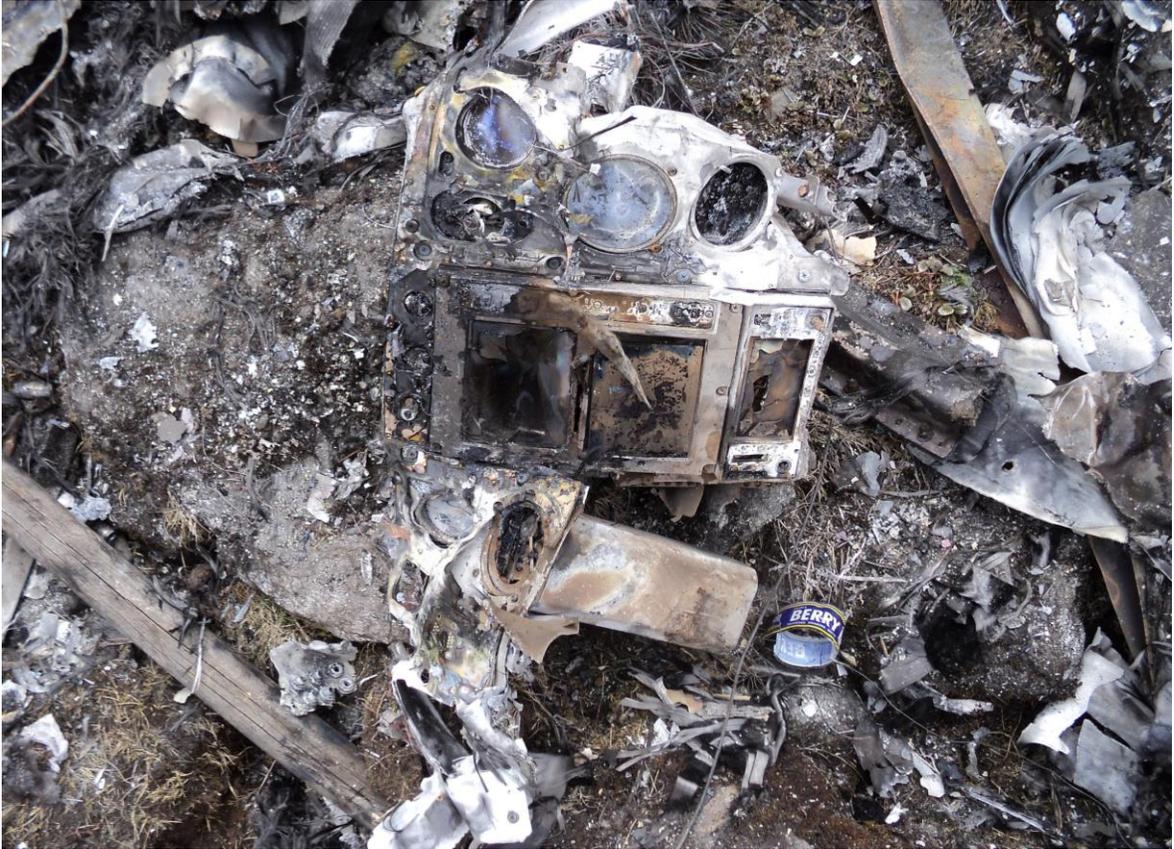
HELICOPTER DEBRIS

Except some small parts of the helicopter scattered around the main point of impact the majority of wreckage is located in a concentrated area which is relevant with an impact with a high energy. The main rotor blades exhibit significant mechanical and thermal damages resulting from the crash sequence and post-crash fire. Due to the difficulties to reach the crash site, only limited Air Frame components have been recovered. These include the Tail Rotor assembly, the recovered parts of the MGB to Engine coupling and the Engine to Tail Rotor Drive Shaft coupling.

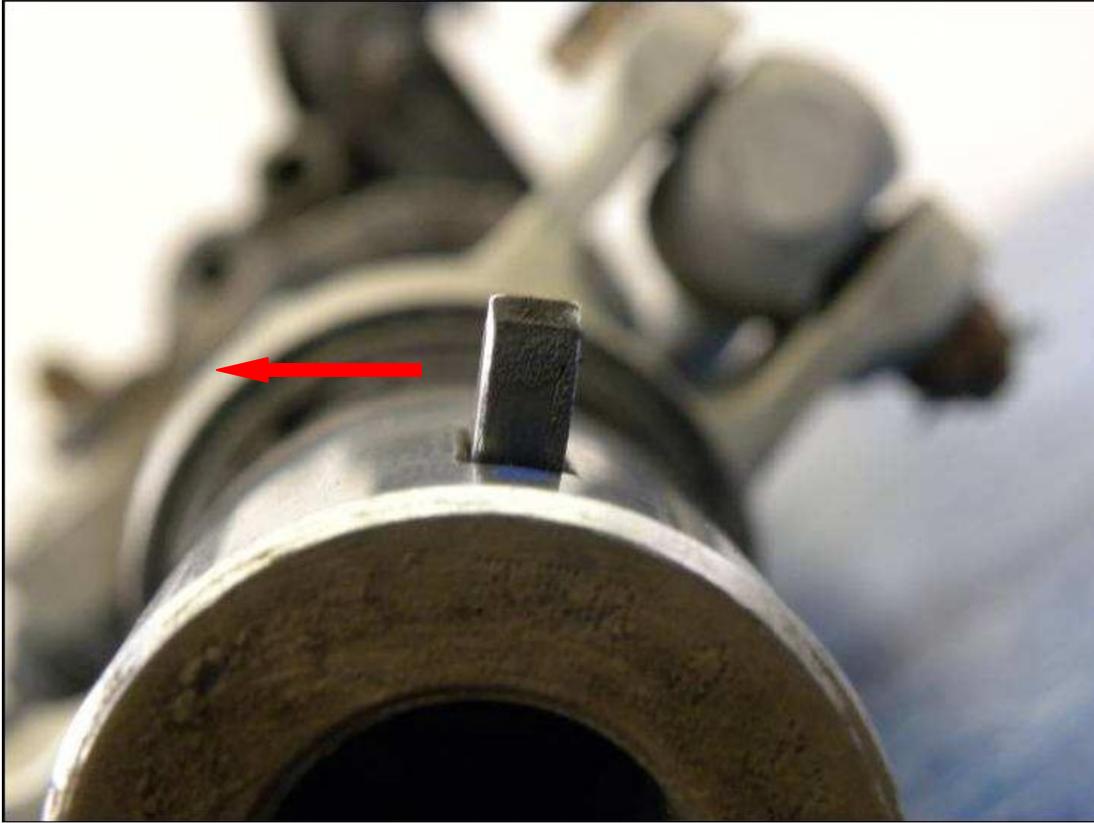
Tail Rotor Hub To Gearbox Shaft Coupling Woodruff Key

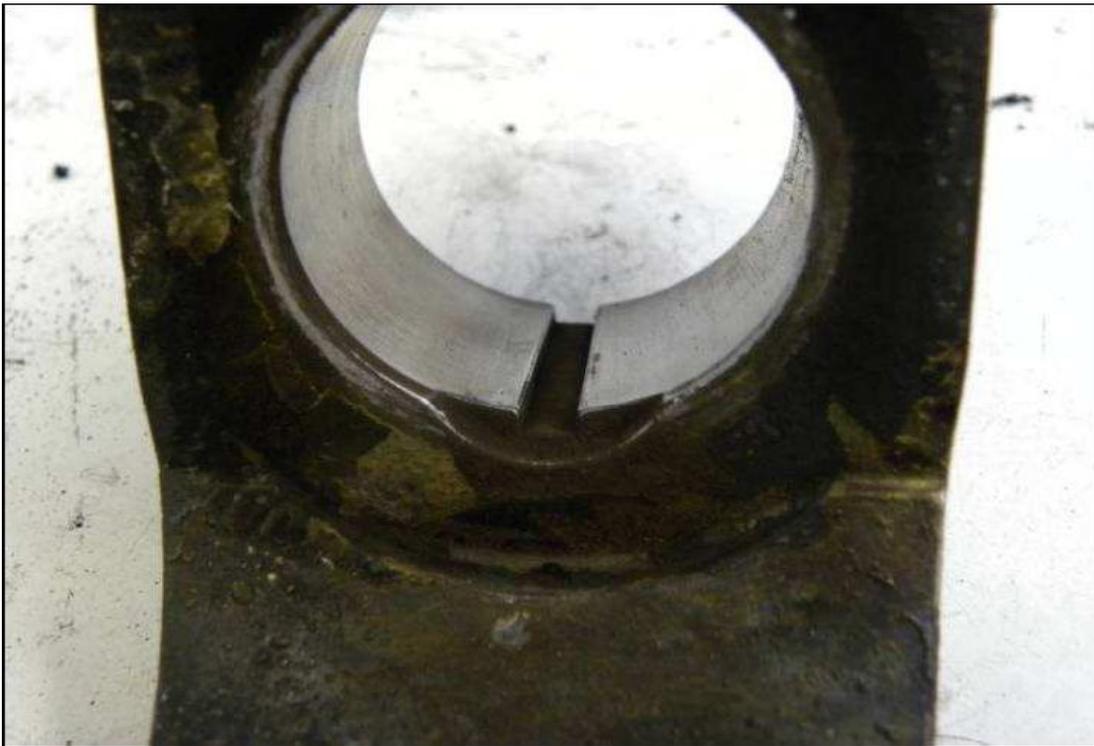
Tail Rotor Hub to Gearbox Shaft Coupling Woodruff Key
Beginning of Shearing in the Direction of the Arrow (inertia direction)

The examination of the recovered part of the tail rotor assembly does not indicate any evidence of any pre-crash failure. All the damages observed are the consequence of the crash and post-crash fire. The coupling woodruff key evidences a beginning of shearing in the inertia side (direction of a sudden stoppage of the Main Rotor Head).

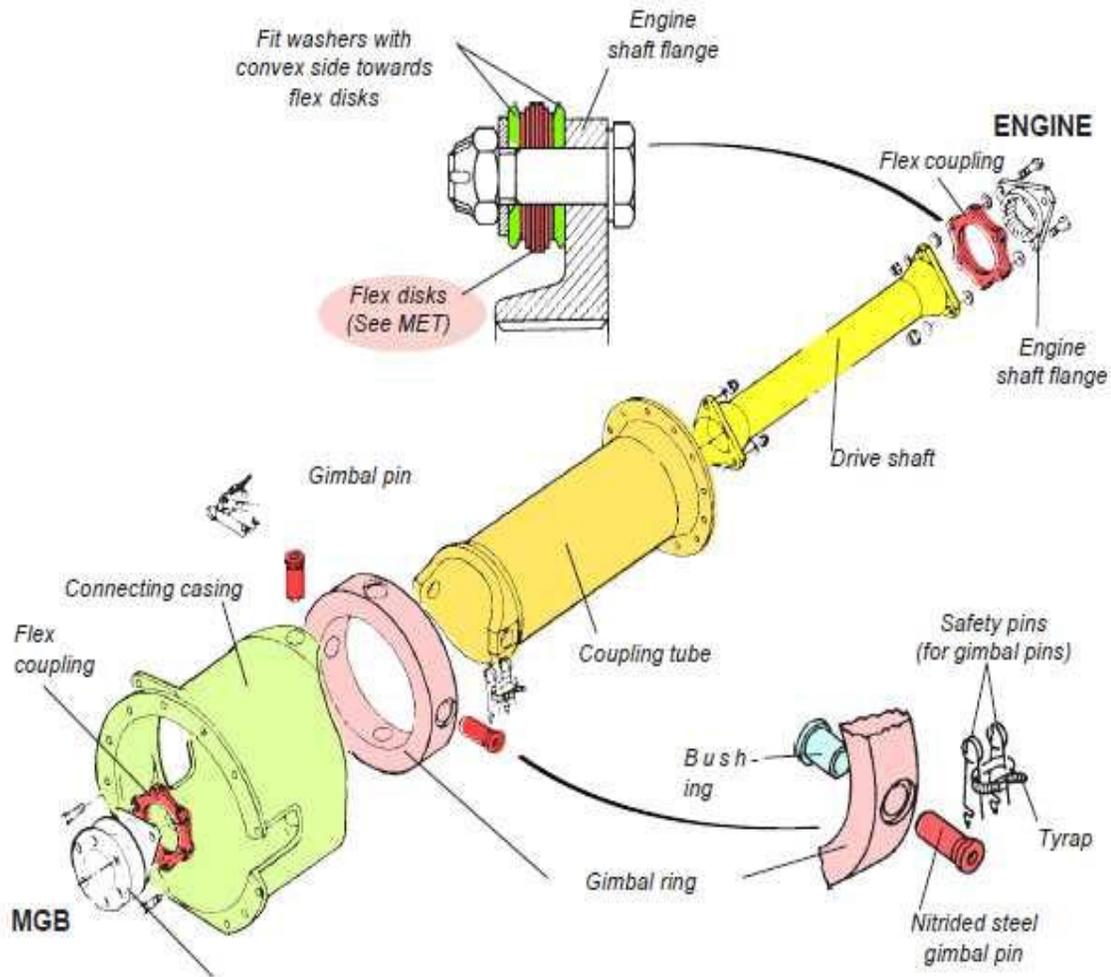
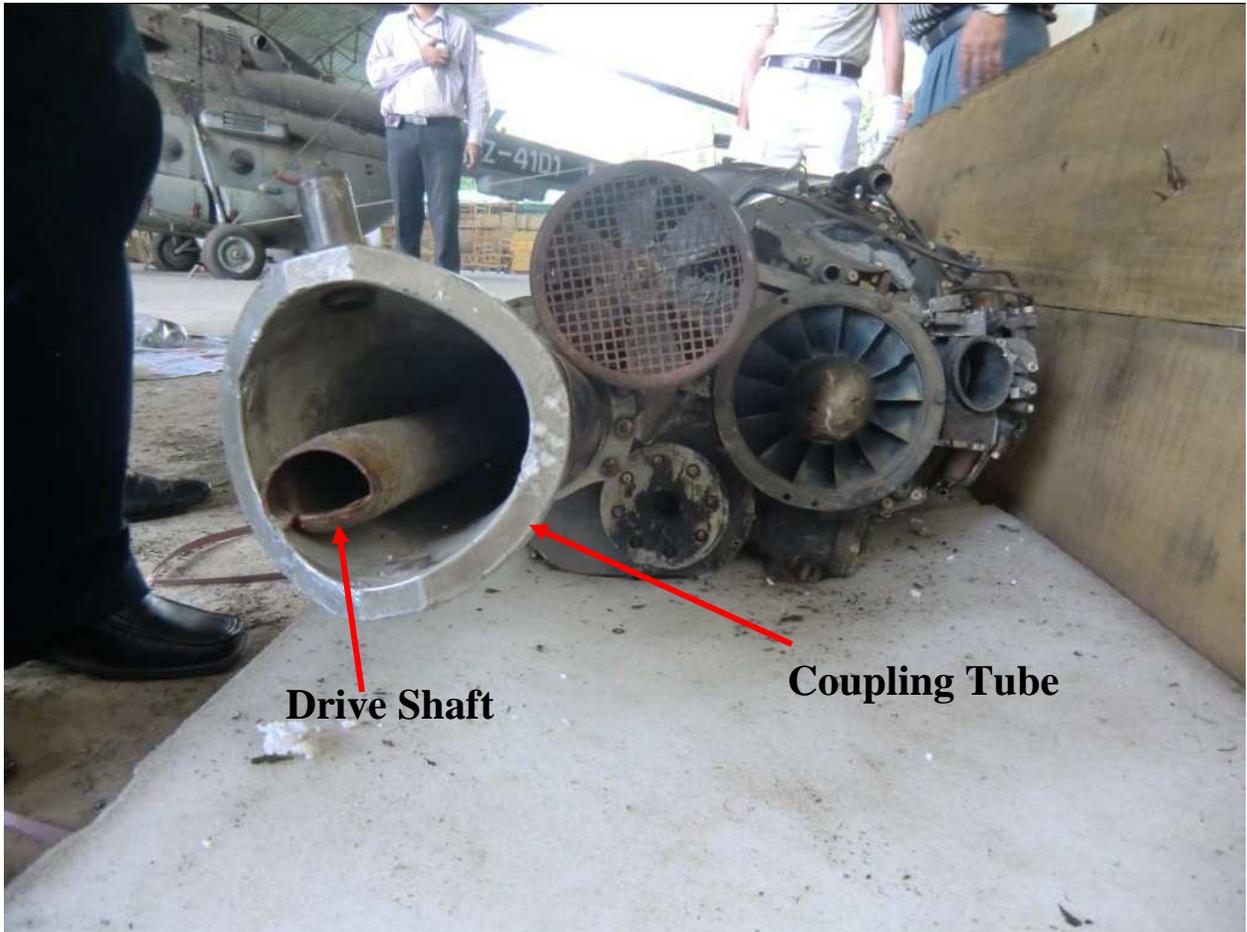
1.15.2 Engine To MGB Coupling

The Engine side flexible coupling exhibits some buckling resulting from the crash loads. The coupling tube evidences some internal damages resulting from the mechanical interference with the drive shaft during the crash sequence and a significant elongation resulting from compressive load resulting from the impact force during the crash.

The examinations of the recovered part of the Engine to MGB coupling do not show any evidence of any pre-crash failure. All the damages observed during this examination are the consequences of overloads resulting from the crash sequence and relevant with a high compressive energy during the crash.

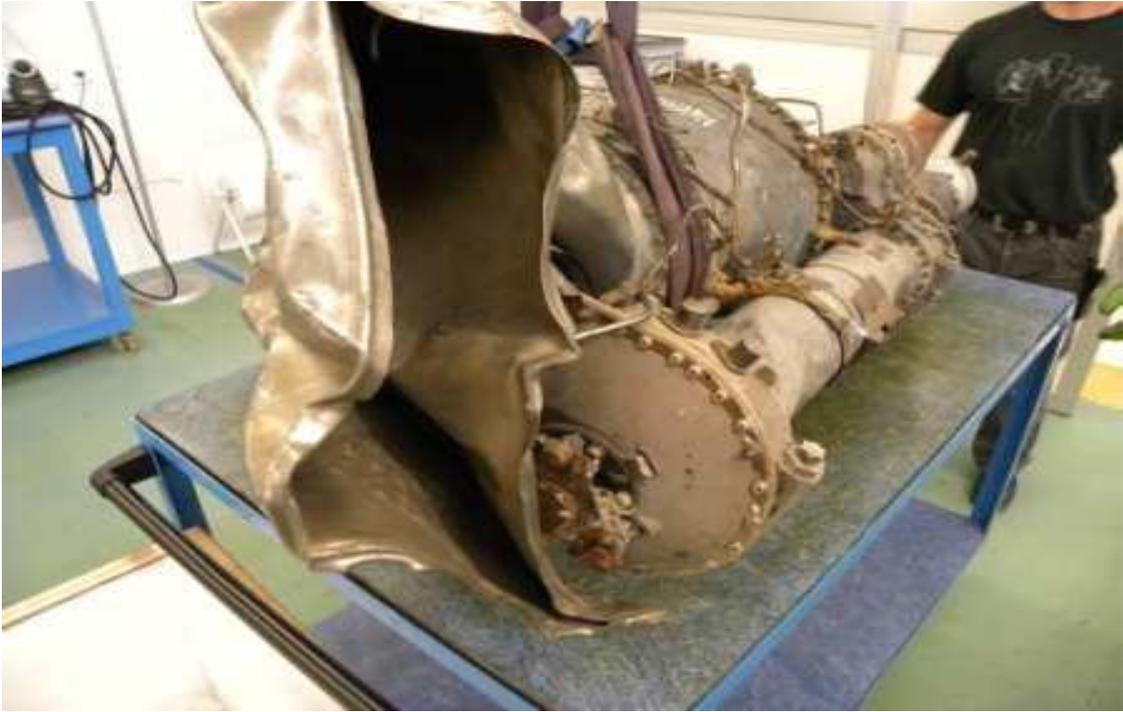
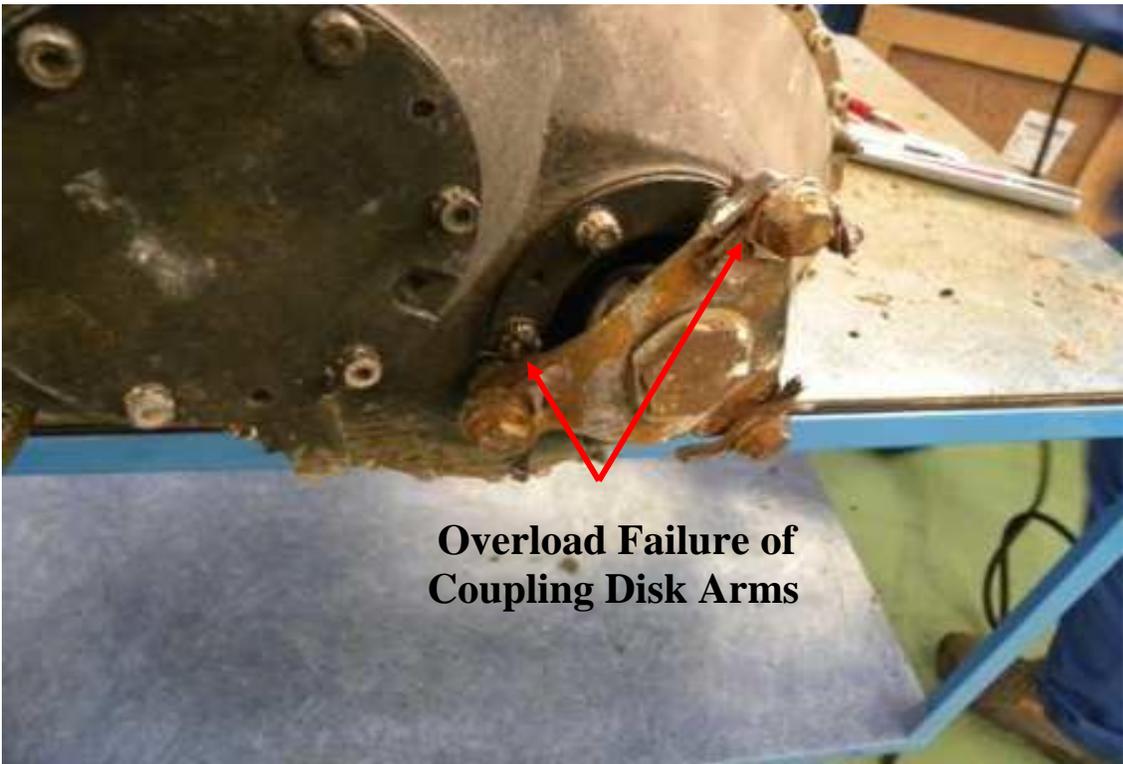
1.15.3 Engine To Tail Rotor Transmission Shaft Coupling

The Engine to Tail Drive Shaft flexible coupling is broken as the result of the crash (overload failure). The examination of the Engine to Tail Rotor Drive Shaft coupling does not indicate any evidence of pre-crash failure. The failure observed on this coupling is the consequences of the overloads resulting from the crash sequence.

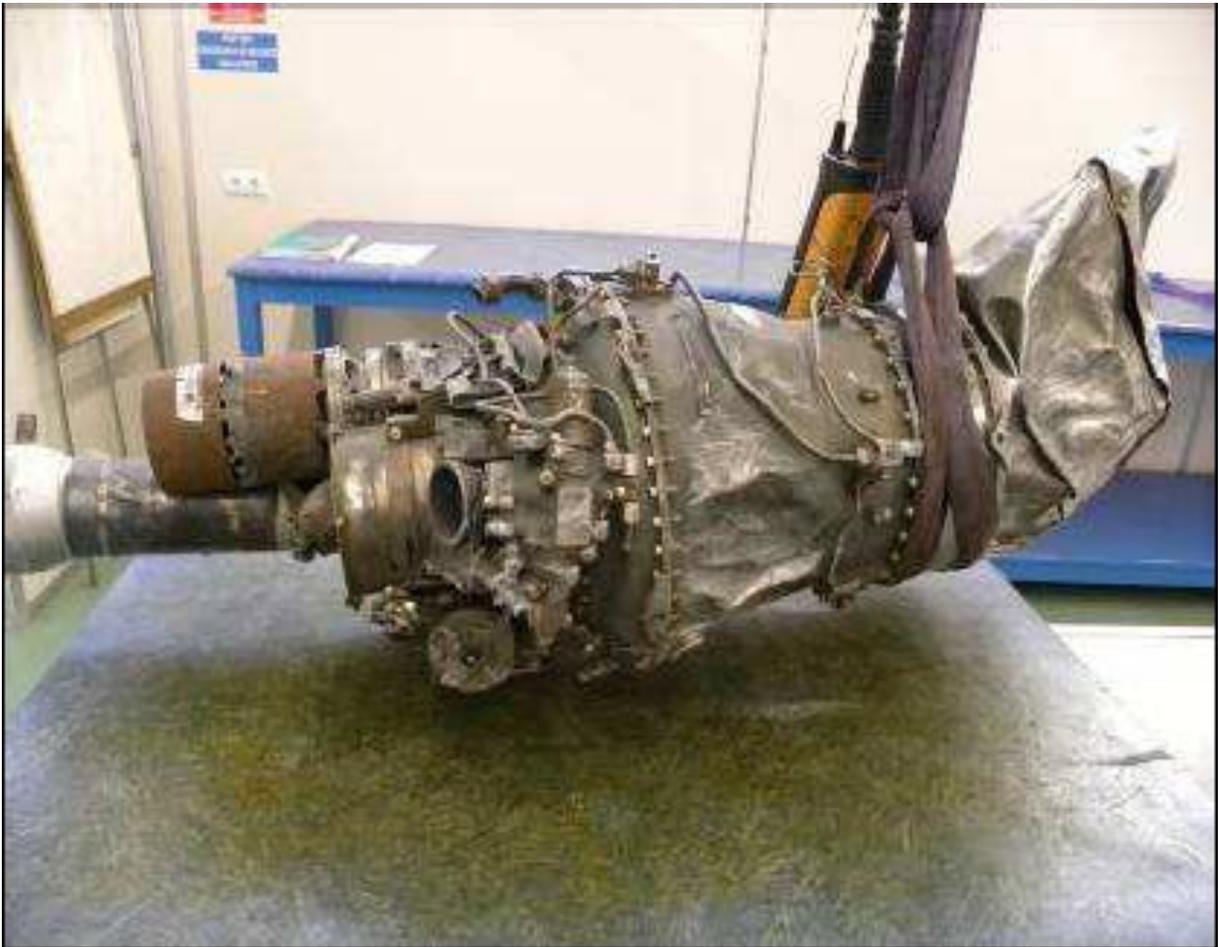
All engine parts were found to be seized except the free wheel, which operated correctly. The magnetic plugs were found to be burnt and without any trace of metallic particles. The reduction gearbox showed the marks were aligned on the transmission nut. The engine front attachment was bent. The transmission gear and accessory box gears were seized but in good condition. The axial compression erosion was within limits. One axial compressor blade displayed severe impact mark in the direction of rotation. The axial compressor shaft correctly drove the accessories gearbox. The bleed valve was in open position. The centrifugal

ENGINE RECOVERED FROM THE CRASH SITE

The engine tear down analysis does not show any pre-crash discrepancy. The engine has been damaged during the impact and by the post-crash fire. Some rotating marks could be observed.

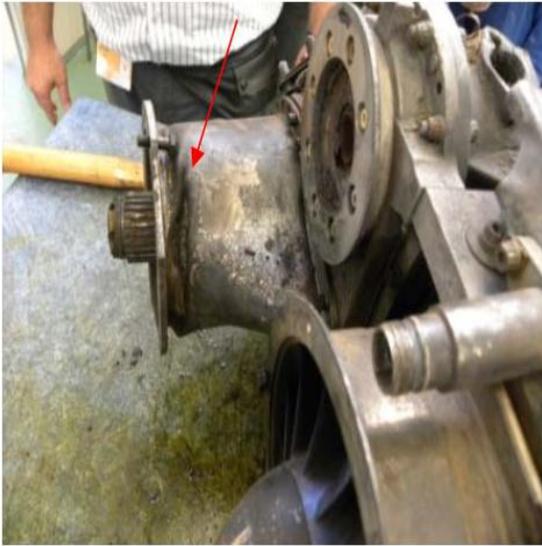
Front attachment bent

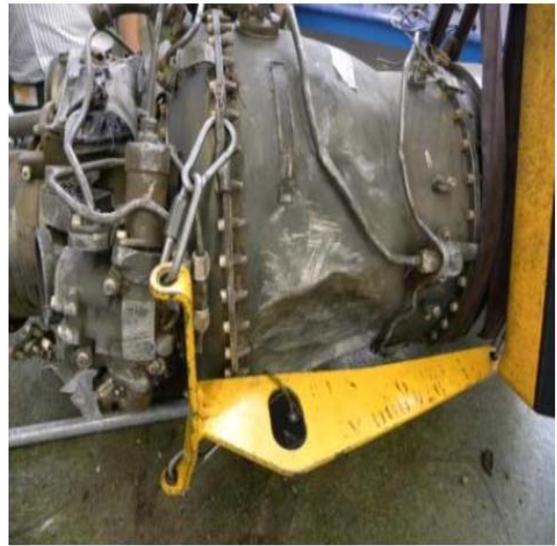
Turbine casing severely impacted

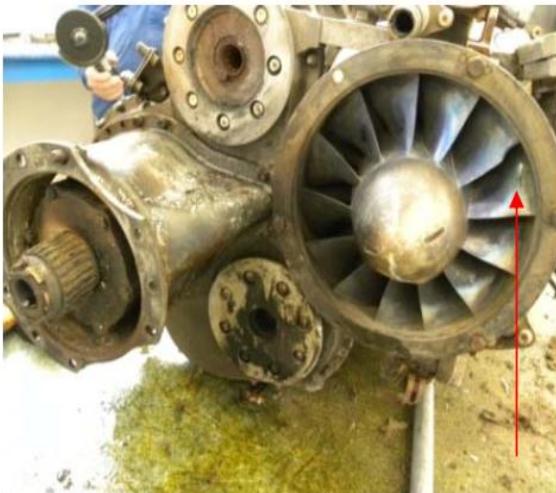
Impact mark on axial compressor blade

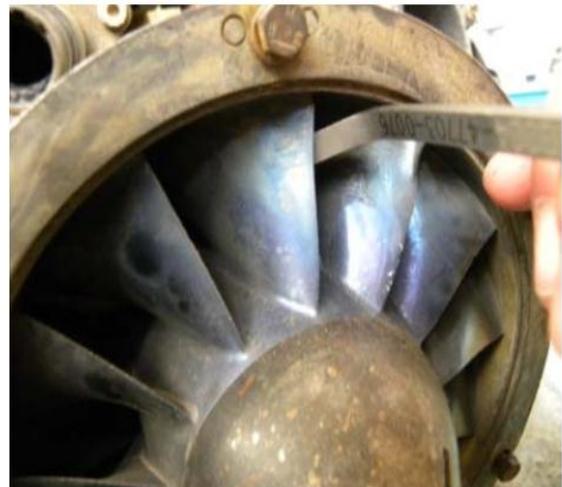
Erosion check: compliant

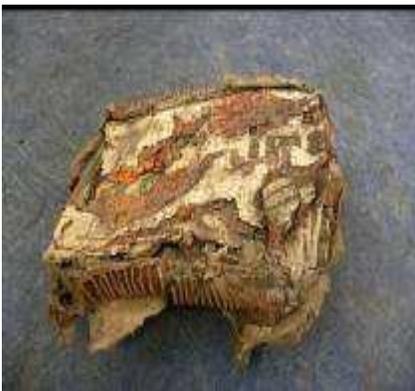
The ECU was totally damaged due to post crash fire and no data could be retrieved.

The computers were individually visually examined by the BEA in Turbomeca facilities in Tarnos, France. Evidence of severe fire damage was observed (over 600°C). At these temperatures, any electronic data stored in computers such as ECU is lost.

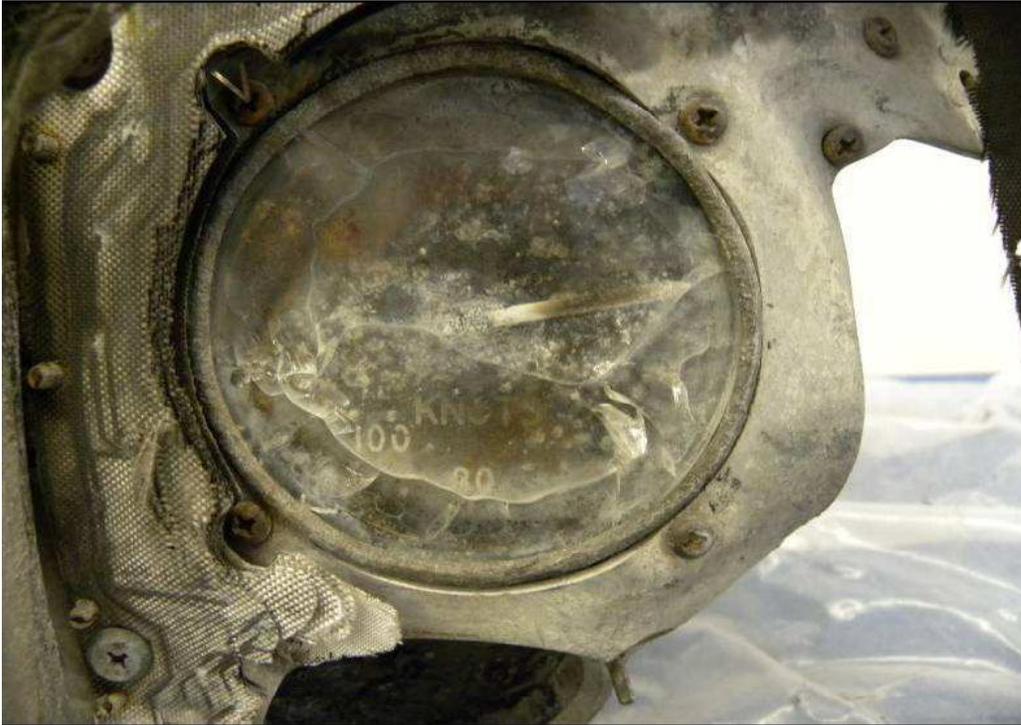
AIR SPEED INDICATOR

The airspeed indicator, a barometric air data instrument, is indicating around 30 kts. However, this value may not represent the value before the accident due to post-impact damages.
