REPORT

**ON ACCIDENT TO M/S PIONEER FLYING ACADEMY
CESSNA-152 AIRCRAFT VT-PSJ AT VILLAGE
DHANIPUR, DISTRICT ALIGARH (UP) ON 29/07/2011**

**AIR SAFETY DIRECTORATE
O/o DIRECTOR GENERAL OF CIVIL AVIATION
OPP. SAFDARJUNG AIRPORT, NEW DELHI**

**REPORT ON ACCIDENT TO M/s PIONEER FLYING
ACADEMY CESSNA-152 AIRCRAFT VT-PSJ AT
VILLAGE DHANIPUR, DISTRICT ALIGARH (UP)
ON 29/07/2011**

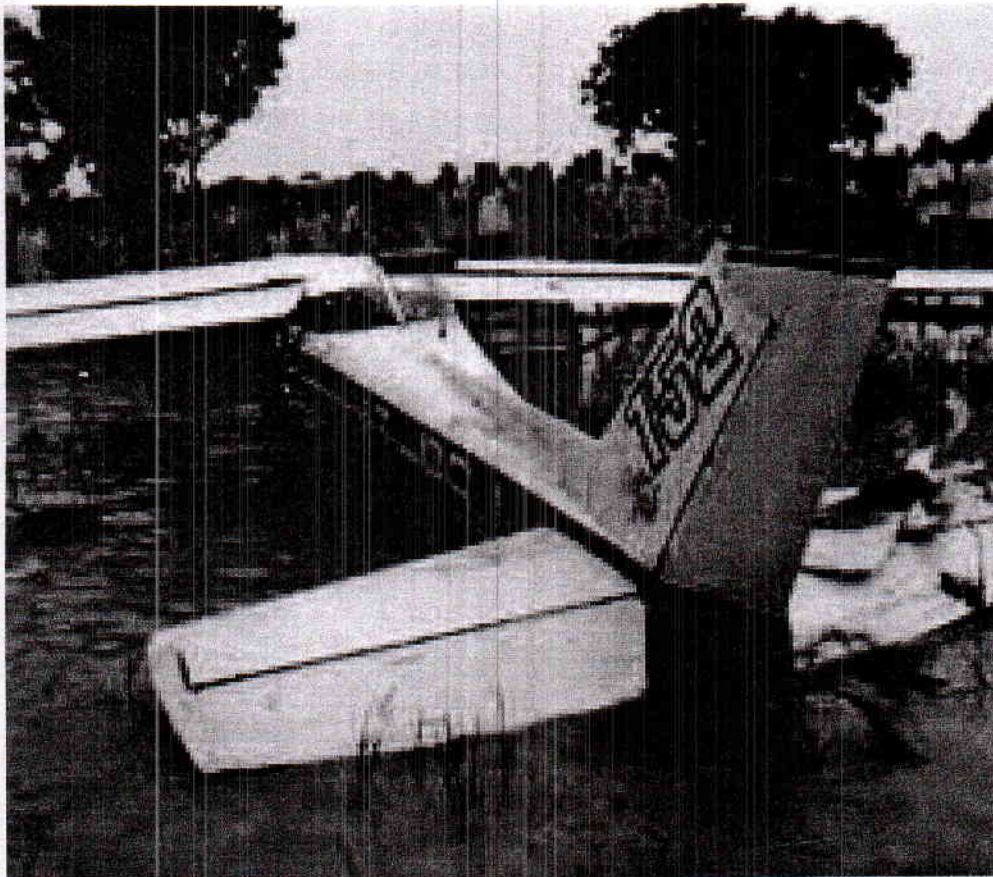
Fig. 5 Wreckage in final resting position (Photograph from media)

During site examination, propeller marks have not been recorded. As per the revised statement of chief engineer the propeller assembly was found lying before the final resting place of aircraft main wreckage and towards the left of direction of motion. However exact location of the separated propeller could not be ascertained. Comparing Fig. No. 5 and No.6 and taking into consideration the statement of the chief engineer, apparently the propeller had separated from the aircraft along with the mounting bolts and bushes before the final resting place of the wreckage. **After the accident the propeller was shifted and kept near the main wreckage (ref. fig. 6).** Then the aircraft impacted a bund of mud, almost 1m. high. During this process nose of the aircraft smashed into the cockpit and cockpit bottom area was completely damaged. The aircraft moved forward and finally came to rest at around 10 meters from the bund. Wreckage diagram is enclosed as Appendix 'A'.

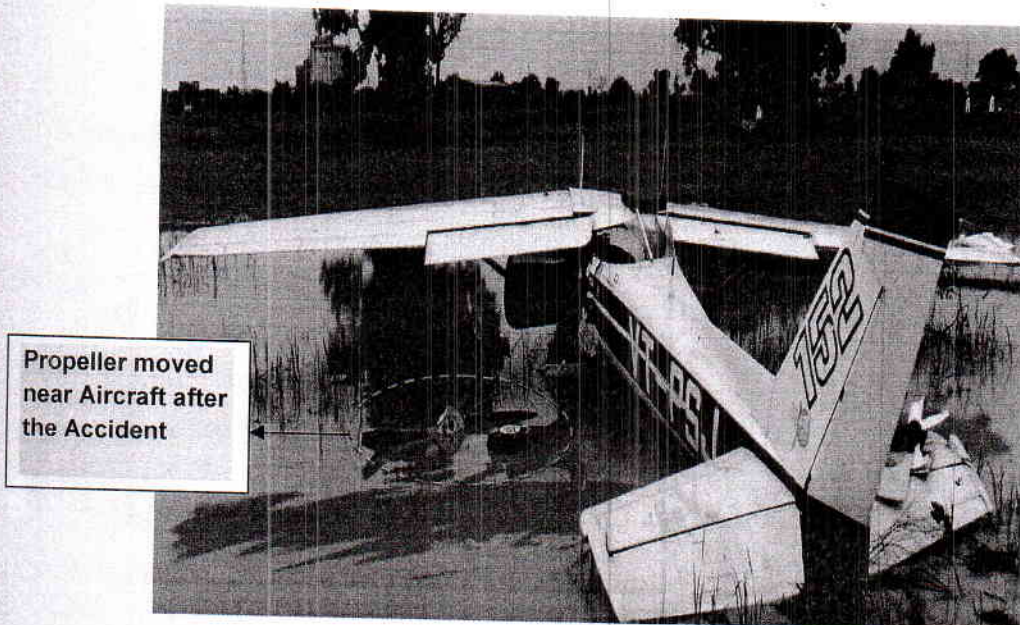
Fig. 6 Wreckage in its final resting place (Photograph by First IOA during site visit)

The accident site was a paddy field with standing water. The final resting place of the main wreckage was at a distance of approximately 740 meters from the edge of runway 29 of Aligarh Airfield. The coordinates of the accident site are N 27°51'26.06", E 78°09'36.74" and elevation is 185m.

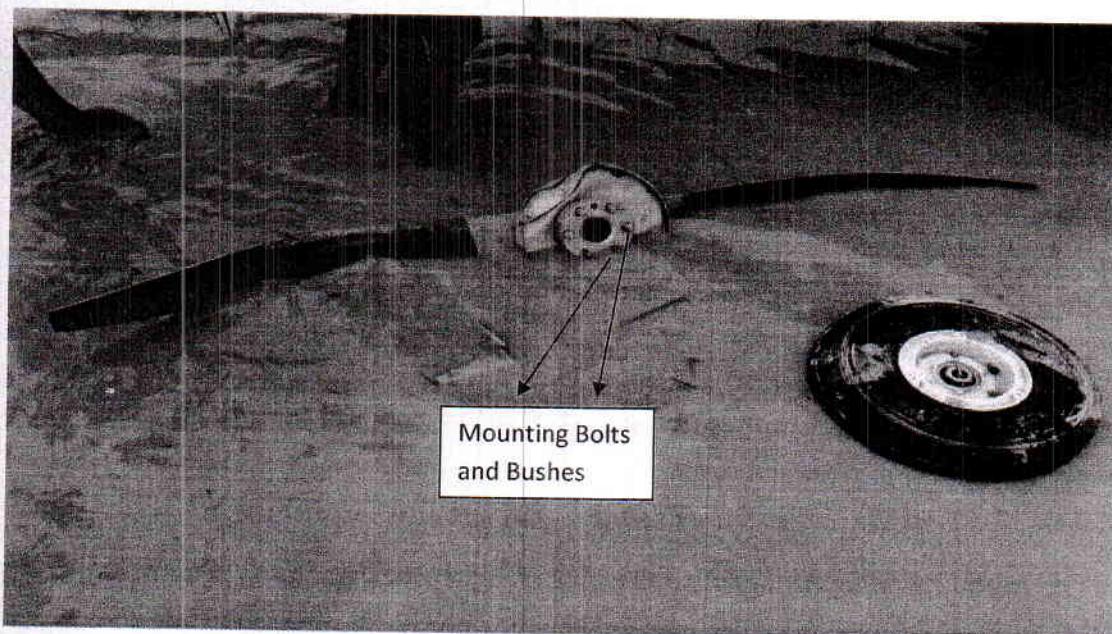
Fig. 7 Propeller and hub Assembly

The propeller assembly had come out from the fitting of the flange along with the mounting bolts and bushings. Collar has separated from each of the bush and they were not recovered. Propeller spinner was found deformed on one side due to impact with blunt object and there was penetration of the metal surface. Both the propeller blades had slight bent which can be associated to static impact. There was no damage to tip of the propeller. Apparently the propellers were not rotating at the time of impact.

Propeller assembly had separated from the engine along with its mounting bolts and the crankshaft flange bushings. Propeller had separated before the final resting place of the wreckage and was found lying left to the direction of the motion of the aircraft. **However later it was shifted to the main wreckage.**

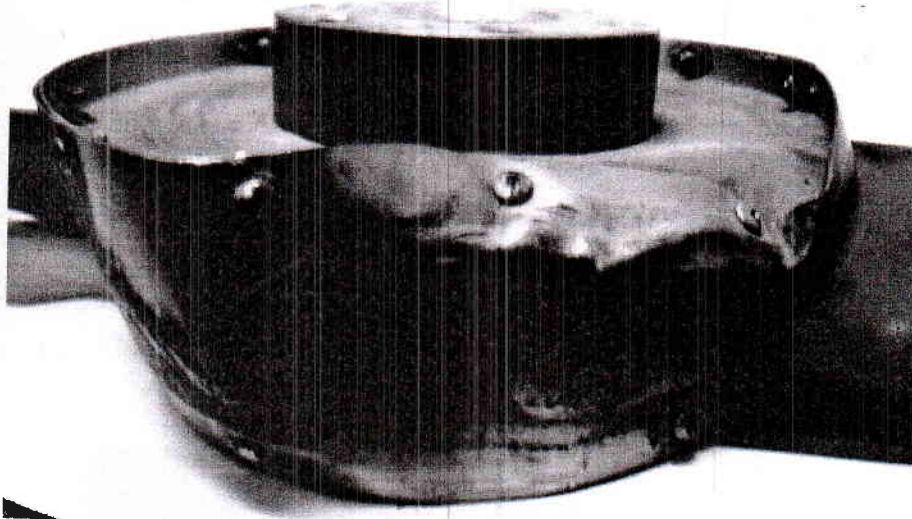
Fig. 8: Damage on the propeller hub.

- On the spinner dome no sign of rotation was observed. Flat spots /penetration was observed on the opposite sides on the propeller hub due to impact with some hard object.

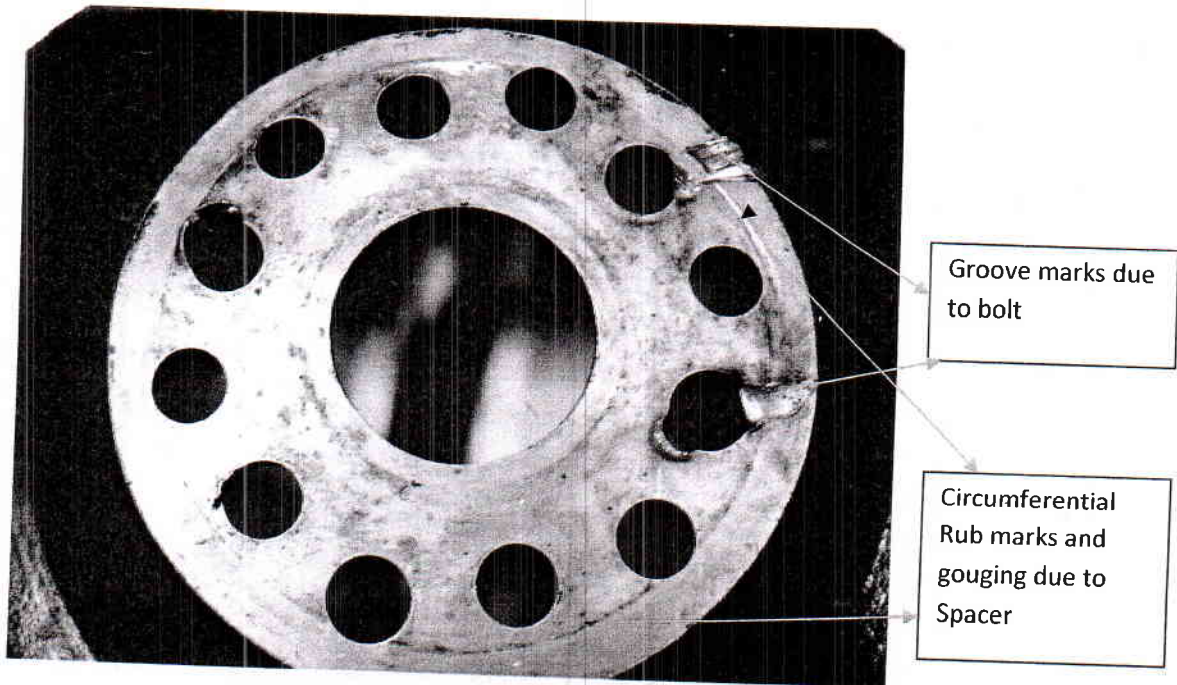
Fig.9 Starter Ring Gear

- No twist was seen on the propeller blades. Both the propeller blades were bent backward. No nicks, gouges, and scratches were observed on the blade face/back, lead/trail edges and tips.
- Threads of all the propeller mounting bolts were intact and there was no appreciable bend.
- Circumferential rub marks/gouging of the metal were observed on the front face of the starter ring gear abutting with the aft face of the spacer indicating relative motion between the two. The holes of the ring gear for carrying the bushing were found to obliterated /oval in shape. In two of the holes groove marks/erosion of metal due the bolt was seen indicating the direction of the release of the bushing along with the bolts. On rear face of the ring gear abutting with the flange of the crankshaft, circumferential rub marks due to flange of the crank shaft was observed.

- Circumferential rub marks/gouging of the metal were observed on the front face of the starter ring gear abutting with the aft face of the spacer indicating relative motion between the two. The holes of the ring gear for carrying the bushing were found to obliterated /oval in shape. In two of the holes groove marks/erosion of metal due the bolt was seen indicating the direction of the release of the bushing along with the bolts. On rear face of the ring gear abutting with the flange of the crankshaft, circumferential rub marks due to flange of the crank shaft was observed.

The above damage to the propeller assembly indicated that there was relative motion between the ring gear and the propeller spacer which caused the

circumferential scoring/rub on the ring gear. This is possible only if the few of the fasteners are loose or given way. The damage on the ring gear also indicated the forcible release of the bushing/bolts.

3.1.8 There was relative motion between the ring gear and the propeller spacer which caused the circumferential scoring/rub on the ring gear. This is possible only if the few of the fasteners are loose or given way. The damage on the ring gear also indicated the forcible release of the bushing/bolts.

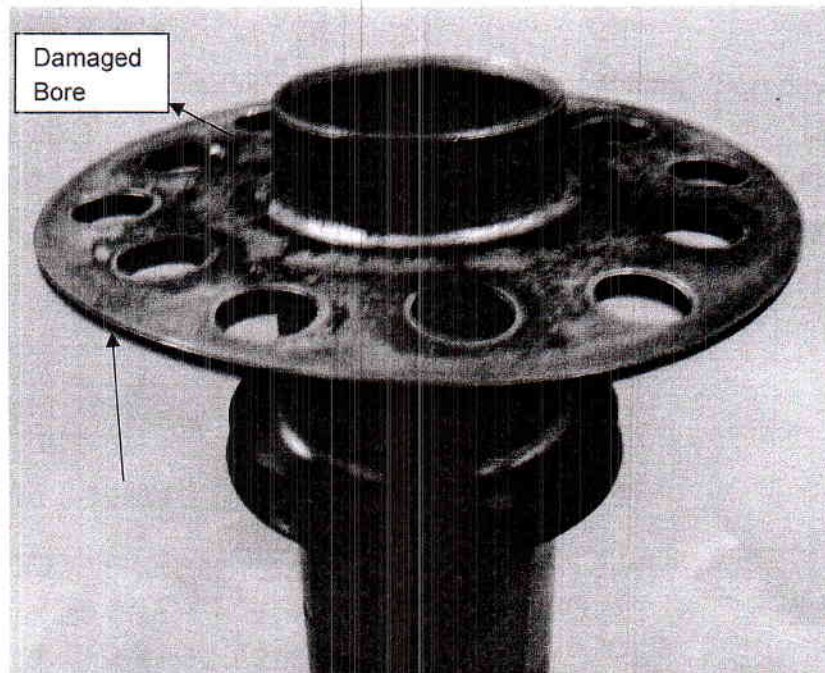
Fig. 9 Crank Shaft Flange indicating bend

- All the six crankshaft flange bushings had come out from the flange. **The collars of the bushes had separated and were not recovered.** The flange had bent and the bent was about 0.029 in. (run out). Ref fig 9. In one of the bore the edged was damaged in the backward direction indicating aft motion of the bushing.
- The diameter of bushing holes/bore on the crankshaft flange was measured and are as follows. (As the propeller assembly was disassembled without locating the reference position, the bore no. are not with reference to the location of the indexed part no. of the bush) :

From above measurements it is seen that the variation in the flange bore diameter in case of five bores is 0.001 in. The SL does not provide any information for the variation of the bore dia. /tolerance.
