FINAL REPORT ON ACCIDENT TO M/S
SPICE JET LTD.Q-400 AIRCRAFT VT-SUA AT
HUBLI ON 08/03/2015

AIRCRAFT ACCIDENT INVESTIGATION BUREAU
MINISTRY OF CIVIL AVIATION
NEW DELHI

**FINAL REPORT ON ACCIDENT TO M/S SPICE JET LTD. BOMBARDIER
Q-400 AIRCRAFT VT-SUA AT HUBLI ON 08/03/2015**

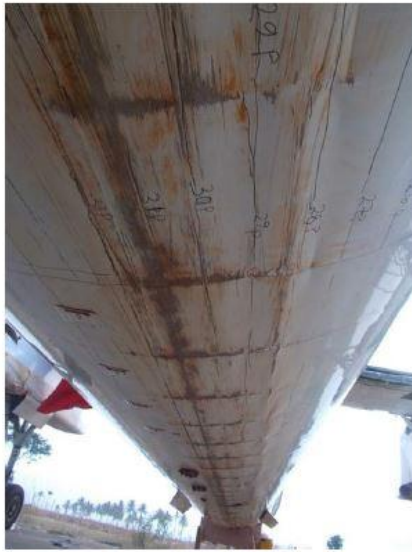
Looking AFT

Extensive skin abrasion
Damage to skin, frames and stringers

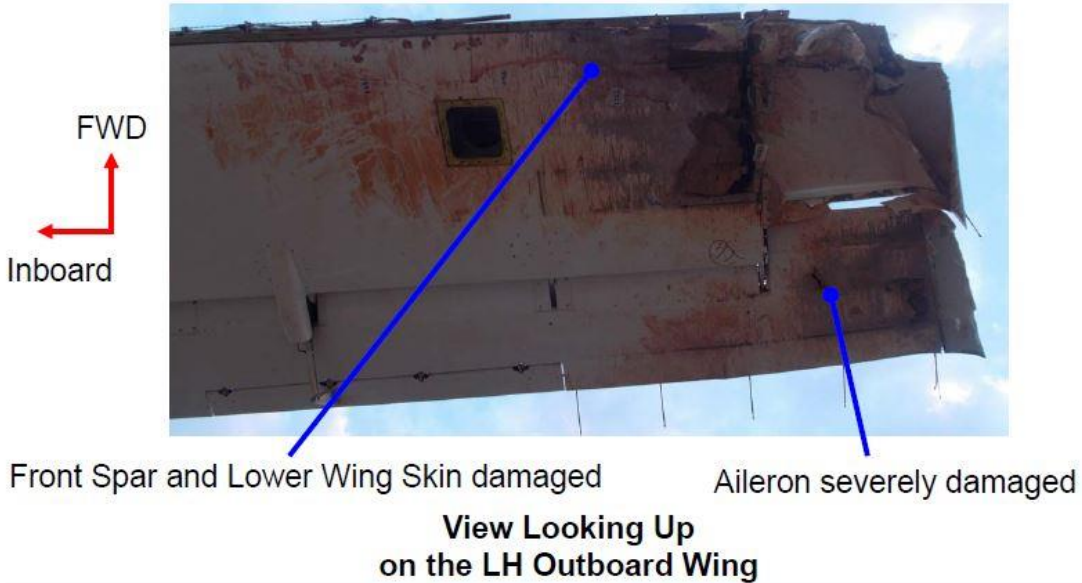
Wing – LHS Overview

- LH Wing OUTBD end damaged, all Left Wing Static Dischargers damaged and warping on all fuel tank access panels
- LH aileron damaged.
- LH inboard flap damaged
- LH flap track OUTBD fairings damaged, Dent on LHS Wing INBD Flap bottom section.

- A section of the bottom wing skin, spar, and stringers is missing. Buckles evident on the outer bay of upper wing skin panel (Buckles in wing skin remained even after aircraft was lifted)

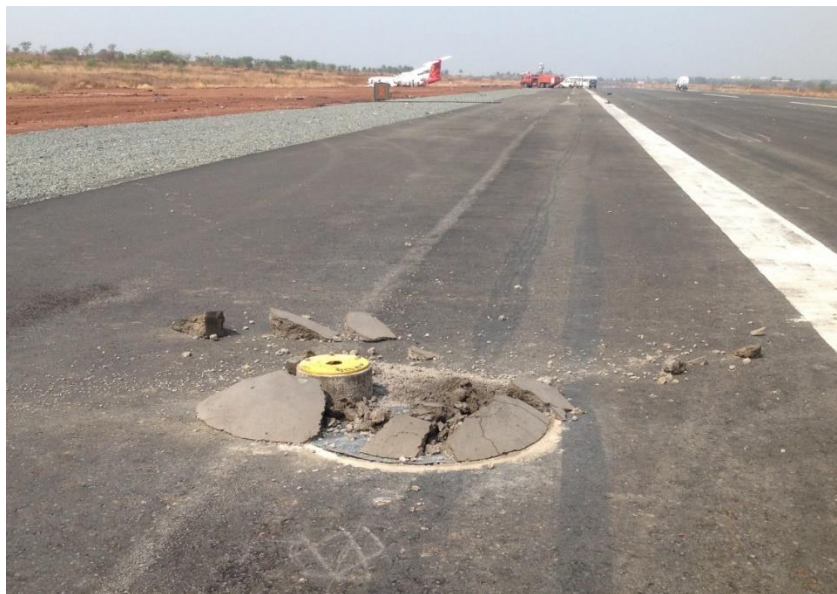
1.4 **Other damage:** 01 runway light was broken and aircraft belly skid marks were observed on the runway.

LH Gear Point of Impact with the runway lights

After the accident, the involved edge light assembly was examined and it was observed that the metal portion of the assembly which is not frangible, was not buried in the ground. Metal portion was temporarily chamfered with the cement and no concrete was used. This kind of arrangement of runway edge light was not as per DGCA requirements.

As the left main wheel hit the light, the frangible portion collapsed as per the design, however the metal portion which was not concealed with the cement impacted the gear. As the speed of the aircraft at the time of impact was around 80 knots the impact was strong and it caused the main left landing gear lock mechanism to unlock and the left landing gear retracted, and eventually resulted into the accident.

1. DGCA may advise AAI to carry out one time exercise to check and address presence of all non-frangible objects within the runway strip as per provision contained in DGCA rules and regulations.
2. Operations department of M/s Spice jet airlines to issue necessary guidelines for use of standard callouts during conduct of flight especially during marginal weather conditions.
3. DGCA to advise all operators to align their policies and guidelines in accordance with latest regulations & requirements.

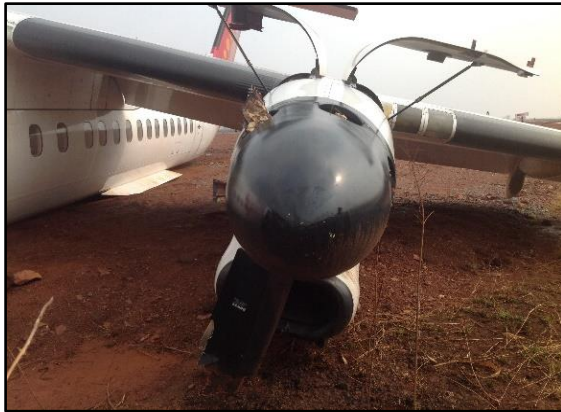
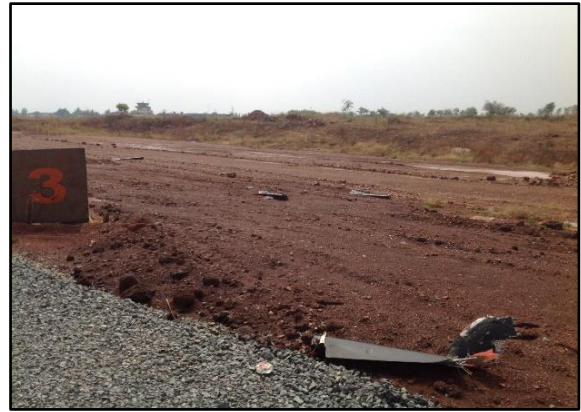
As per the evidences collected at the crash site, the aircraft landed slightly ahead of the aiming point and left to the centre line of the runway at a distance 399 m from the threshold. After travelling for about 841 meter from the threshold the aircraft overrun the runway edge light no. 56. After the impact with the runway

light, the left main landing gear collapsed. As the gear collapsed the left propeller came in contact with the runway surface at around 902 m from the threshold and all the five propeller blades sheared off from the root attachment. The area of the propeller strike marks was about 40 feet long, with approximately 2 feet between marks broken pieces of the propeller were found on the left side of the runway.

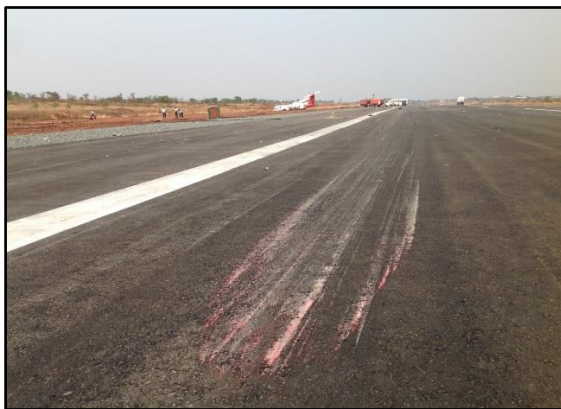
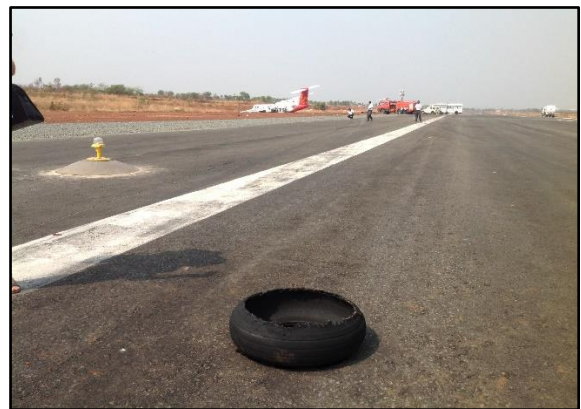
Thereafter the PIC manoeuvred the aircraft back on the runway however the nose wheel tyre failed under over load conditions and the nose landing gear collapsed and the aircraft belly came in contact with the runway surface. The nose wheel of the aircraft was found on the runway at a distance 955 m from the threshold.

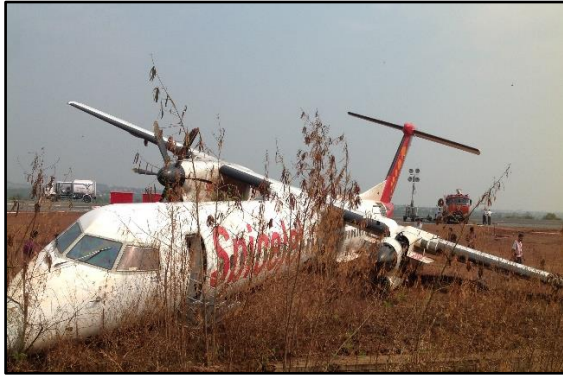
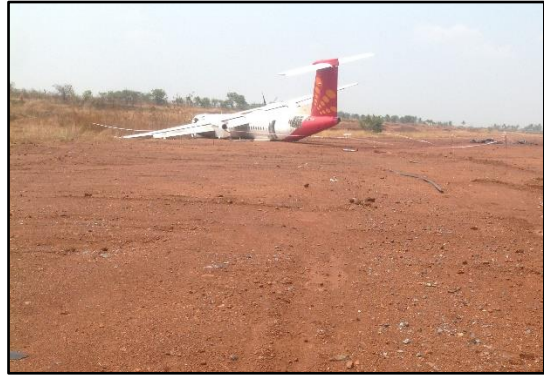
With no directional control on the aircraft the aircraft veered to the left on the soft ground and stopped at round 52 meters away from the runway centre line.

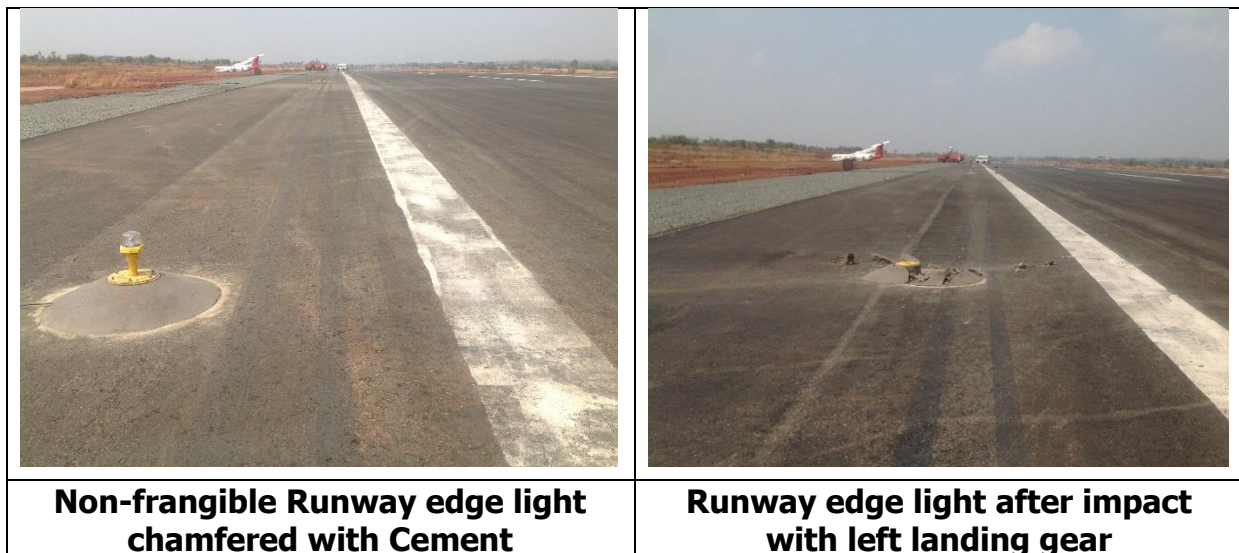
- q) During examination of runway edge light, it was observed that the metal portion of the assembly which is not frangible, was not buried in the ground. Metal portion was temporarily chamfered with the cement and no concrete was used. This kind of arrangement of runway edge light was not as per DGCA requirements.

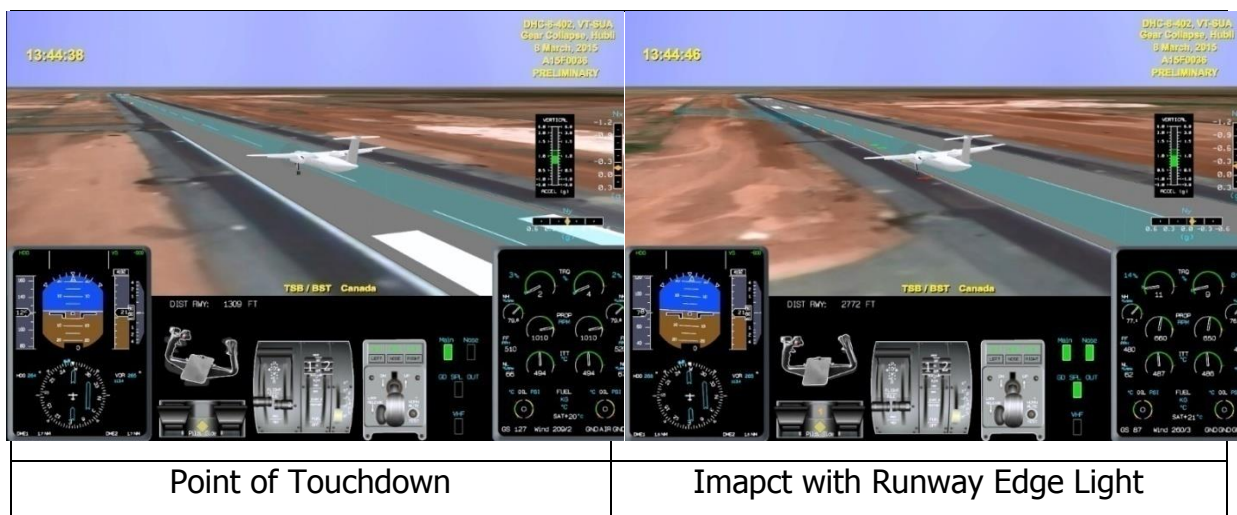
DFDR analysis revealed that the aircraft landed at time 13:44:38 UTC. The aircraft landed slightly left of the centre line and both the power levers were staggered. The left power lever was at 26 degrees and the right was at 11 degrees and the right aileron input was 3.3 degrees. One second later the left lever had gone to reverse with only -2% for two seconds only however the right lever remained at disc.

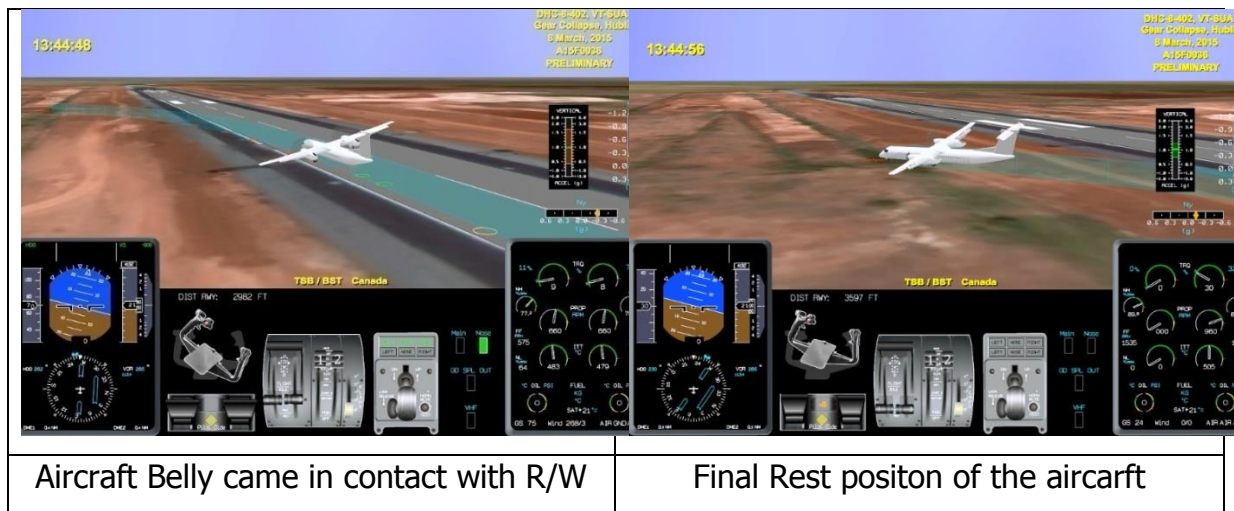
Though the PIC had stated that he selected full reverse on both the engines does not match with the DFDR analysis and is incorrect. Further the PIC has mentioned that he tried to maintain the aircraft on the centerline, however DFDR analysis revealed that there was no rudder input by the PIC to control the aircraft from veering towards the left. As per the DFDR only right aileron inputs were given to steer the aircraft to the right which was ineffective to control the aircraft at that speed. The aircraft veered off the runway and the left landing gear hit the runway edge light and caused the main landing gear to collapse. Subsequently the nose gear also collapsed and the aircraft was uncontrollable and it exited the runway on the left and finally came to halt around 52 meters from the center line of the runway.
