FINAL ACCIDENT INVESTIGATION REPORT ON ACCIDENT TO
M/s SWAJAS AIR CHARTERS LTD., BELL 407 HELICOPTER
VT- SWA ON 19-06-2011 AT LADPUR, DEHRADUN

M/s Swajas Air Charters Ltd., Bell 407 Helicopter VT- SWA while flying from Jolly Grant Airport, Dehradun to Sehestra dhara Helipad crashed at Ladpur, Sunderwala Jungles, Dehradun on 19-06-2011 at 0854 UTC. The Helicopter was under command of Single Pilot with One (01) passenger (Aircraft Maintenance Engineer). Both pilot and passenger received injuries in the accident. There was no pre or post impact fire.

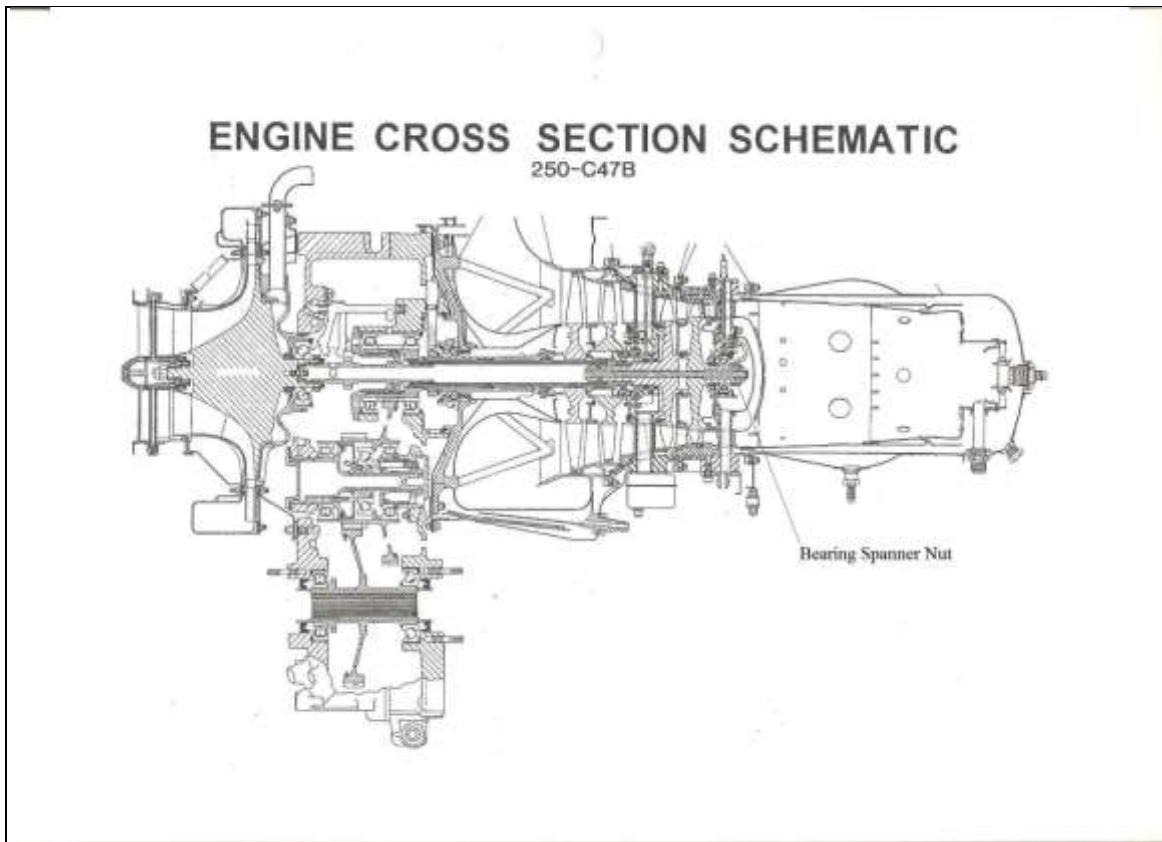
The turbine section of the engine incorporates a two-stage gas producer turbine and a two-stage power turbine. Power to drive the compressor rotor and gas producer gear train is provided by the gas producer turbine rotor. The power turbine rotor develops the power which drives the power turbine gear train and helicopter rotor system. The turbine rotor assemblies are not mechanically coupled, but they are gas coupled i.e. exhaust gases flow through the four turbines. The turbine rotor stages are numbered 1 through 4, with the 1st stage at rear and the 4th stage at the front. There are nine main bearings numbered 1 through 8 in a front to rear direction.

The gas producer turbine rotor consists of the 1st and 2nd stage wheels, tie bolt, and tie bolt nut. The No. 8 bearing and rotating part of its labyrinth seal are retained on the bearing shaft by a spanner nut. The #8 bearing provides both radial and axial support for the gas generator turbine rotor. In addition to providing radial support, the bearing resists the forward thrust being generated by the 1st and 2nd stage turbine wheels. The gas producer turbine rotor are radially supported and axially retained.

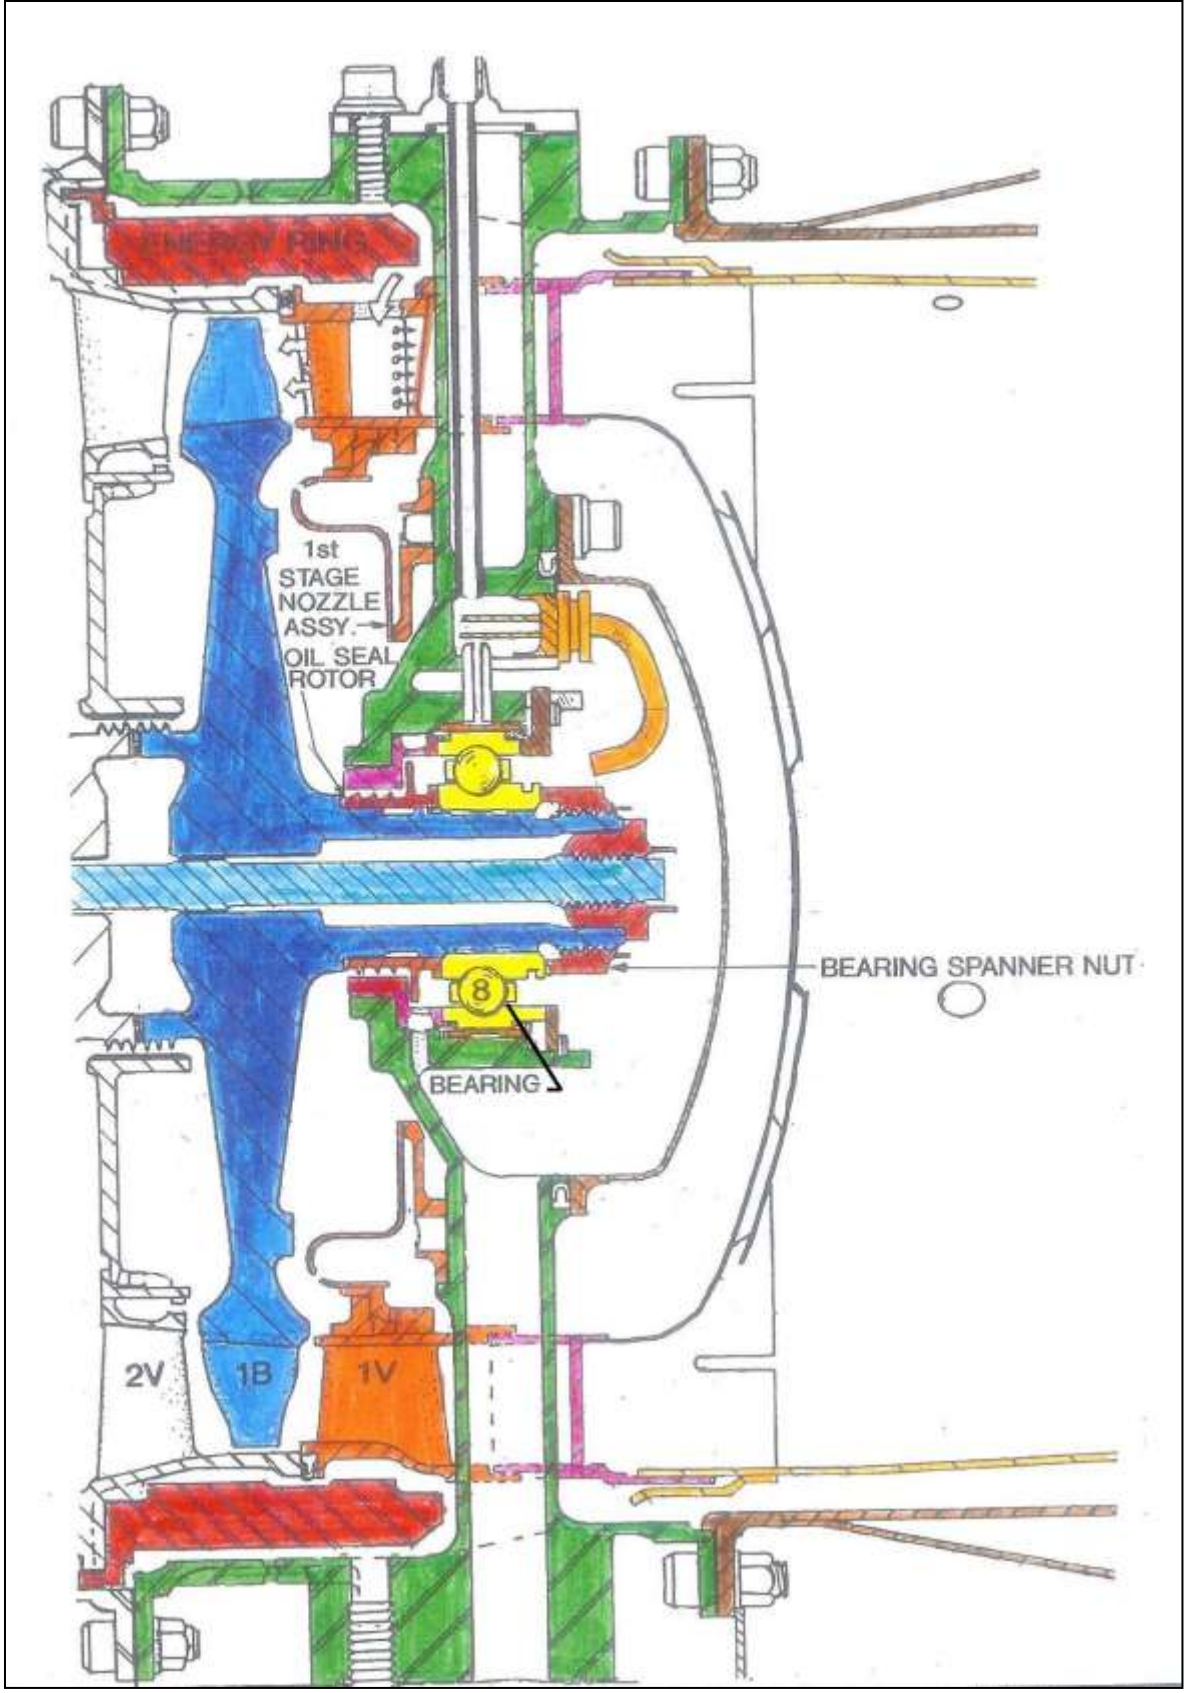
During tear down inspection at Rolls Royce anomaly with the dimpling of the #8 bearing spanner nut was found. Locking of the spanner nut at assembly is accomplished by deforming a section of the ring on the aft nut inward into one of three slots machined in the aft end of the first stage wheel stub shaft. As designed, the dimple is meant to engage with a flat on the 1st stage turbine stub shaft; however the dimple was not engaged with the flat and the nut appeared to have backed off.

Engineering analysis indicates that probably # 8 bearing spanner nut back off due to improper dimple during installation. **The locking dimple on nut was not properly engaged to the locking flat on the turbine stub shaft, allowing the nut to back off during engine operation.** The forward displacement of the gas generator turbine resulted in rub damage to the 2nd stage turbine wheel web area and stub shaft, consequently reducing the cross-sectional area, allowing the shaft to separate from the turbine disk. When the turbine disk separated from the stub shaft, the load on the 2nd stage turbine wheel being lost, an overspeed burst of the 2nd stage turbine wheel occurred.

The Overhaul life of Engine is 2000 hrs. and Inspection of #8 bearing spanner nut can be performed during overhaul.

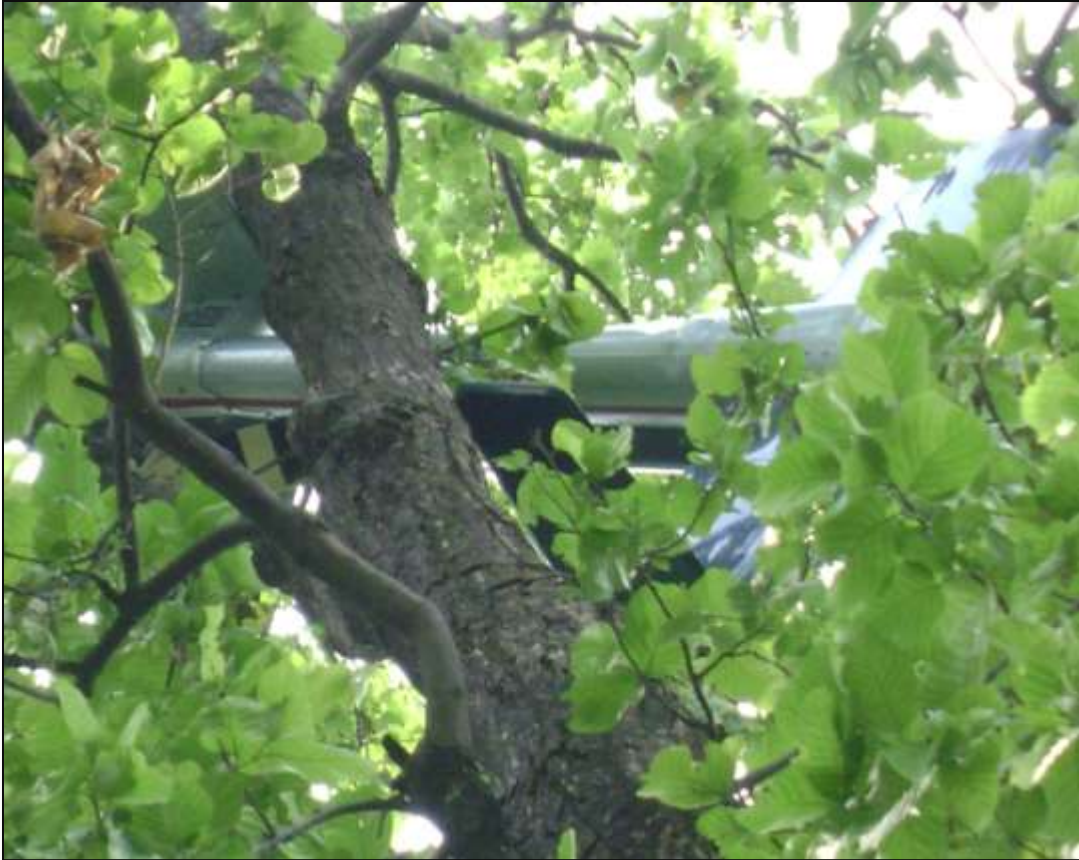
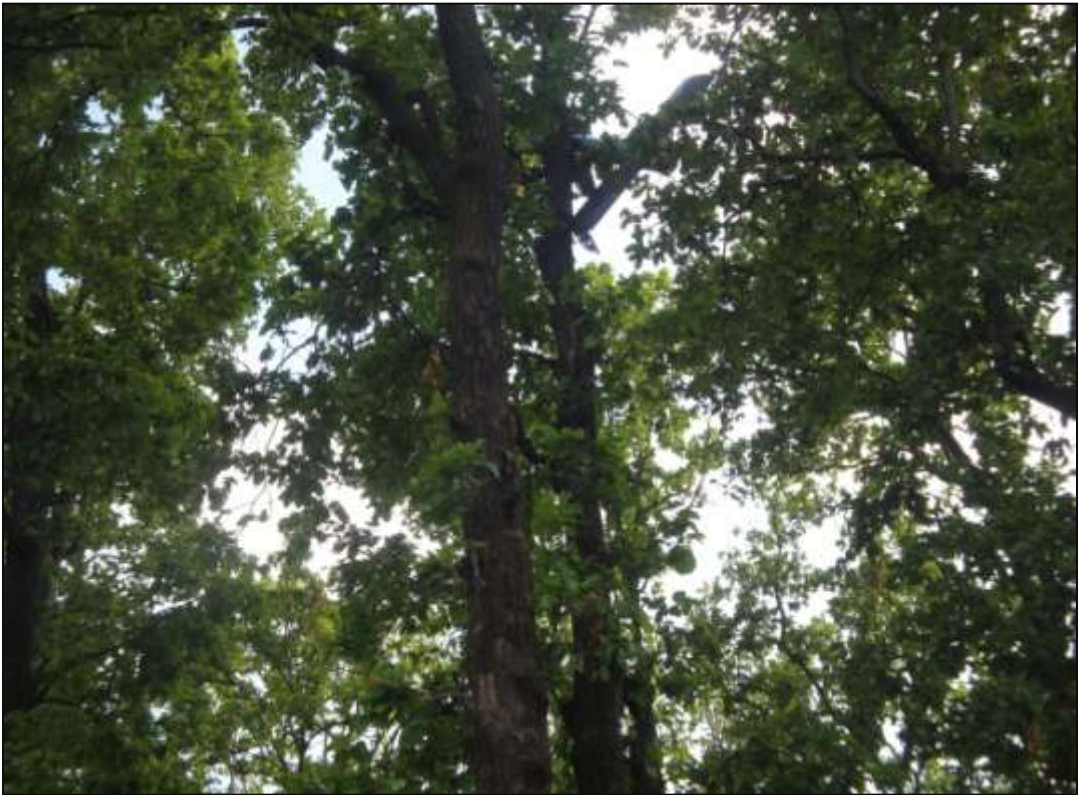
The helicopter impacted high trees & tail boom of the helicopter broke down. The fuselage of Helicopter impacted ground on the skid & toppled to left. Further toppling of helicopter was restricted by trees. Tail boom along with the tail rotor was found hanging on the top of trees. All four Main rotor blades were broken into two pieces and were found near the wreckage. Main rotor hub, swash plate support, Transmission, controls was deformed and broken. Fuel tank, door, windshields, both skids, collective control stick

Tailboom & Tailrotor hanging on tree

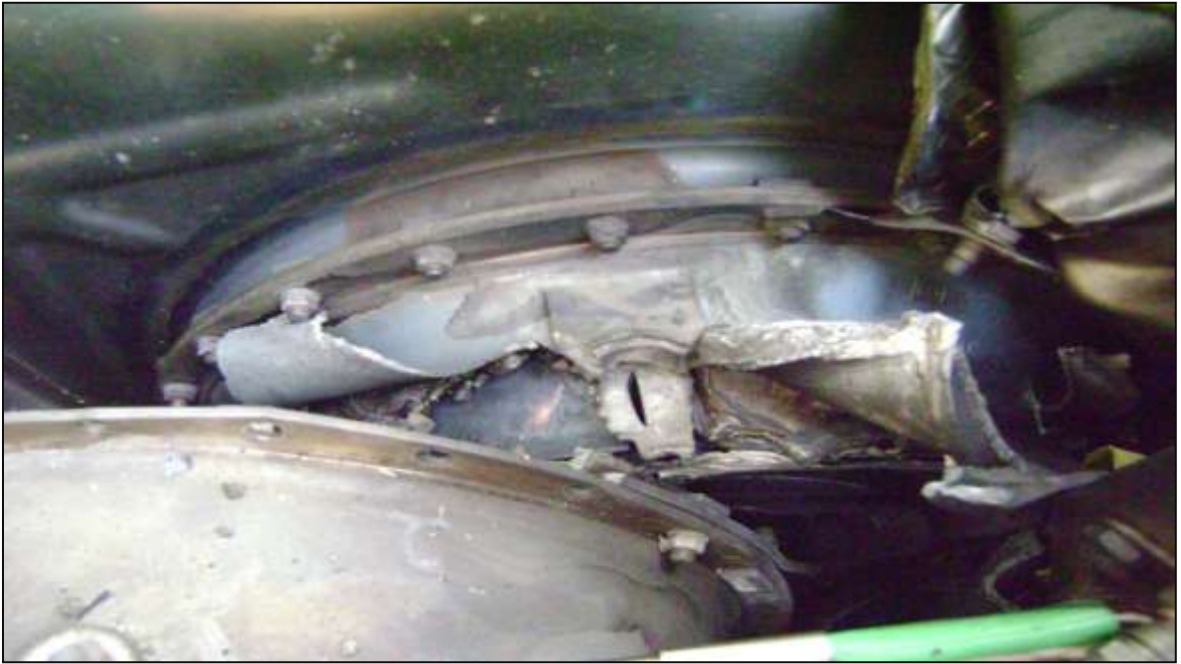
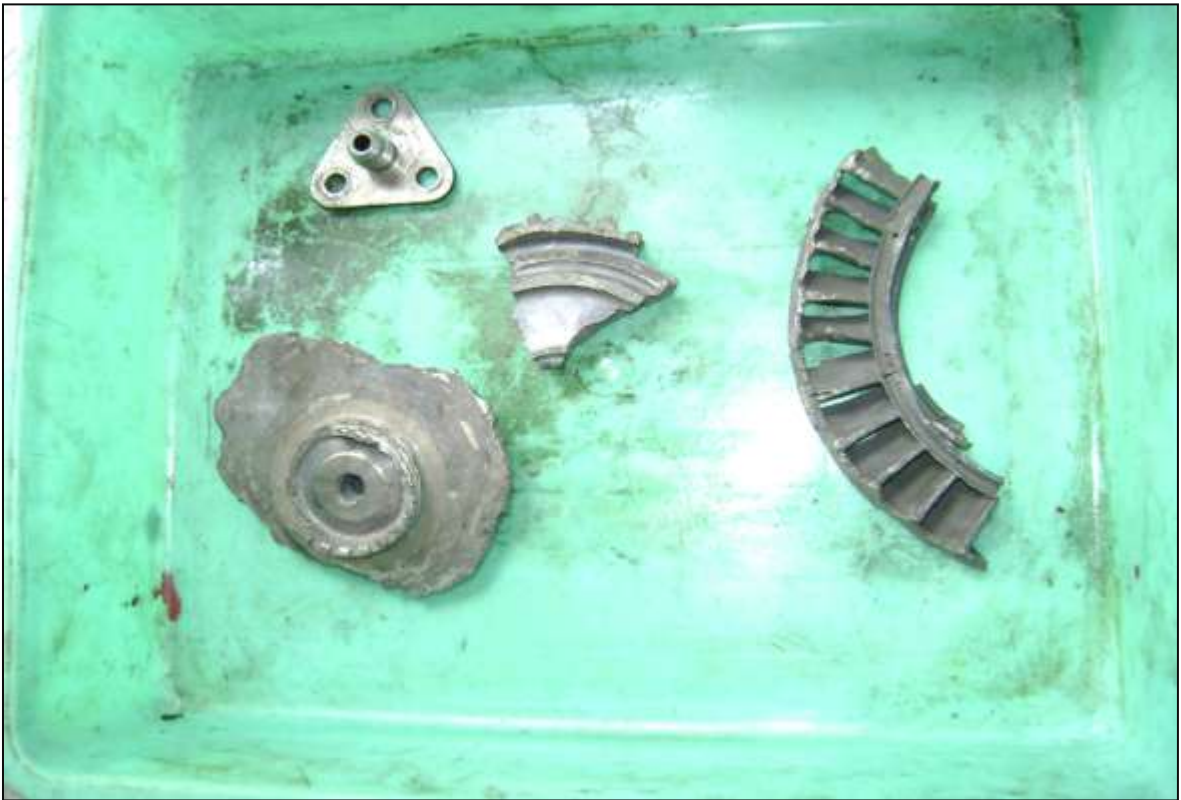
The forward displacement of the gas generator turbine resulted in rub damage to the 2nd stage turbine wheel web area and stub shaft, consequently reducing the cross-sectional area, allowing the shaft to separate from the turbine disk. When the turbine disk separated from the stub shaft, the load on the 2nd stage turbine wheel being lost, an overspeed burst of the 2nd stage turbine wheel occurred.

During investigation, it was found that the gas generator turbine and engine casing around the Turbine Stage No. 2 was found damage. Failure analysis reveals that the #8 bearing spanner nut moved, allowing 2nd stage turbine wheel to separate from shaft and resulted into over speed burst of 2nd stage turbine wheel.

Failed 2nd Stage Turbine
