FINAL INVESTIGATION REPORT ON FATAL
ACCIDENT TO ZENAIR STOL CH 701
MICROLIGHT AIRCRAFT VT-USO BELONGING TO
TWO STAKEHOLDERS AT BEGURKOLI, COORG
DISTRICT ON 02.05.2015

Capt. Pavan Varma
Member, Committee of Inquiry VT-USO

K Ramachandran
Air Safety Officer, AAIB
Chairman, Committee of Inquiry VT-USO

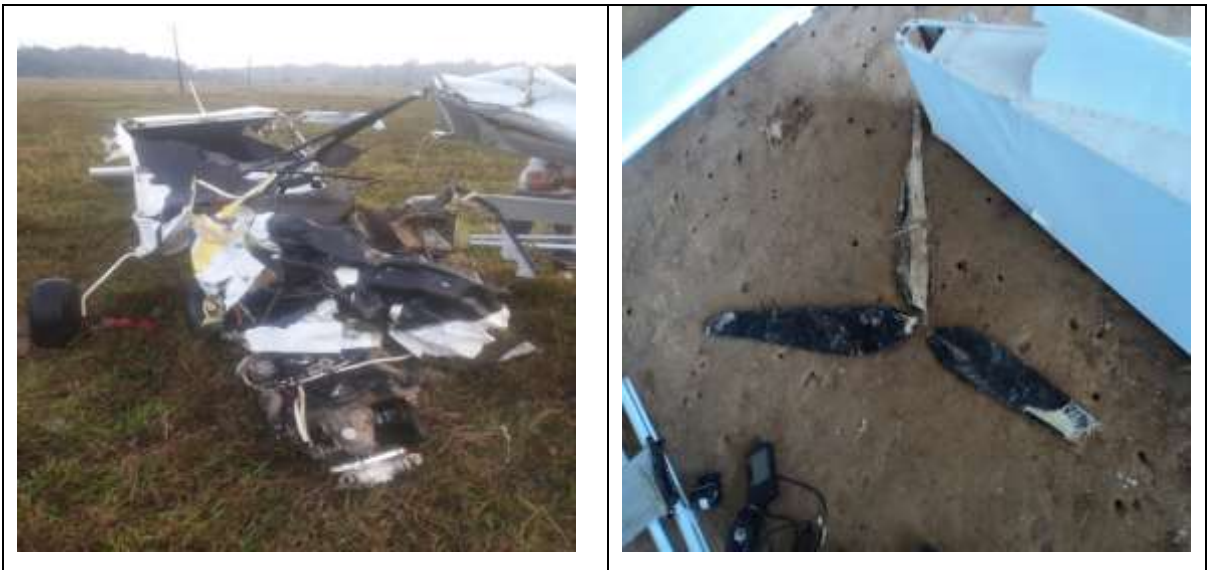
1. The nose and the front portion of the cockpit were completely destroyed.

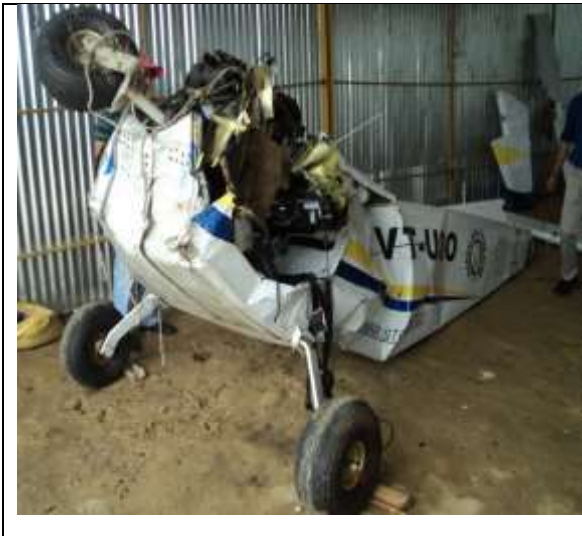
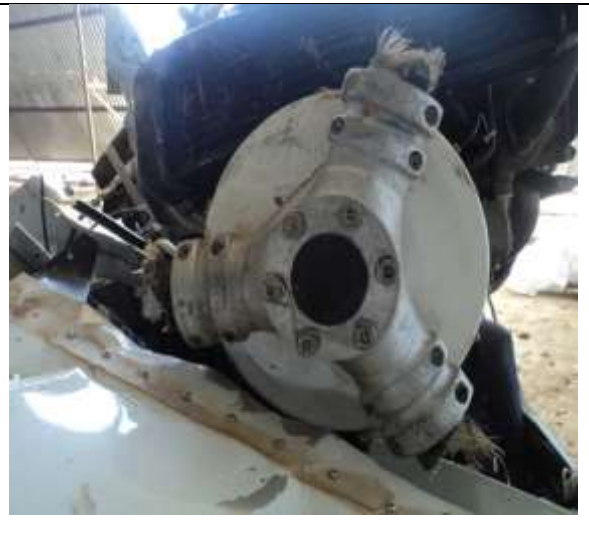
2. The cockpit windshields were found crushed.
3. All the 03 propeller blades were sheared off from the hub and found delaminated into two halves.

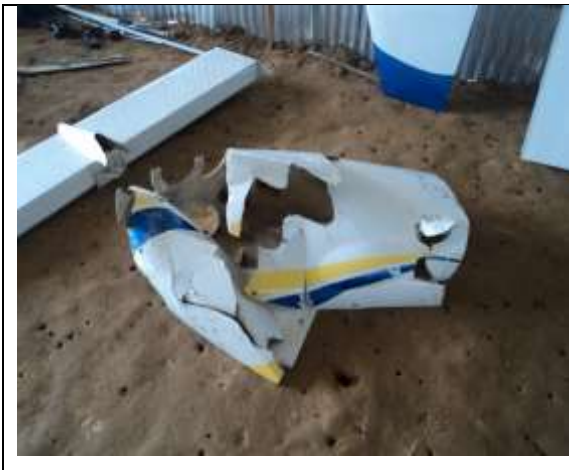
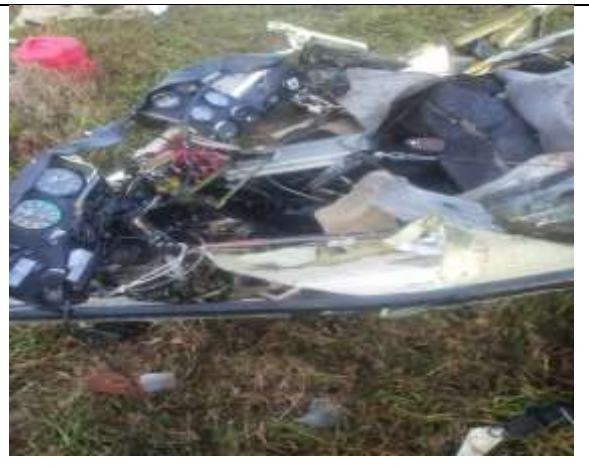
4. The engine was found intact with its mounting, however its base was found partially disengaged from airframe.

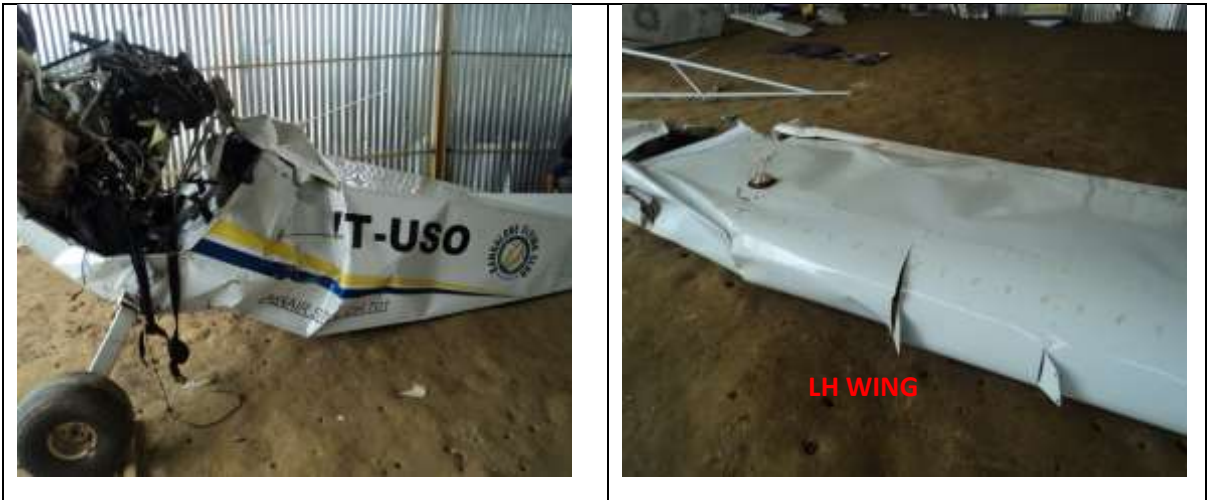
5. The engine cowling was damaged and found disengaged from the airframe.
6. The cockpit instrument panel was substantially damaged.
7. The front portion of the fuselage was found compressed due high impact with ground.

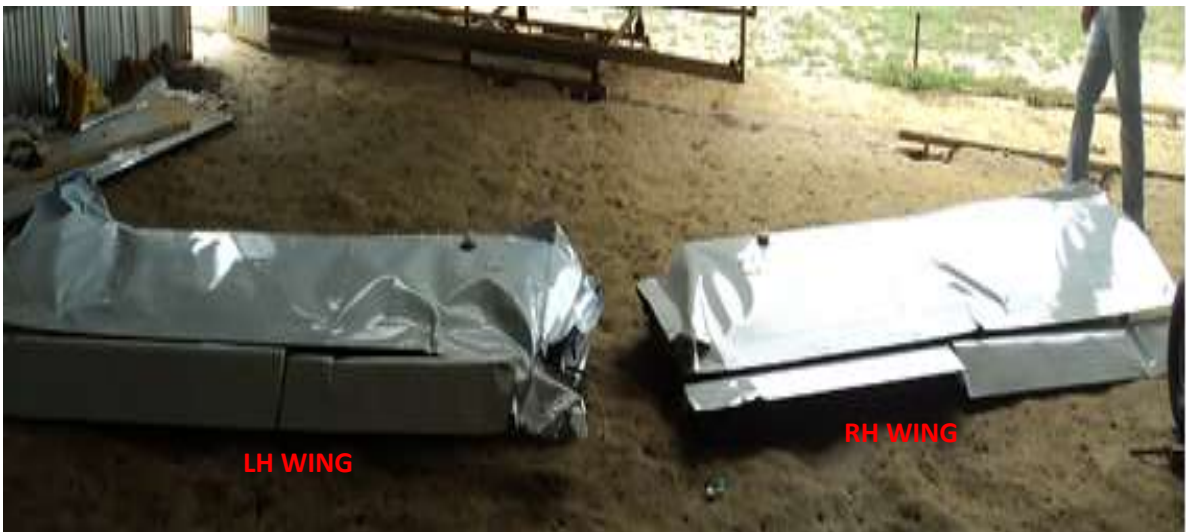
8. Many dents and wrinkles were found at various locations along the length of the fuselage.
9. Many dents and wrinkles were observed along the span of the LH and RH wing.
10. The LH wing sustained more damages. The tip section of the LH wing was found crushed.
11. The leading edge of both the wings was found teared at various span wise locations.
12. The LH inboard flap was found disengaged from root section.

13. The nose landing gear strut was found damaged and bent towards right.
14. The nose landing gear wheel was jammed due to impact with ground.
15. No damages were observed on vertical and horizontal tails.

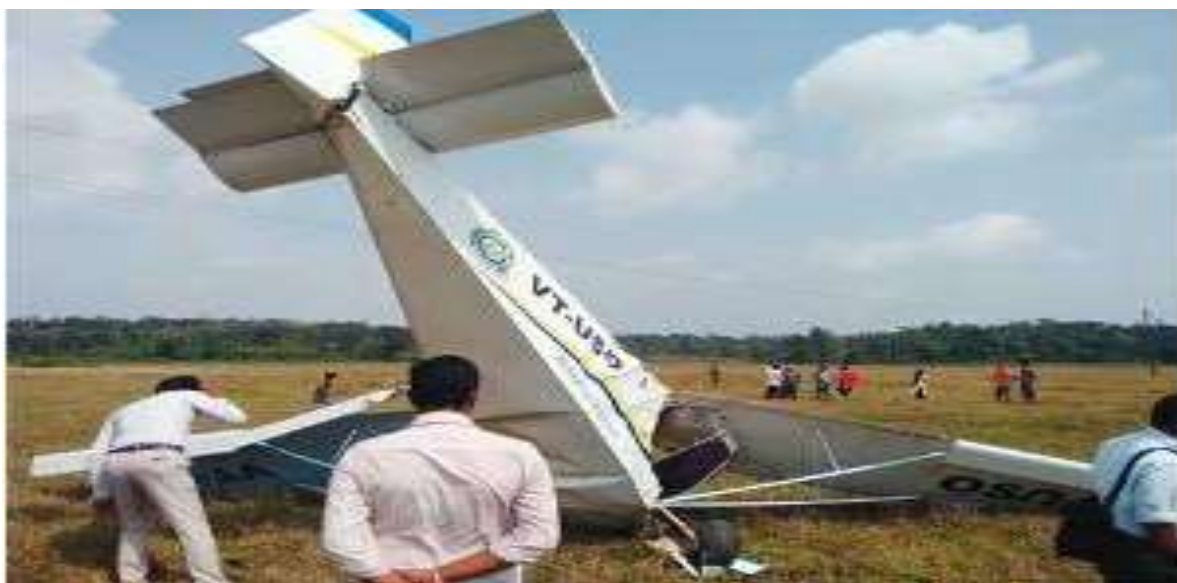
The pilot after making delayed touchdown on grass strip subsequently initiated go around and took-off. During take-off it climbed to about 40 to 50 feet at a steep angle when it suddenly lost lift turned left and impacted ground on its nose. The final resting position of microlight wreckage (Point of Impact with ground) was at a radial distance of 167 meters from runway 31 end. The microlight was resting on its nose into the soft ground with tail up. There was no evidence of disintegration of any part of the microlight in air.

Final position of the microlight wreckage resting on its nose with tail up.

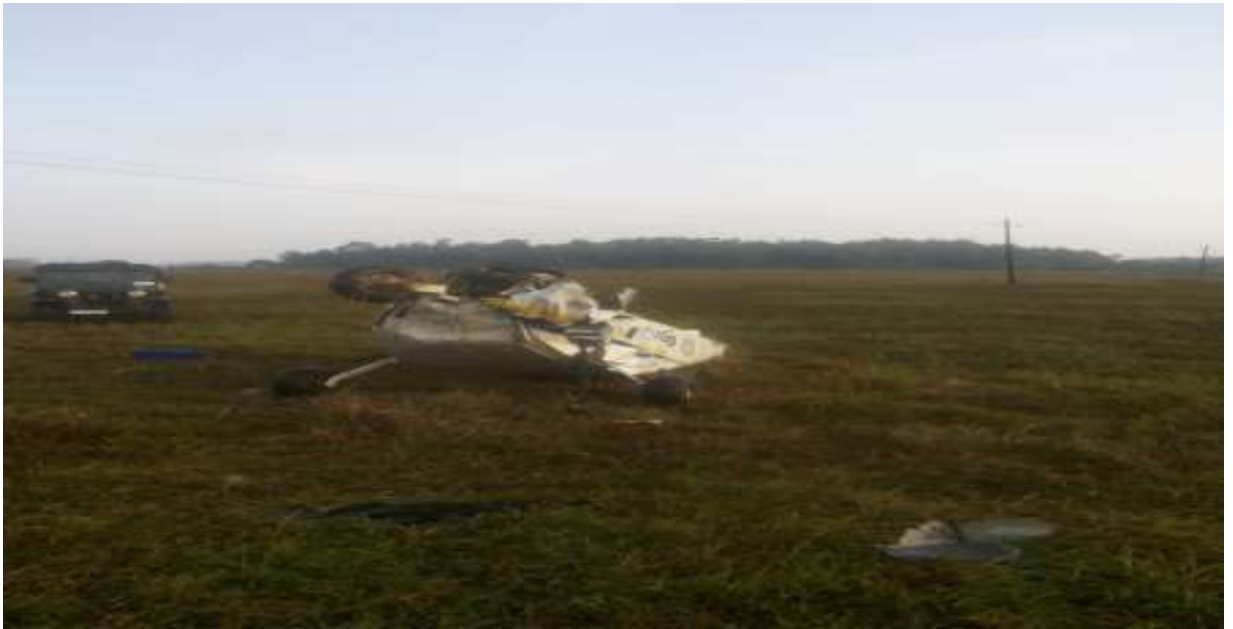
1. Before shifting the wreckage both the wings along with horizontal and vertical tails were dismantled from the microlight wreckage. The doors were also removed.

Wings along with Vertical & Horizontal Tails removed before shifting the wreckage.

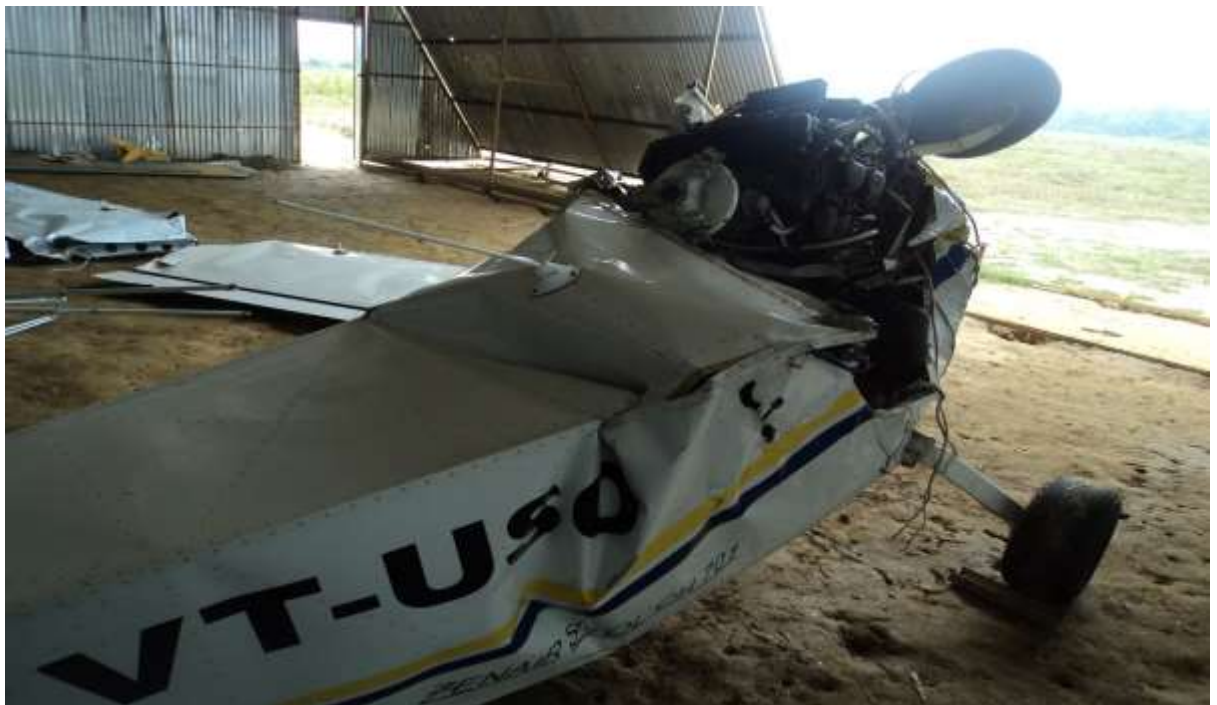
2. The nose portion and front panel of the cockpit were compressed and crushed due microlight heavily impacting the ground on its nose. The fuselage front portion was also compressed due high impact and in many places the skin was found teared.

3. The engine along with nose portion was found resting on top of the fuselage, this was probably done during shifting of the wreckage.

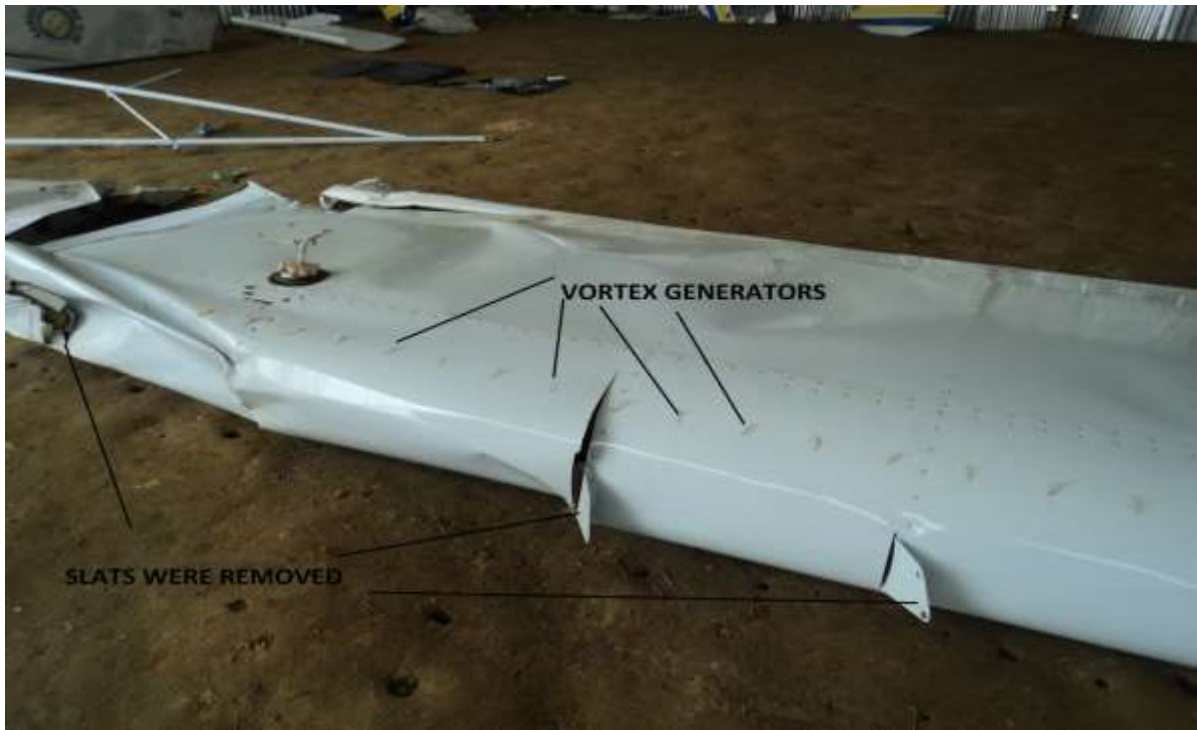
4. The Zenair STOL CH 701 microlight aircraft is equipped with fixed leading edge slats on both the wings, however on examining the wreckage both the slats were found missing and its attachment brackets were found bent due impact.
5. Small vortex generators were found installed at various positions all along the span of the wing.

The Zenair STOL CH 701 microlight aircraft is installed with fixed full span leading edge slats on both the wings, however on examining the wreckage both the slats were found missing and its attachment brackets were bent due impact with ground. It is therefore quite evident that the slats were removed earlier and the pilot was flying the microlight without slats. It was also observed that the slats were replaced by Vortex Generators and were fixed all along the wing span at various positions. The removal of slats hampers the performance of the microlight aircraft especially during take-off and landing. It drastically reduces the stalling angle of attack and increases the stalling speed thereby diminishing the STOL capability of the microlight.

11. The pilot was flying the microlight without the leading edge slats.
12. The slats were replaced by number of small Vortex Generators placed at various positions all along the wing span.

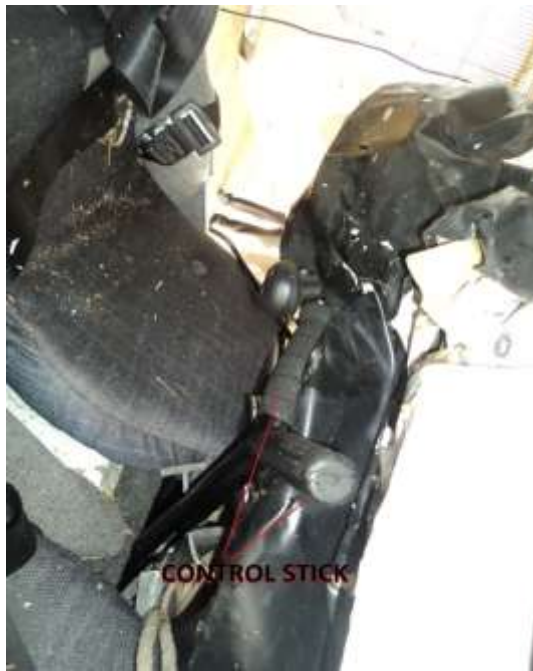
6. Since the wings and the tail plane were dismantled, the serviceability of the control surfaces could not be established. However the continuity of the control cables were checked by operation of pedals and flaps and found intact.
7. The control stick was bent and jammed due heavy impact with ground.

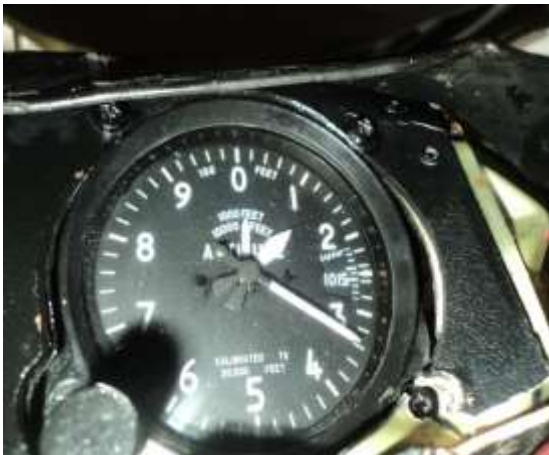
Altimeter Reading

9. Few of the instruments were intact with the panel. Instrument readings were taken, the needle of air speed indicator was pointing at 0 (zero) and the Altimeter reading was showing approx. 133 feet (1015 milibar).
