**FINAL INVESTIGATION REPORT ON ACCIDENT TO M/S ARYAN AVIATION
AGUSTA 109 C HELICOPTER VT-VKS AT RANCHI AIRPORT ON 09.05.2012**

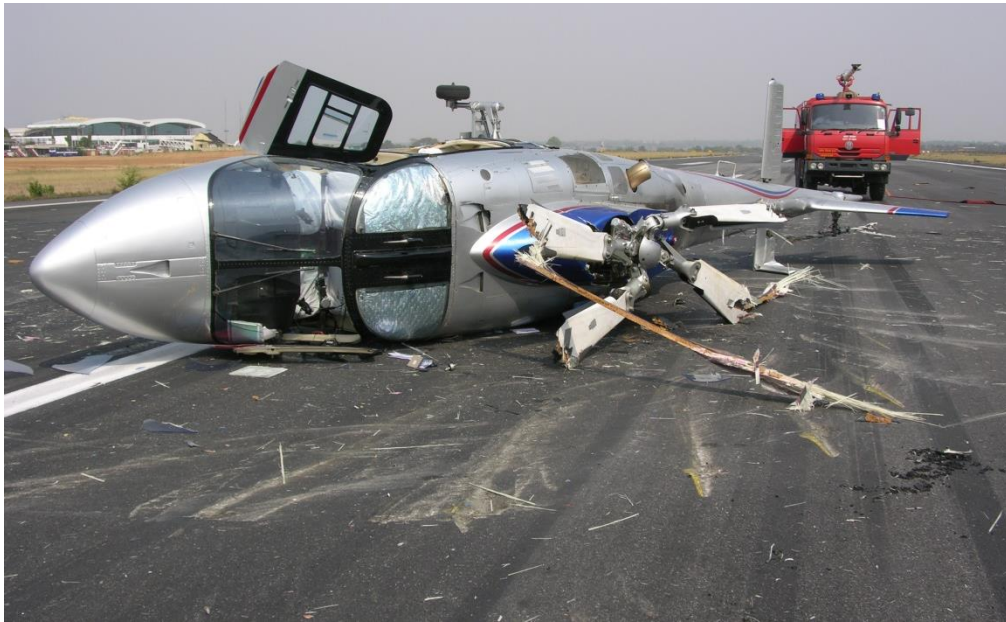
The helicopter was substantially damaged due impact and post impact rotor striking the runway surface.

Figure 1. Final position of the crashed helicopter

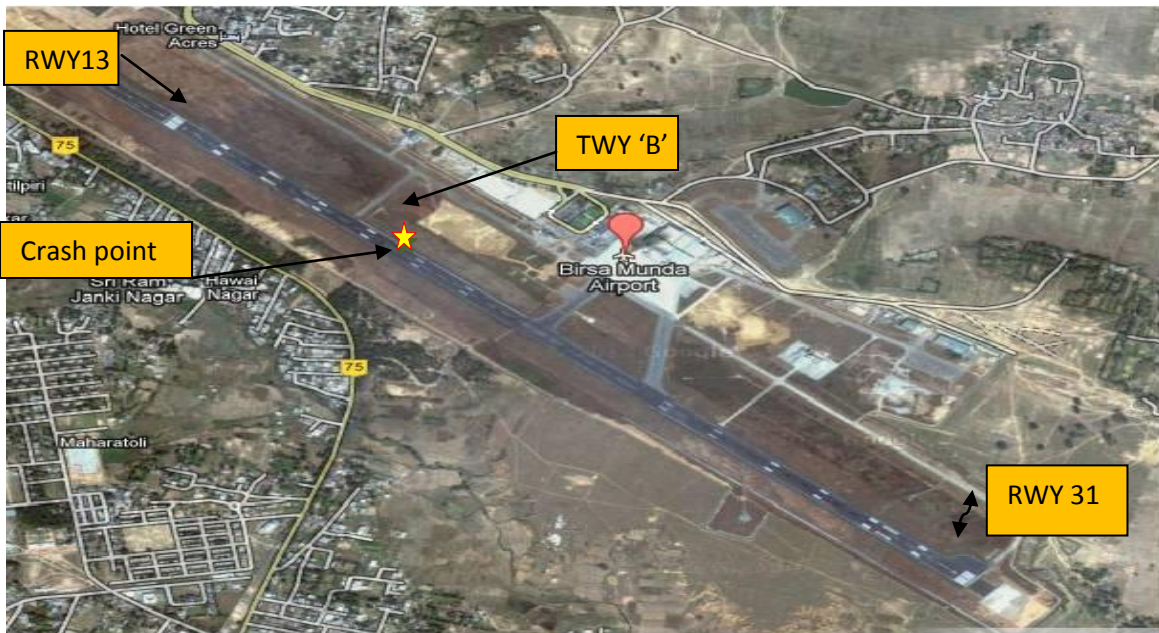
1.12.1 The helicopter crashed on active runway while attempting a low forward speed emergency landing. It turned through 540 deg approx on short finals and impacted the runway. Left undercarriage hit the surface and the helicopter topple on the same side. The helicopter thereafter rotated viciously through 360 deg approx and came to rest. The MR blades impacted the runway while in rotation and broke into pieces that got scattered around the main wreckage. The wreckage remained localised within the width of the runway.

Fig.2 Crash/Impact point and location of wreckage on Runway

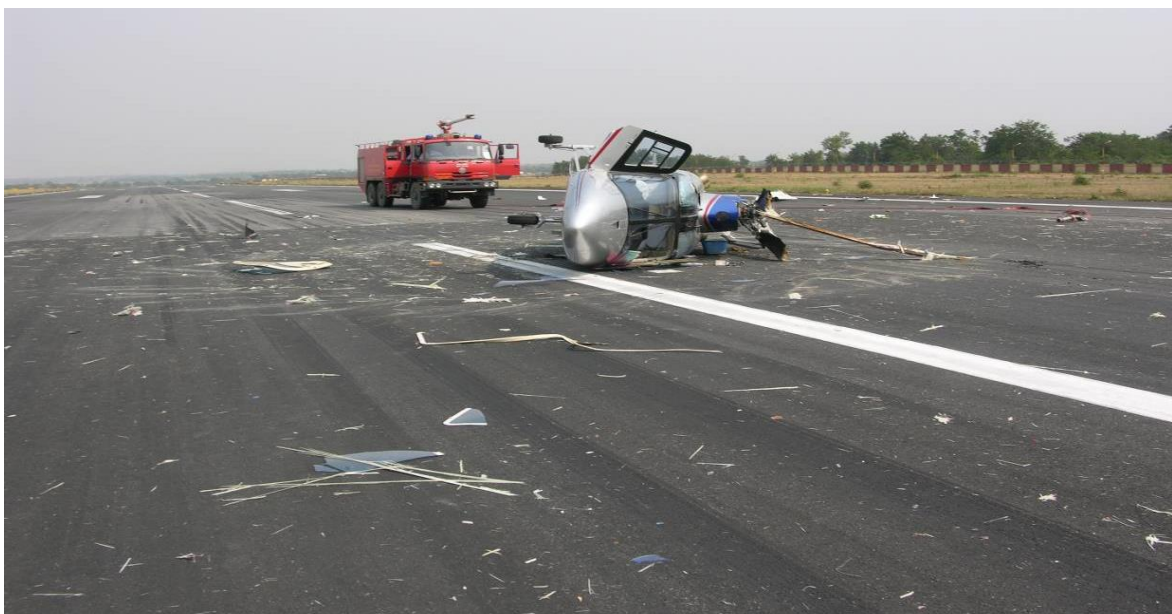
- The Main Rotor blades impacted runway surface several times and broke into pieces that got scattered around the main wreckage.
- Tail Rotor blades got shredded & delaminated.
- Tail Boom skin got damaged at a few places.
- The Left Main landing gear got pierced through the body structure.
- The left side of the cockpit got deformed.
- The Pilot & Co-pilot seats had come off their attachment points in the cabin floor.
- The cabin window Plexiglass panels were broken.
- Right side Passenger door jettisoned.
- Co-pilot side door damaged and seized.
- Tail fin damaged.
- LH horizontal stabilizer broken at mid-section.
- MGB fairing broken.

Fig. 3 MR blade marks, scattered pieces of blades & other broken parts.

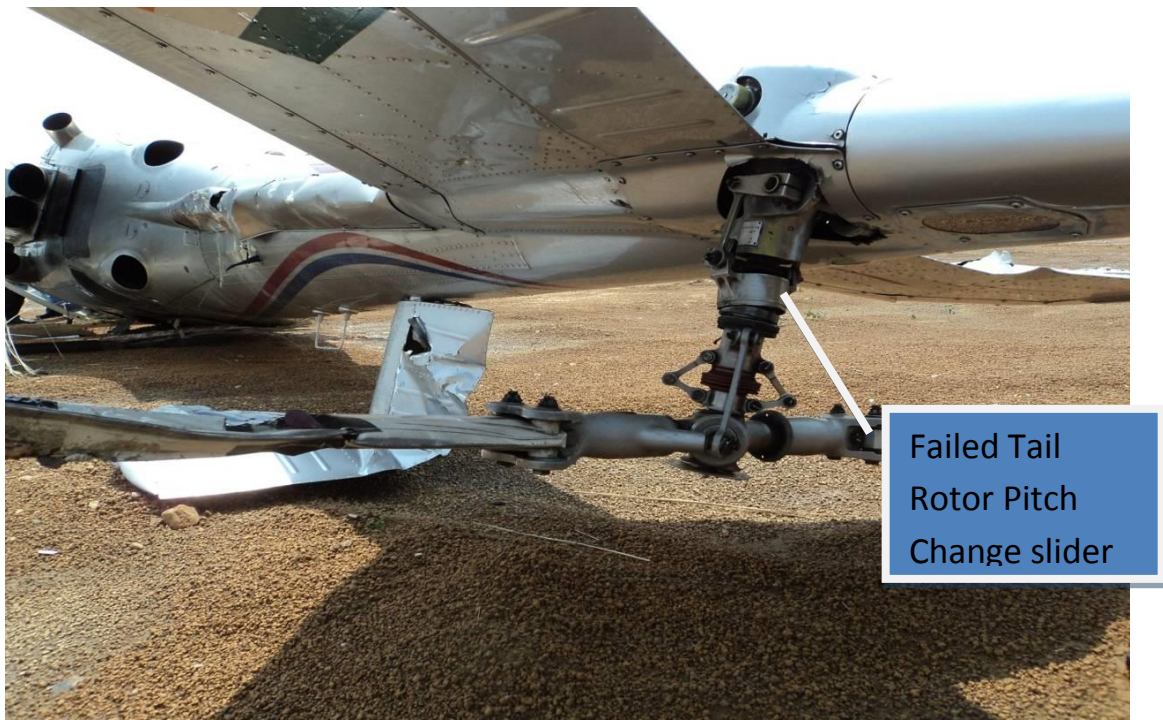
Fig.4 Failed Tail Rotor Pitch Change slider

- i) No grease was available inside the bearing support Sleeve.
- j) All pitch change links and their bush bearings were intact.
- k) The Teflon sleeve inside the pitch change slider had burnt down to fine black powder.

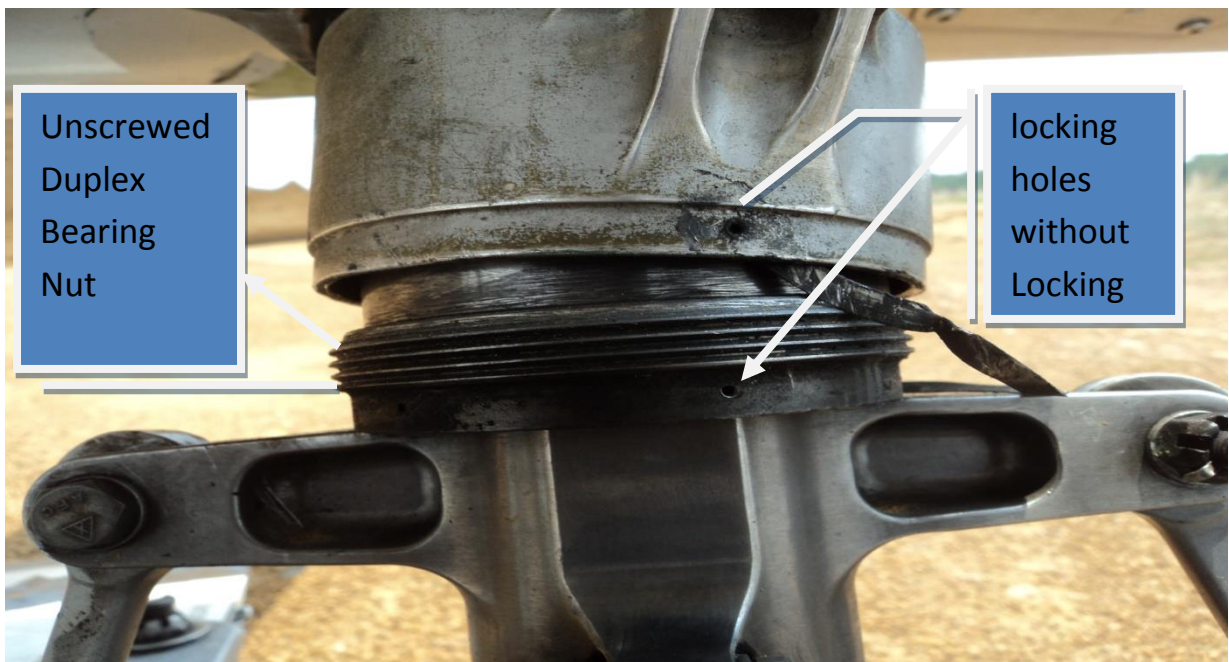
Fig.5 Unscrewed Duplex Bearing Nut & its locking holes without Locking wire

- e) There was no trace of the Safety locking wires on either side of the Duplex Bearing Support Sleeve for securing and preventing Ring Nut from loosening/ threading out.
- f) Position of Inner Races of the bearings indicated that the Duplex Bearings had been assembled correctly during last 600hr/6month servicing conducted on 22.01.2012.

2.1.9 There were no visible signs at the locking wire holes of the Duplex Support Sleeve (housing) and the Ring Nut to suggest the presence of locking wire before originating the accident flight. It is evident that the Ring Nut had not been wire locked during last servicing and remained undetected till the post accident inspection. The AME who signed the Duplicate

3.2.1 The accident was caused due to the malfunction of TR Pitch Control Mechanism due to unwinding of Ring Nut from Duplex Bearing Support Sleeve in absence of the locking wires.

2.1.11 In order to prevent reoccurrence of such accidents, the manufacturer, after the accident, has also advised through Revision No.15 to Temporary Revision MM 64-2, of A109C, dated 14.07.2010 that the value of torque applied to the Ring Nut be increased from 500-600 kg.cm to 1200-1300 kg.cm. Further a special “clearance checks” on Duplex Bearing and technique for applying Primer LCM-34 or 35 and Sealing compound LCM-19 during the tightening of the Ring Nut have been advised. The Safety Locking wire LCM-24 too has been replaced by LCM-36 vide the above Temporary Revision.

- increment in torque application from 500-500 Kgcm to 1200-1300 Kgcm
- Special technique for applying Primer LCM-34 or 35 & Sealing compound LCM-19 during tightening of the Ring Nut
- Use of Safety Locking wire of higher thickness viz. replacement of LCM-24 by LCM-36.

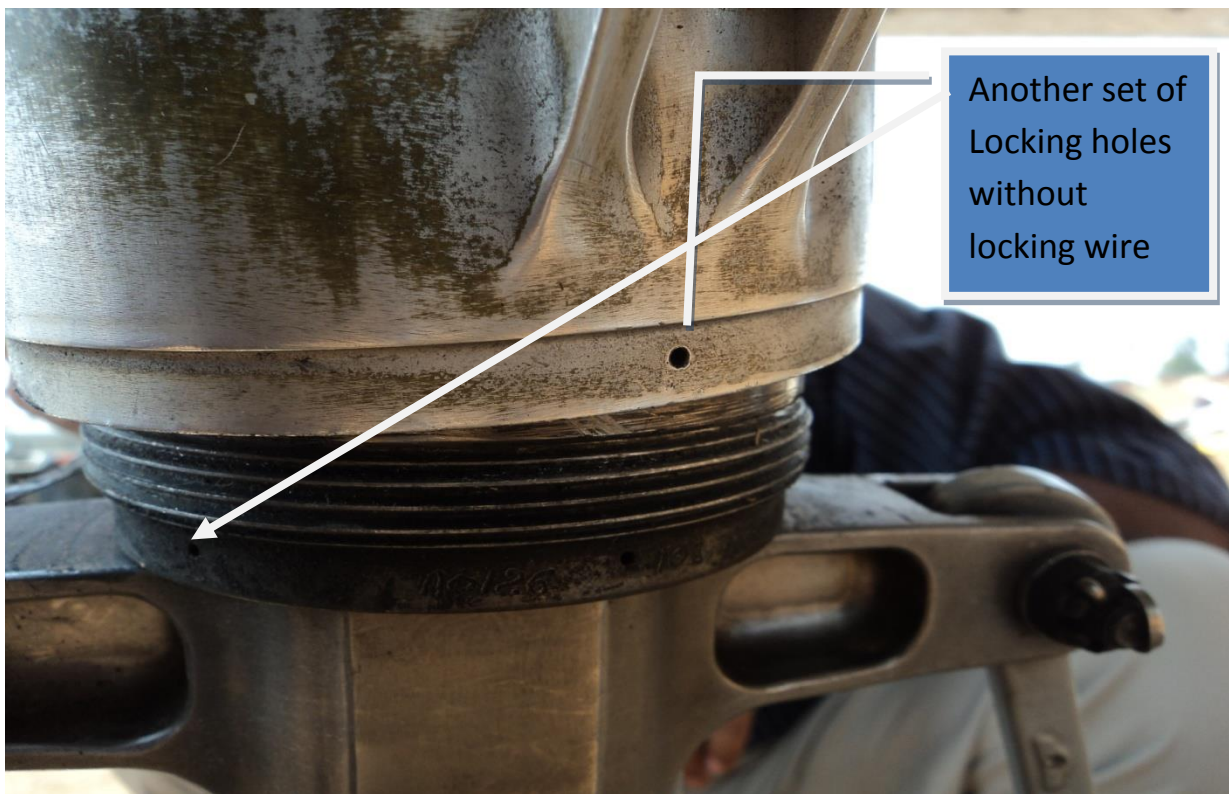
Fig. 6 Second pair of holes without locking wire.

3.1.8 Safety locking wires on either side of the Duplex Support Sleeve (housing) were found missing in TR Pitch Change Mechanism. These were not noticed till post accident inspection.

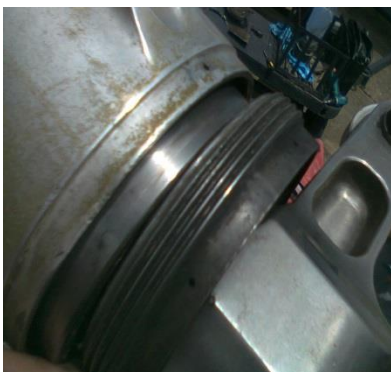
Figs.7 Dislodged Ring Nut.

- c) Fasteners and linkages were intact;
- d) Ring Nut of Duplex Bearing P/N 109-0133-05-101 had got fully dislodged from the support sleeve. One of the Outer Races of Duplex Bearing had also come out, which prevented free and full movement of Slider Sleeve for effective positive TR blade pitch change application.

2.1.8 The Ring Nut of the Duplex Bearing P/N 109-0133-05-101 Support Sleeve had got fully dislodged from the Support Sleeve (housing) along with one of the Outer Races of the Duplex Bearing, thereby preventing free and full movement of the Slider Sleeve for effective left rudder application.

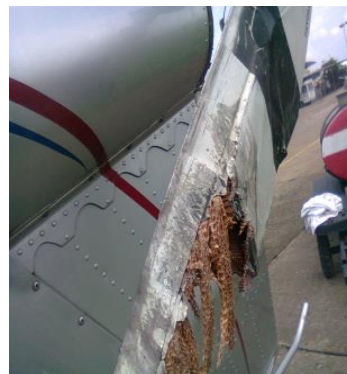
- a) The Tail Gear Box and Tail Drive Shaft were undamaged.
- b) Both Tail Rotor Blades had shredded (delaminated) due to impact.

Fig. 8 Shattered TR Blade

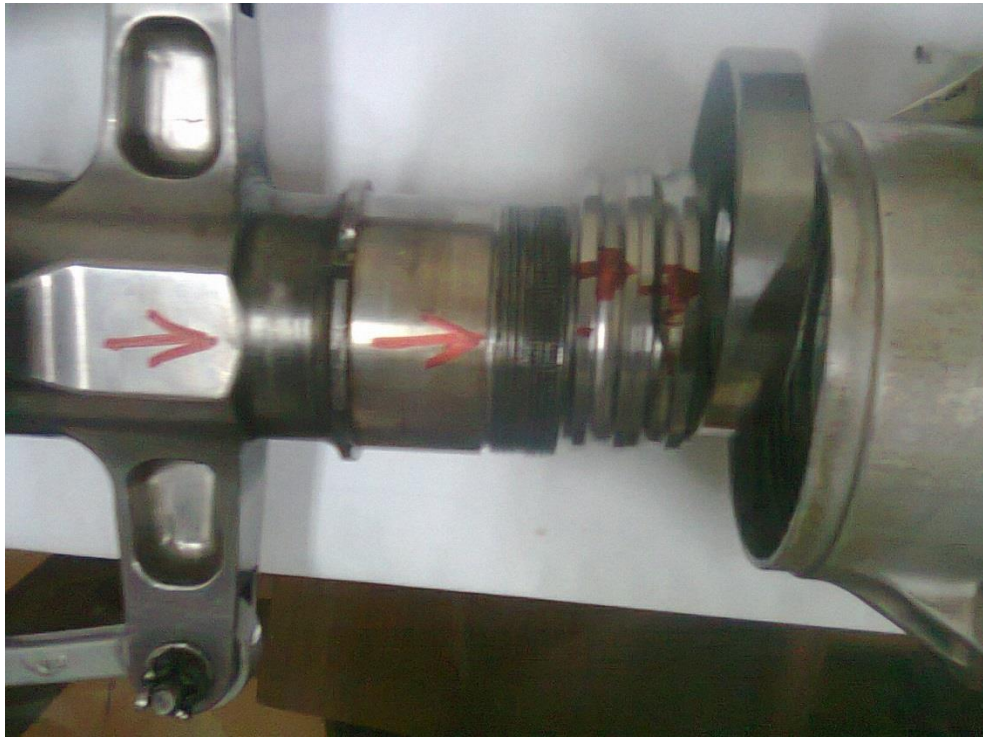
Fig. 9 Direction of inner races of Duplex Bearings

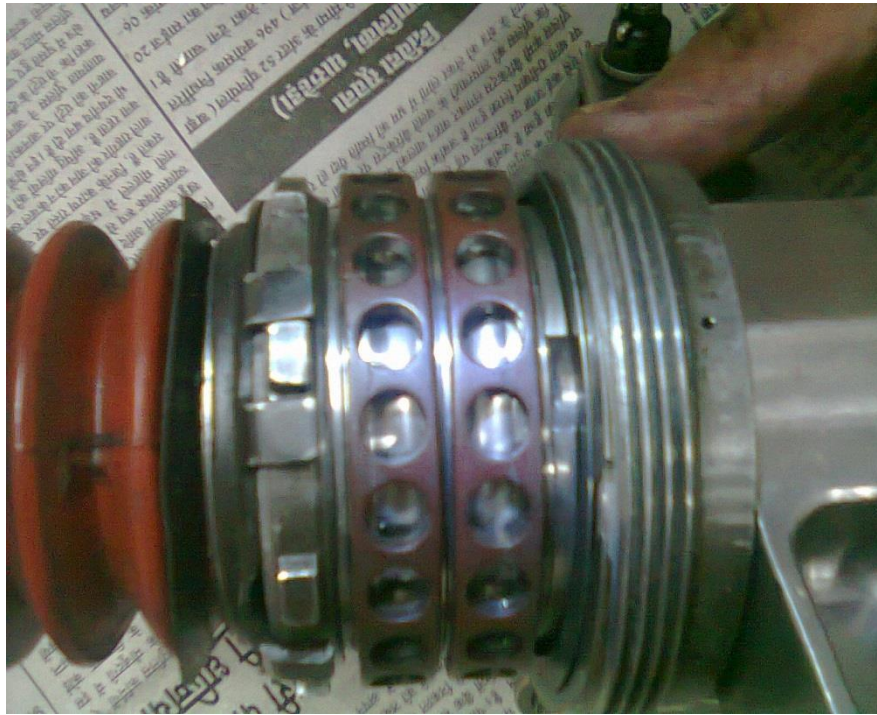
- g) Outer Race of one half of the Duplex bearing was found stuck obliquely inside the Support Sleeve.
- h) There were no signs of rubbing, pitting, corrosion or over heating on steel ball bearings.

Fig. 10. Condition of Ball Bearing Holders
