**FINAL INVESTIGATION REPORT ON SERIOUS INCIDENT**  
**TO M/s CATHAY PACIFIC LTD. BOEING B747-400**  
**AIRCRAFT REGISTRATION B-HUL AT IGI AIRPORT**  
**DELHI ON 27.07.2015**

**COMMITTEE OF INQUIRY B-HUL**

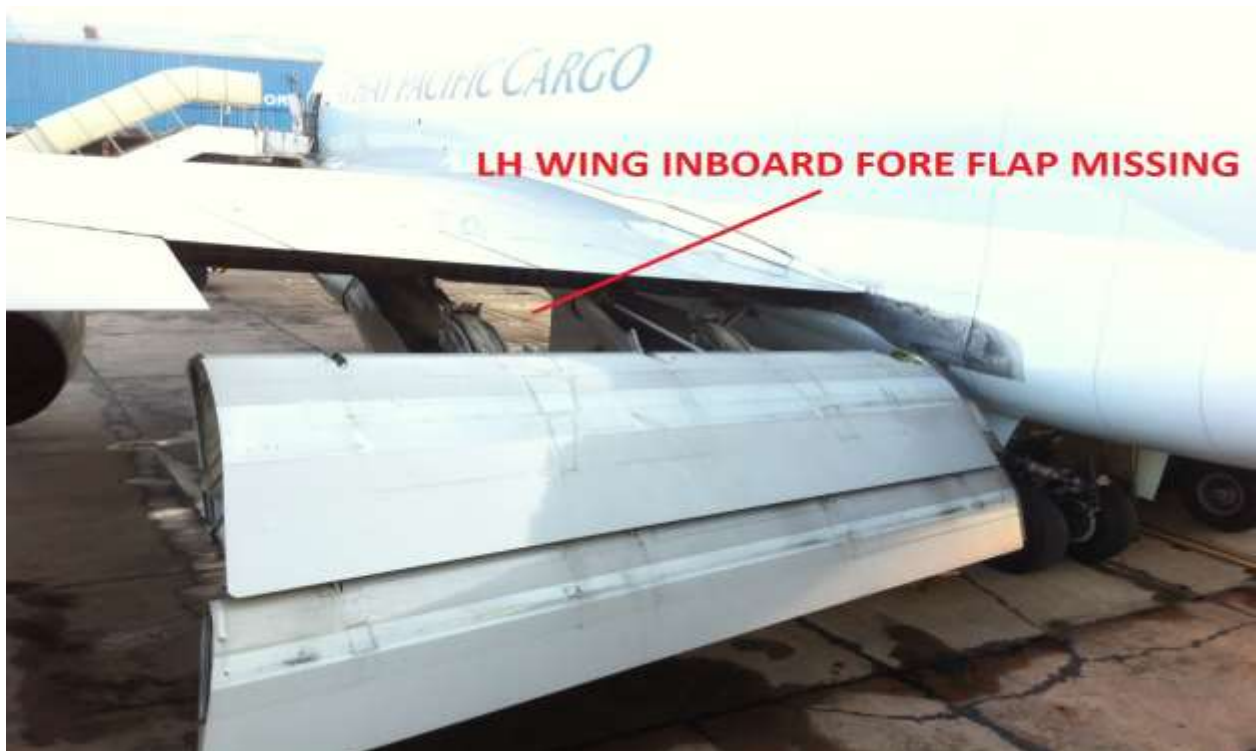
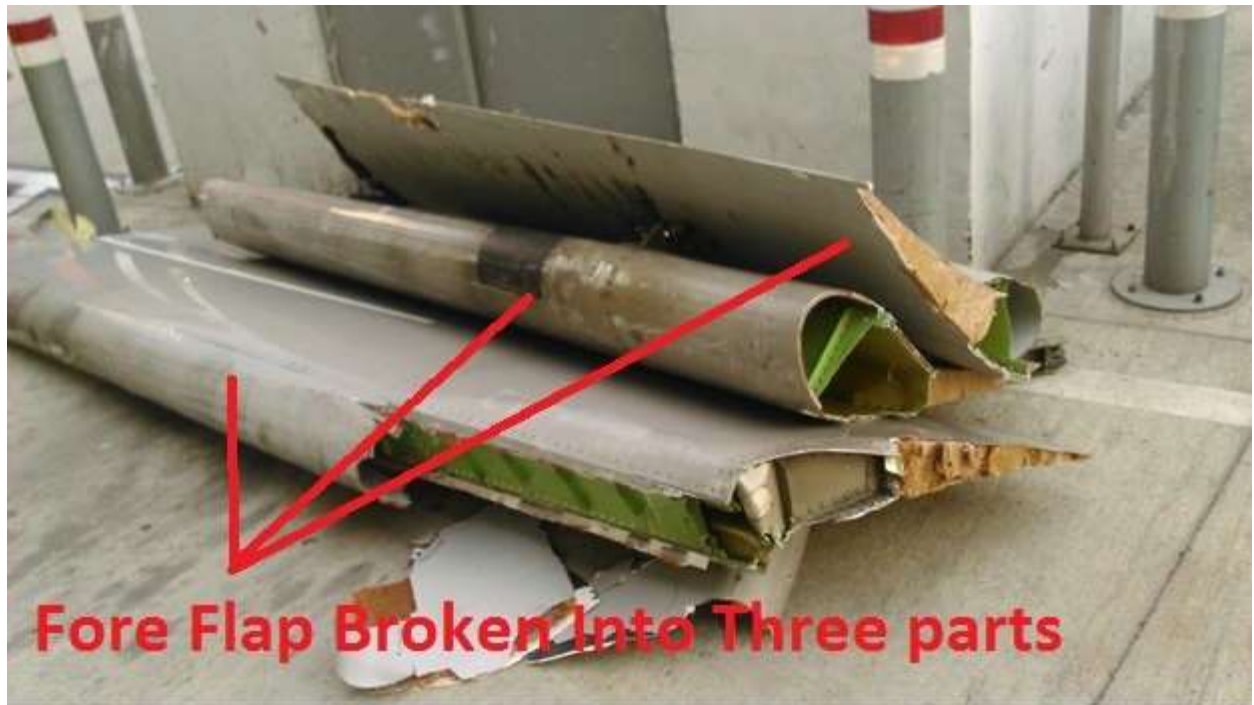
The left wing inboard trailing edge fore-flap detached from its mounting. The fore flap fell on the runway and was broken into three pieces.

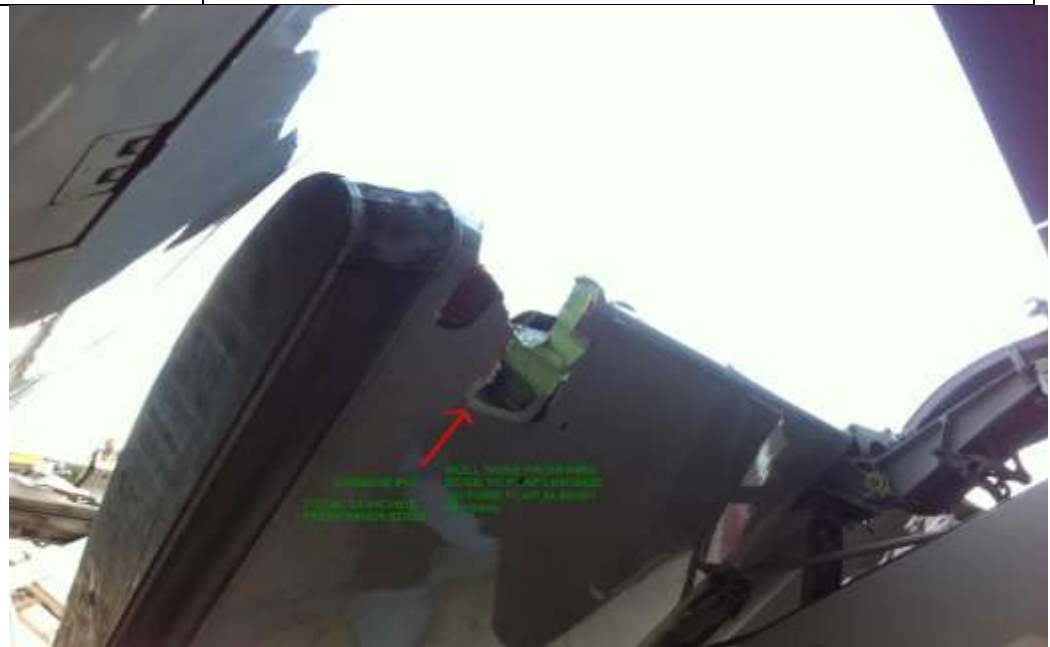
| Damage 1 | Damage 1A | Bull Nose of about 24 Inches from inboard edge was found missing. |

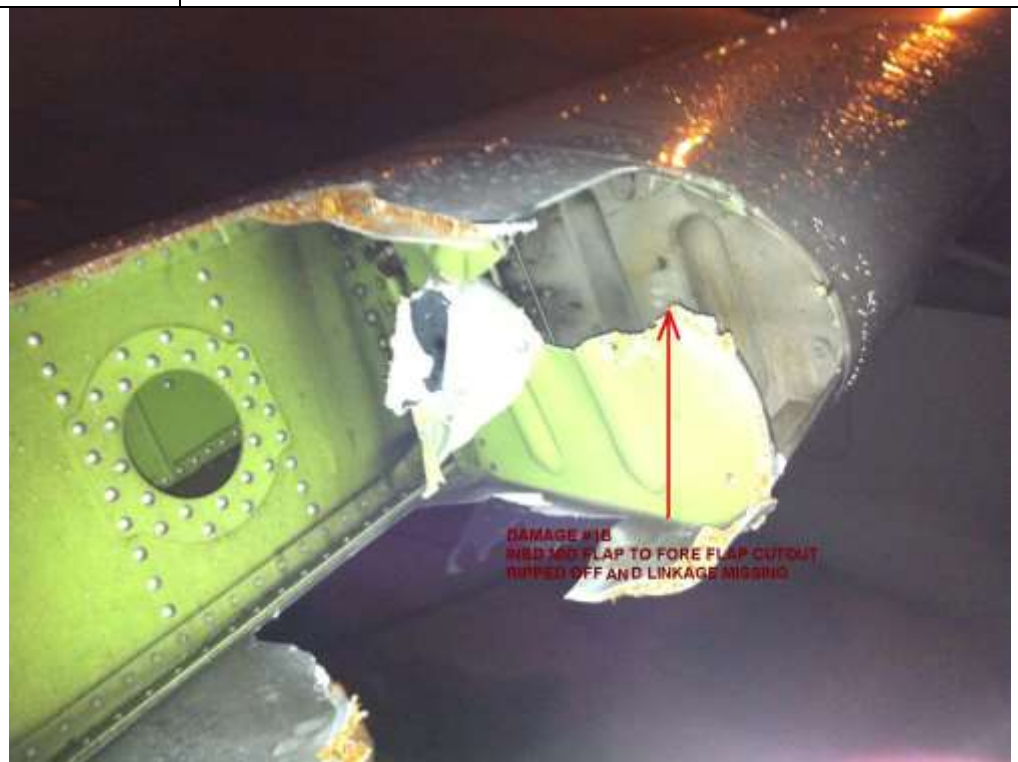
| Damage 1B | Inboard Mid Flap to foreflap Cut out was found Ripped Off. |

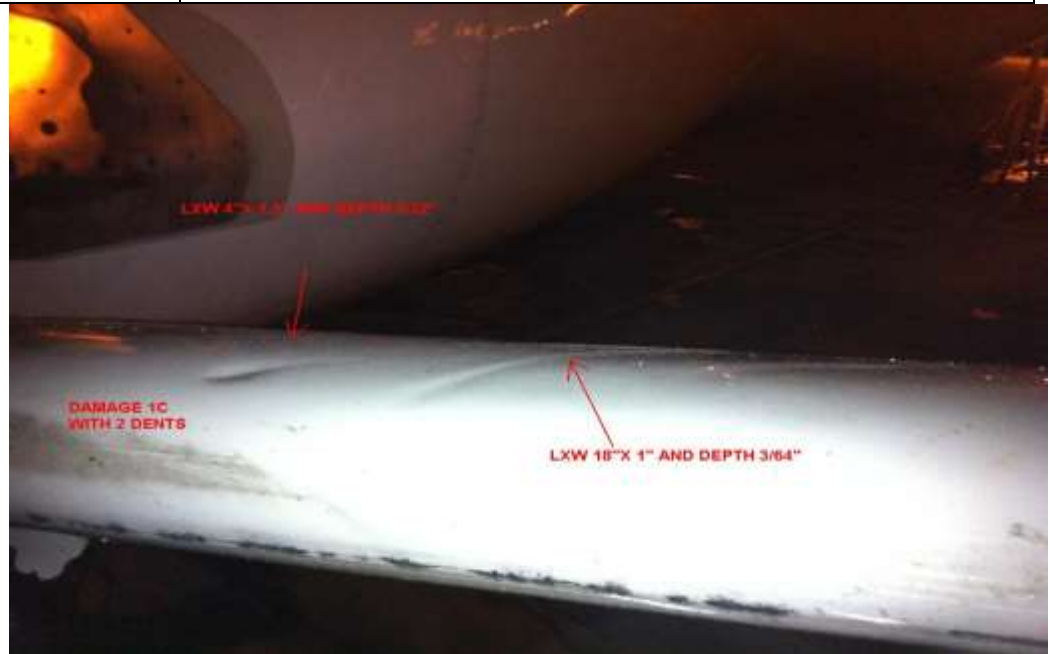
Damage  
1C

2 Dents Measuring 4" X 1.5" X 3/32" and 18" X 1" X 3/64"

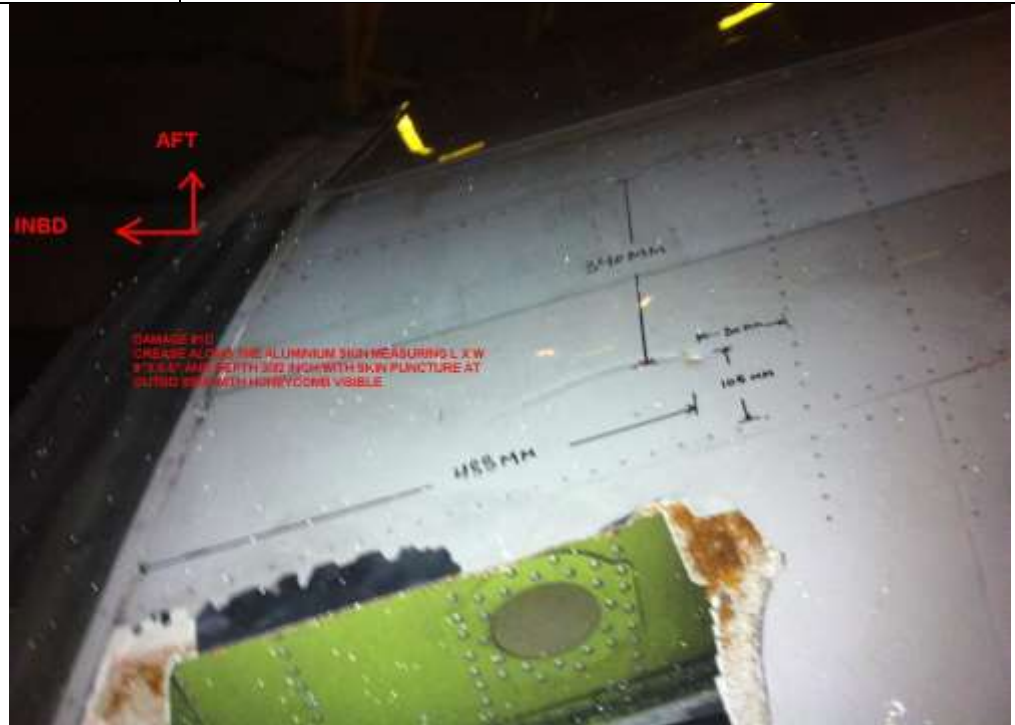
Damage  
1D

Crease along the AL Skin 9" X 0.5" X 3/32" with skin puncture at outboard side and Honeycomb Visible.

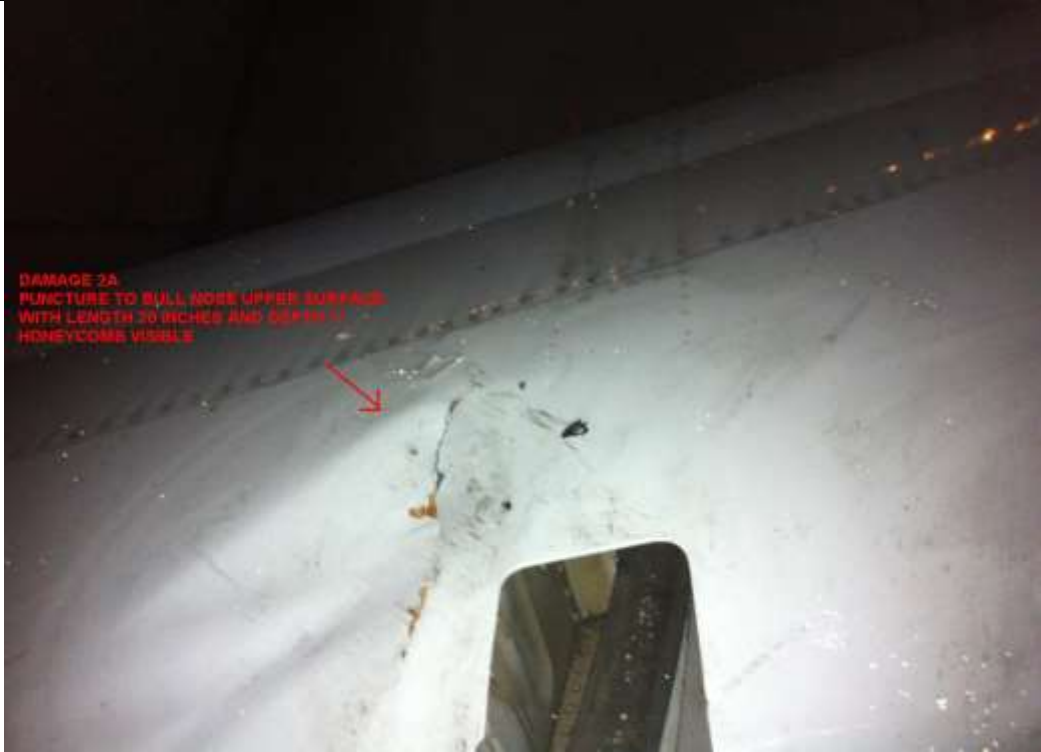
Damage  
2A

Puncture to Bull Nose Upper Surface with Area 20" and depth 1" Honeycomb Visible.

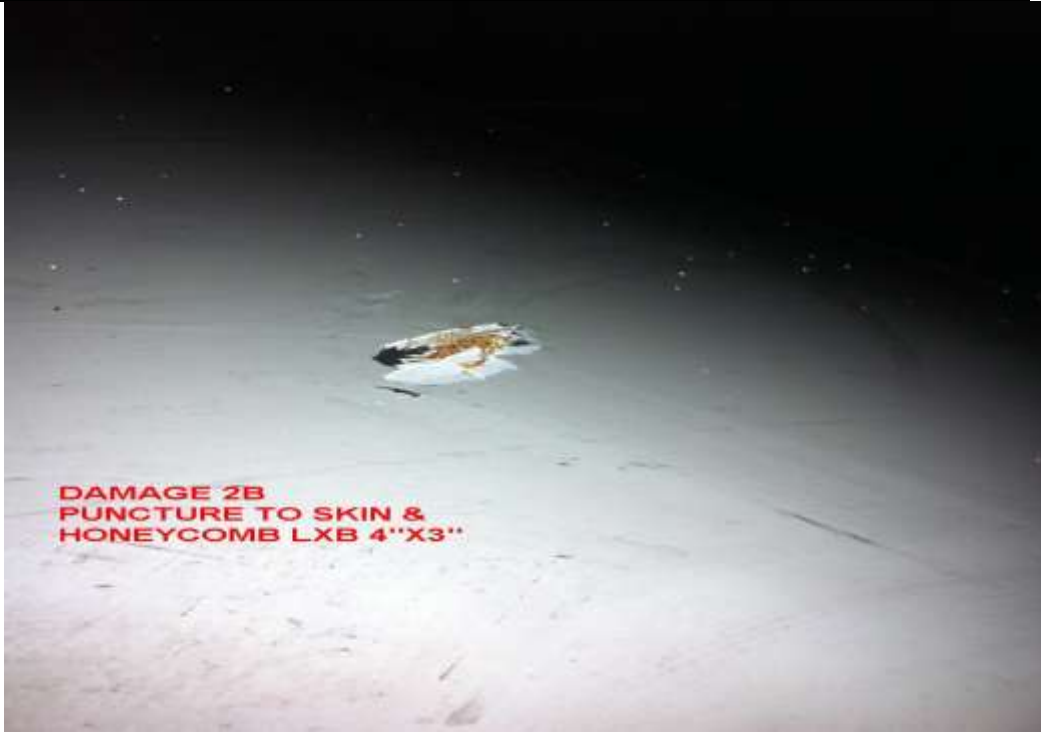
Damage  
2B

Puncture to skin to Honeycomb L X B = 4" X 3"

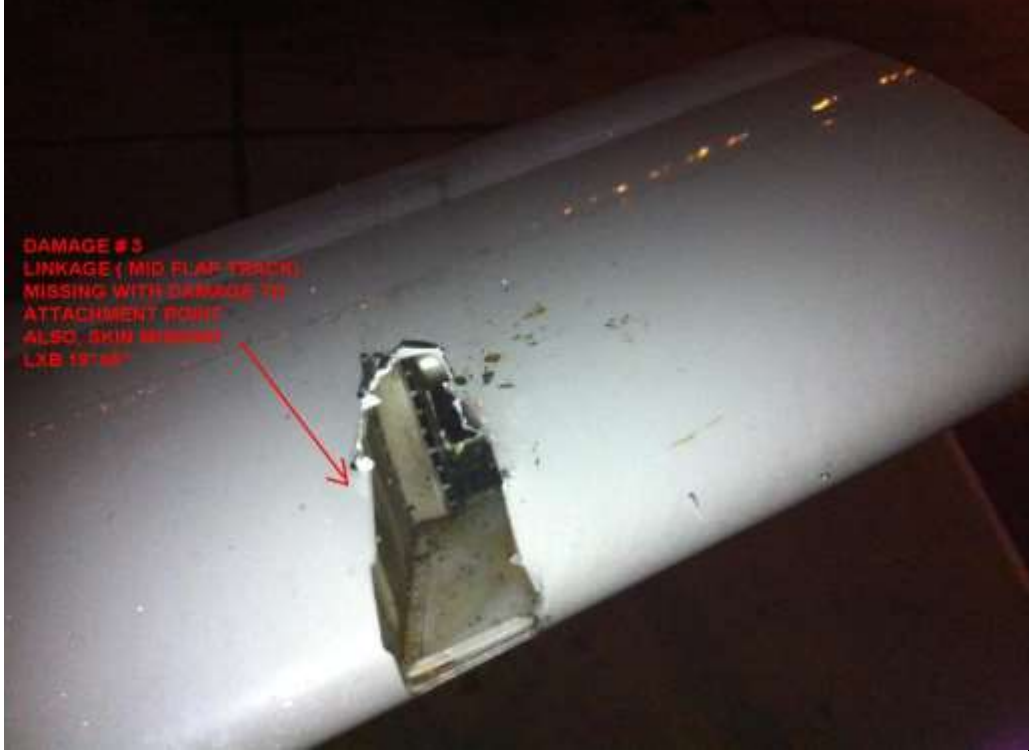
| | Damage 2C | Linkage Cut out Bottom Angle Bracket deformed and detached. |
| Damage 3 | Linkage (Mid Flap Track) sheared off (Missing) with Damage to attachment Point. Also skin missing (L X B =19"X5"). | |

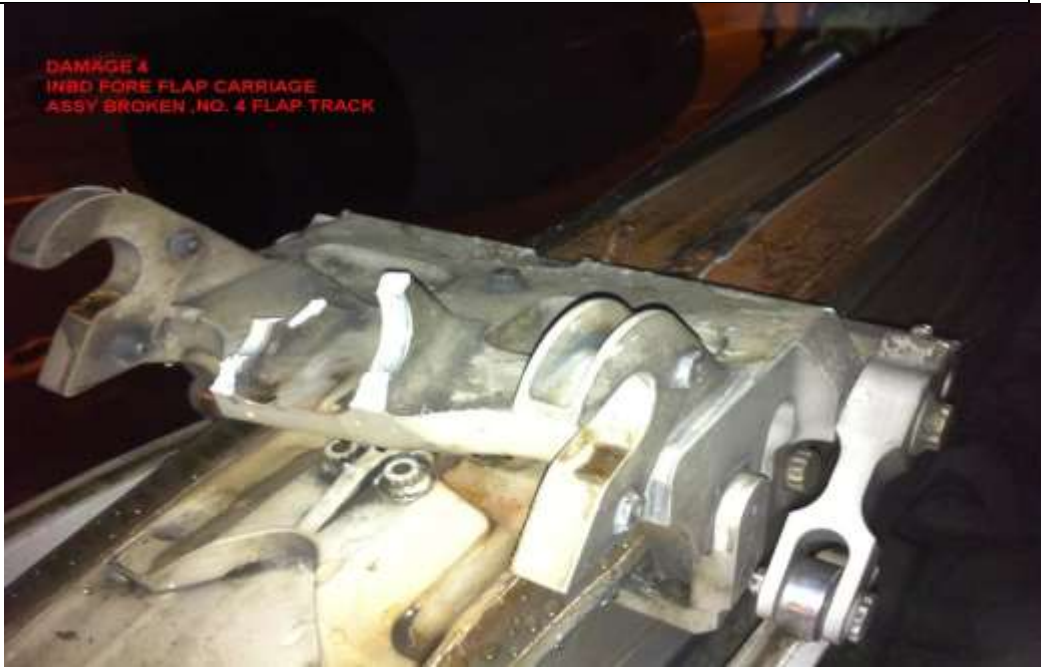
Damage 4 No. 4 Flap Track Inboard Fore Flap Carriage Assembly Broken.

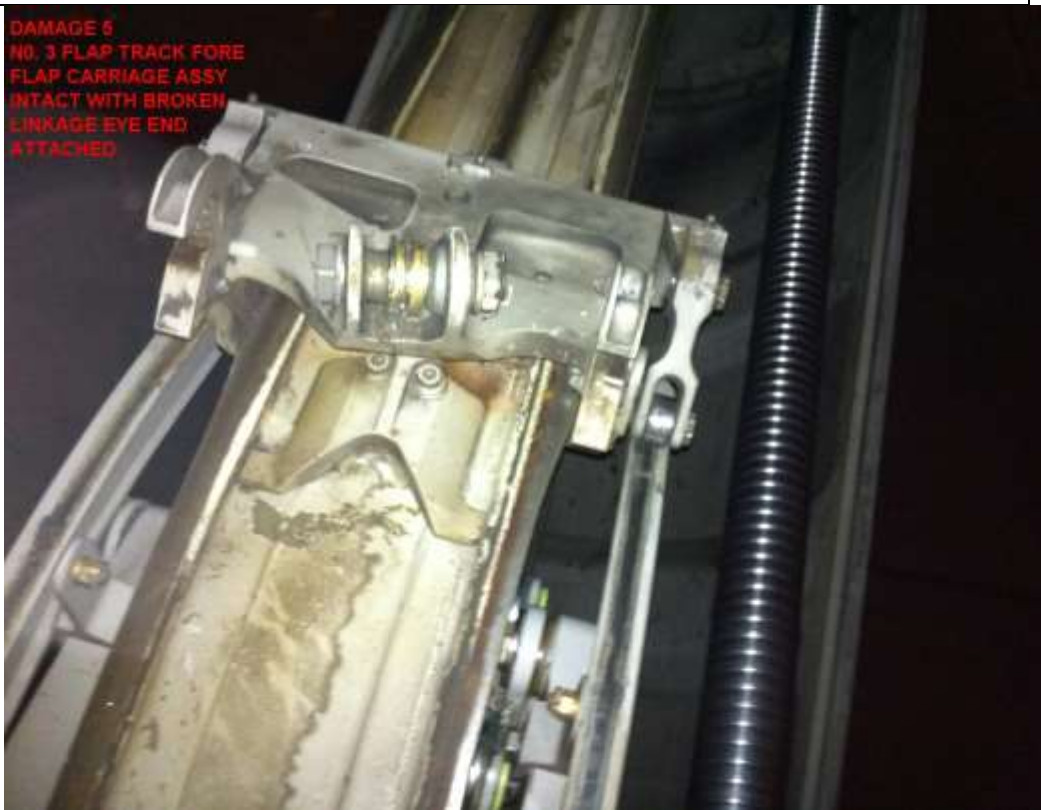
Damage 5 No. 3 Flap Track Inboard Fore Flap Carriage Assembly Intact With Broken Linkage Eye End Attached.

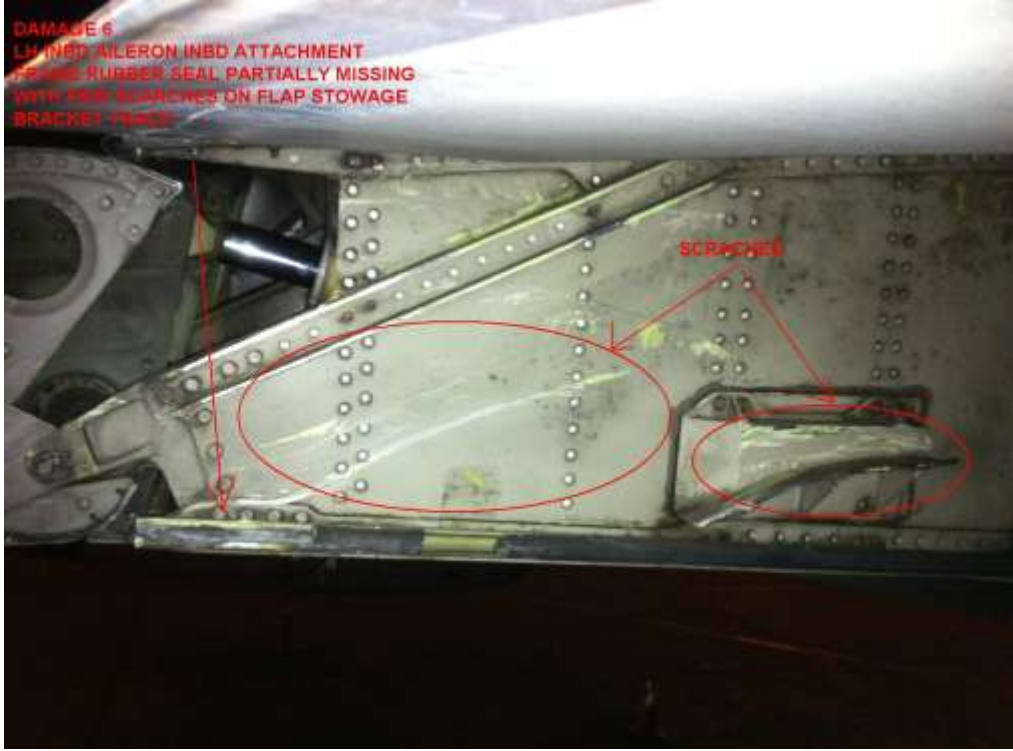
Damage 6 LH Inboard Aileron Inboard Attachment Frame rubber seal partially missing with few scratches on Flap Stowage Bracket Track.

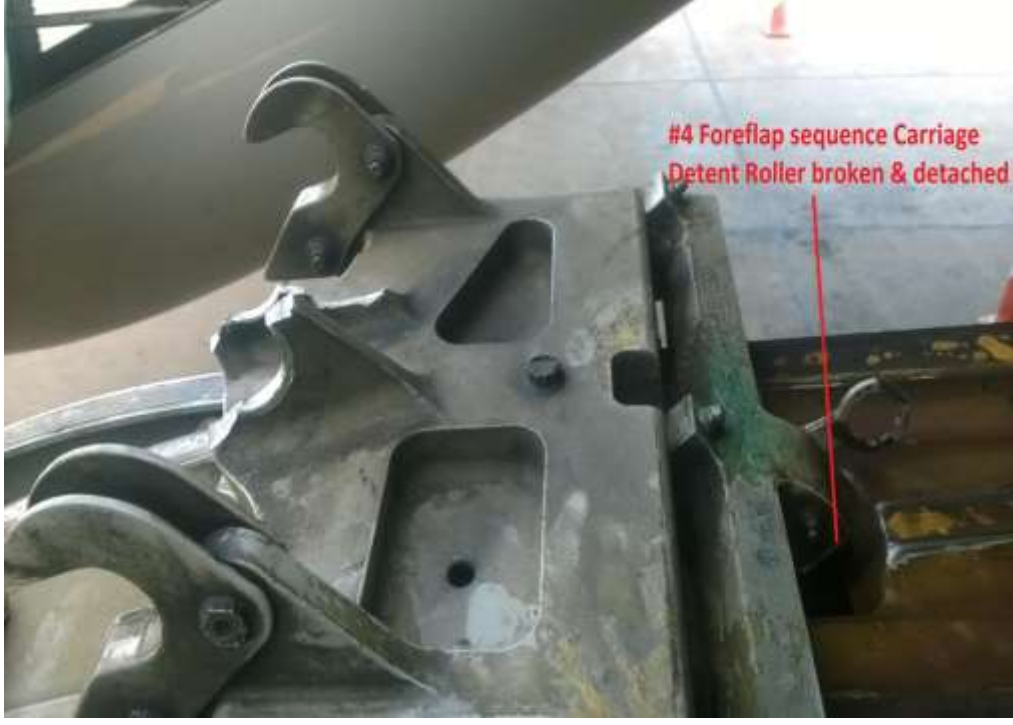
Damage 7 Detent roller of #4 sequence carriage was found broken and detached from the carriage.

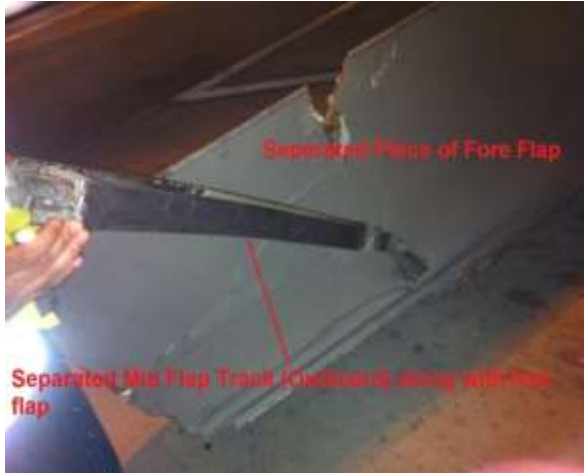
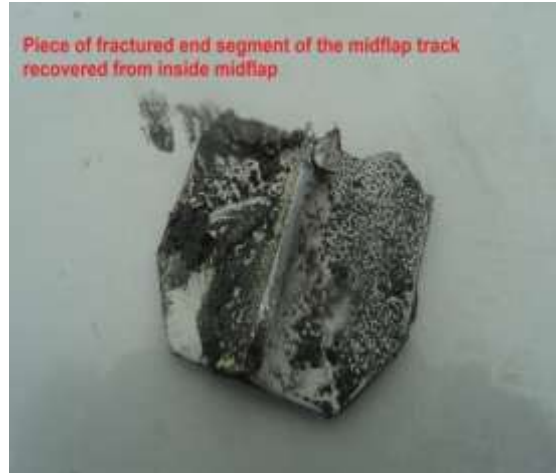
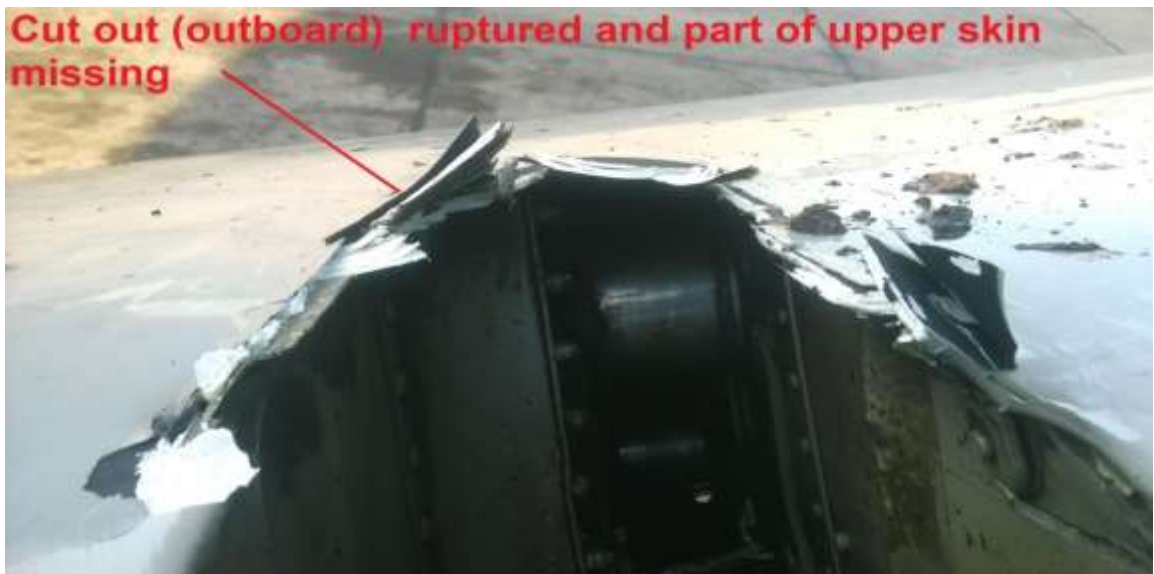
- The fore flap was broken into three span wise pieces after impacting with the runway.
- **Mid flap track & fore flap track (Mid flap track linkage with fore flap)**
  - The outboard mid flap track (which supports the fore flap and extends into the mid flap) was found attached to the fore flap track (which is attached to lower surface of fore flap). The outboard mid flap track was found broken at the aft end (point of attachment with mid flap) which resulted into its separation from the mid flap. Only a piece of fractured end segment of the mid flap track was recovered from inside mid flap. The mid flap cut out (outboard) at leading edge for mid flap – fore flap track was found ruptured and part of upper skin missing.

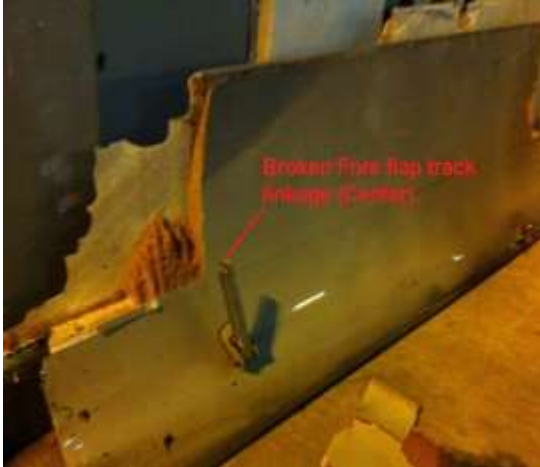
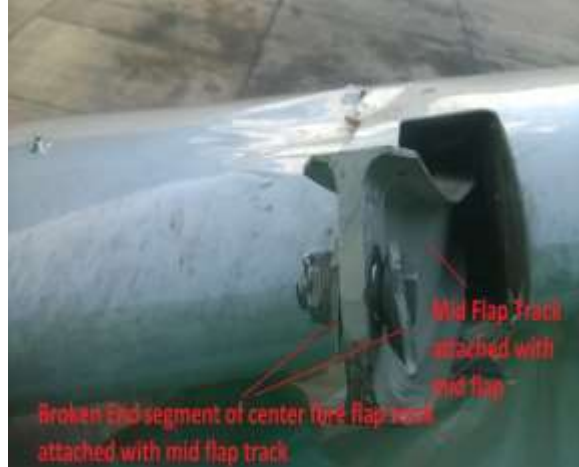
- The centre mid flap track was found attached with the mid flap, however was found slightly bent due to overload. The fore flap track was broken from its aft end (point of attachment with mid flap track). The broken end segment of fore flap track was found attached to the mid flap track along with bolt and nut. The mid flap cut out lower skin was found ruptured.

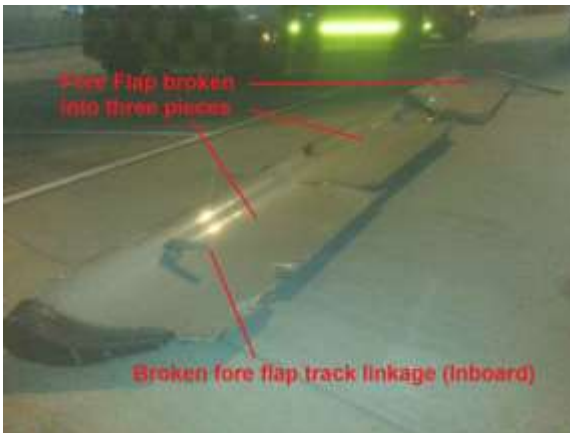
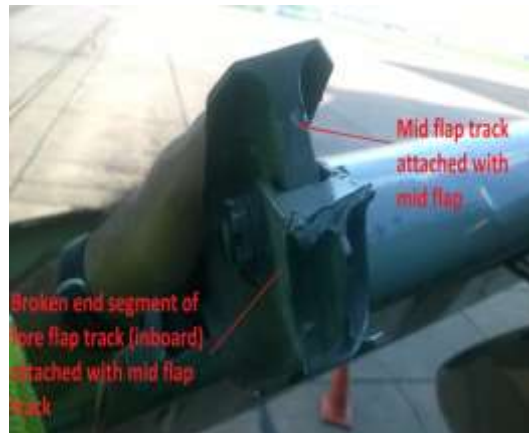
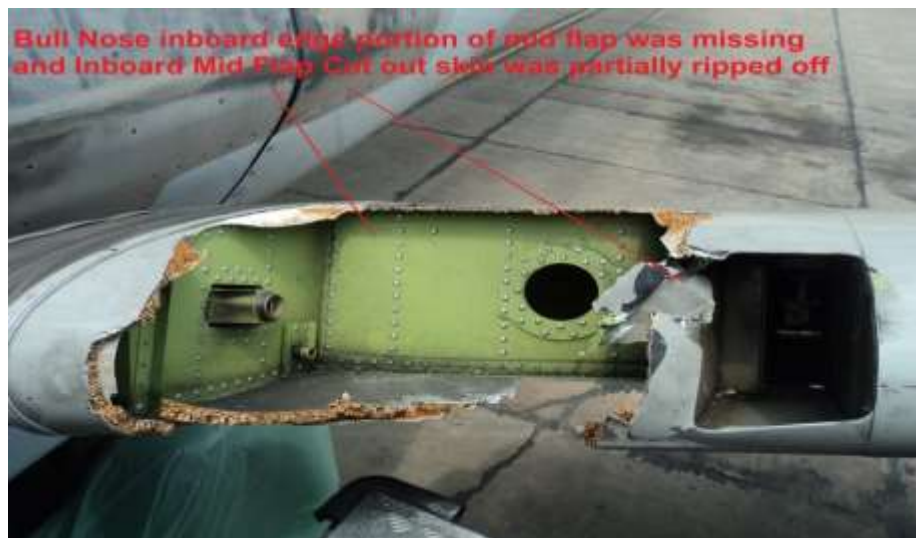
- The inboard mid flap track was also found attached with the mid flap and like centre fore flap track, the inboard fore flap track was found broken from aft end. The broken end segment of fore flap track was found attached to the mid flap track along with bolt and nut. Bull Nose of about 24 Inches from inboard edge was found missing and Inboard Mid Flap Cut out skin was partially ripped off.

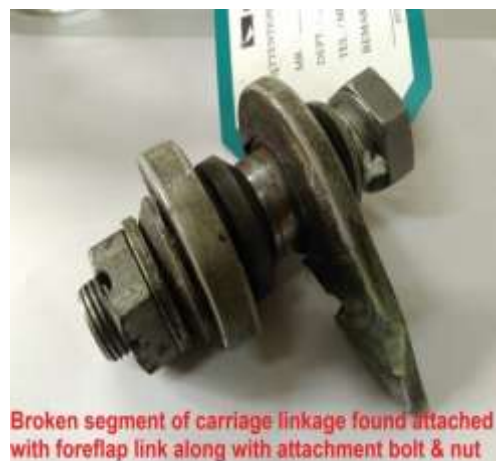
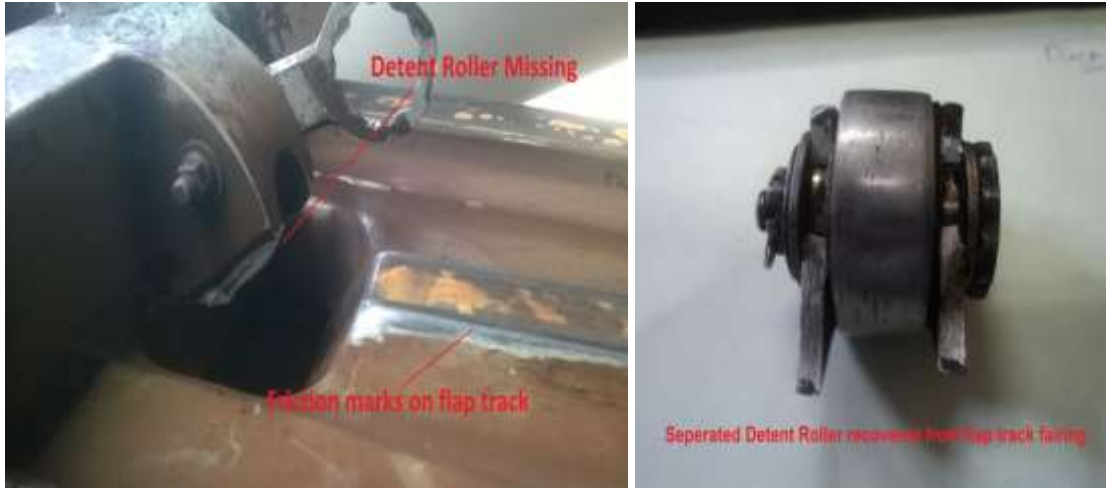
- The # 4 (inboard) sequence carriage was found intact on flap track. However the carriage linkage (with fore flap attachment link) was found broken and separated from the carriage. The broken segment was found attached with fore flap link along with attachment bolt & mono ball bearing. The detent roller was found broken and separated from carriage. The carriage slide on the flap track without roller as evident from the friction marks observed on the upper flange of flap track. The detent roller was recovered from the inner flap track fairing.

The inboard sequence carriage was found intact with the flap track. However while inspecting the carriage it was found that the attachment lug (attachment with fore flap inner link) was fractured and the fractured segment of the lug was

found attached with the fore flap inner link along with bolt, nut, washers and bushings. The detent roller of the carriage was also found sheared and separated from the carriage assembly. Friction marks were observed on the flap track which indicates that when the flaps were extended the sequence carriage moved on the flap track for some distance after the detent roller was separated. This reveals that there may be some anomalies in the inboard sequence carriage assembly thereby resulting in inboard sequence carriage getting out of phase with the other sequence carriage. This may have led to fracture of carriage attachment lug (attachment with fore flap inner link) or the outboard fore flap inner link and subsequently led to failure of other links one after another under severe air loads when the flaps were extended fully for landing. Hence anomalies in sequence carriages may be the primary reason for failure/fracture of carriage attachment lug and fore flap inner attachment link.

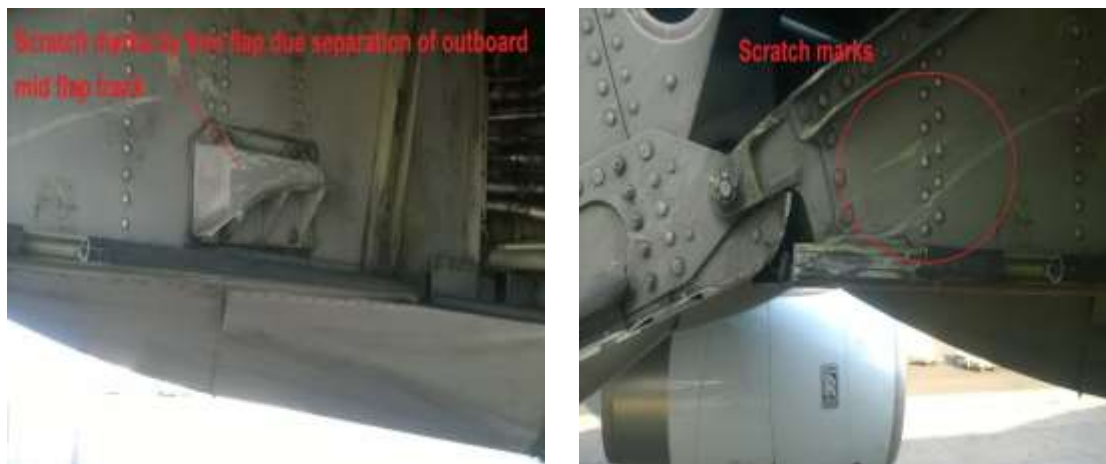
- Scratches were observed on the Flap Stowage Bracket Track probably due to separation of outboard mid flap track from mid flap causing the fore flap to come in contact with adjacent surface.

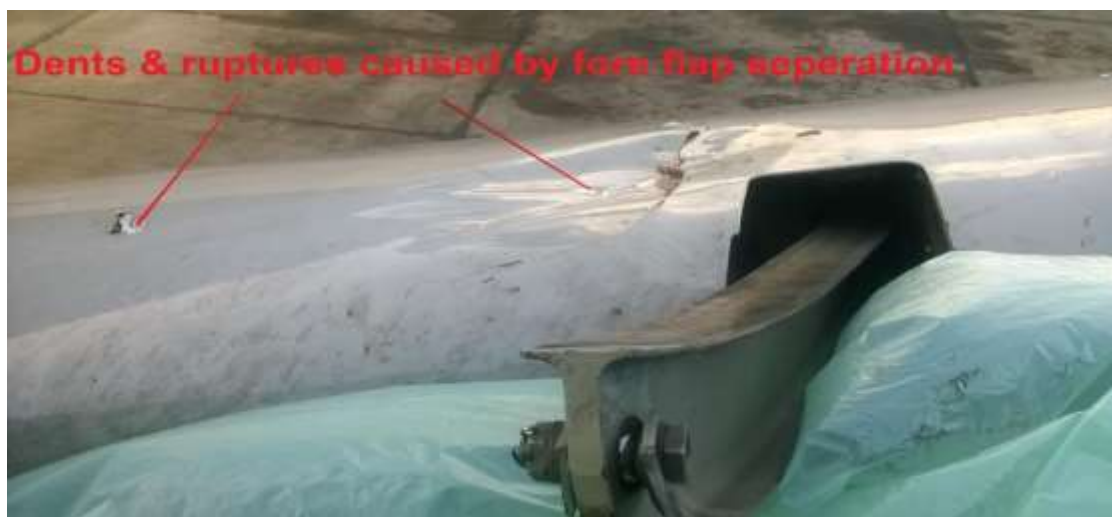
- The fore flap separation caused damage to mid flap skin and honeycomb.

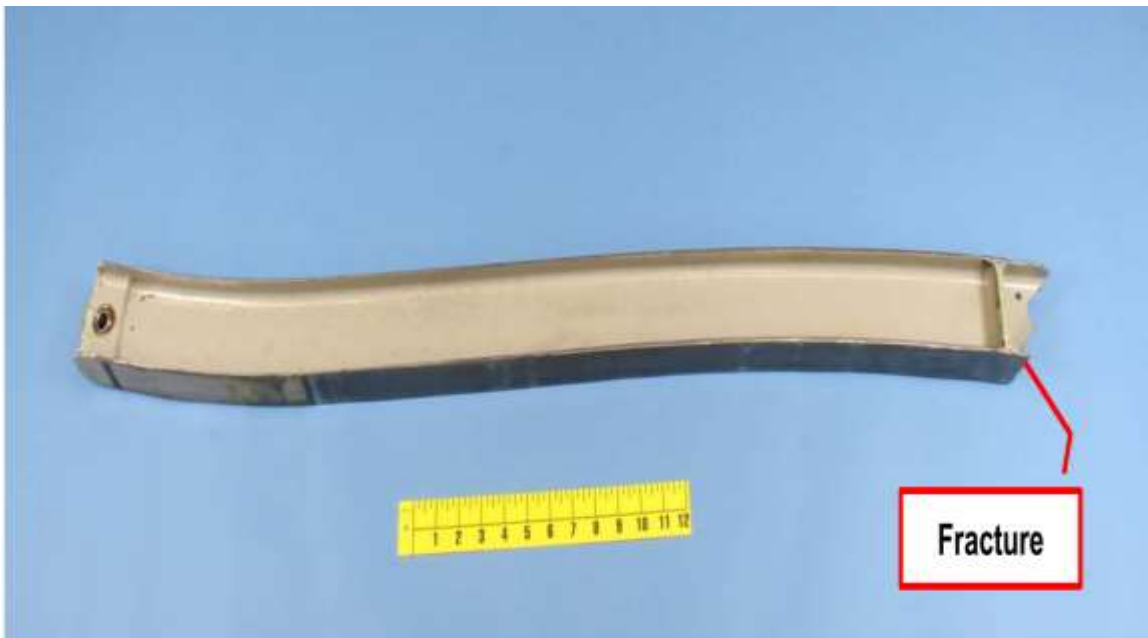
The lower flange at the aft end of the track was fractured, optical examination of the fracture faces found markings and adjacent deformation patterns indicating a bending overstress separation. The bending direction was as if the aft end of the track bent upward. No indications of pre-existing cracking or corrosion were noted on the fracture or other locations on the track. The lower running surface of the track near the fracture had a local deformation on the outboard side. The overall track also had a slight longitudinal twist and a slight sideways bend.

*The lower flange at the aft end of the track was fractured*

- 21) Examination of the LH wing mid flap track revealed that it sustained bending overstress separation. The bending direction was as if the aft end of the track bent upward. There were no indications of pre-existing cracking or corrosion was noted on the fracture or other locations on the track.
