FINAL INVESTIGATION REPORT

**GROUND INCIDENT BETWEEN SEJ123, B738, VTSGV AND IGO769,A320, VTINT AT IGI
AIRPORT, NEW DELHI**

**OFFICE OF DIRECTOR OF AIR SAFETY (NORTHERN REGION), GOVERNMENT OF INDIA,
SAFDARJUNG AIRPORT,NEW DELHI-110003**

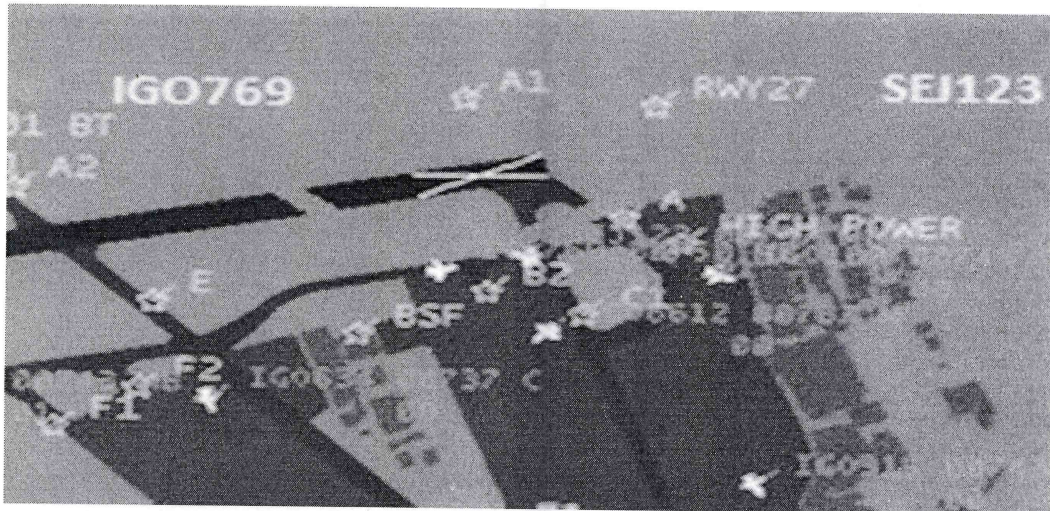
- l. SEJ123 on reaching short of taxiway E2 requested for further taxi, and third controller abruptly gave taxi to SEJ123 as 'taxi to stand 130 via E', which was an incomplete instruction.

- m. SEJ123 turned left to join E2 and came face to face with IGO769 which was taxiing on taxiway E2 for A lane.

- l. SEJ123 on reaching short of taxiway E2 asked for further taxi. Third controller, who came to help ground controller abruptly gave incomplete taxi to bay 130 via taxiway E. From TWY C1 to TWY E there are two connecting routes one via RWY 27 and

another via TWY E2. SEJ123 on getting the instruction turned left on E2 without confirming the route.

- m. SEJ123 was monitoring the ground frequency but at that time there was no conversation with IGO769. Thus she was not aware of any opposite traffic on TWY E2 assuming this she turned left on taxiway E2 without confirming the route. Visibility was very low and there was no follow me to assist or cross check the route or to advise the opposite traffic. Follow me jeeps are equipped to monitor the frequencies of their area and can communicate with aircraft and tower.
- n. On turning left SEJ123 and IGO769 came face to face and the separation between the two became approximately 30m which was abeam B2 thus none of them could take a turn. To resolve the traffic they were towed to their respective bays.

- a. Appropriate training for the involved controllers.

b. DIAL may re assess the number of follow me vehicles requirements to cater increase in Air Traffic movements at Delhi Airport and may designate a dedicated vehicle for VIP Services.
