**Report on Ground Collision Incident to M/s Air India
Boeing 787-8 Aircraft VT-ANE at Stockholm Airport on
28/11/2018**

**O/o Director Air Safety(NR),
Safdarjung Airport,
New Delhi-03**

Investigation Report on Ground Collision Incident to M/s Air India B 787-8 Aircraft VT-ANE at Stockholm Airport on 28/11/2018

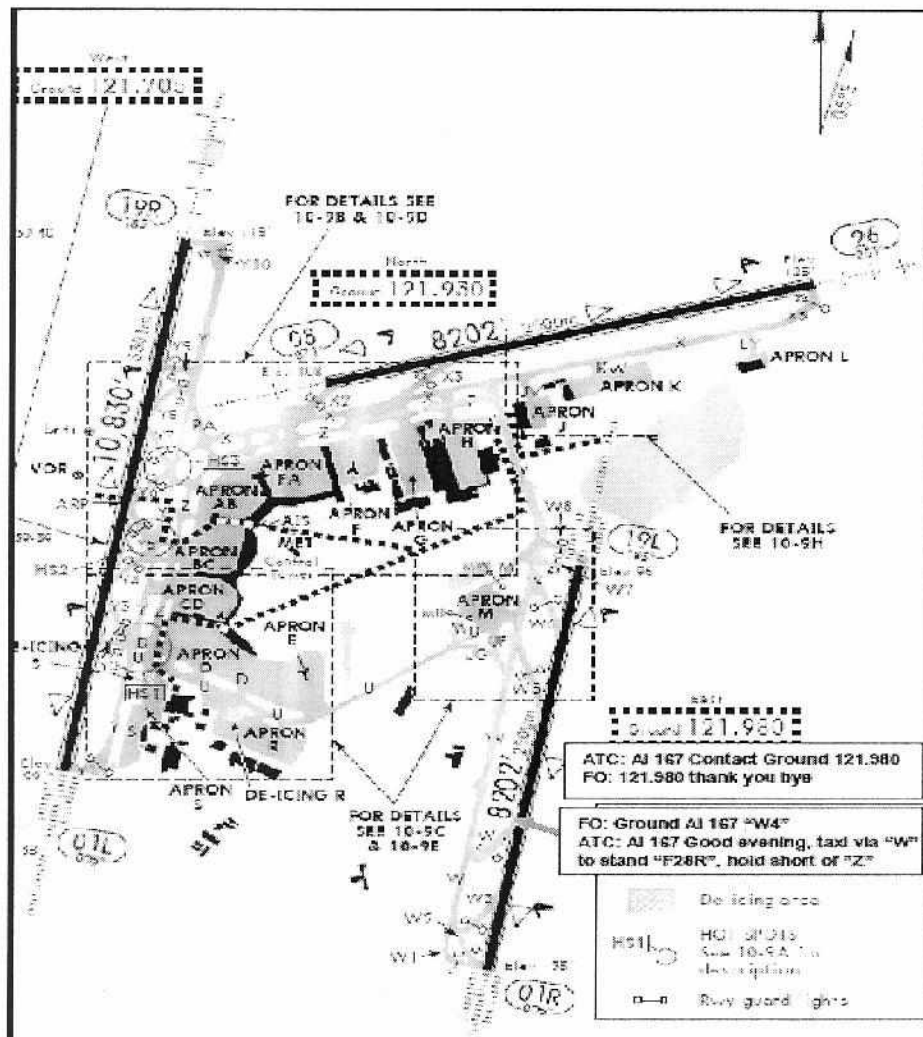
Fig No.1 Path followed by the Aircraft

Aircraft arrived in Stockholm at 16:50 UTC. After landing the aircraft vacated Runway 19L via "W4" and was given taxi clearance by the ATC (ground) at Stockholm to taxi via Taxiway "W" to stand F28R and hold short of "Z" and the same was acknowledged by the First Officer.

The first officer also made note of it on the flight plan. Then aircraft was given further Taxi clearance via "Z" and "ZQ".

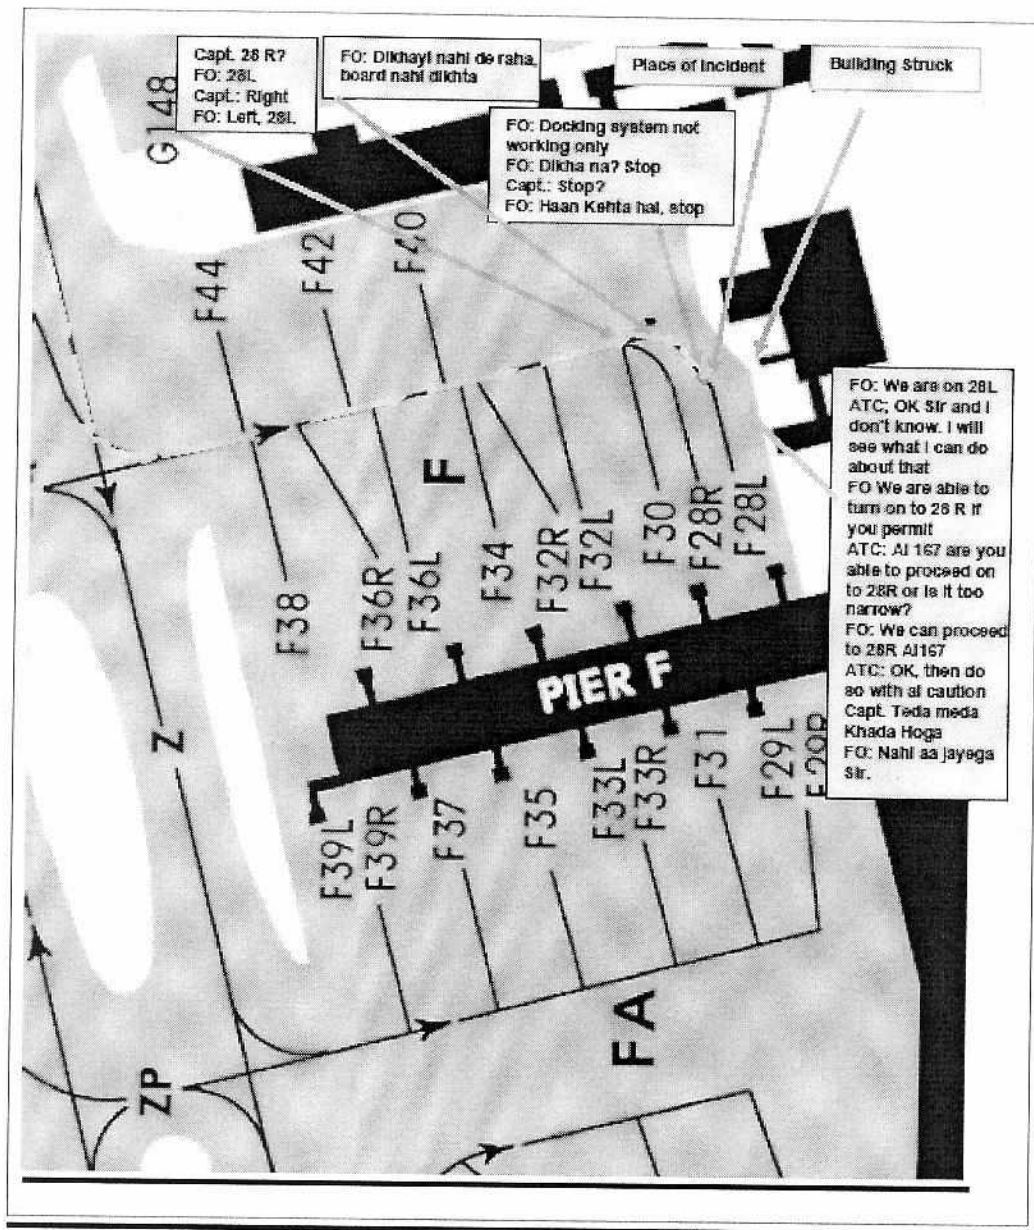
Figure No.2 Events near F28 Stand

During taxi, when the aircraft was passing stand F30 (Ref fig.2), the PIC asked the first officer if the stand allocated was F28 Right. The first officer replied that it was F28 Left. While approaching the stand, the PIC asked the first officer where to turn as the lead in lines to stand F28 Left and F28 Right were not clearly visible on the ground due to wet surface and reflection of light. F28 is Multiple Apron Ramp System (MARS) and is equipped with the Visual Docking Guidance system (VDGS). When the aircraft reached near stand F28, the VDGS of stand F28Right was not activated by the ground handling agency. Neither the VDGS of stand F28 Left was activated. The aircraft turned into stand following the lead line for stand F28L. After moving forward, the first officer made a call to stop the aircraft as he believed to have seen Stop on the VDGS, while the commander was not able to see anything on the display of the VDGS as it was not activated. The aircraft was stopped. At this stage again, PIC asked whether they had to go to the left or right. The copilot again reiterated that they had to go to the left. Then the PIC recollected that First Officer earlier had said the right stand. They then sought confirmation from the ATC. ATC reconfirmed that the F28R stand was allocated to them. They informed ATC that they had come on stand F28L lead line. The ATCO stated that "OK Sir and I don't know I will see what I can do about that".

At this stage, the first officer advised PIC that they can turn to the right and the crew of the AI-167 communicated to ATC that they are able to turn to the right if the permission is granted. The permission was given by ATC but with CAUTION. There is a building on the left side of the apron and outboard of left wing was in close proximity. As per the available information, the building was neither lit nor it had any obstruction light. While maneuvering from F28L line to F28R line, left wing leading edge impacted the building. PIC stopped the aircraft immediately and passengers were deplaned normally. There was no injury to any person on board the aircraft.

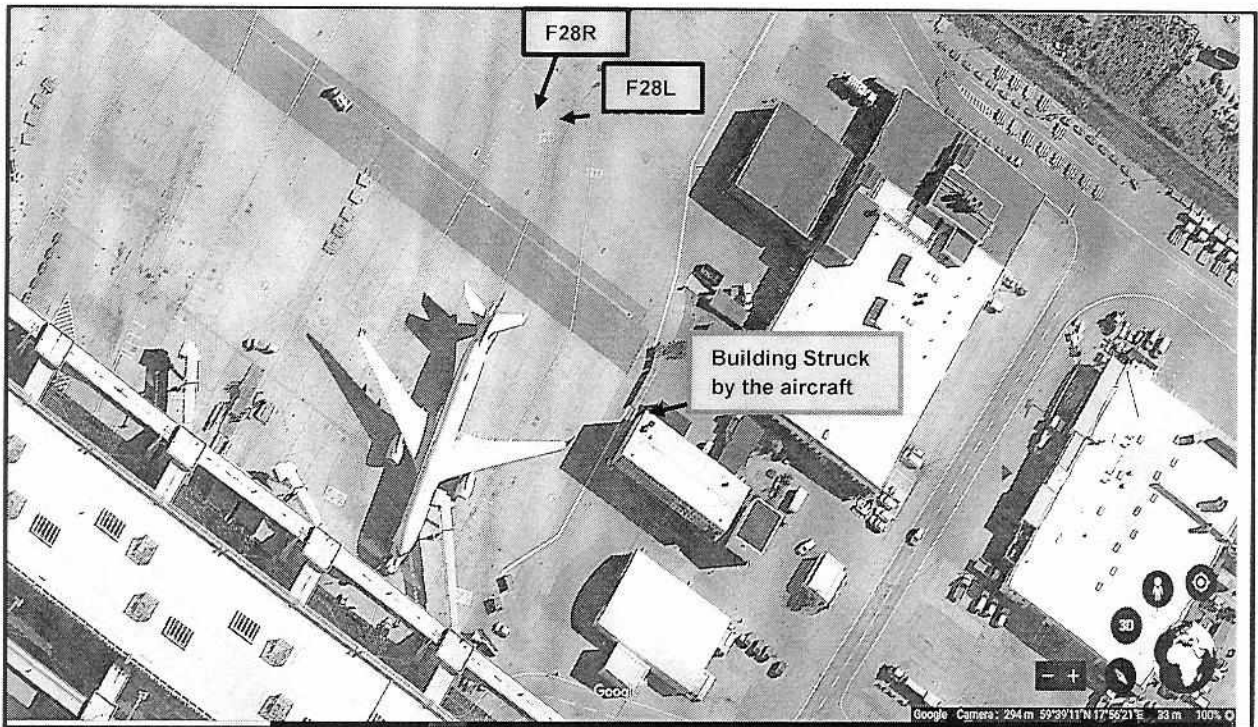
Stand F28

The lead in line for the stand F28L is at an angle for some distance and then goes straight. It is on the edge of the apron and on its left side there are buildings due to which wing clearance reduces as the aircraft taxi in to the stand. As per the crew statement, the building was not well lit and also there was no obstruction light on the building. Using the google tool, it is estimated that the

distance between the lead line of the stand F28L and the edge of the building struck by the wing of the aircraft is 26.9 meters. The distance between the lead line of the stand and apron edge making is 22.26 m. This makes the stand suitable only for category "C" aircraft.

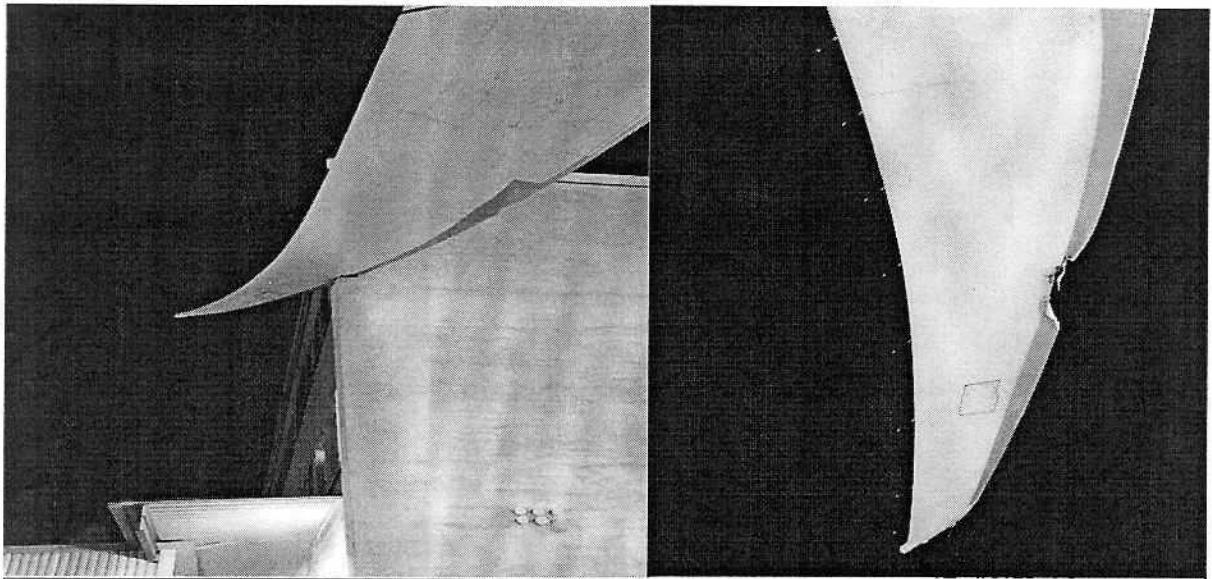
Fig. 4 : Impact with the building

The damage is to the left raked wing tip, inboard of the removable wing tip. The damage extends into the left wingtip structure with the leading edge, spar, ribs and skin. The aircraft electrical wiring & NAV light assembly was also damaged. The width of the damage along the leading edge is approximately 70cms in length.

The leading edge of the outboard portion of left wing of the aircraft impact the building. Due the impact the left wing outboard side leading edge area (just inboard of the removable wingtip) was damaged.

Fig.5 Damage to wing

The damage extends into the left wing structure, the leading edge, spar, ribs and skin. The aircraft electrical wiring & NAV light assembly is also damaged. The width of the damage along the leading edge is approximately 70cms in length.

- 4.1 Necessary Corrective action may be taken in respect of the concerned crew.
- 4.2 Air India should put in place a robust and meaningful system for hazard identification and risk assessment. This should include structured feedback process from the operating crew, station managers and other stake holders responsible for the safe operation.
- 4.3 Appropriate action may be taken in respect of the ground handling agency for not activation of the VDGS before the arrival of the aircraft.

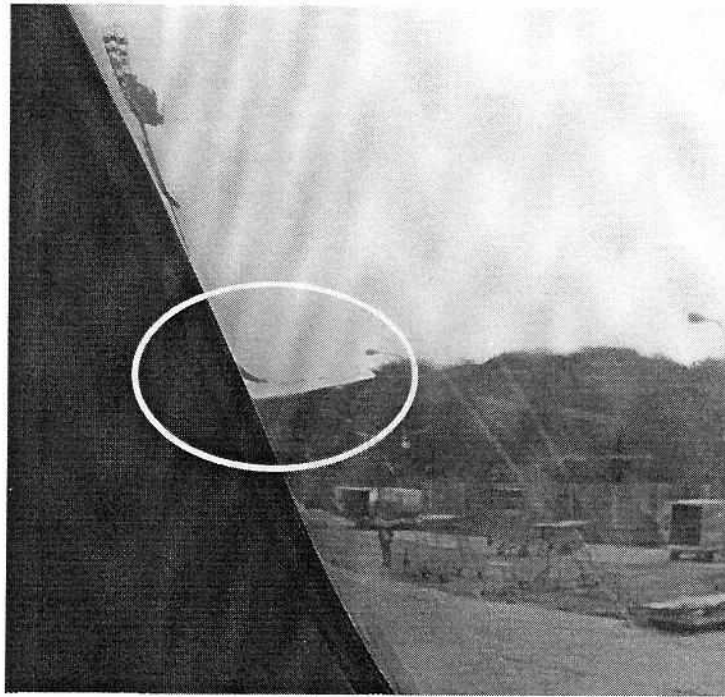
Fig. 6 View of the LH wing tip as seen from the LH side window

To assess whether the wingtip is visible while seated on the LH pilot seat, an exercise was performed on B787-800.

It was observed that, by turning back the wing tip can be seen from the LH side window, while seated on LH pilot seat (Fig.6).
