GOVERNMENT OF INDIA
CIVIL AVIATION DEPARTMENT

FINAL INVESTIGATION REPORT
INCIDENT TO M/s AIR INDIA BOEING 787-800 AIRCRAFT VT-ANI ON
19/04/2018 IN AMRITSAR AIRSPACE

FINAL INVESTIGATION REPORT OF SEVERE TURBULENCE
INCIDENT TO M/S AIR INDIA BOEING 787-800 AIRCRAFT VT-ANI IN
AMRITSAR AIRSPACE ON 19.04.2018

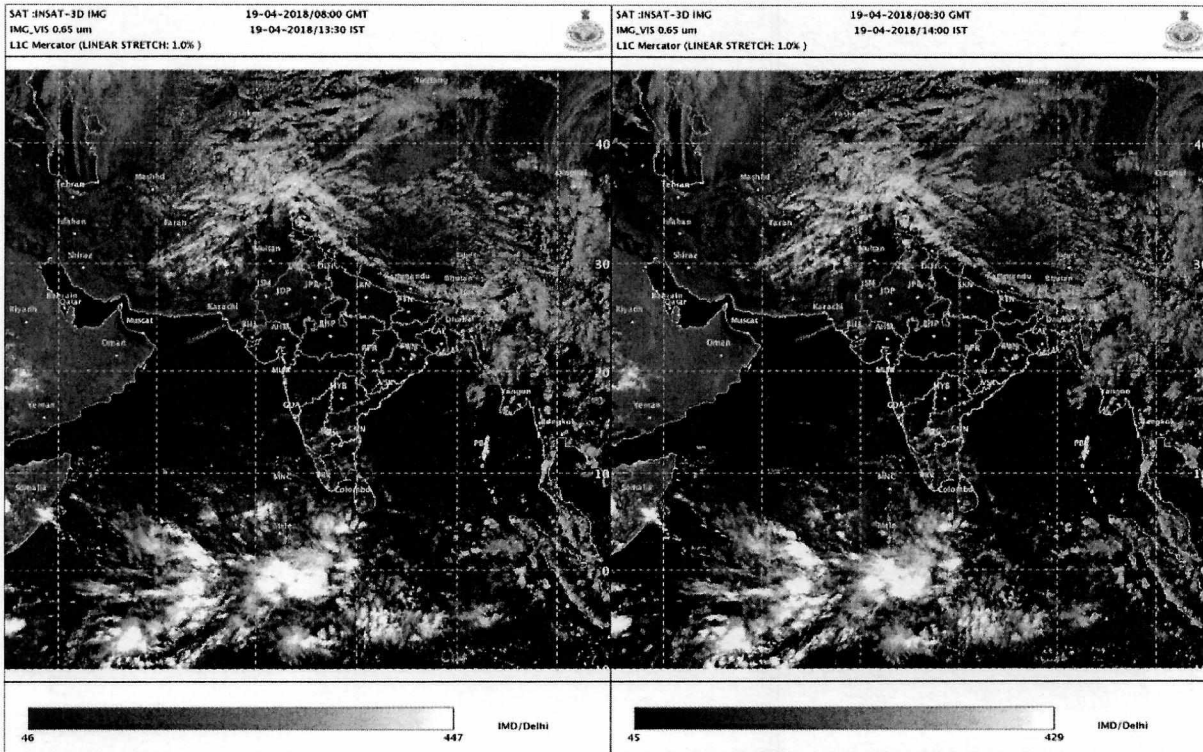
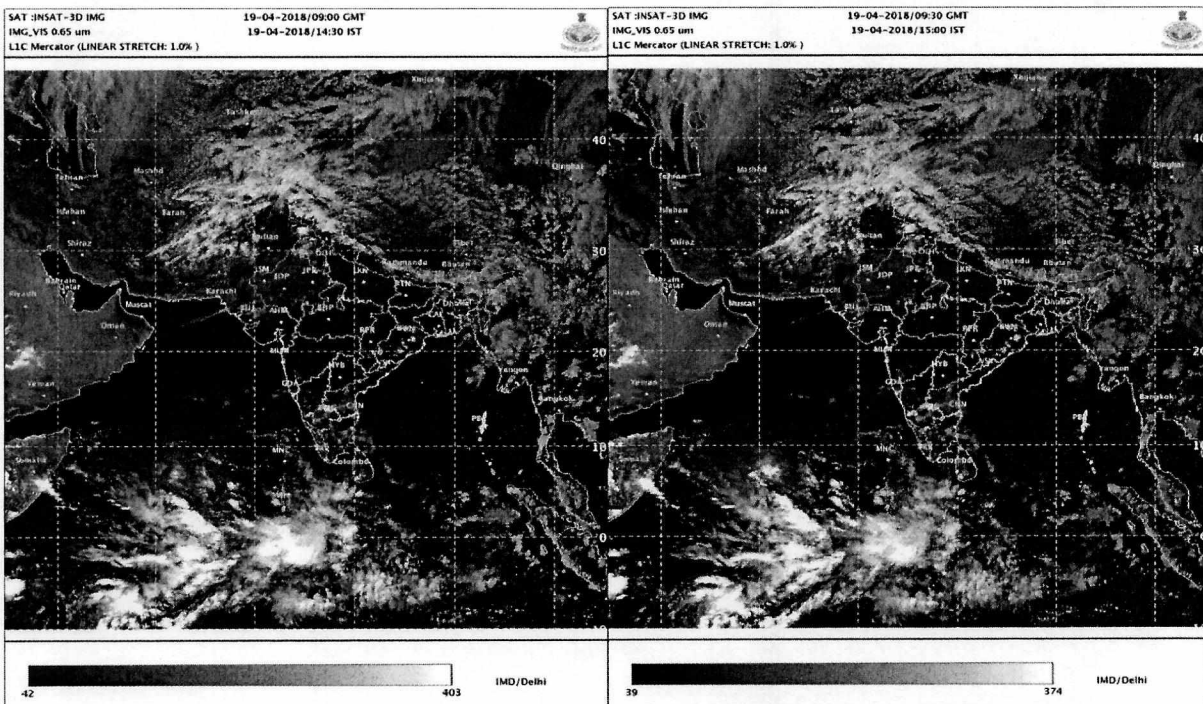
1.7.3 Weather situation at Amritsar: As per Satellite Images on 19 April 2018 from 0800 UTC to 0930 UTC confirms the formation of CB clouds at and around the airport.

2.1.2 INSAT 3D images for both VIS (VISIBLE)/IR (INFRARED) for 19.4.2018 from 0800 UTC to 0930 UTC confirms the formation and intensification of convective and CB clouds from 0800 UTC onwards at and around Amritsar aerodrome during the period.

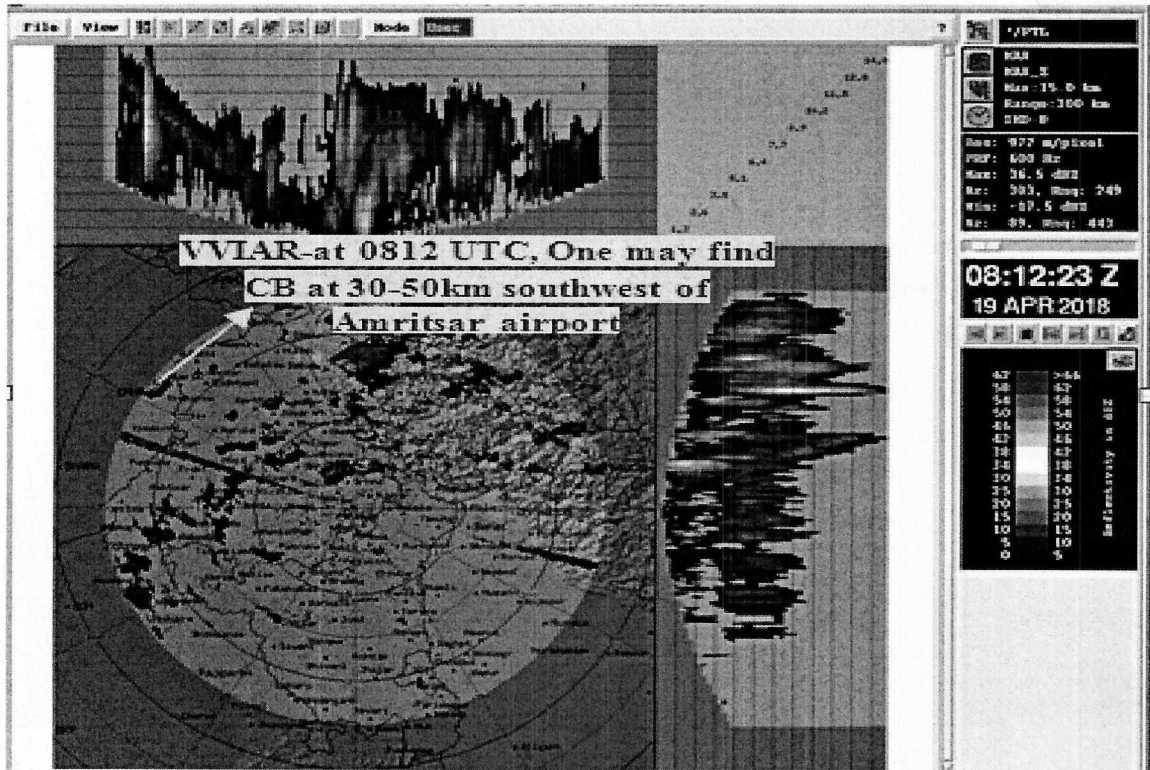
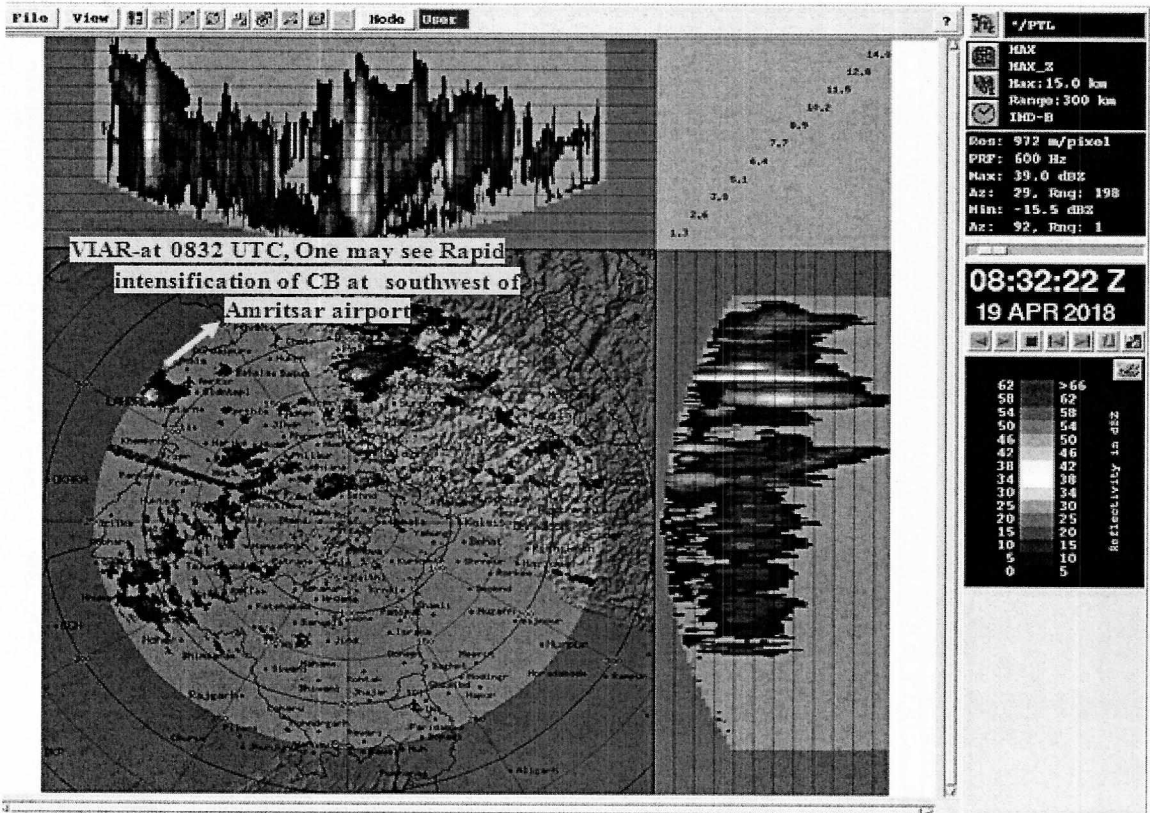
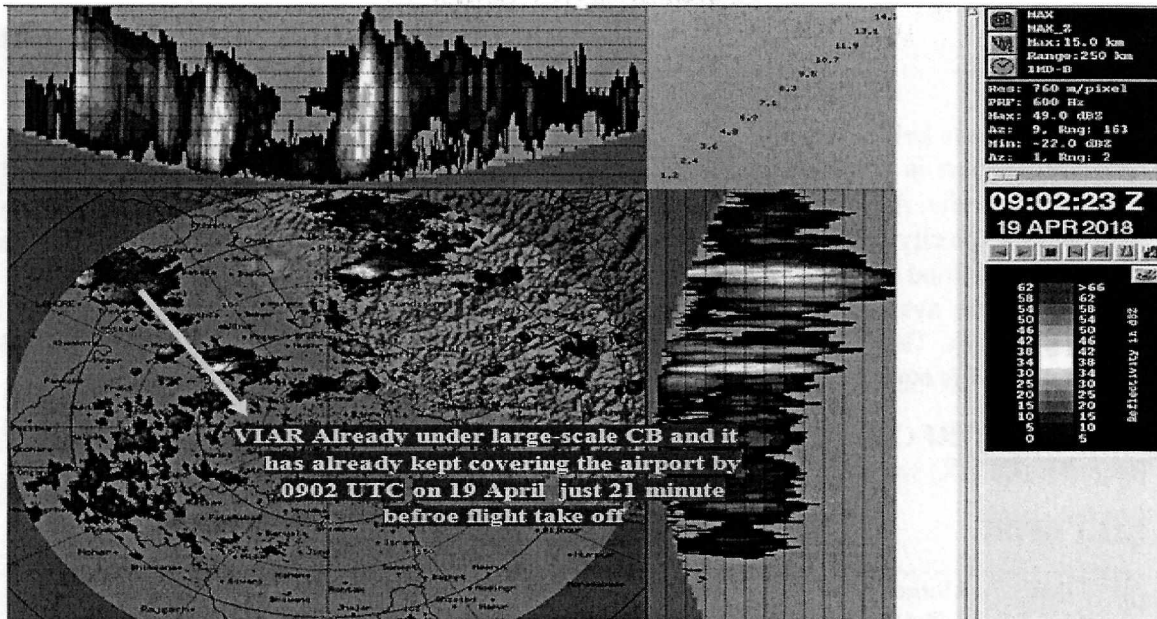
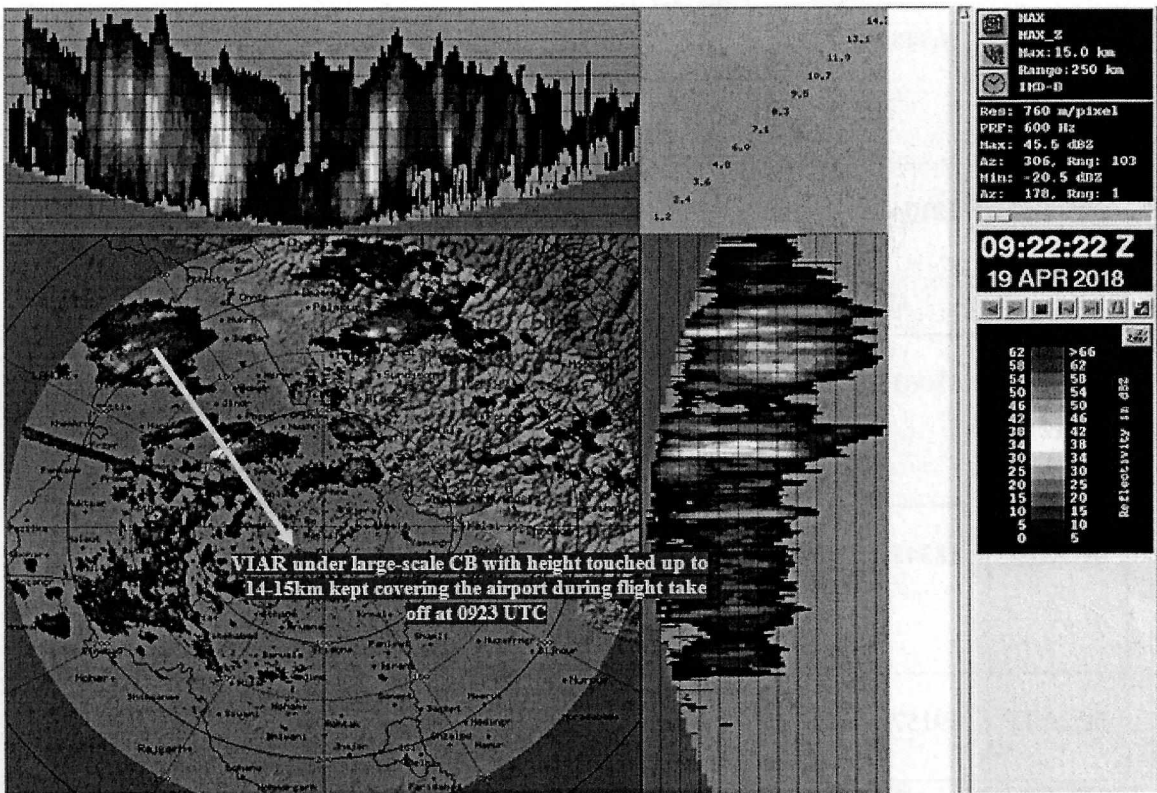
DWR pictures from 0812 UTC to 0922UTC also confirm formation and intensification of large scale CB.

2.1.3 DWR (Doppler Weather Radar) pictures of Patiala from 0812 UTC to 0922UTC confirms that CB cells already observed in the DWR at south-southwest sector of Amritsar as early as 0812UTC of 19 April 2018 and by 0832 to 0902UTC, it had intensified into a very big CB cell with a bubble type sudden growth type and formation of large-scale CB. The TS occurred as per current weather and as per DWR of 0922UTC, it is observed that the associated CB had vertical altitude of 14-15km and hence must have created very high wind shear or a CB cloud caused moderate to severe updraft/downdraft over the airport which have caused moderate/severe turbulence at and around the airport.
