## DIRECTORATE GENERAL OF CIVIL AVIATION

FINAL INVESTIGATION REPORT ON SERIOUS  
INCIDENT TO M/S. GLOBAL VECTRA HELICORP  
LTD HELICOPTER, VT-AZT AT BOMBAY NORTH  
FIELD, MUMBAI, MAHARASHTRA

SERIOUS  
INCIDENT ON  
19<sup>TH</sup> APRIL.  
2012

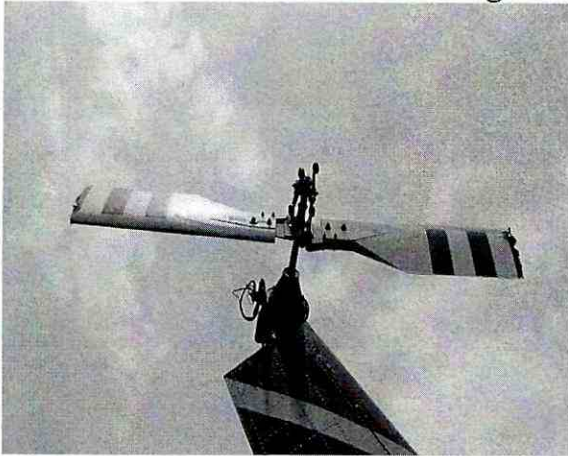
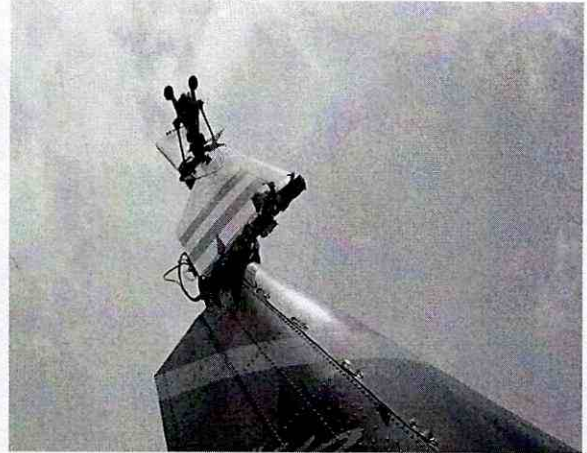
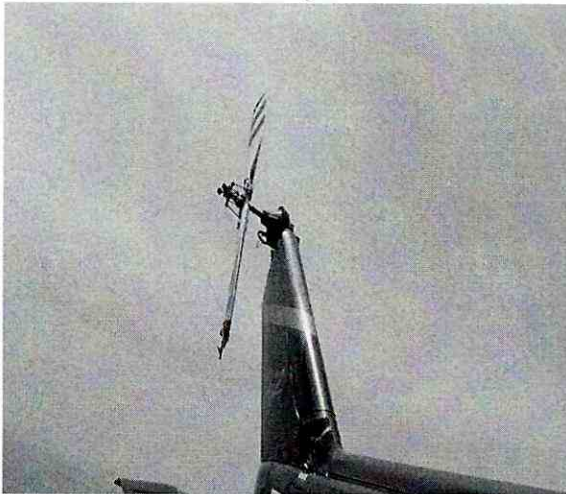
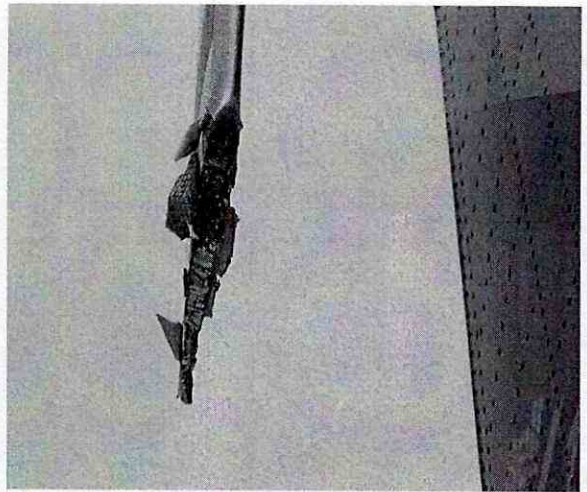
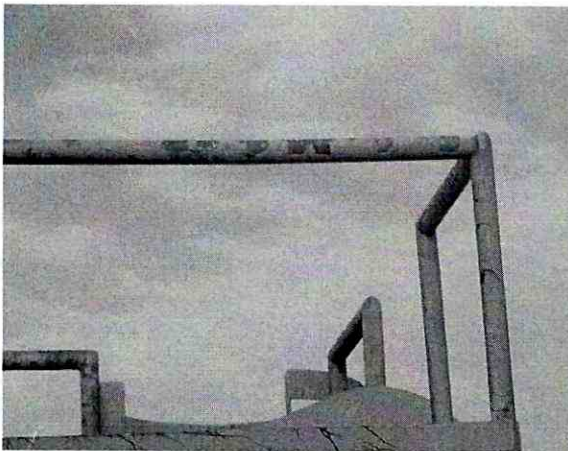
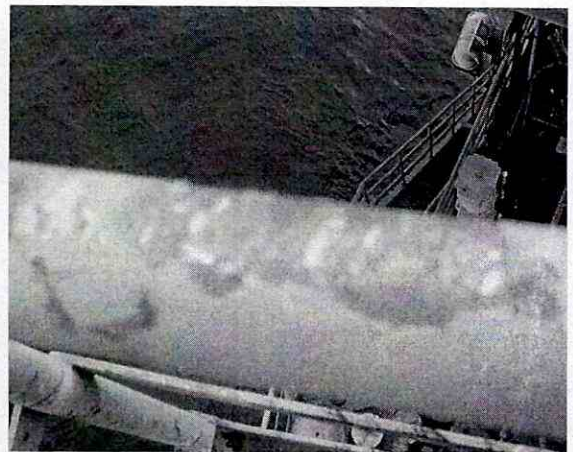
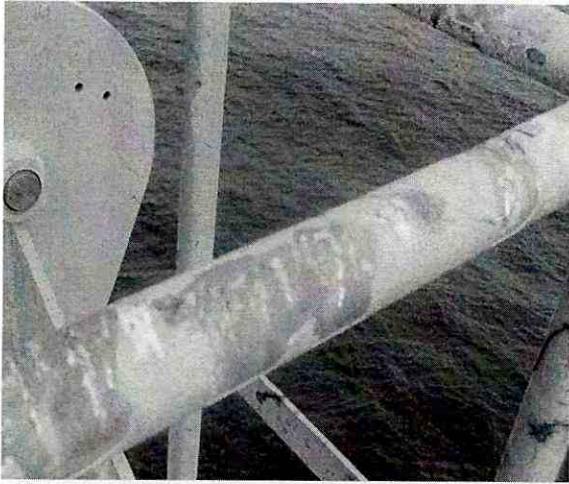
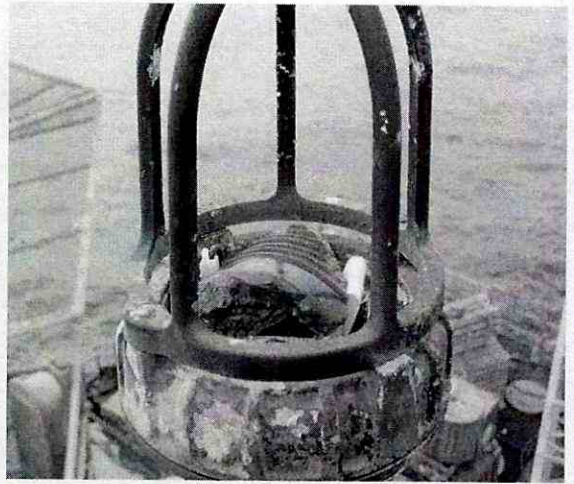
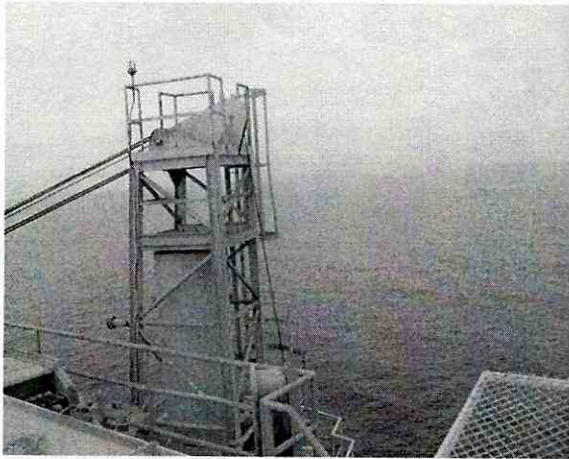
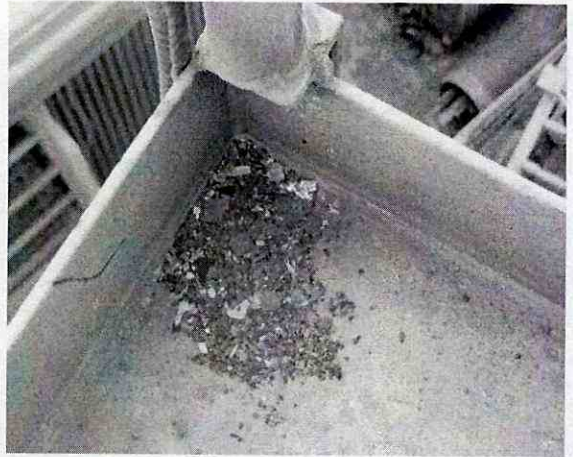
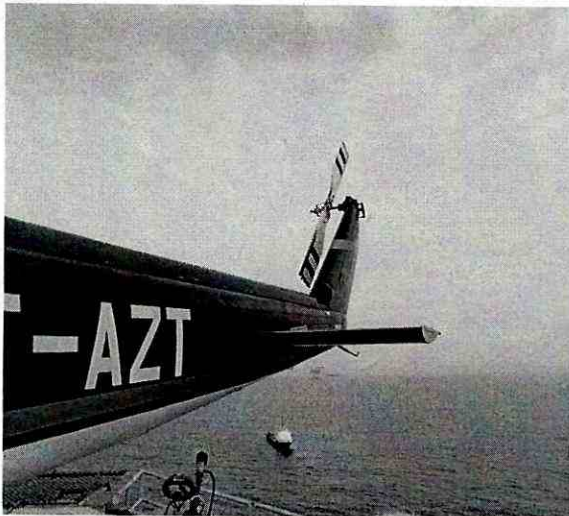
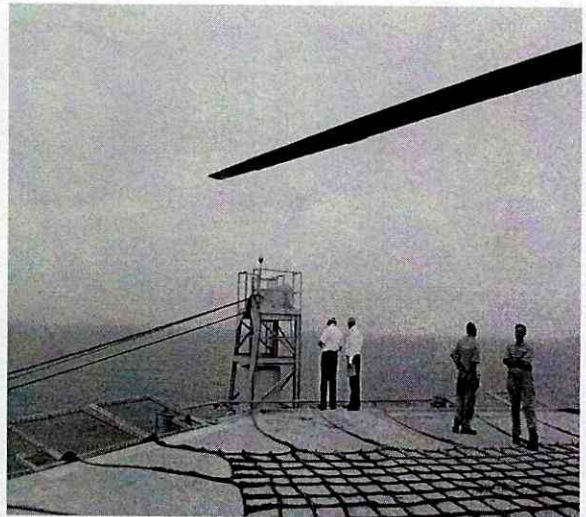
Approximately 10 inches each of both the tail rotor blades were sheared off at the tips and there was skin damage on one main rotor blade.

1. Hole in the crane cabin top glass & side glass.

- 28
- (3)
- Obstruction light was damaged.
  - Scratches on the railing near the crane strobe light.

Approximately 10 inches of both the tail rotor blades were sheared off at the tips and there was skin damage on one main rotor blade. Some metal pieces were found lying on the WI3 deck.

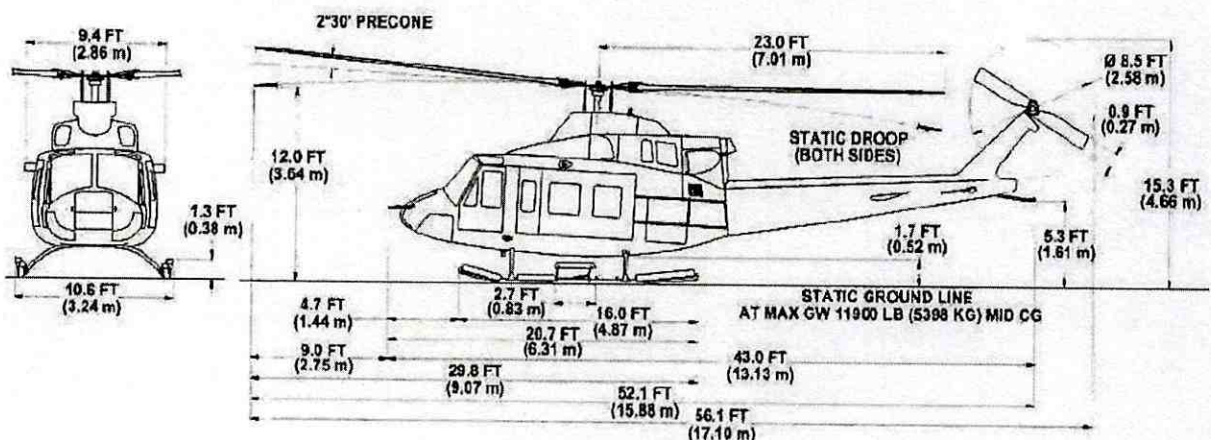
## Helicopter's dimension. (D value 17.1 meter)

smaller than the D value of the helicopter. The D value of the H/c is 17.13 meter. When helicopter made a 40 degree turn it hit the crane structure, as the deck size is smaller than the D value of the H/c. The smaller size of the deck caused obstacle to come well within inside the helicopter D value.

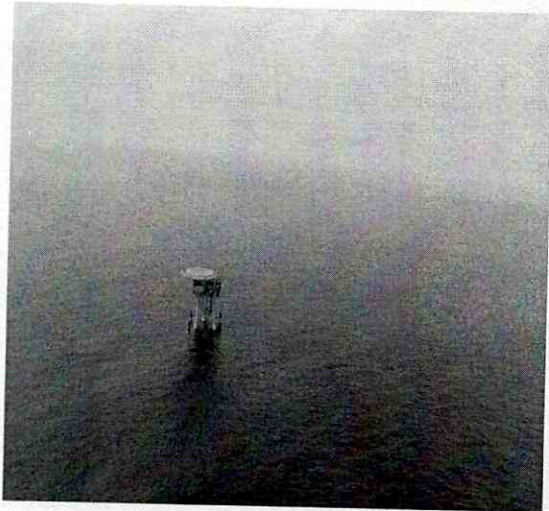
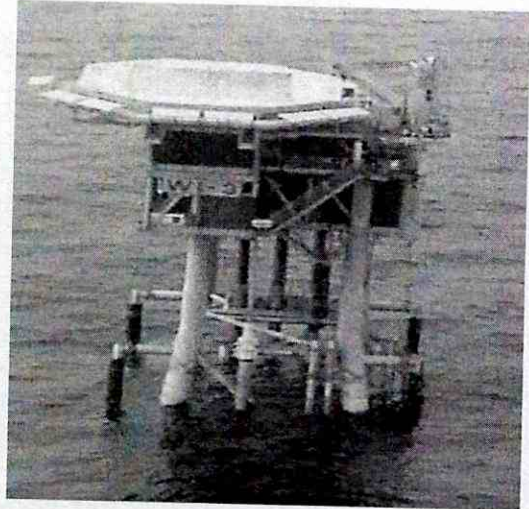
Information	NC Deck	WI3 unmanned P/F (Incident place)	WIN
D value	13.5 meter	14.7 meter	25 meter

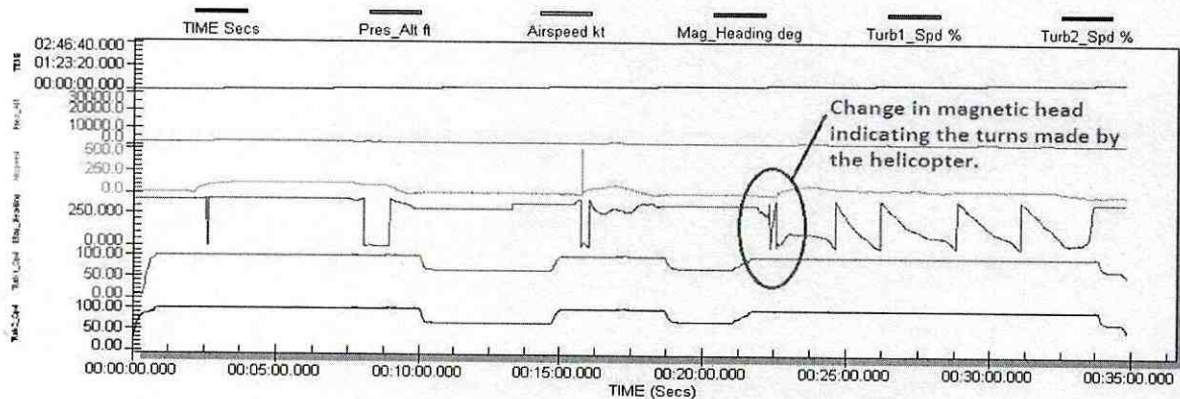
Graphs (from DFDR readings):

From above data it is observed that, the helicopter approached the deck with the heading 313<sup>0</sup> with an average airspeed of 15 kts. At an relevant time from 21:54:8 to 21:59:8 i.e. in 4 seconds helicopter heading changed from 311<sup>0</sup> to 273<sup>0</sup> i.e. almost 40<sup>0</sup>.

As shown in circle in above DFDR data.

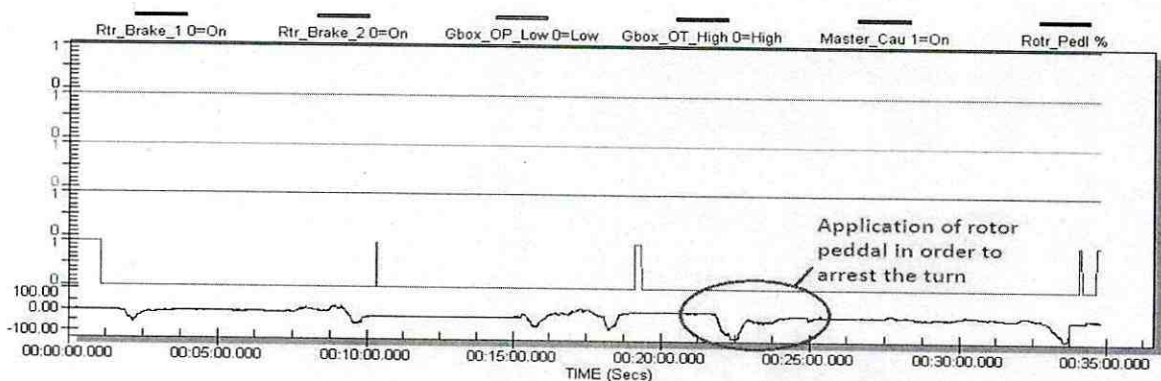
Graphs (from DFDR readings):

Helicopter heading changing twice in a rotational motion while the forward speed of the H/c is zero. Also the rotor pedal application was up to its maximum level during this period.

From DFDR it is also observed that the pilot tried to arrest the helicopter turn by applying the rudder pedal to the maximum. But, he was unable to arrest as the tail rotor of the helicopter got sheared after heating the structure and lost its effectiveness.
