**FINAL INVESTIGATION REPORT ON
SERIOUS INCIDENT TO M/s. PAWAN HANS
LTD. DAUPHIN SA 365 N HELICOPTER
VT-ELR ON 20.11.2013
NEAR CHOWRA ISLAND.**

S. Durairaj
Deputy Director-AAIB
Chairman, Committee of Inquiry - VT-ELR

1	Aircraft		
	Type		DAUPHIN SA 365 N HELICOPTER
	Nationality		Indian
	Registration		VT-ELR
2	Owner		M/s Pawan Hans Ltd.
3	Operator		M/s Pawan Hans Ltd.
4	Pilot – in –Command		Flying under Rule 160
		Extent of injuries	None.
5	Co Pilot		Flying under Rule 160
		Extent of injuries	None.
6	No. of Passengers on board		05
		Extent of Injuries	None
7	Last point of Departure		Kamorta Helipad.
8	Intended landing place		Car Nicobar Helipad.
9	Place of Incident		About 35 NM from Kamorta Helipad.
10	Date & Time of Incident		20.11.2013, 05:55 UTC
11	Type of Incident		Rear Sliding/flap Door Flown off during flight

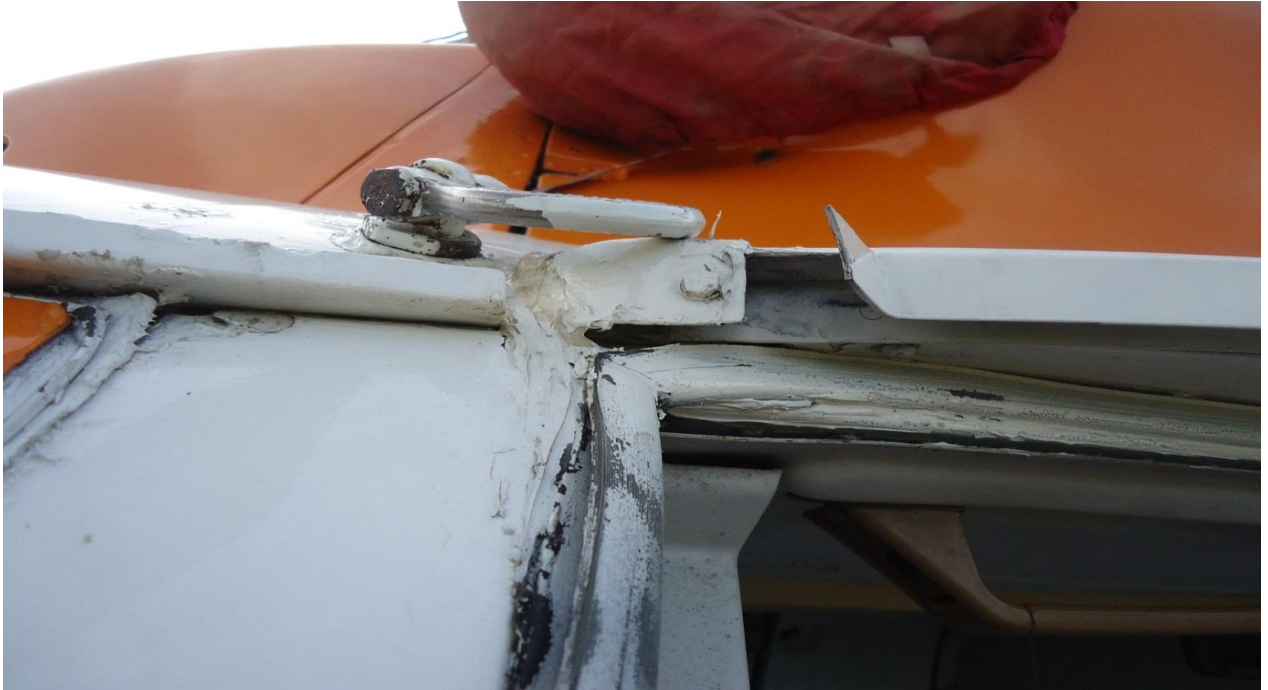
1. Portion of LH sliding door Upper Rail had a tear near the forward end.

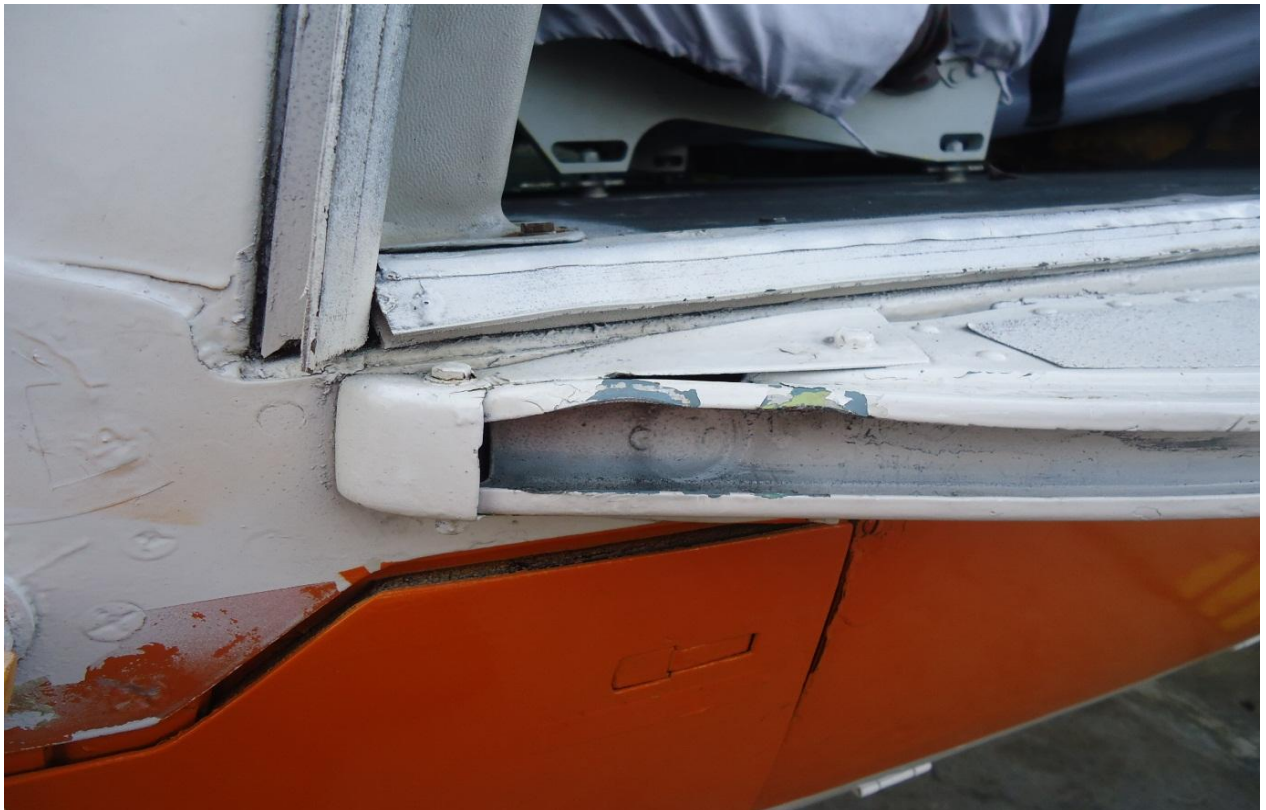
2. LH Sliding door lower rail had two curved displacement of the upper side rail near the forward end due rollers being forced through it.

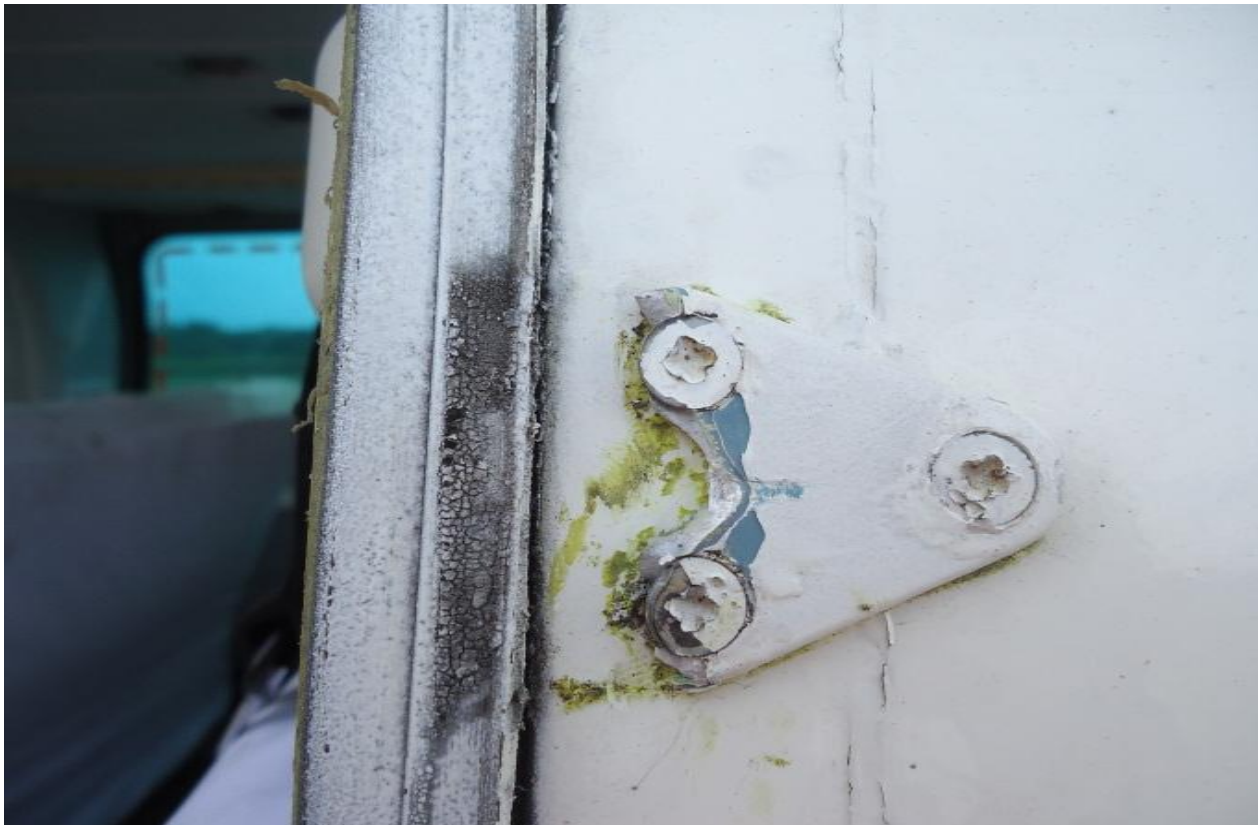
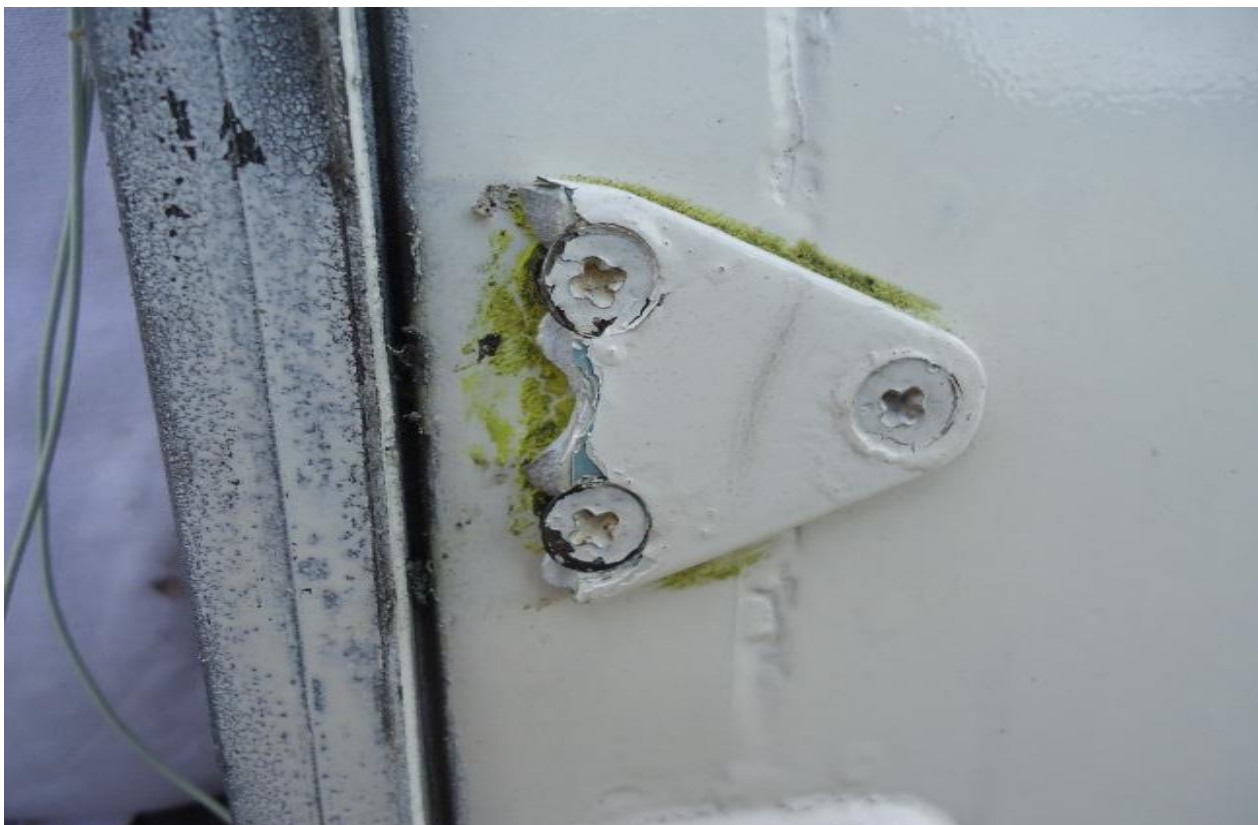
3. Flap door locking plates(upper & lower) were sheared off.

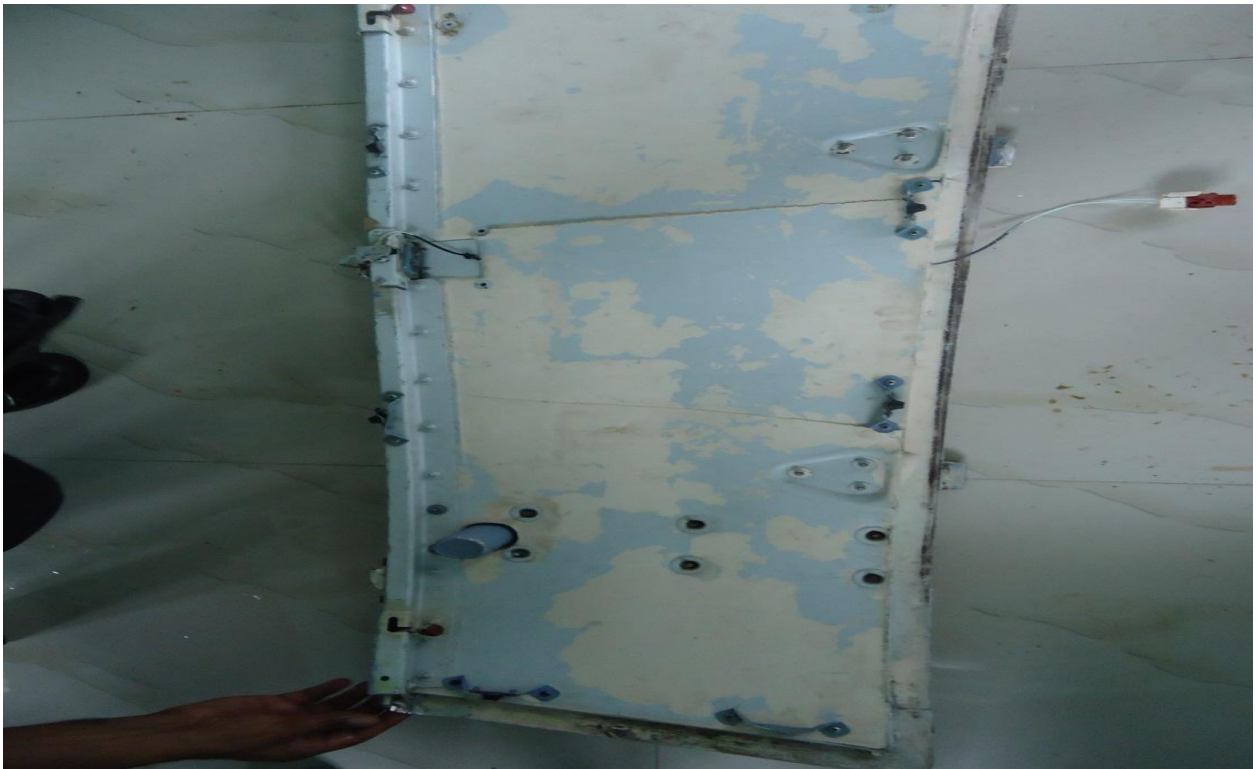
6. Damaged Flap door recovered from the Sea Coast on 22.11.2013.

The fixed door and its central lock was found cracked probably due to post failure damage.

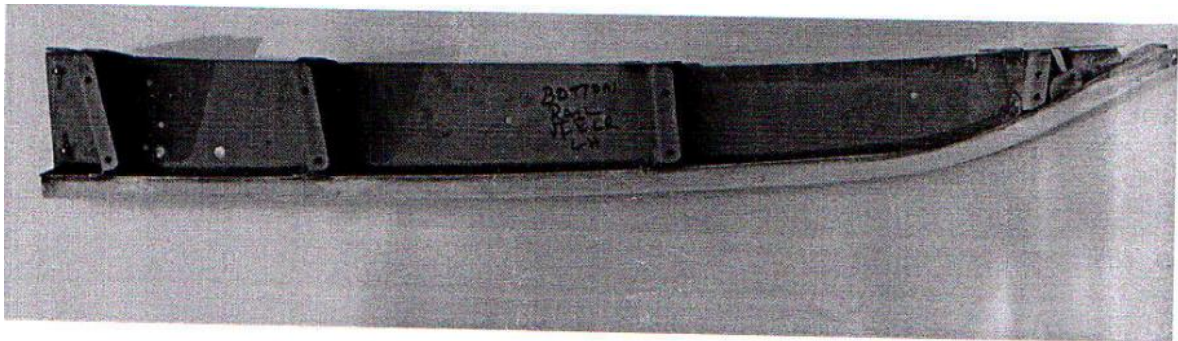
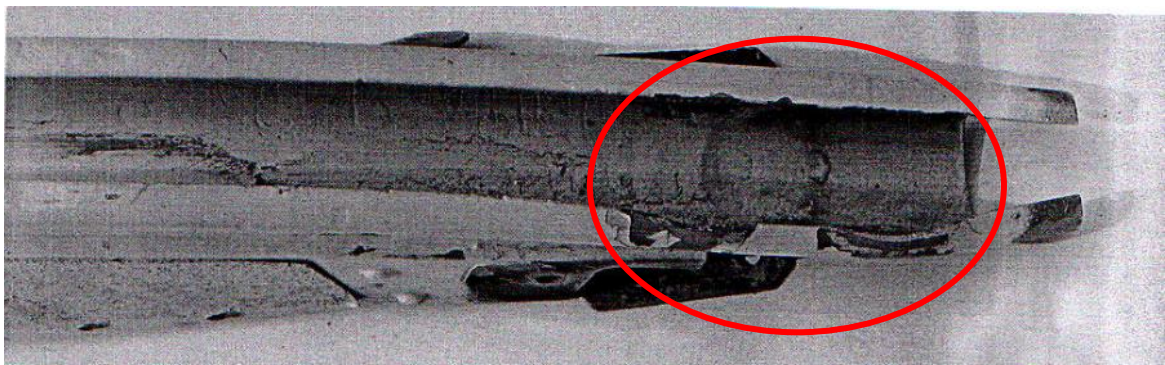
Both ends of the lower rail along with complete rail portion were examined on the microscope as shown in Fig. 1(a) & 1(b). On one end, there is an evidence of excessive load/oversize marking of the roller as shown in figure:-

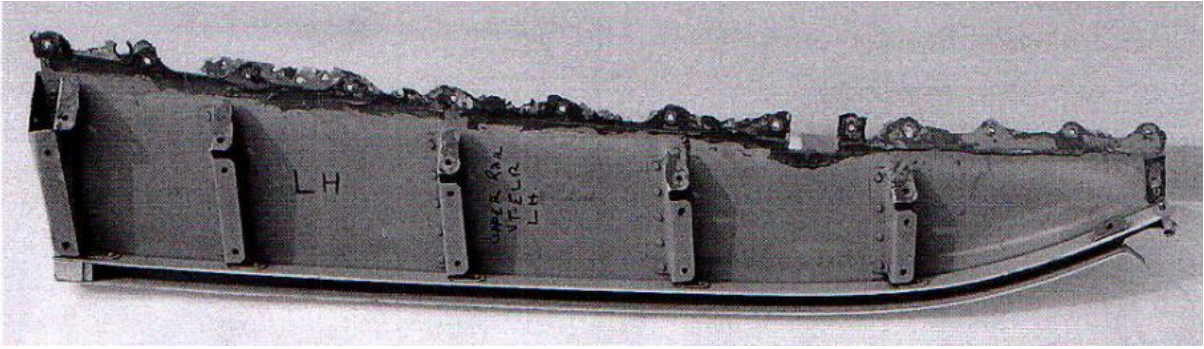
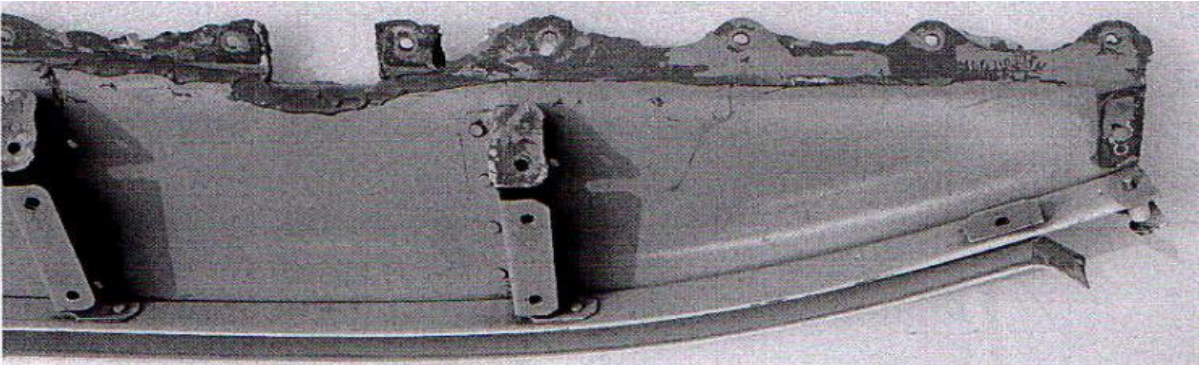
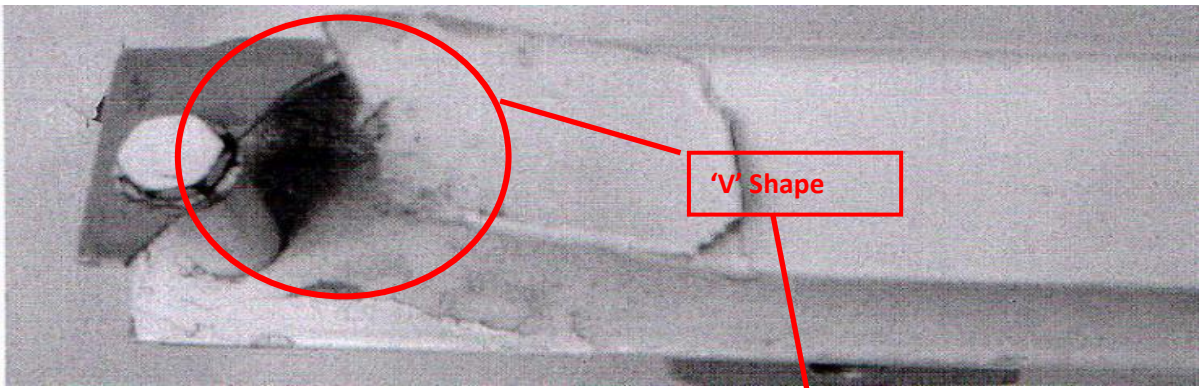
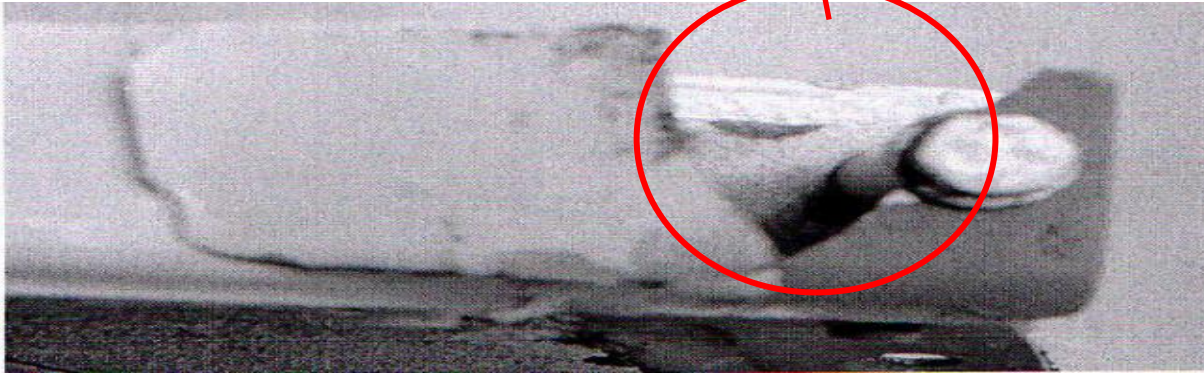
Complete rail portion was examined on the microscope as shown in Fig 2(a) & 2(b). It was noticed that on one end, some portion of the rail was found bent. After straightening the bent portion, it was found that some portion ('V' shape) was missing as shown in Fig 2(c) & Fig 2(d). It appears that this portion might have gone missing after fracture during the helicopter operation, the remaining mating portion of 'V' shape was cut to observe the fracture surface. The same was prepared for detailed examination after cleaning with acetone. Fig. 3(a) 3(b) are the fractographs indicating the slowly developed progressive crack originating from bolt hole followed by final overload fracture.

The missing(V-shape) portion was found to be cracked in a progressive manner as shown by smooth fracture on available fracture surface which has probably initiated from the bolt hole, the bent portion of rail shows that overload might have caused the bend resulting into detachment of V shaped portion.

The probable cause of the incident is due to the progressive failure of upper rail followed by final overload fracture which created excessive air pressure through the partially opened LH door forcing both LH Sliding and flap door to detach from its security of attachment and consequently resulted into the incident.

- 4.1 M/s PHL may review the in-house procedures on frequency of inspection on the door operation including its security of attachment.
- 4.2 M/s PHL may review the in-house procedures for traceability of non-serialized part and shall reflect in the respective log book whenever any such part is replaced/cannibalized.

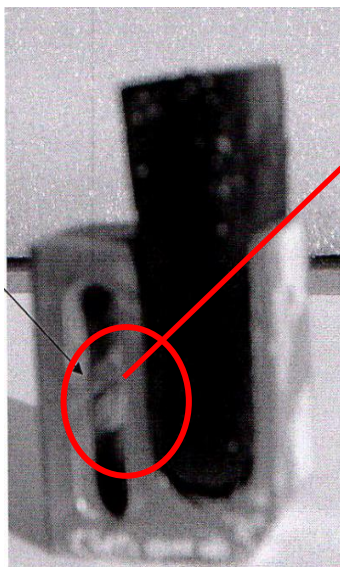
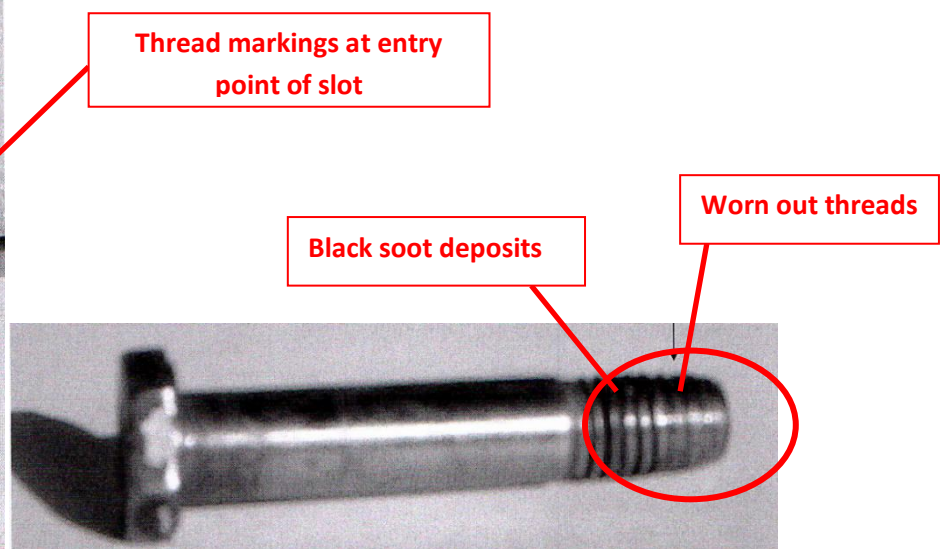
Sliding door stop & screw was studied on the microscope as shown in fig. 4(a) & 4(b). Some threads markings were observed at the entry point of the slot perhaps due to misalignment of stop & screw during the service. Initial portion of the screw threads were found worn out. On the remaining threads, black soot was found deposited.

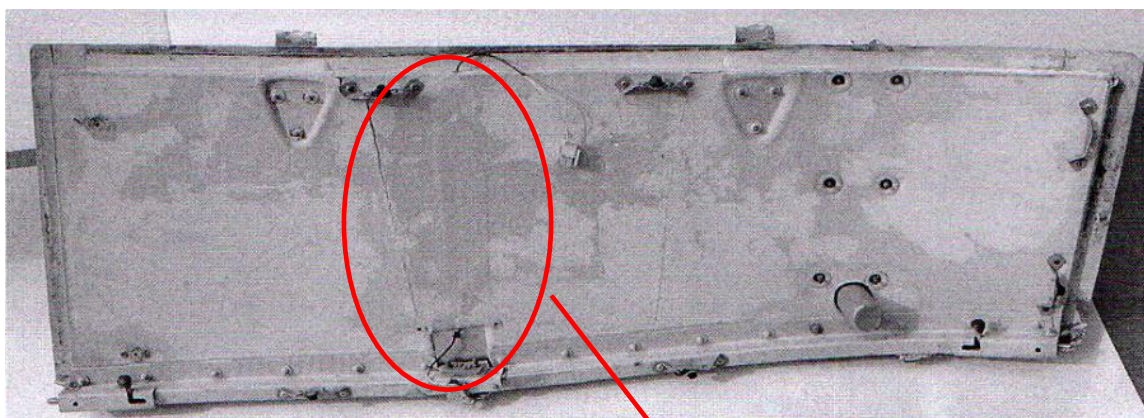
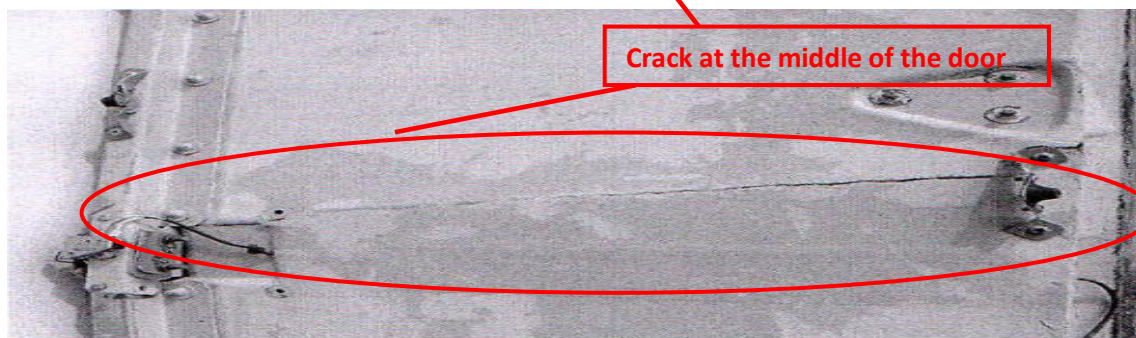
Flapdoor is shown in fig 5(a) & 5(b). After inspection, it was found that door was cracked from the middle (approx.), which is perhaps due to bending of door post incident.

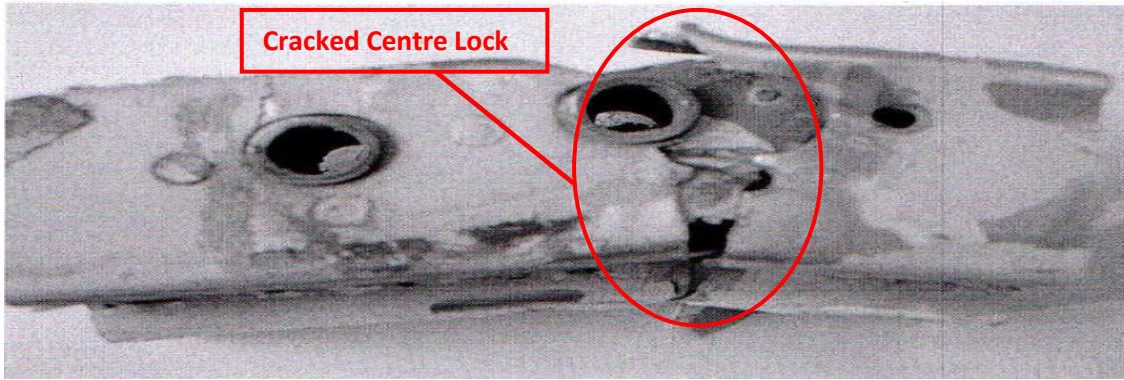
Fig. 5 (d)

Examination of the centre lock revealed that it has cracked (fig. 5d).

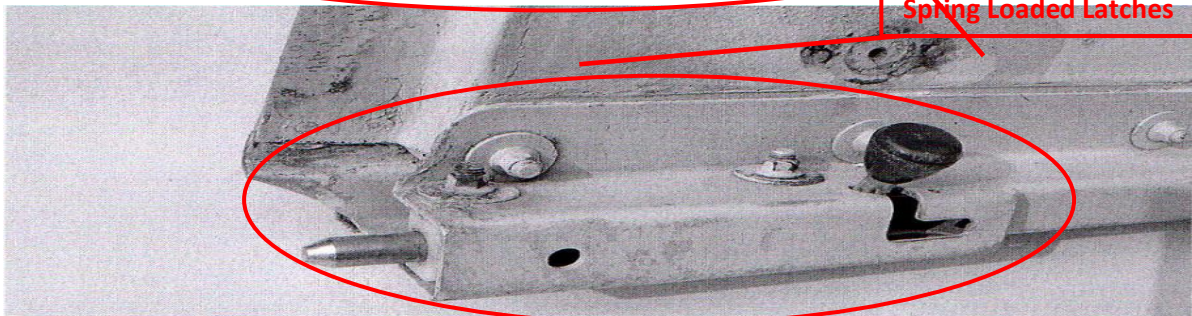
Spring loaded Latches were available on the both sides of the door as shown in fig 5(e) &5(f). Both latches were found in intact condition as shown in figures.
