**FINAL INVESTIGATION REPORT OF SERIOUS
INCIDENT TO HARYANA INSTITUTE OF CIVIL
AVIATION CESSNA 152 AIRCRAFT VT-EMT
AT PINJORE ON 03.11.2012**

GOVT OF INDIA
CIVIL AVIATION DEPARTMENT
O/O DIRECTOR AIR SAFETY
NORTHERN REGION
SAFDARJUNG AIRPORT
NEW DELHI-03

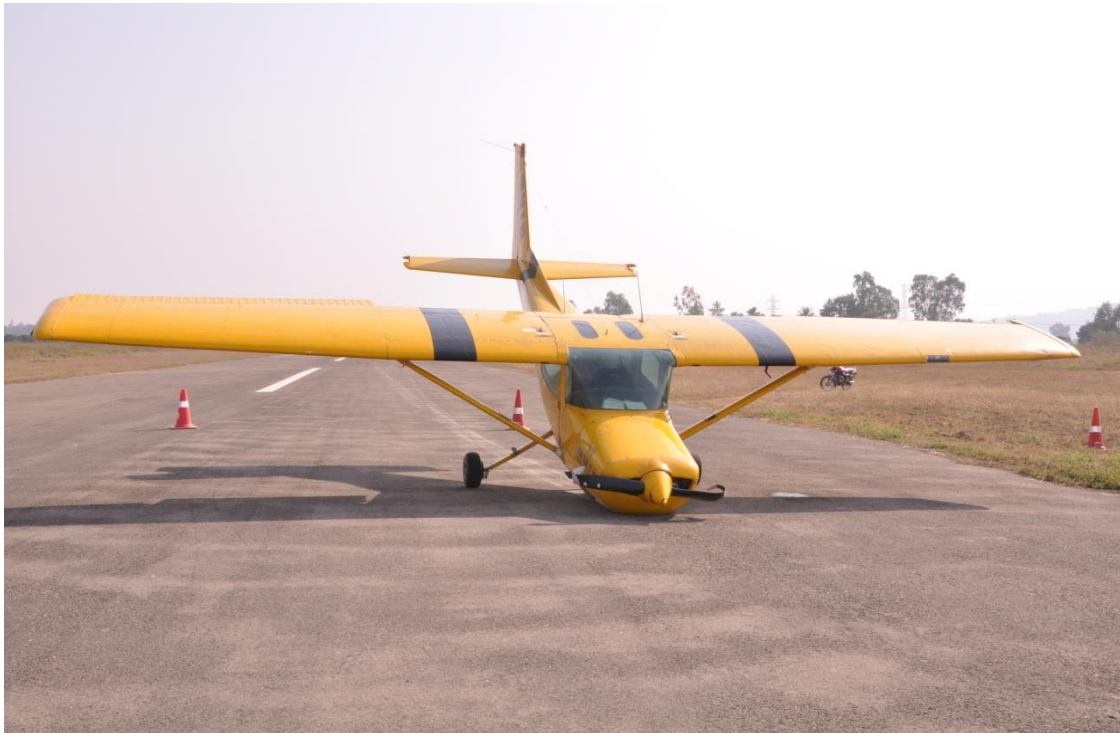
Fig.1 Showing aircraft final position veering to the left with nose under carriage collapsed.

11. Subsequently pilot tried to carryout go around by applying full power and forward pressure on the stick however aircraft impacted its engine cowl due collapsed nose gear with the runway surface and dragged on the runway and stopped.

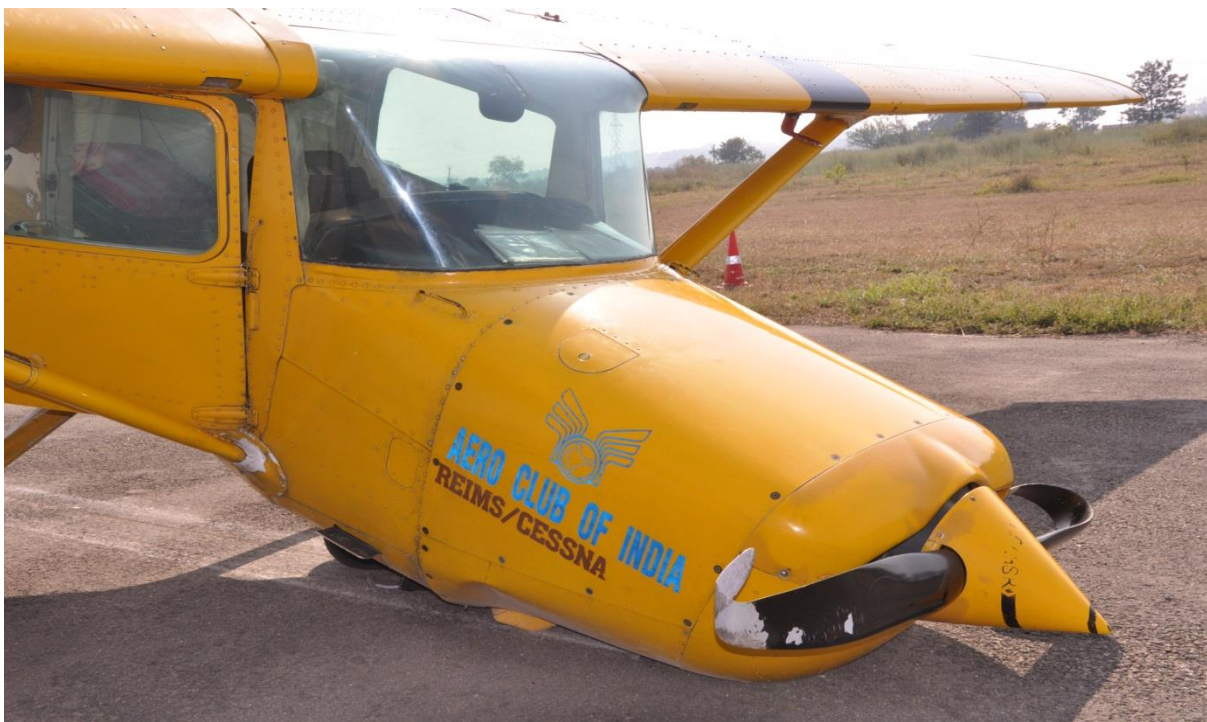
1. Both the Propeller blades damaged.
2. Engine mount damaged.
3. Nose undercarriage damaged.
4. Main undercarriage axles bent.
5. Firewall dented.

Fig.2 Showing both the propeller blades bent

10. Student pilot when approached the runway 34 for landing did not give proper check before touch down which resulted in propeller blades contacting the runway surface due collapsing of nose gear.

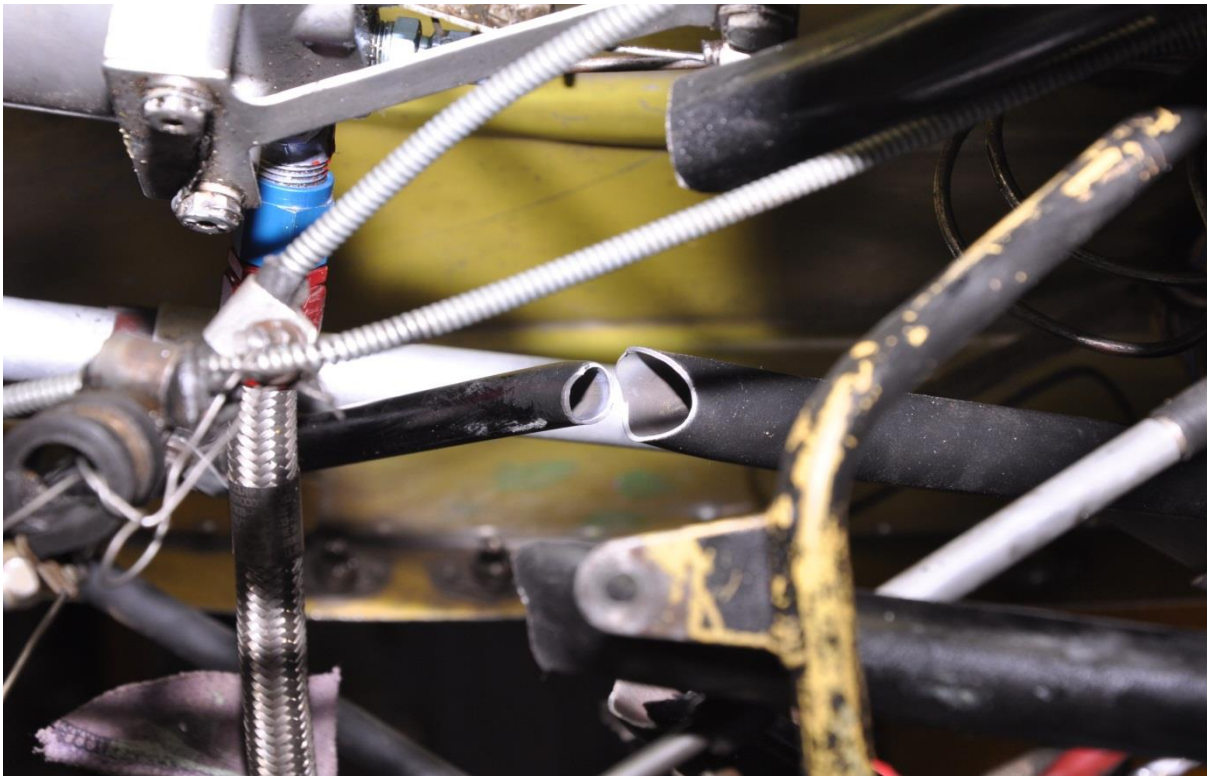
Fig.3 Showing Engine mount damaged.

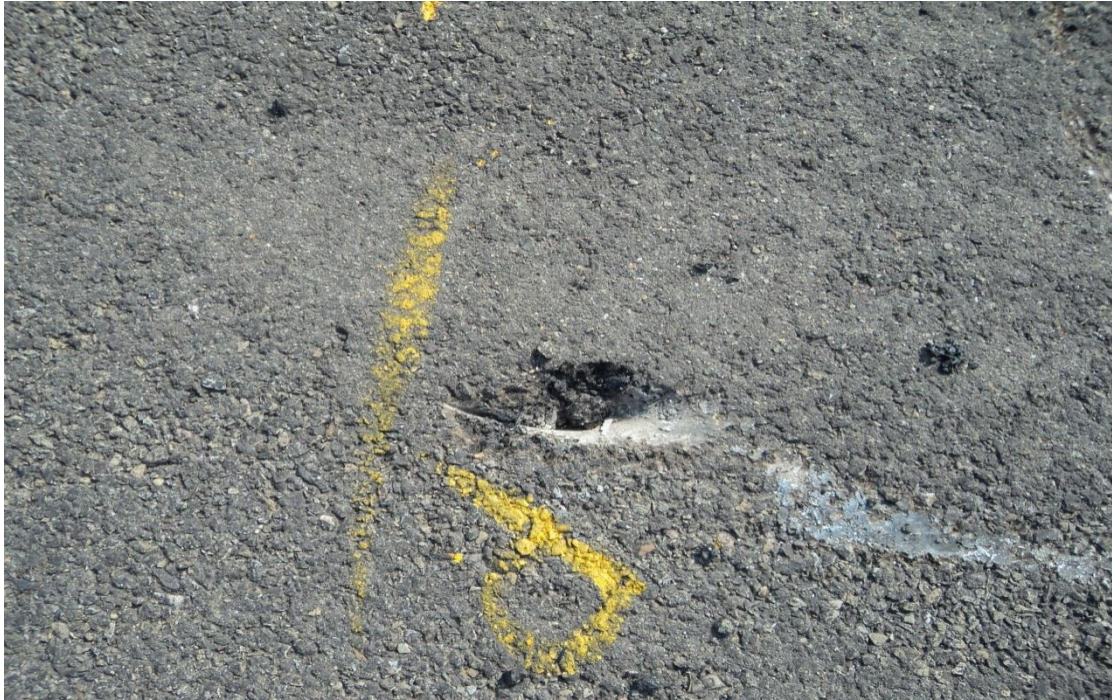
The aircraft approached from R/W 34. The aircraft first came in contact with the runway surface at about 400 feet from beginning of R/W 34 with the propeller blade marks after its nose gear collapsing. Thereafter the engine cowl marks were present which continued upto 684 feet of R/W. The aircraft finally stopped at 684 feet from the beginning of R/W 34. Aircraft dragged around 250 feet on the runway before coming to final halt. The flap lever was found at 20° position in the cockpit. The rubbing marks were found towards the left of centreline of the runway indicating that during final approach the aircraft was not aligned with the runway.

Fig.4 Showing deep cut due propeller blade strike on the runway

12. Ground marks indicates that when the aircraft first contacted runway surface on its nose with propeller blades contacting the runway the full power on the engine was not applied by the pilot and he relaxed on the stick as it travelled small distance in air and then touches on its engine bottom cowling and finally came to halt.
