SYNOPSIS:-

Cessna-FA152 aircraft VT-EMU operated by M/s. M.P. Flying Club was engaged in a dual flying for touch and go exercise at Devi Ahilyabai Holkar Airport, Indore on 12/06/2013. At around 1251UTC, during second sortie while climbing on the crosswind leg at approx. 2200ft, abnormal noise was heard by the crew from the engine, followed by vibrations and complete power loss. The instructor took over the controls of the aircraft and turned the aircraft towards the runway. Meantime he tried to recycle the throttle in order to regain power, but there was no response. The instructor selected an open field and carried out forced landing on cultivatable land just outside the airport. When the aircraft was about to stop, the nose wheel mired in soft soil and the aircraft toppled.

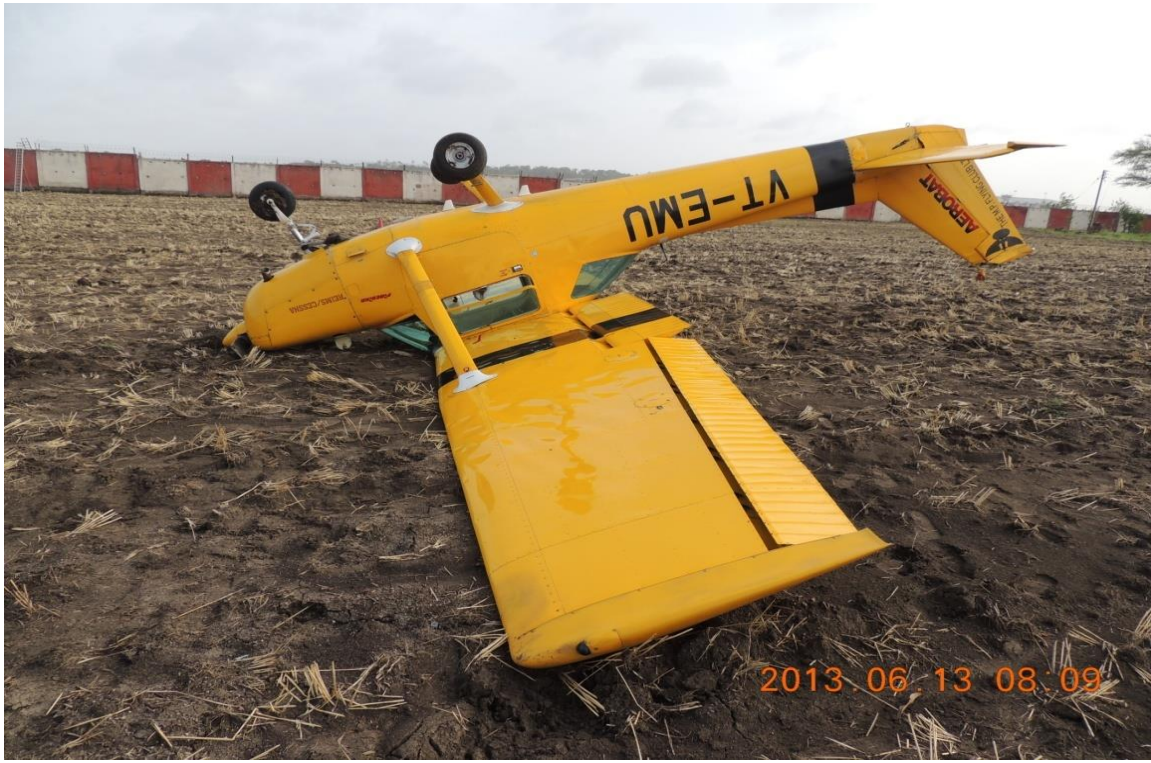
Fig: 3:-Portside wing leading edge near wingtip found damage.

- (a) Leading edge of Fin at the attachment of Beacon found damaged.
- (b) Rudder tip found damaged.
- (c) Tail cone bottom surface found wrinkled.
- (d) Port wing leading edge near wing tip found damaged.
- (e) One side propeller blade found bent inward (approx. 15-20 degrees)
- (f) VHF antenna found broken.
- (g) LH inboard lower wing skin wrinkled at rear spar.
- (h) LH wing leading edge skin outboard at wing tip found cracked and buckled.
- (i) LH wing tip found cracked.
- (j) Fuselage bottom tail cone wrinkled.
- (k) Top of fin skin buckled and damaged.
- (l) Beacon assembly at the top of the fin found damaged.
- (m) Rudder cap assembly found damaged.

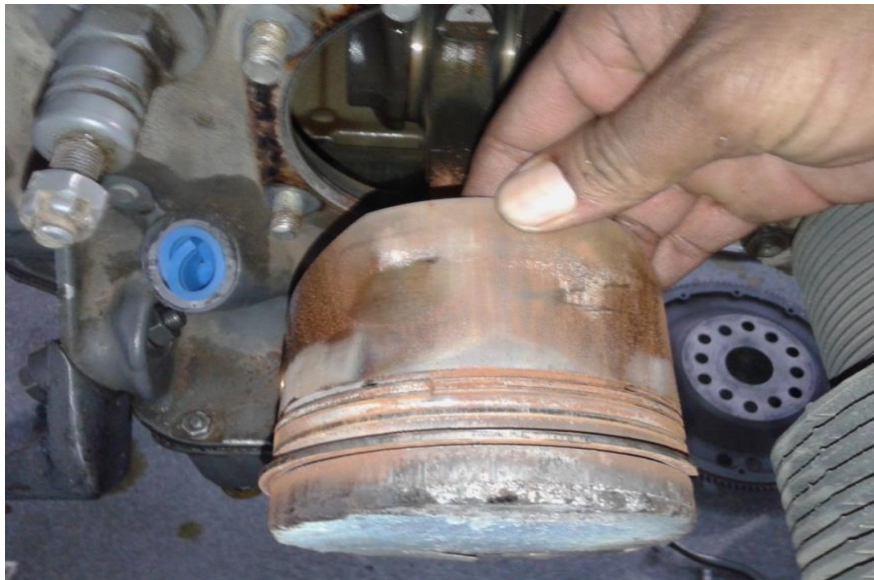
- d) After removal of cylinder No.3 the engine was found rotating freely. Heavy corrosion was noticed in No. 3 cylinder bore and the rings of the piston. The piston rings were also stuck in groove of the piston. The heavy corrosion was noticed on No. 3 cylinder.

Fig 5: No.3 Cylinder and its Piston rings

After removal off no.3 piston, the crankshaft was free to rotate and subsequently other pistons were removed. During engine strip analysis, it was observed that heavy corrosion was noticed in No. 3 cylinder bore and the rings of the piston. The piston rings were also stuck in groove of the piston.

14.2. Lack of lubrication lead to the seizure of the piston rings. The Lack of lubrication could be due to overheating of the No. 3 cylinder because of lack of cooling of the Cylinder head and barrel and/or due to supply of lean mixture to No.3 Cylinder due to external air leakage to the cylinder which can occur at the joint face of air/fuel mixture intake pipe and to No. 3 cylinder.

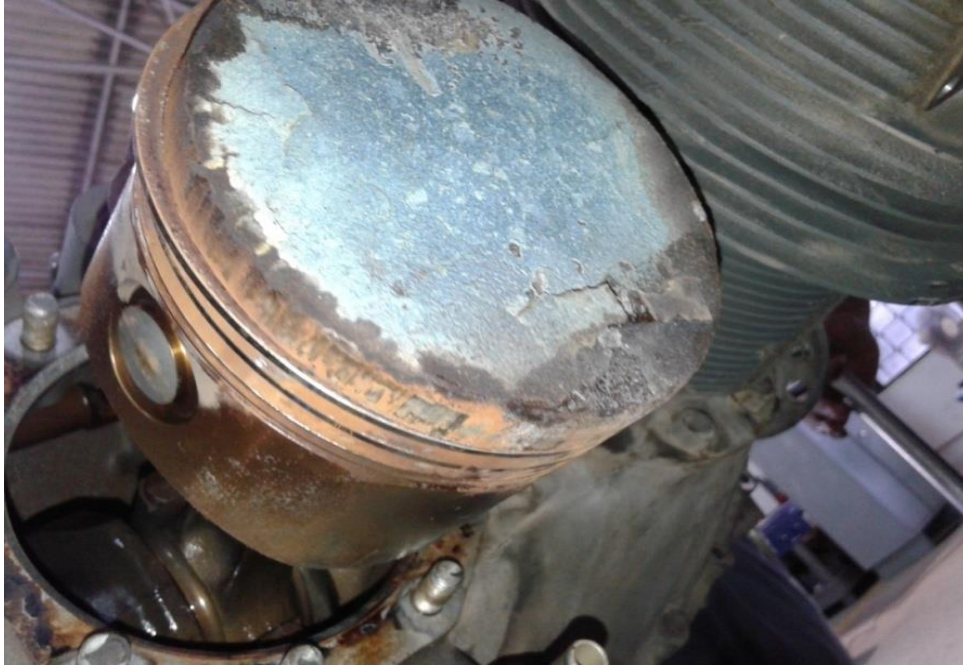
- a) Visual inspection of pistons were carried out and followings were the observations:-
 - i. High amount of carbon deposit was found in the ring grooves of Piston No. 3 as compared to other three pistons.
 - ii. Carbon deposits noticed on dome of the Piston.
 - iii. No detonation sign was found on all the pistons.
 - iv. Piston rings were found in stuck position on No. 3 piston without any movement and badly corroded. Blockage of oil ring passage was also witnessed.
 - v. No.3 piston's Piston ring no. 2 was found to be flushed with piston wall inside the groove with no end clearance and also Ring no. 1 & 3 were found flushed with piston wall on one half and protruded on the other half.
- b) Visual Inspection of crankshaft and connecting rod bearing were carried out. No abnormal wear out or scuffing of bearing was found.

Fig 6: Piston dome (Carbon deposits noticed)

- b) Improper cooling of cylinder No.3 leading to high Cylinder Head Temperature (CHT) and resulting in lack of lubrication and seizure of piston in the cylinder No.3.
- c) Heavy carbon deposit in the piston ring grooves of piston no. 3 would not have allowed lubricating oil to enter properly inside and this would have caused seizure of piston in the cylinder.

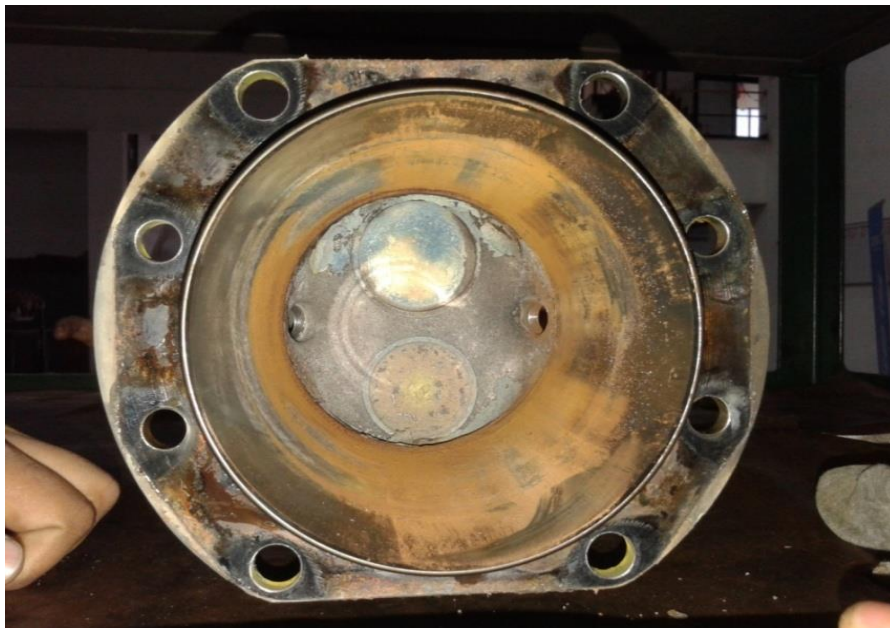
Fig 7: No. 3 Cylinder barrel (in corroded condition)

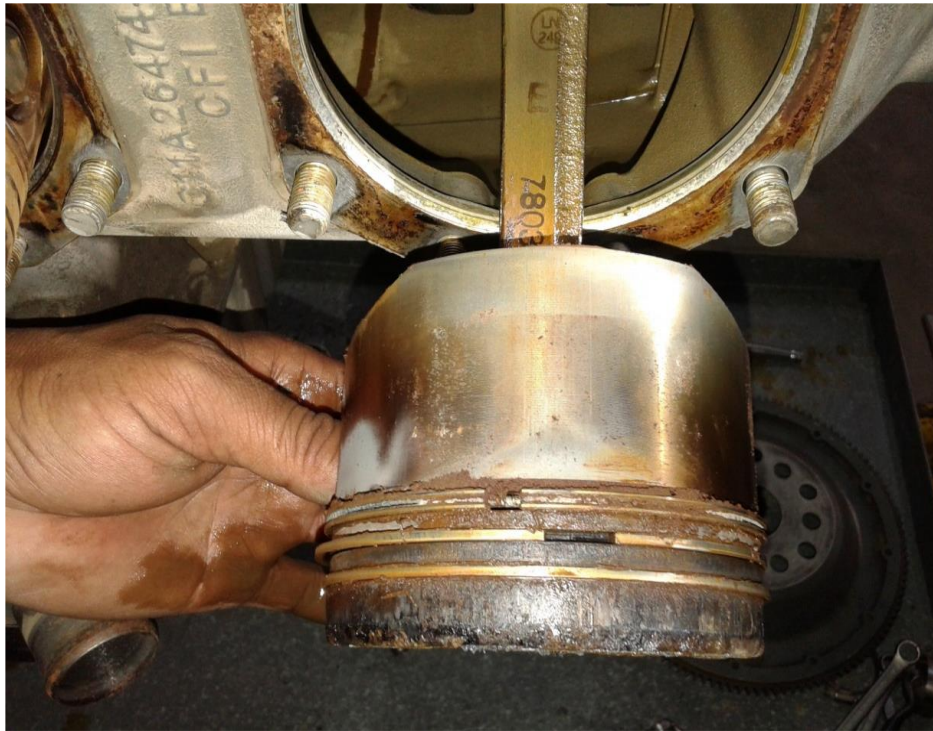
- e) Cylinder no. 1, 2 & 4 were removed one by one. All the cylinder barrels (Cylinder No. 1, 2 & 4) were found slightly corroded. Rust was visible in piston rings area, and piston rings were not free to move in the grooves. On cylinder no. 1, second compression ring and oil regulating ring were found almost in line. On cylinder no. 2 & 4 piston rings were in staggered position. Cylinder bore diameter and Piston rings end clearance was found to be within the limits.

Fig 8: Condition of No.1 piston& its rings

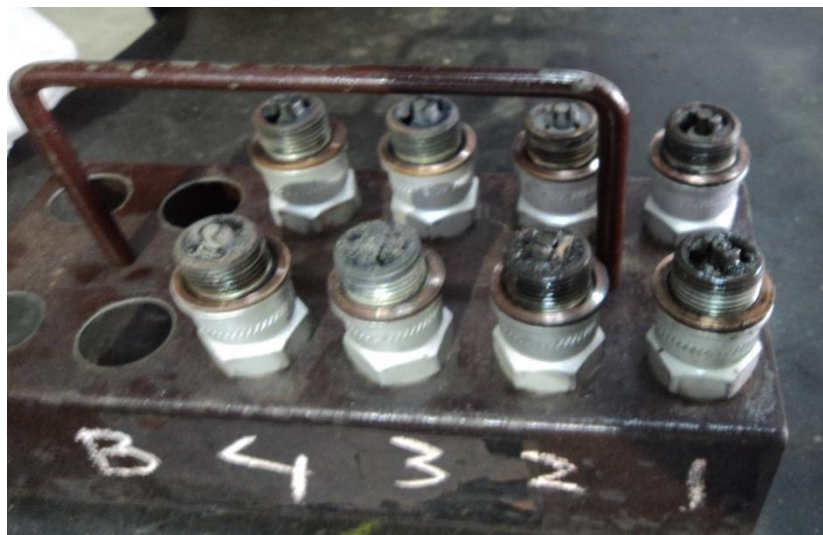
Fig 9: Condition of T(Top) and B(Bottom) Spark plugs after removal

- a) Use of unspecified fuel.
- b) Lead fouling of spark plug due to low power operation of the engine which lead to weak spark and ultimately inefficient burning of charge inside the cylinder.
- c) Burning of oil with the charge.

11. All 08 spark plugs were inspected and found heavy carbon deposits on three bottom spark plugs and particularly more carbon deposits on No. 3 cylinder bottom spark plug. Bottom cylinder No.1 sparkplug found with oil and carbon deposit.

12. During engine inspection at vendor facility it was observed that;
 - 12.1 All the eight spark plugs were subjected to BOMB test and the test revealed that the bottom three spark plugs failed in the test. However No.1 bottom spark plug and four top spark plugs were found satisfactory during test.

14.1. Due to heavy carbon deposits on the bottom spark plugs of three cylinders (Cylinder No. 2, 3 & 4), the spark plugs would have produced low intensity spark resulting insufficient burning of charge inside the cylinder.
