FINAL INVESTIGATION REPORT ON
SERIOUS INCIDENT TO AIR INDIA
LTD. AIRBUS A-320 AIRCRAFT VT-ESI
AT COCHIN ON 21.08.2014

FINAL INVESTIGATION REPORT ON SERIOUS INCIDENT

TO AIR INDIA LTD. AIRBUS A-320 AIRCRAFT

VT-ESI AT COCHIN ON 21.08.2014

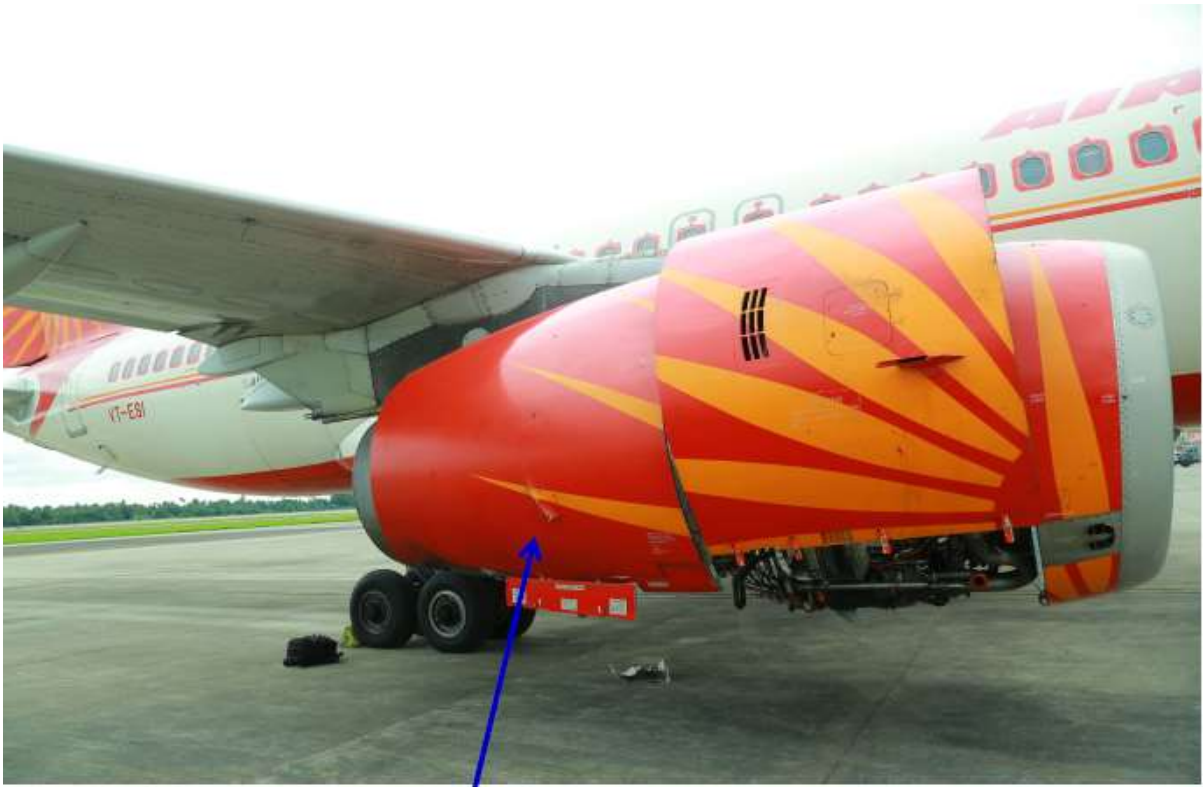
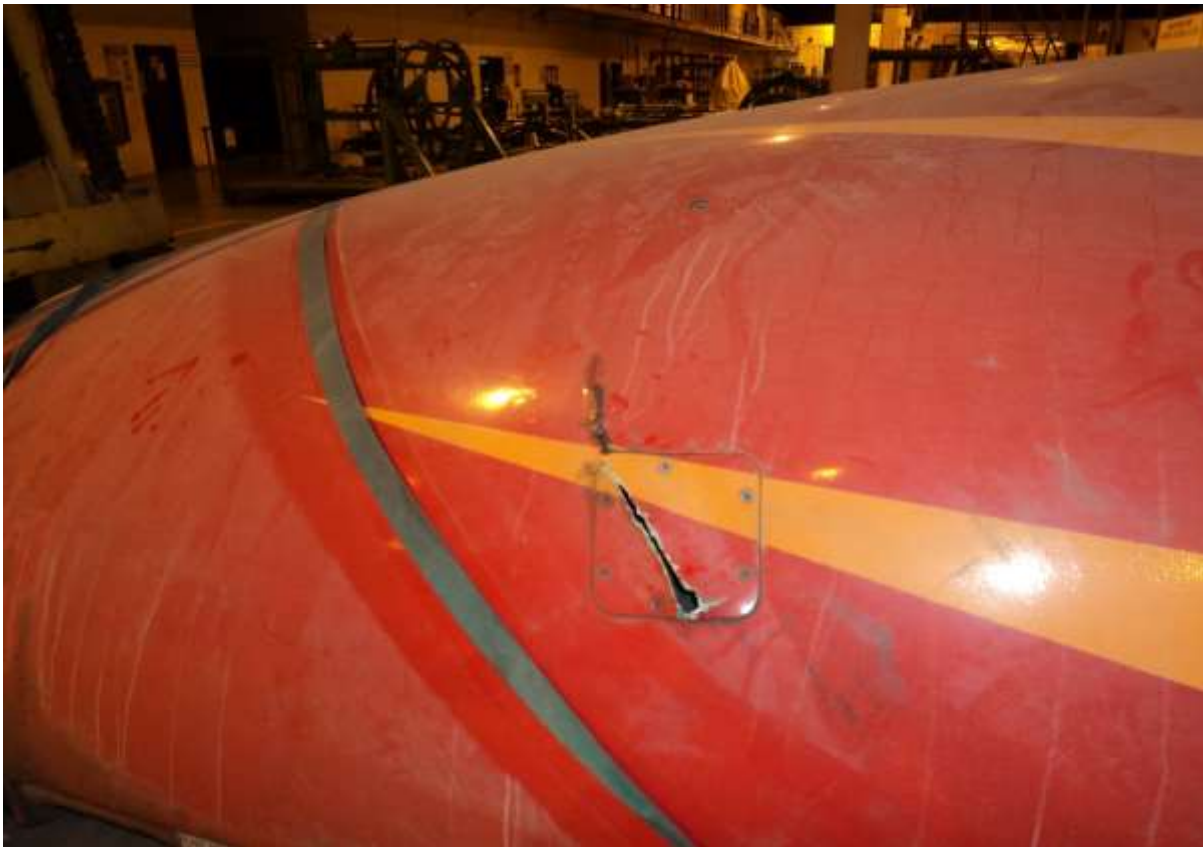
1. Outboard C Duct
 - Outer Barrel found ruptured approximately 12 inches.
 - Inner Barrel Burn mark & rupture observed
2. Inner C Duct
 - Inner Barrel found burnt at 6 O’Clock position.
3. LPT (Low Pressure Turbine) stage 4 blades
 - more than 20% of blades found damaged
 - Most of the stage 4 NGV’s (Nozzle Guide Vanes) found damaged.
4. Overheating was observed on all the latches.

Damage to C Ducts

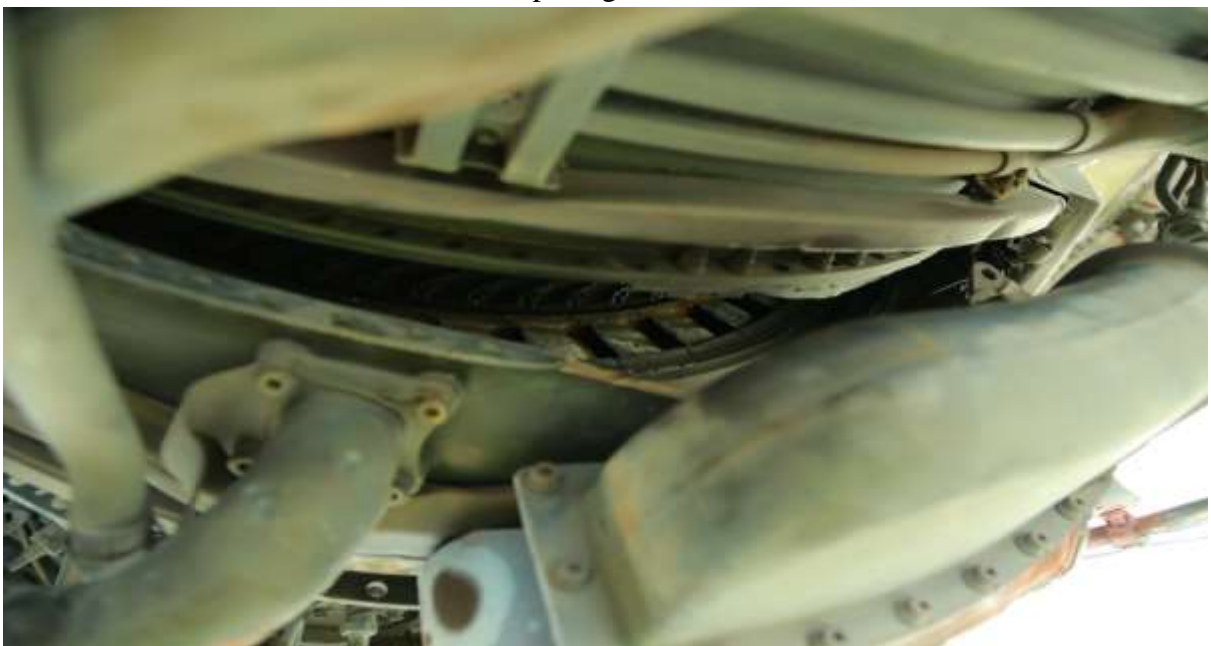
5. The turbine cooling air feed tube at 4 O' Clock position found ruptured.
6. HPT (High Pressure Turbine) case between 1 & 3 O' Clock position found ruptured open.
7. HPT case opened up and ruptured from 6 to 9 O'clock position shearing the 27 bolts on front side and 18 on rear side exposing entire HP turbine area.

The High Pressure Turbine case breached

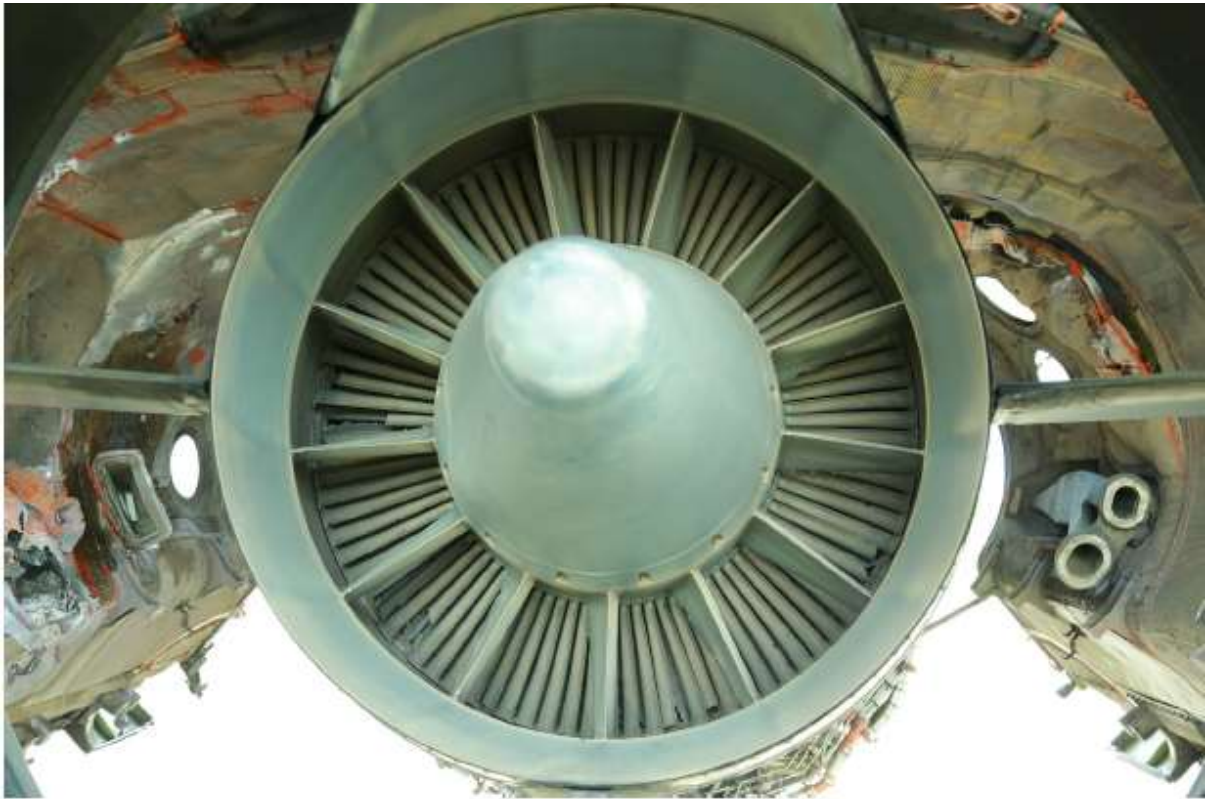
Engine Rear View

8. All the turbine blades of stage 1 & 2 and stage 2 NGV's found missing.
9. Turbine cooling air feed tube at 7 O'clock position found damaged.
10. HPT ACC duct found ruptured.
11. Lot of metal debris found stuck at different locations of the engine.
12. No. 2 shaft seized.
13. The No.1 shaft was found stuck and found difficult to rotate.
14. Fire bottles were found discharged.

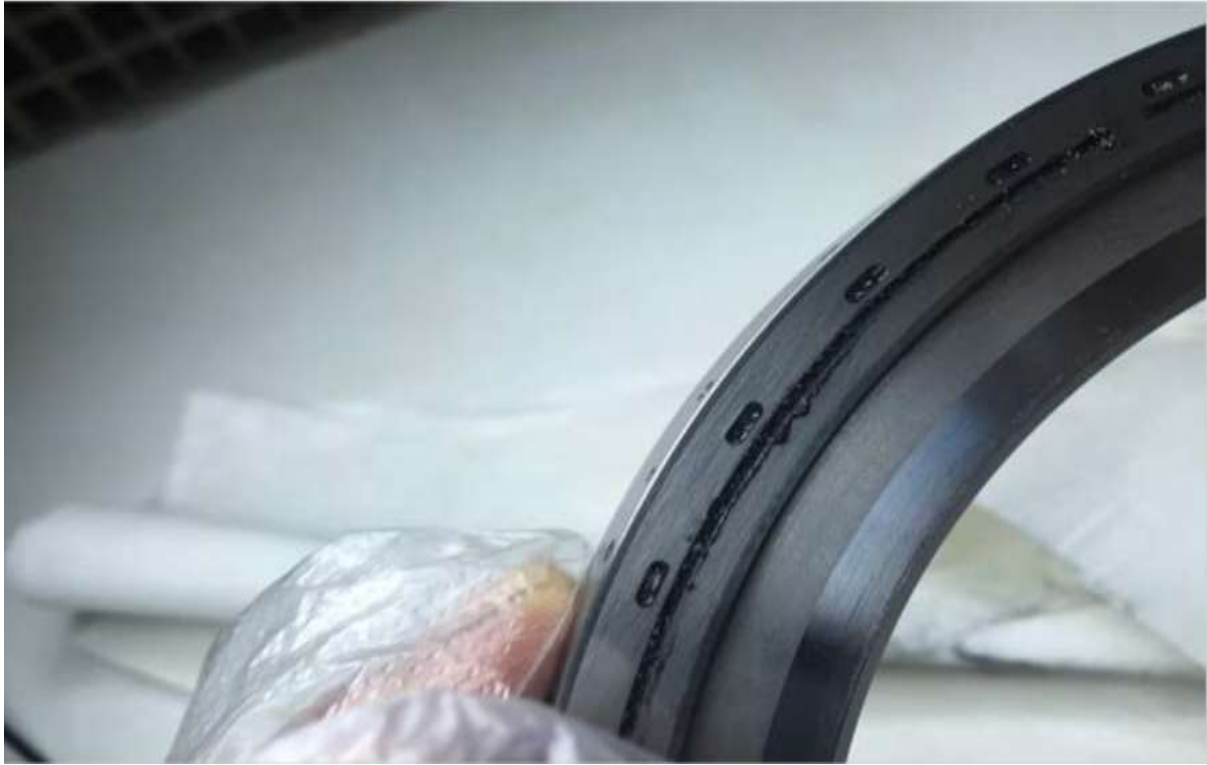
Image #9 – Debris removed from demonstration seal plate groove after process complete.

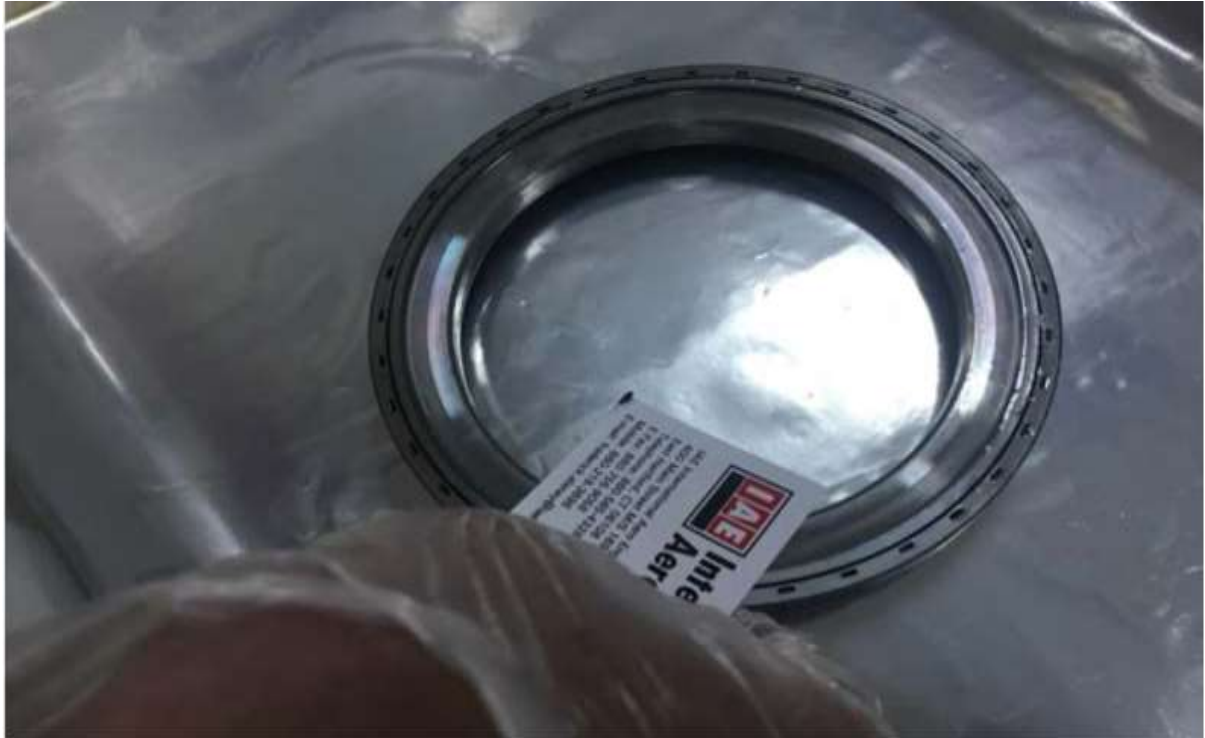
After this observation was made, JEOC personnel then physically removed as much material as possible with plastic picks and ran the part through the cleaning cycle a second time. Another business card was inserted and debris was present again but to a lesser degree than the original attempt to check for debris. See image #10.

Image #10 – Debris removed from demonstration seal plate after second cleaning cycle.

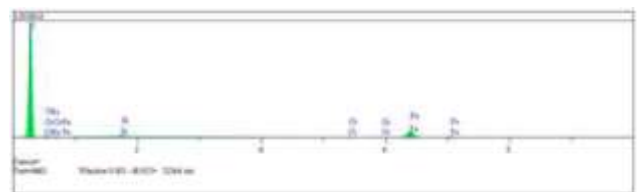
Debris from JEOC Demonstration Seal plate

- Chemistry and aspect ratio of metallic Debris & Diamond particles matches OEM lapping Debris.
- Diamond particles not found in environmental debris
- Barium found in anti-weep grooves of both V0118 event seal plates & JEOC demonstration seal plates; source identified as preservation fluid (AeroShell Fluid 12).

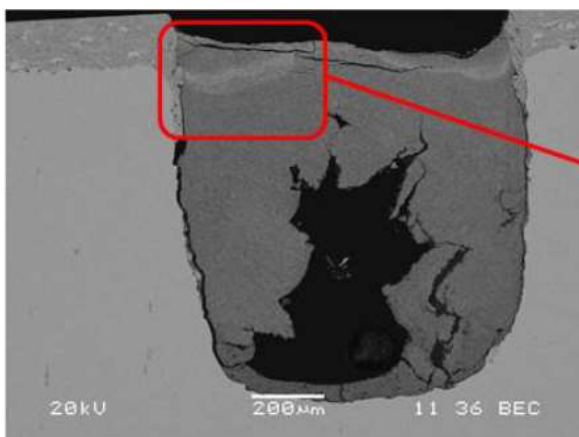
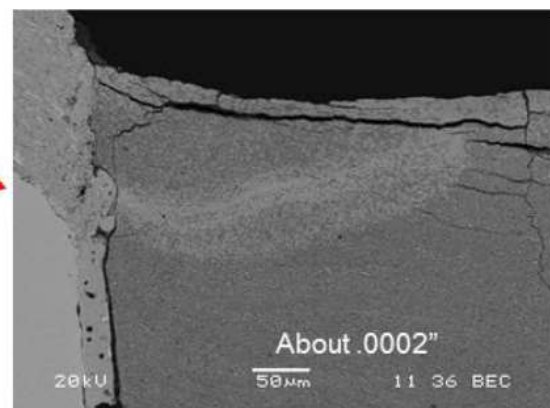
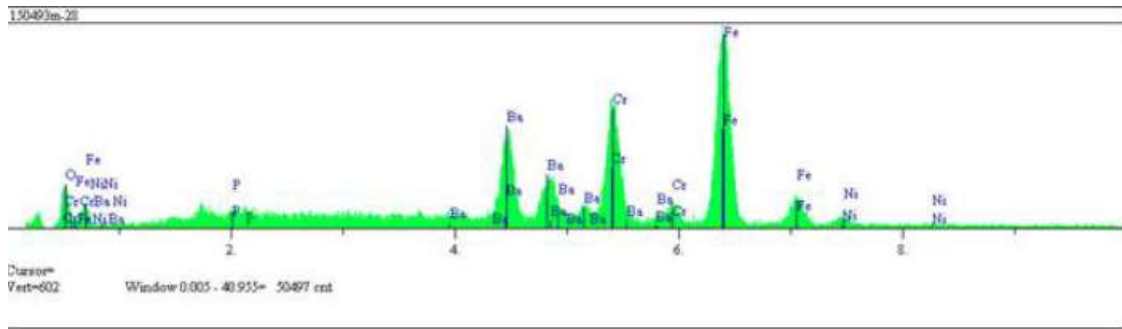
Cross section of V0118 seal plate Anti-weep Groove

- *Barium was not found outside of V0118 Anti-Weep Groove, Therefore it was not environmental.*
