FINAL INVESTIGATION REPORT

**GROUND INCIDENT INVOLING M/S ETHIOPIAN AIRLINES
AIRCRAFT ET-AMG AND M/S AIR INDIA AIRCRFT VT-EXD AT DELHI
ON 08.08.2017**

FINAL INVESTIGATION
REPORT ON GROUND INCIDENT INVOLVING M/S ETHIOPIAN AIRLINES
AIRCRAFT ET-AMG AND M/S AIR INDIA AIRCRAFT VT-EXD AT DELHI
ON 08.08.2017

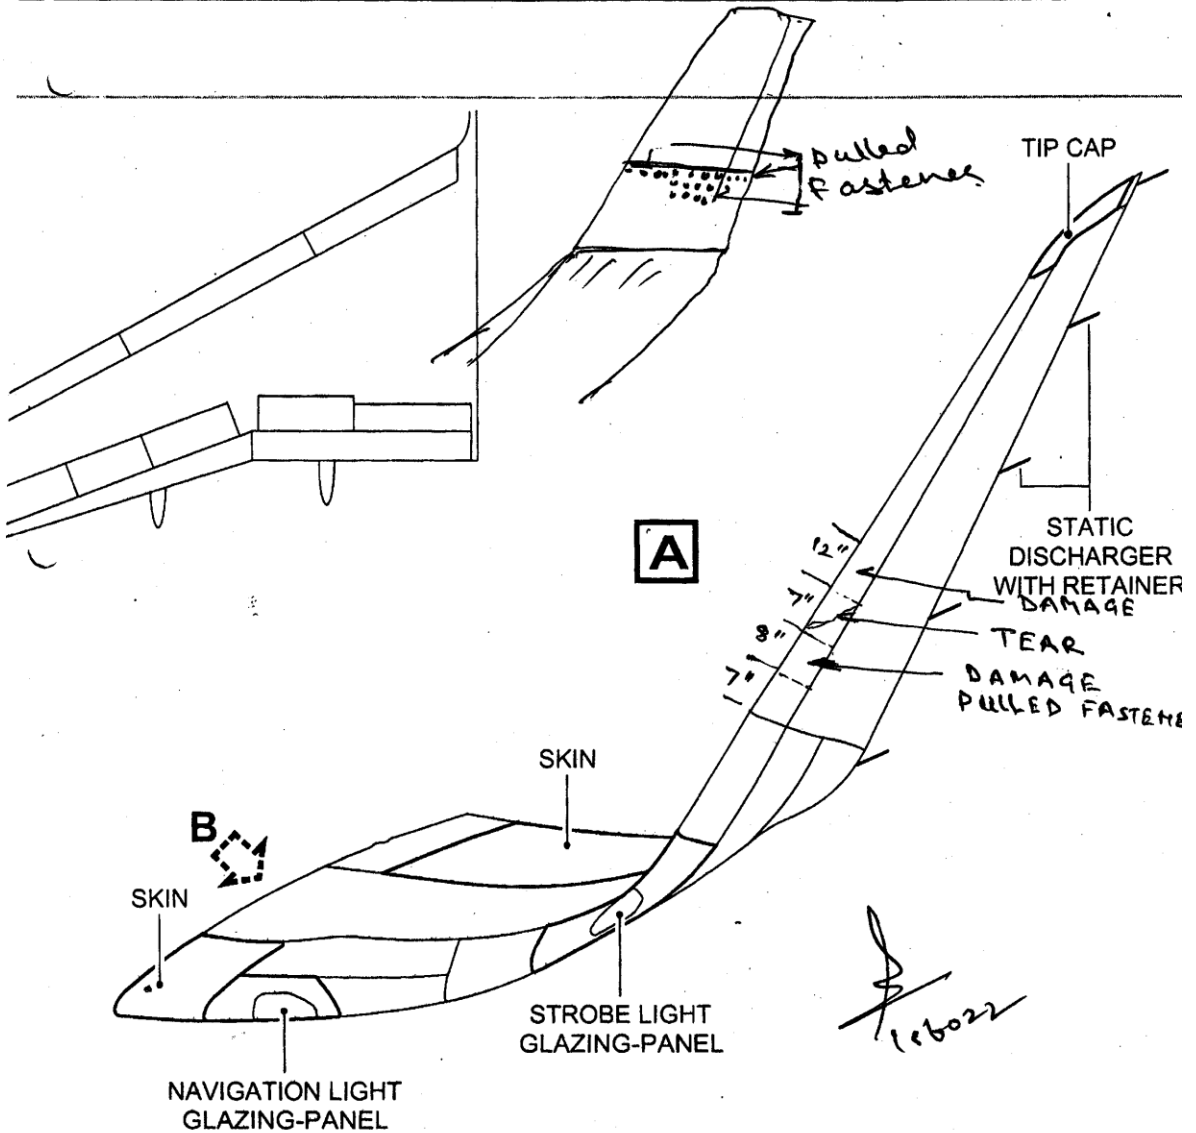
M/s. Air India A320-214 LHS Sharklet got damaged.

- A. Leading Edge of Sharklet Out Board side has the following damages;
Dent and Distortion, Tear, Fasteners were pulled, small portion of Leading Edge had separated from Sharklet spar.
- B. Inboard side middle chord wise joint has pulled 20 fasteners.

DAMAGE REPORT
 LHS SHARKLET VT-EXD: MSN 6724
LEADING EDGE - OIB SIDE HAS
 DAMAGE, TEAR, PULLED FASTENER
 SMALL PORTION SEPERATED FROM SPAR.

Schematic depicting damage to Air India aircraft

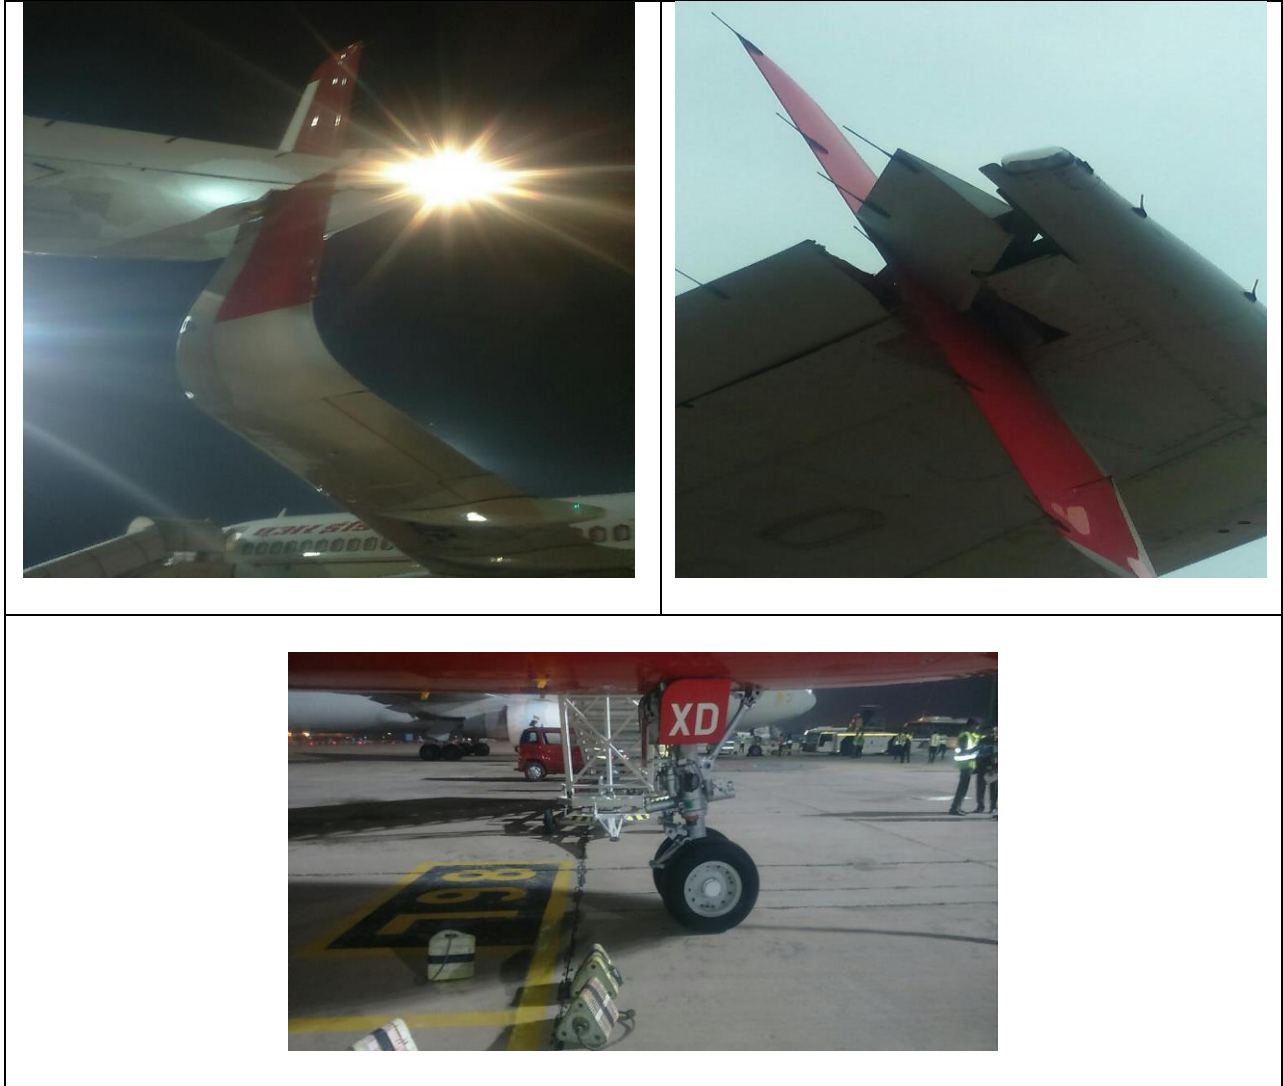
M/s. Ethiopian aircraft after being pushed back approximately 47ft from its nose wheel parked position on lead in/out line of Bay no.87, its starboard side wing made contact with the port side wing of M/s Air India aircraft which was parked on Bay no. 86L.M/s. Ethiopian aircraft starboard side aileron and wingtip sustained damages. M/s Air India aircraft shark let received damages. Approx. 2ft of Ethiopian aircraft starboard side wing pierced into Air India aircraft shark let on its portside.

The Air India aircraft was parked on stand 86L. However after the occurrence, the Air India aircraft got displaced towards the port side. At the displaced position, the nose wheel found approx. 3'4" ahead of nose wheel marking and 5'1" towards portside from the lead line.

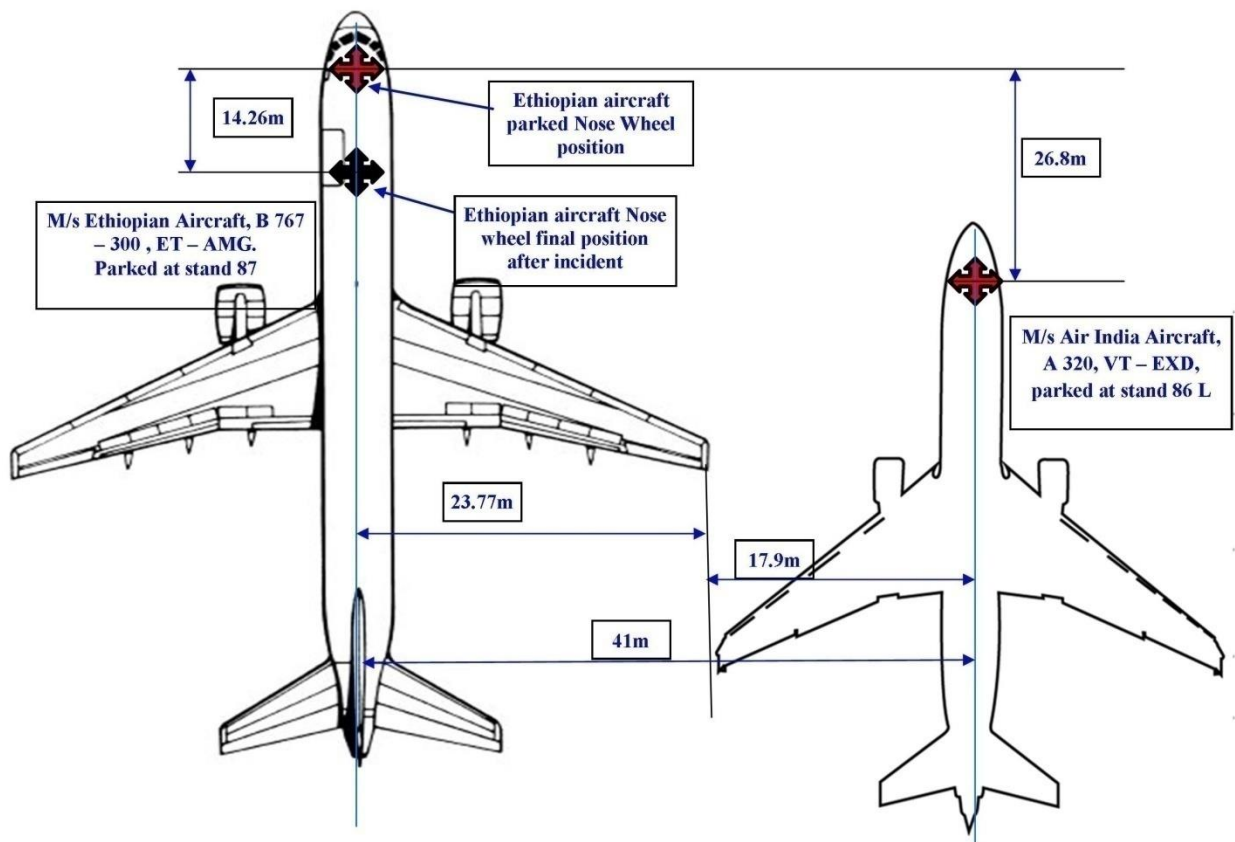
Schematic of the Stand allocation to Ethiopian and Air India aircraft (not to scale).

As per the UFIS history log, initial bay allotment for Air India aircraft was made to Bay No. 86. However, at 14:58 UTC (20:28:23IST), 86 was changed in to 86L by GOS desk operations executive.

AI5542(A): Aircraft restriction/ Wing overlap with aircraft ET686 B763 at position 087.
