FINAL INVESTIGATION REPORT OF SERIOUS INCIDENT TO
M/s INDIRA GANDHI RASHTRIYA URAN AKADEMI , DA-40 AIRCRAFT
VT-FGA ON 03.07.2015 AT FURSATGANJ, AMETHI, UP.

Office of Director of Air Safety (NR)
Civil Aviation Department
Safdarjung Airport, New Delhi-110003.

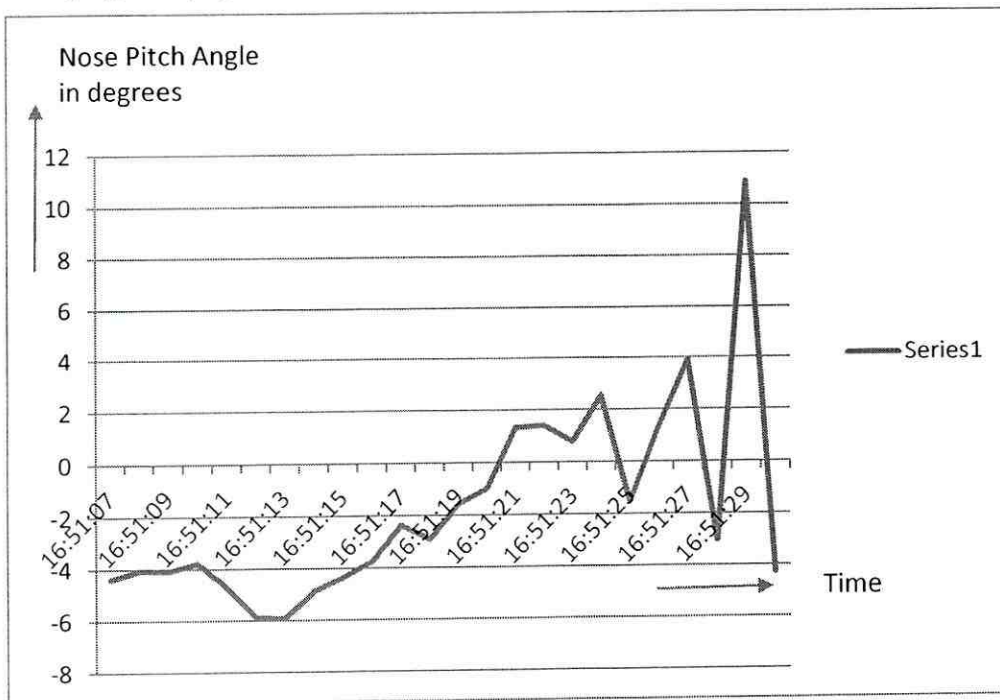
Nose Pitch Angle versus time graph during touch down and landing.

(Kinks in the graphs show bounces from 1 to 7)

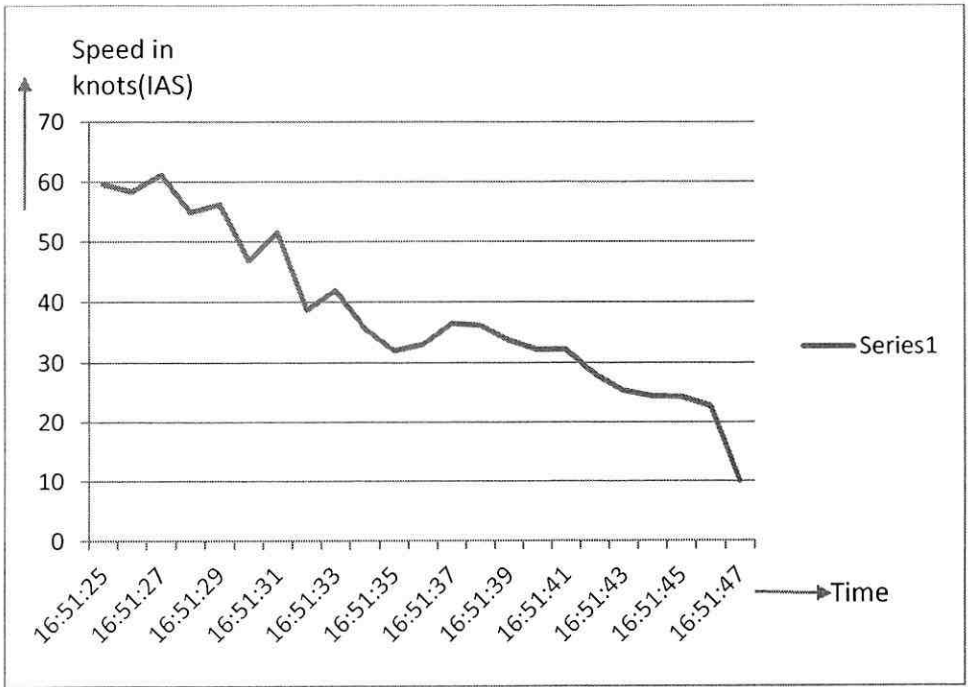
Speed versus Time graph of landing roll.

After touch down, aircraft speed can be seen reducing with successive bounces. Also change in altitude values can be seen after touchdown, which correspond to bounces.

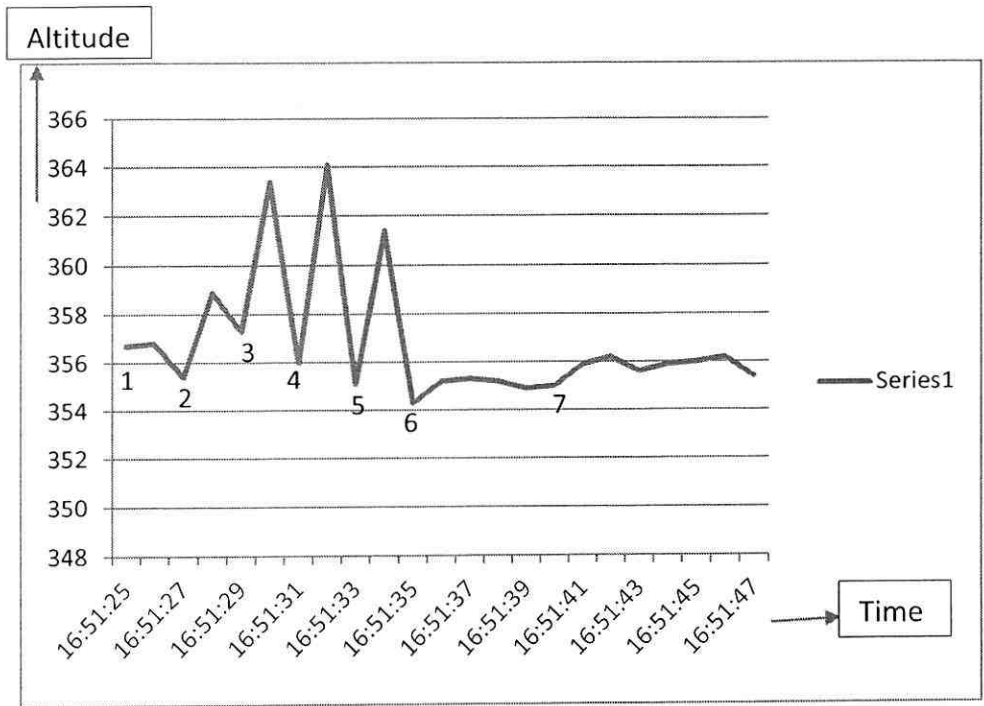
Altitude versus Time graph of landing roll.

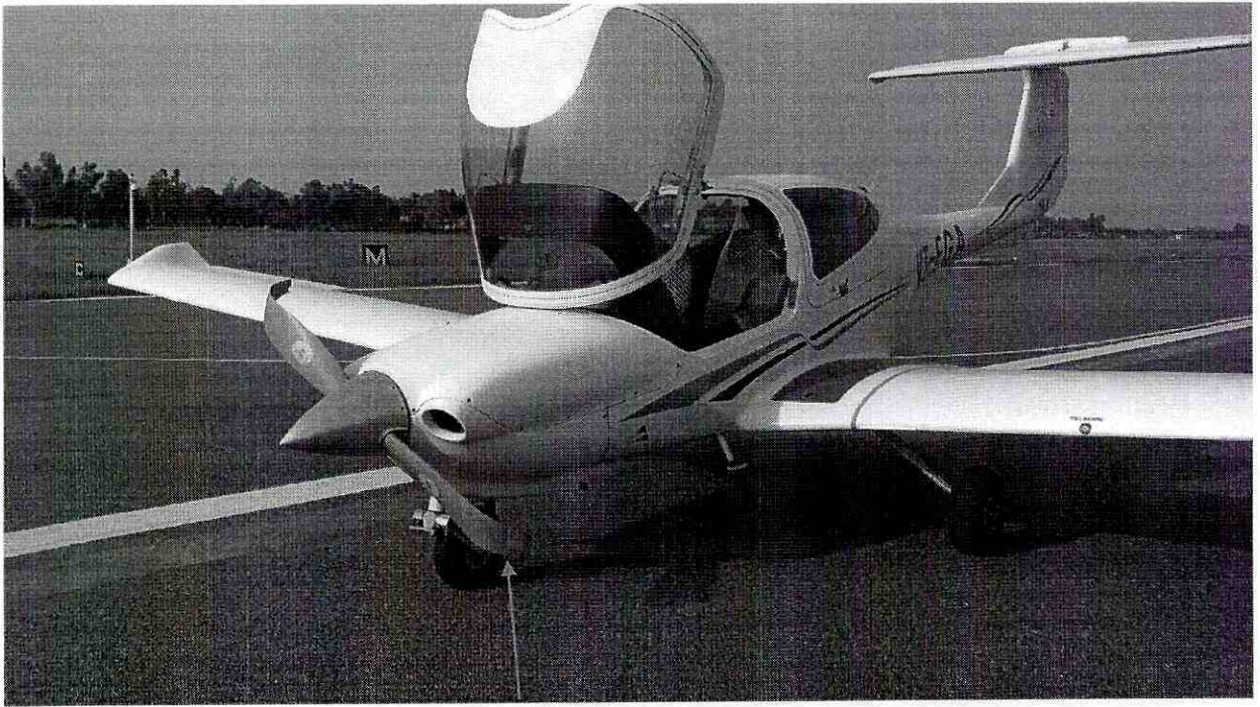
- 1.11.1 Both the propellers blades of the single engine aircraft were bent at 0.3 metres from the tip and damaged beyond economical repair.
- 1.11.2 Nose landing gear shock absorbers called ELASTOMERS consisting of rubber segments and metal plates were found sheared off and damaged and scattered at the bottom of the engine cowling.

VT-FGA: Both propeller blades bent in propeller strike.

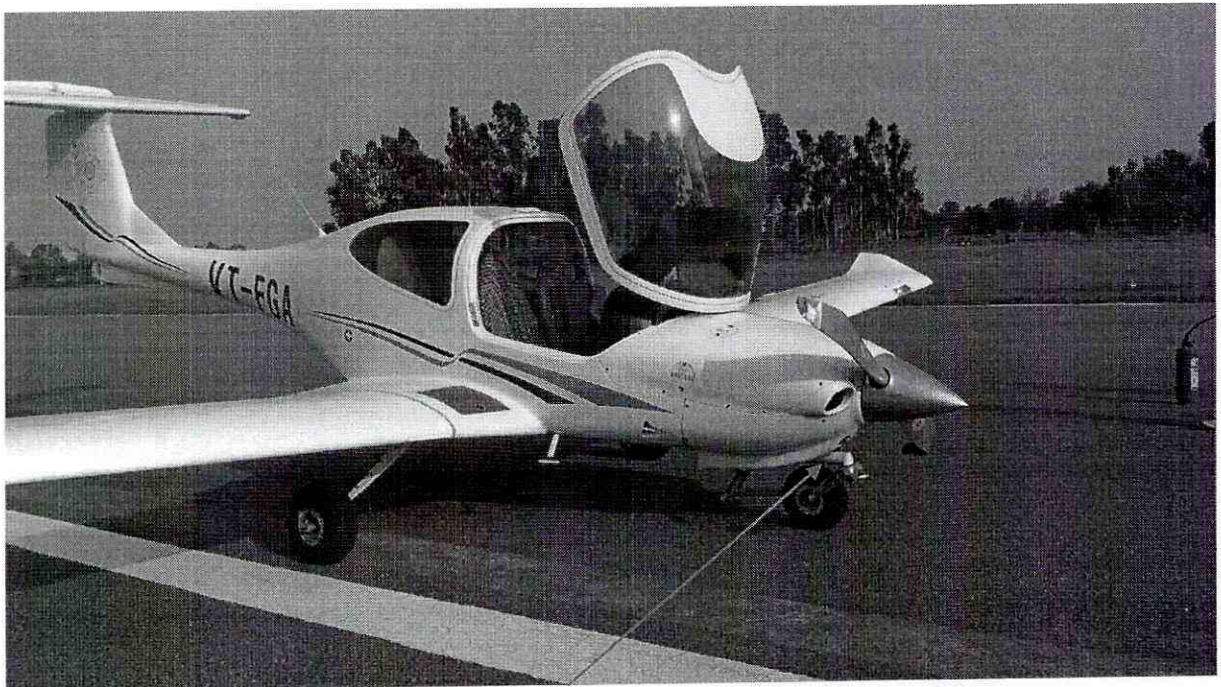
- 1.11.3 The broken shock absorber had caused a dent in the metal cladding on the 'fire wall'.
- 1.11.4 The bottom of the engine cowling was damaged by upward movement of nose landing gear strut caused due to impact.

VT-FGA: Nose landing gear strut broken.

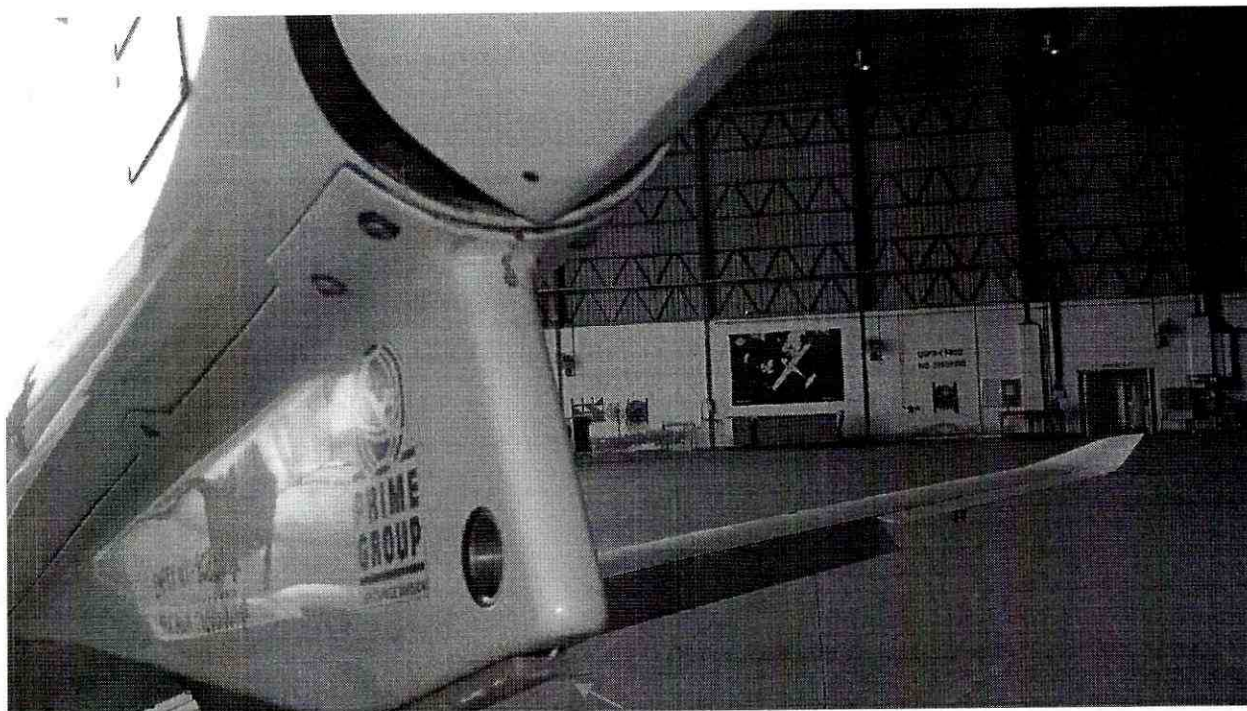
1.11.9 Metal 'Tail Skid' fitted below the ventral fin had deep rubbing marks.

VT-FGA: Rubbing marks on the tail metal skid.

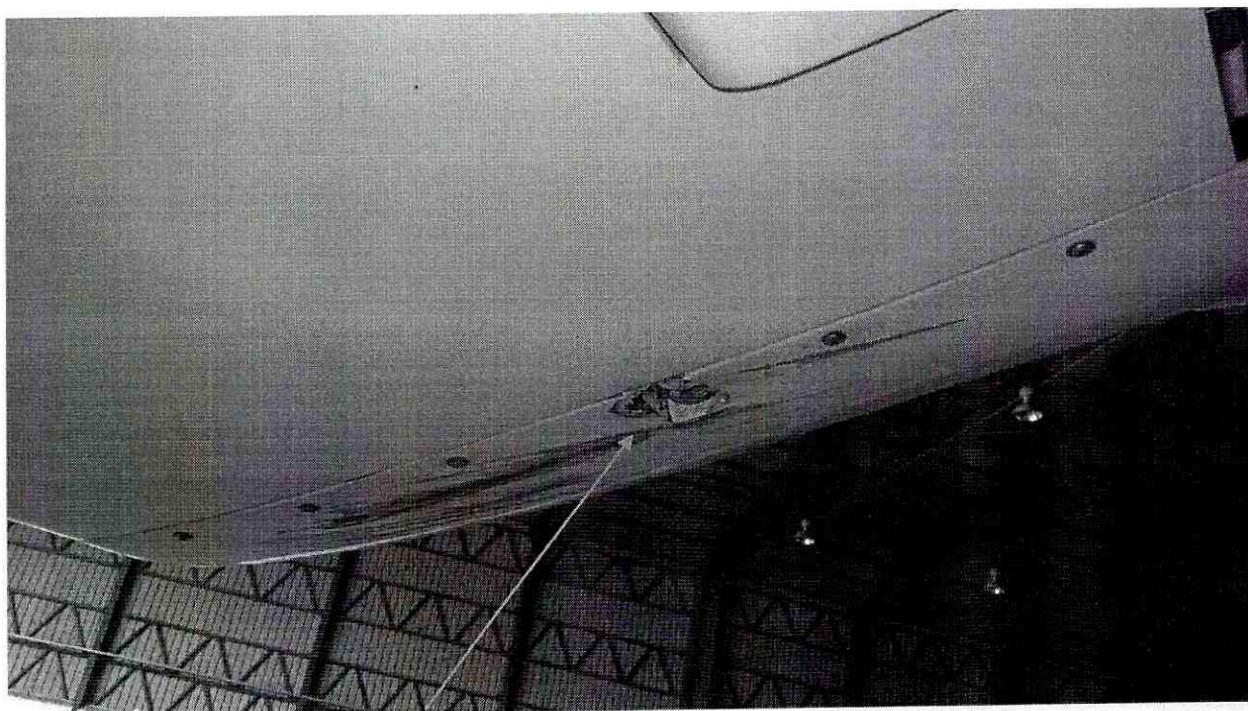
- 1.11.7 Mooring ring attached to the wing tip got bent and was pushed inside wing surface under the impact, damaging outermost rib of the wing structure.

VT-FGA: Mooring ring below right wing tip pushed inside. Skin of lower surface damaged due rubbing.
