**FINAL REPORT ON INCIDENT TO M/s INDIGO AIRLINES AIRBUS A320**  
**AIRCRAFT VT-IEU AT KATHMANDU ON 08/03/2014**

| 14. Type of incident | : Emergency evacuation due fire on right main landing gear |

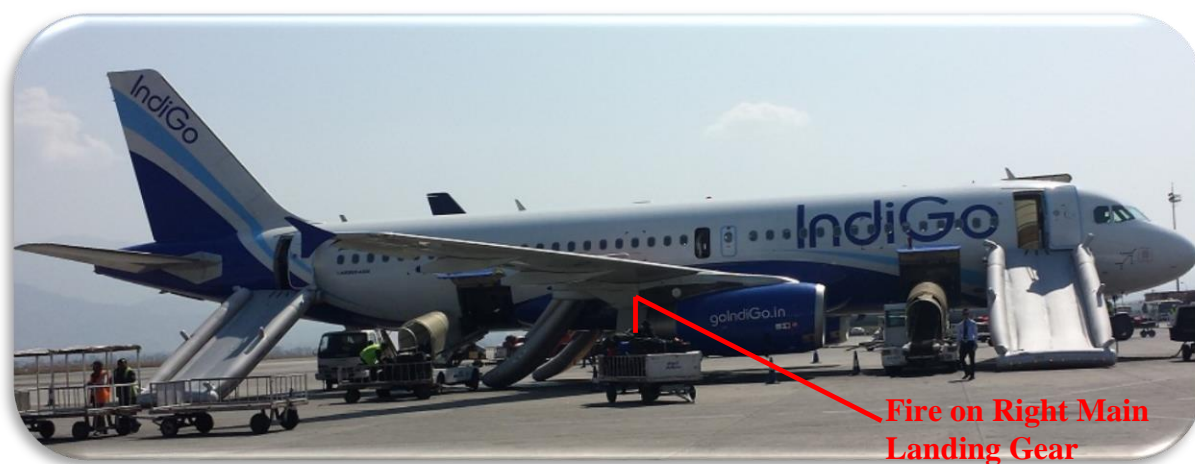
**Slides deployed for evacuation**

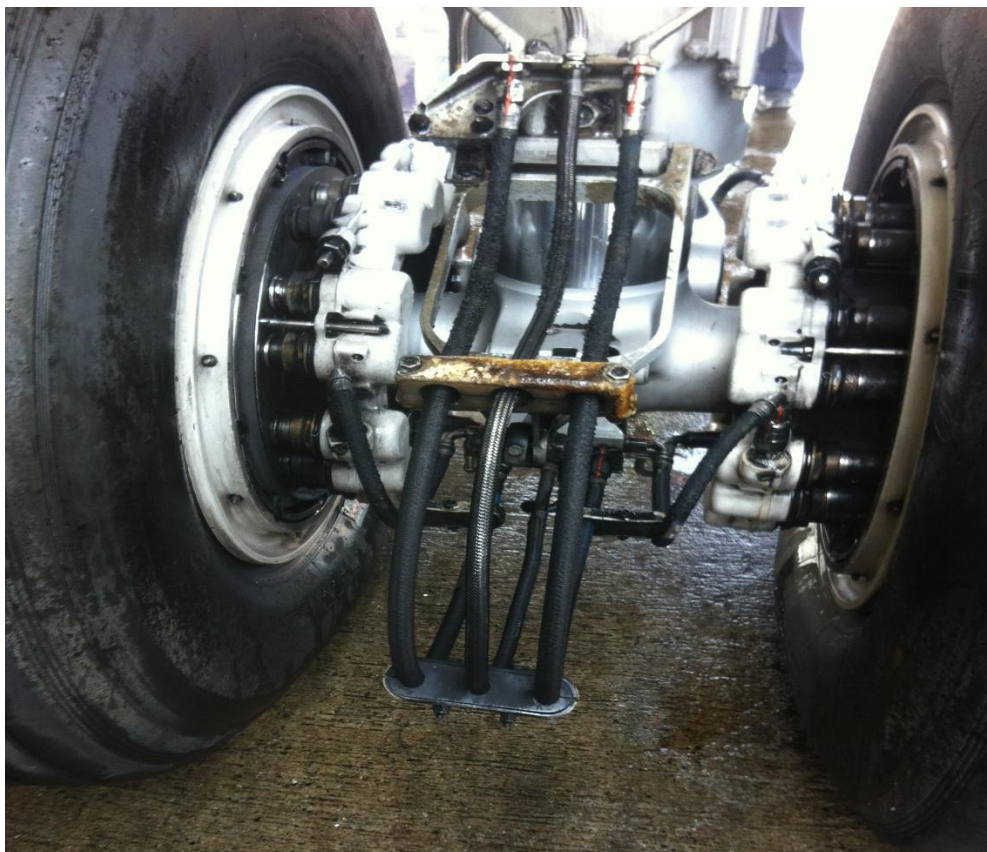
1. Both RH main wheel # 3 & # 4 were found damaged/ deflated, however the brake assembly were found satisfactory.
2. The hydraulic hoses for #3 and #4 had fire marks.

**Other than the hydraulic hoses there was no damage on brakes and wheels**

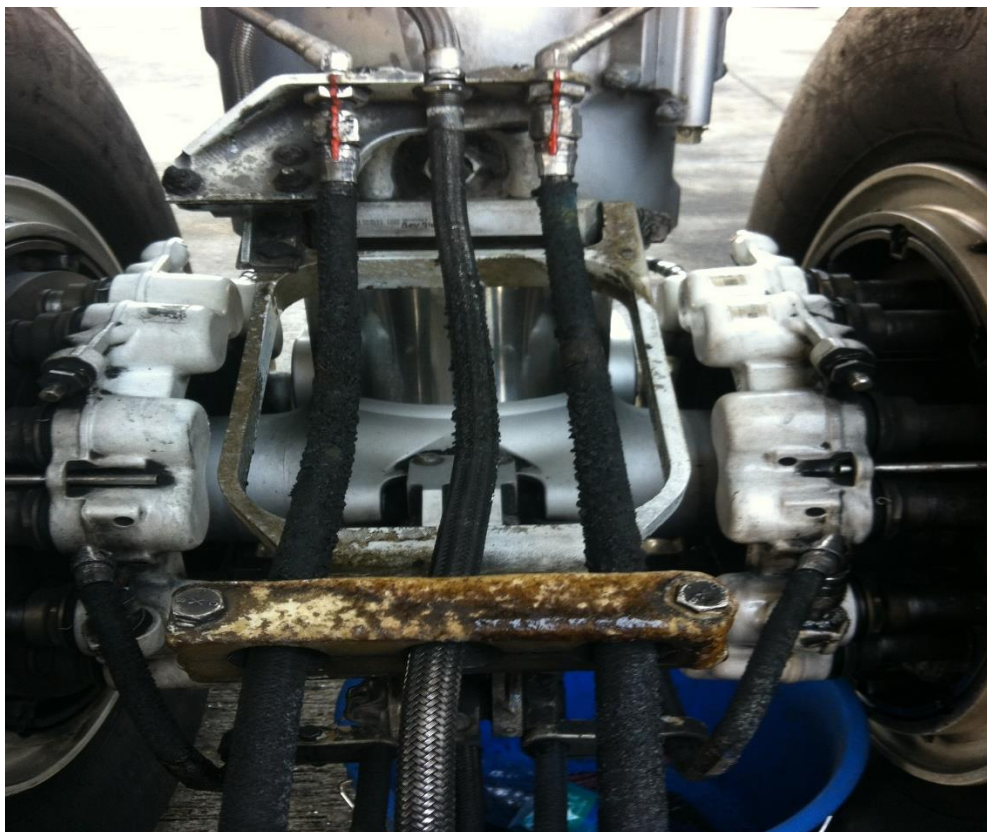
**Fire soot marks on the hydraulic hoses.**

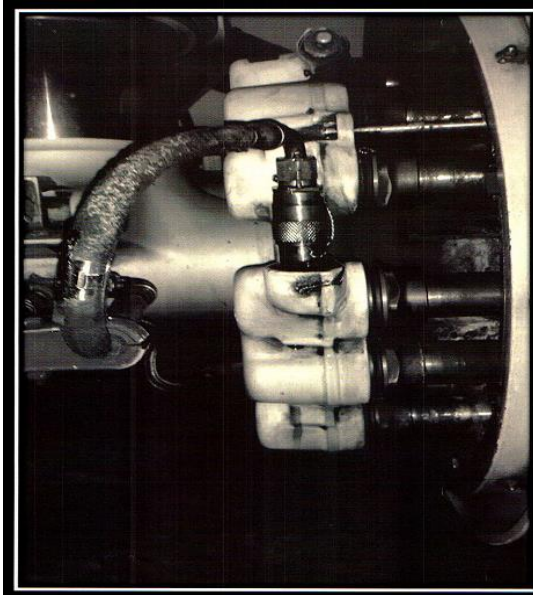
During ground inspection, leakage of hydraulic fluid was seen from the QAD the alternate brake system. Both the hoses (Part no. 201042275 and 201042274) along with quick release coupling were send for detailed examination and investigation to ascertain the cause of leakage at Aircraft Engineering Directorate, DGCA.

Figure 1: shows the location of Leakage

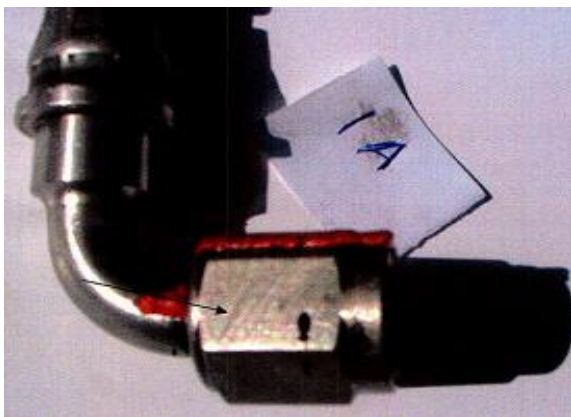
1. Some rubbing marks were observed on the 1A end as shown in Fig. 3a, which appears to be due to rubbing of some external object during service.

Figure 3a: Shows the rubbing marks on end 1A due to the rubbing of some external object during service

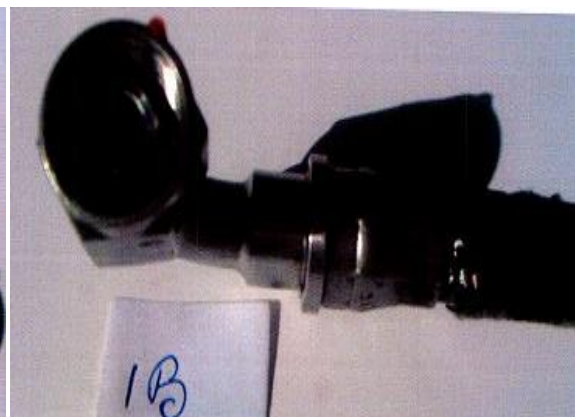
Figure 3b: Shows deep marking on the face of ferrule in the hose pipe

2. On the end 1B as shown in Fig. 3b, deep marking on the face of ferrule was observed in the hose pipe. It seems to be due to the over tightening of the nut. However, there is no abnormality found on the other end.

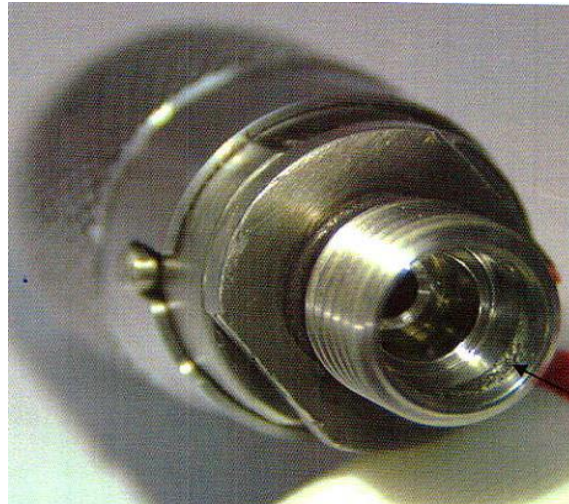
3. While examination of the Quick release coupling, in the bore (inner diameter) of the coupling, scratches/metal gauging marks were observed. Two dent marks are also noticed on the outer surface of the coupling.

Fig. 4 shows quick release coupling with internal scratches/ metal gauging

Leakage of hydraulic fluid has probably occurred due to scratches/metal Gauging marks in the sleeve. Scratches/metal gauging marks occurred in the sleeve have occurred due to over torque.

1. M/s Indigo should ensure that the pilots (PIC) adheres to standard operating procedure in case of emergency evacuation and not to influence the cabin crew during evacuation process.
2. M/s Indigo procedures for arming/disarming the doors to be inline with the Airbus/aviation operators within the country.
3. M/s Indigo to ensure that during cabin crew training emphasise are made on the importance of handling crowd control during emergency evacuation and also to strictly adhere the standard operating procedures for assessing the external conditions before commencing evacuation.
4. Engineering Department to issue internal circular highlighting the incident and advising precautions while handling QAD during servicing/maintenance on the aircraft.

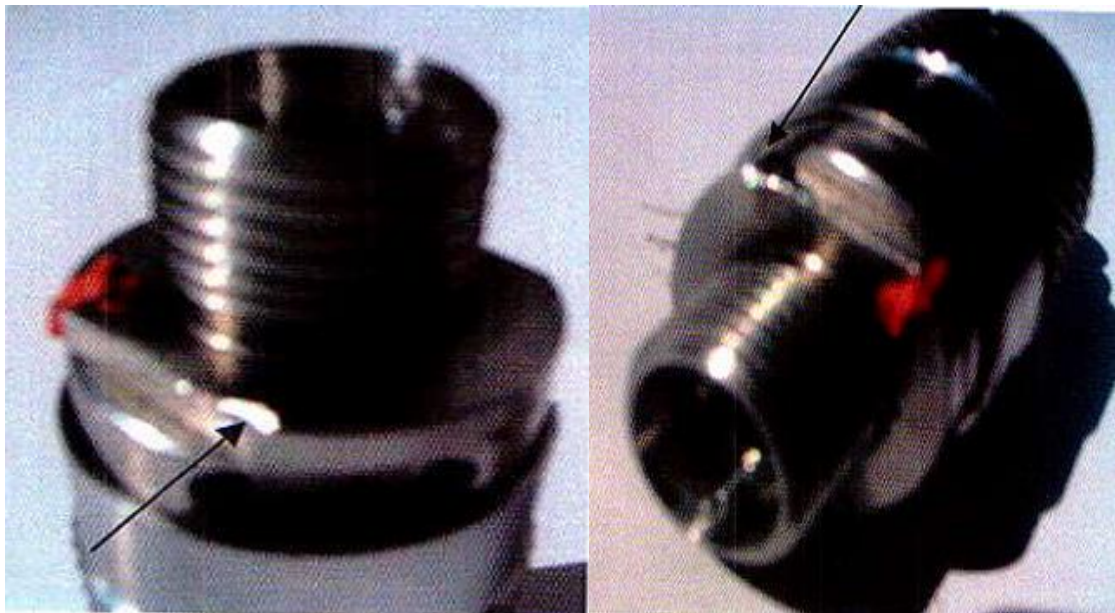
Fig. 5 External Dent marks indicating striking of hard material
