FINAL REPORT ON INCIDENT TO M/s INDIGO AIRLINES AIRBUS A320
AIRCRAFT VT-IGV AT BENGALURU ON 12/09/2013

| 14. Type of incident | : Aircraft veered right of center line after touch-down and ran over runway edge lights resulting in tyre deflation. |

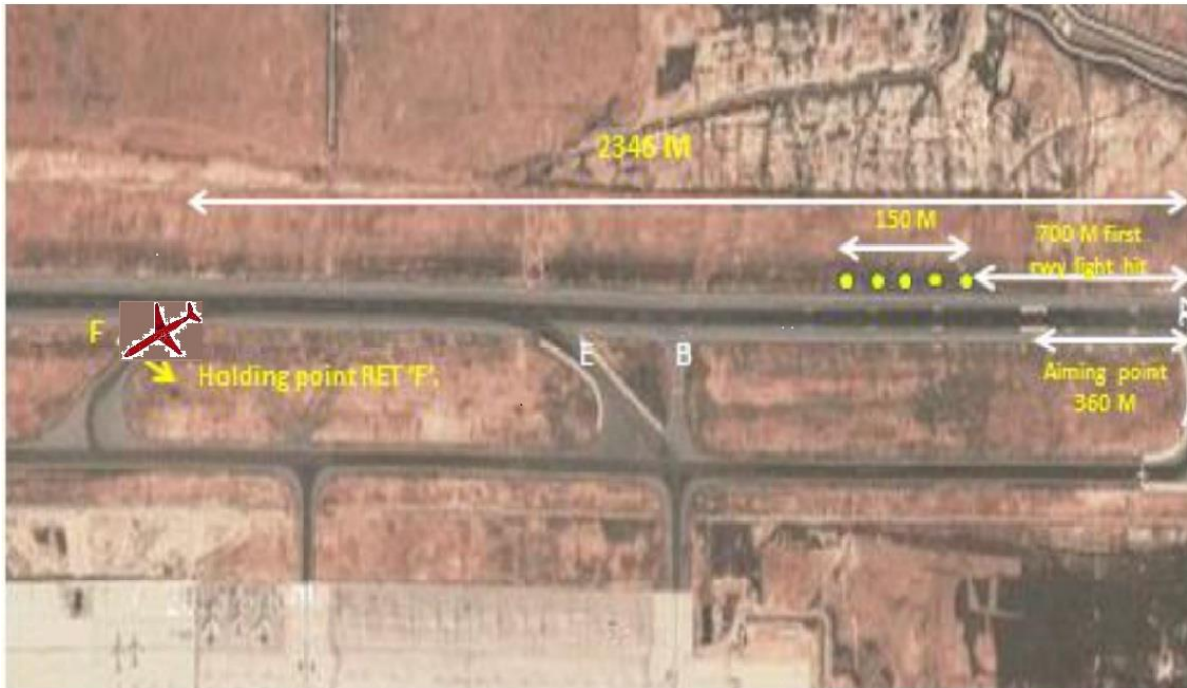
Runway 09/27 Layout and Aircraft Final Rest Position

Airport follow me jeep had carried out runway inspection and reported 5 edge lights were broken on the northern side of R/W 27. At time 14:48 UTC Flight crew had reported ATC that unable to taxi further and requested for tow tractor. The IndiGo Engineering Department without assessing the damage on the RH main wheels, tried to tow the aircraft on to the bay. However the tow bar sheared off and the aircraft could not be moved. Thereafter the PIC requested ATC for disembarking of passengers at taxiway 'F'. The deplaning of the passengers finally commenced through passenger door normally at 16:05 UTC.

Since the aircraft had not fully vacated the runway holding point Rapid Exit Taxiway (RET) 'F', the runway was not available for aircraft operations for 2 hrs 44 minutes (from 14:40 UTC to 17:24 UTC). During this period 24 flights were diverted from Bengaluru out of which 16 flights to Chennai and 8 flights to Hyderabad. The deflated wheels were replaced at taxiway and aircraft was towed to parking stand 66 at 17:14 UTC.

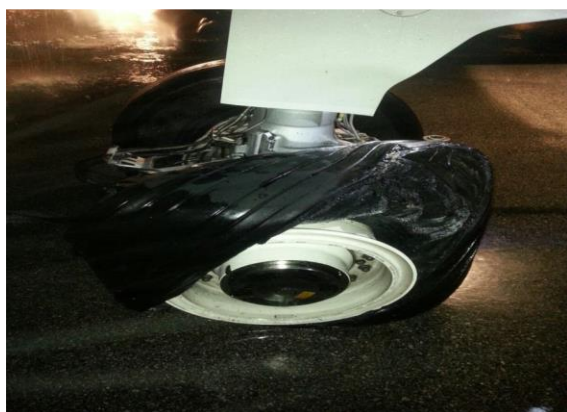
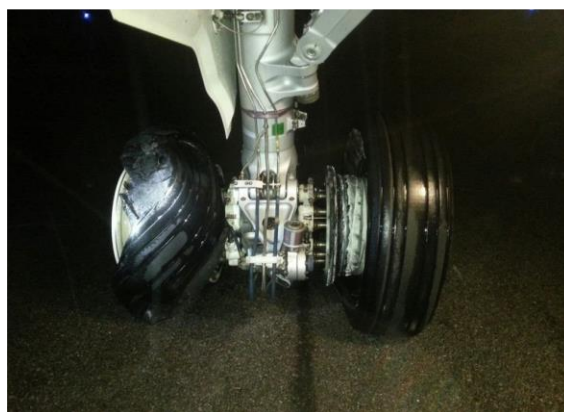
Damaged Right main landing gear wheels

During inspection both RH main wheel # 3 & # 4 were found damaged /deflated. Both the removed main wheels were inspected and no visible damage to crown portion of tyres was noticed. The side walls of the tyres had got adrift and moved sideways with reference to hub but were remaining attached to hub assembly. The brake assembly was inspected and found satisfactory. The damaged RH (#3 & #4) main wheel tyres including brake assembly were replaced. Other than this there was no damage to any part of airframe/engine/any other part of aircraft was observed and aircraft was released for further passenger flights on 13.09.2013.

There was no major damage to the aircraft. However during landing the RH side main landing gear wheels over ran the runway shoulder lights which resulted into the deflation of both wheels. Other than this there was no other damage on the aircraft.

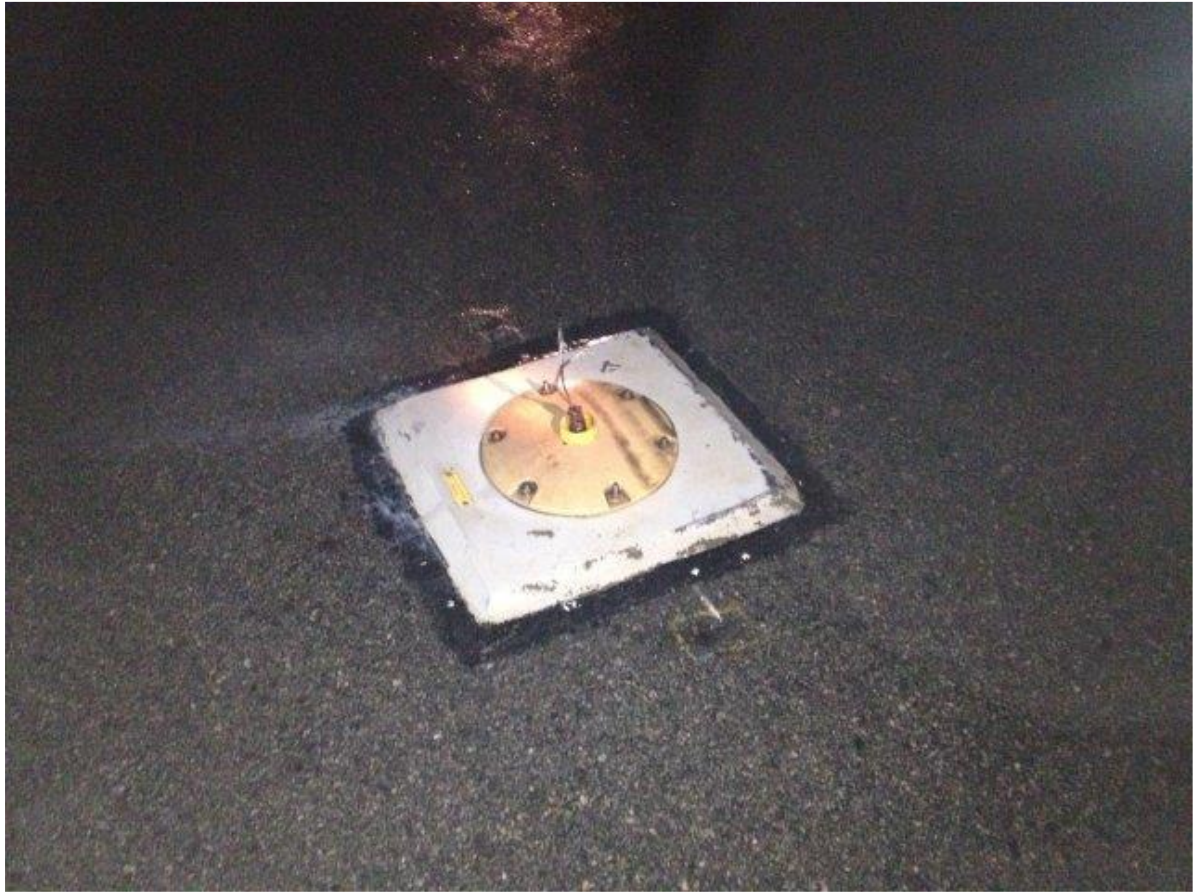
Damaged Runway shoulder edge light

Consecutively 05 runway shoulder edge lights were damaged (i.e. at a distance of 700 meters from threshold R/W 27).

There was no in-flight disintegration of any part of the aircraft and it was confined around its final rest position. At no point the aircraft left the paved runway surface, however 05 runway edge light were damaged by RH main landing gear. There was no other visible damage on the aircraft. DFDR analysis was carried out and it was observed that after touchdown the aircraft drifted towards the right however adequate rudder correction was applied by the PIC and the aircraft was brought back to the centreline. Prior to the incident flight the aircraft had operated flight Mumbai - Delhi and no snag was reported on the aircraft.
