**FINAL REPORT OF SERIOUS INCIDENT TO M/s JET  
AIRWAYS ATR 72-500 AIRCRAFT VT-JCV AT  
CHANDIGARH AIRFIELD ON 02/03/2012**

1. Aircraft  
    Type : ATR 72-500  
    Nationality : INDIAN  
    Registration : VT - JCV
2. Owner/ Operator : Injet Leasing Company Ltd/Jet Airways
3. Pilot – in –Command : ATPL holder on type  
    Extent of injuries : Nil
4. First Officer : CPL Holder qualified on type  
    Extent of injuries : Nil
5. Place of Incident : Chandigarh Airfield
6. Date & Time of Incident : 02<sup>nd</sup> March 2012 0900 UTC(Approx.)
7. Last point of Departure : Jaipur
8. Point of intended landing : Chandigarh
9. Type of operation : Schedule Operation
10. Crew on Board : 5  
    Extent of injuries : Nil
11. Passengers on Board : 28  
    Extent of injuries : Nil
12. Phase of operation : Landing
13. Type of incident : Aircraft bounced twice after touchdown thereafter carried go around.

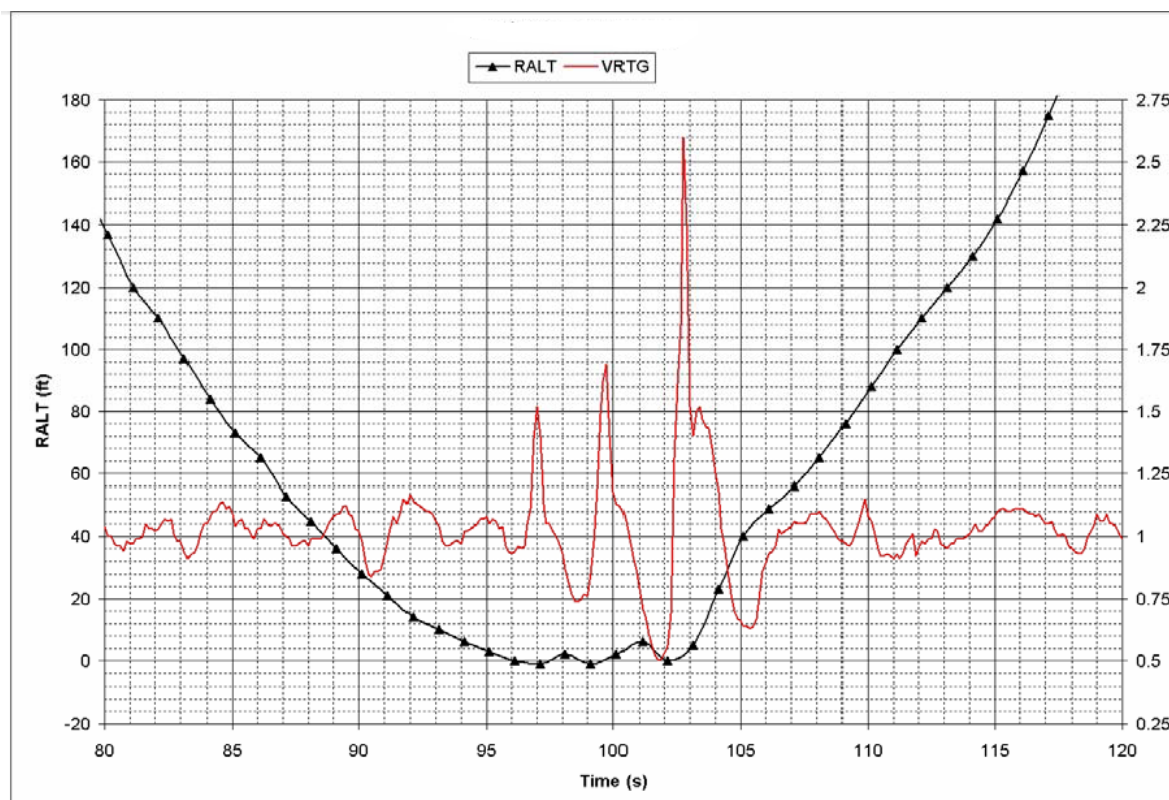
a touchdown on runway surface on nose landing gear and the right main landing gear with a pitch of  $-1.93^{\circ}$  and vertical 'g' of 1.51. After the first impact the aircraft bounced and landed after 02 second with vertical g of 1.68, and thereafter it bounced again after 03 seconds with vertical 'g' of 2.68. Subsequently the pilot initiated a go-around as per the bounce recovery procedure of ATR 72 aircraft.

***Variation of Vertical 'g' during landing and go around***

DFDR analysis revealed that during landing the pilot did not flare and retard power to idle as per Standard Operating Procedures. At the time of touchdown the power levers angle were at 42°, which was well above the idle power. The pilot maintained the same speed and the pitch almost till flare height of around 30 ft. Since the speed was very high by the time the pilot initiated flare the aircraft nose landing gear made a touchdown on the runway surface with a pitch of -1.93° and vertical 'g' of 1.51. It bounced and landed after 01 second with a vertical g of 1.68 and thereafter bounced again after 03 seconds with vertical 'g' of 2.68. Thereafter the pilot initiated a go around.

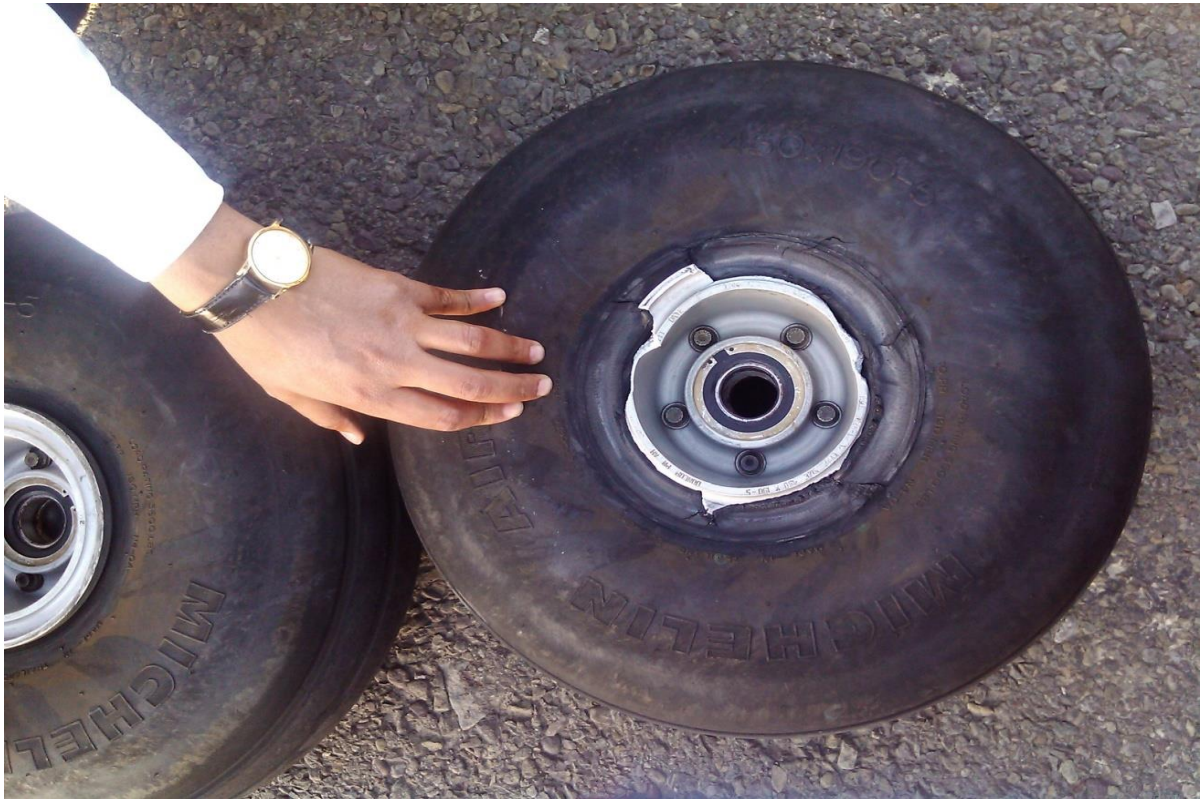
The right nose wheel flange was damaged. About 90% of inboard side of metallic right nose wheel hub found missing. Right wheel axle sleeve was also damaged.

***Inner Metal Hub of the Nose Wheel Disintegrated during impact***

The nose landing gear of the aircraft and the right gear impacted the runway during initial touchdown thereafter the aircraft bounced twice with a maximum vertical g of 2.6 before initiating go around. During inspection it was observed that the right nose wheel flange was damaged. About 90% of inboard side of solid

metallic portion of right nose wheel hub was found missing. Right wheel axle sleeve was also found damaged due impact with the runway. The DFDR raw data was forwarded to manufacturer (ATR) for detailed analysis. As per the analysis

*As a consequence, the Energy withdrawn by the NLG leg assembly at landing was above the specification value of NLG. As per the ATR recommendation NLG to be discarded.*

**1.18.1** After the incident the aircraft was grounded for detailed inspection and rectification in consultation with the manufacturer, ATR. The work/inspection package was formulated by the manufacturer as per the DFDR analysis. The inspection/work package as desired by the ATR was carried out at Chandigarh. The details of the work package are tabulated below. As per ATR recommendation the nose landing gear was replaced at Chandigarh.
