**Final Investigation Report on Serious Incident to M/s Jet Airways  
aircraft VT-JEK at London Heathrow Airport on 30.08.2016**

## **Final Report on Serious Incident to M/s Jet Airways Ltd. B777-300, VT-JEK at London Heathrow Airport on 30.08.2016**

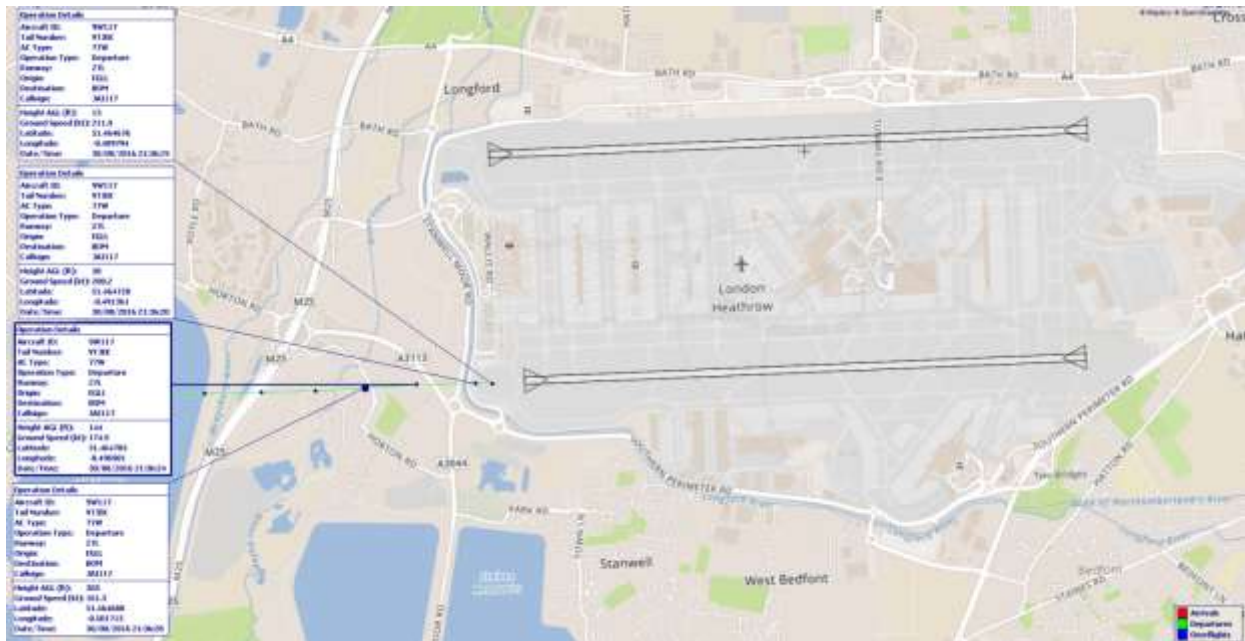
Figure 2 : ANMOS Plot of JAI 117

- III. The pilot of the B773 had clearly stated that they were able to accept a departure from the intersection S4E.
- IV. ATSI obtained a printout from the Heathrow Noise and Track Keeping System (ANOMS) which showed the B773 having just passed a height of 30ft approaching the western perimeter road. A review of the Aerodrome Chart and the AIP entries for Heathrow shows assessed aerodrome obstacles (trees) as high as 31ft. *[The ANMOS height data is not as accurate as the information supplied by Boeing. That is why the Boeing data was used in the AAIB final report and not the ANMOS data when showing the height at which the aircraft crossed the end of the runway.]*

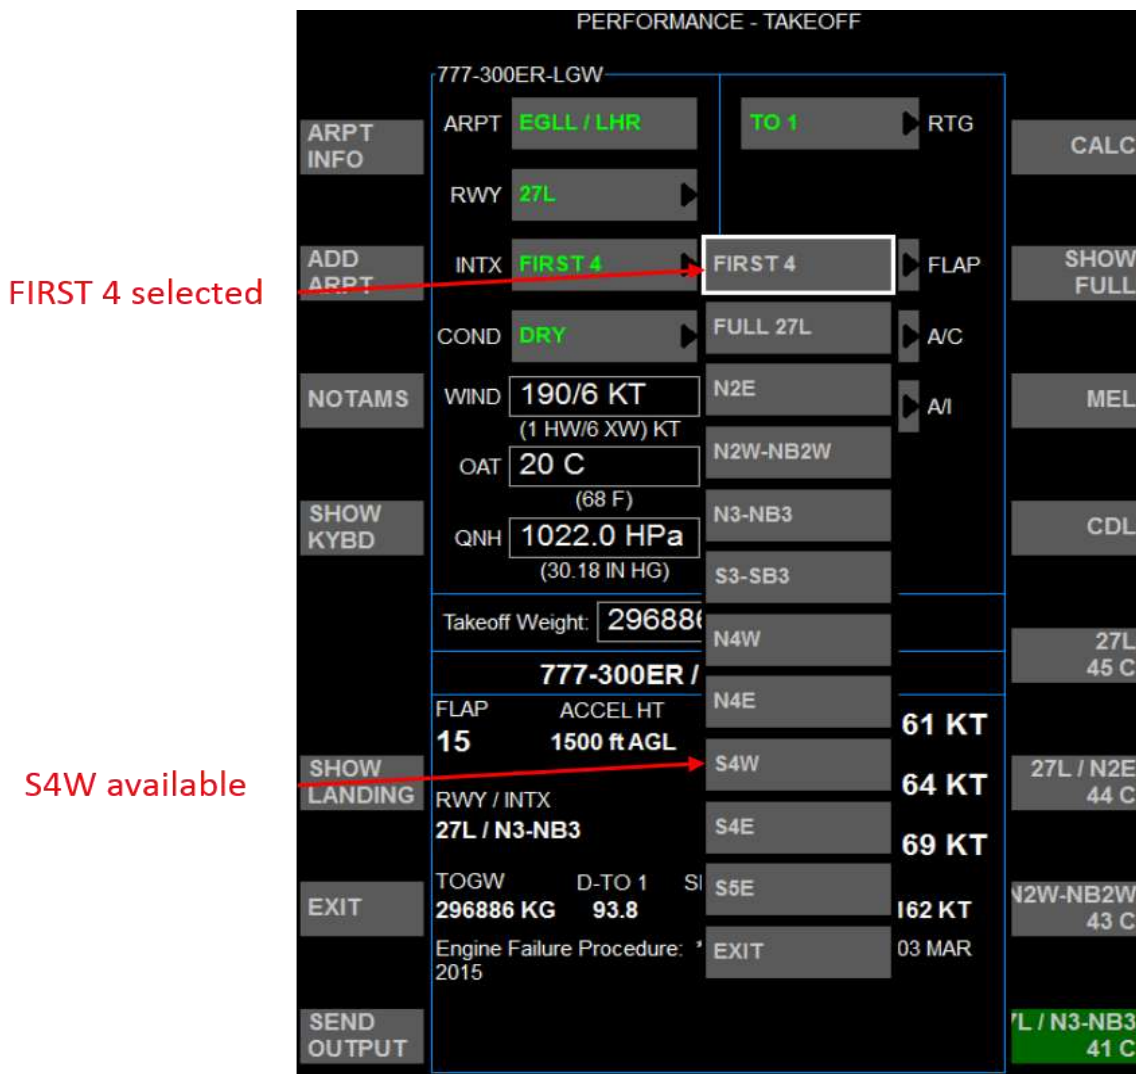
**Figure 6:** OPT drop-down menu for Runway 27L intersection

When the load sheet arrived, each pilot ran the performance calculation again using the actual TOW to establish takeoff speeds and the thrust setting for the takeoff. When the crew cross-checked the output from their respective OPTs, however, it became apparent that the commander had calculated aircraft performance from the first four intersections on the north side of Runway 27L (NB1, NB2E, NB2W, and NB3 in Figure 1) whereas the co-pilot had used S4W. The commander had done this by selecting the “FIRST 4” option from the OPT intersection drop-down menu rather than using the “S4W” option (Figure 6). **The Co-Pilot changed the option in her OPT to match the commander’s option and did not select S4W again.**

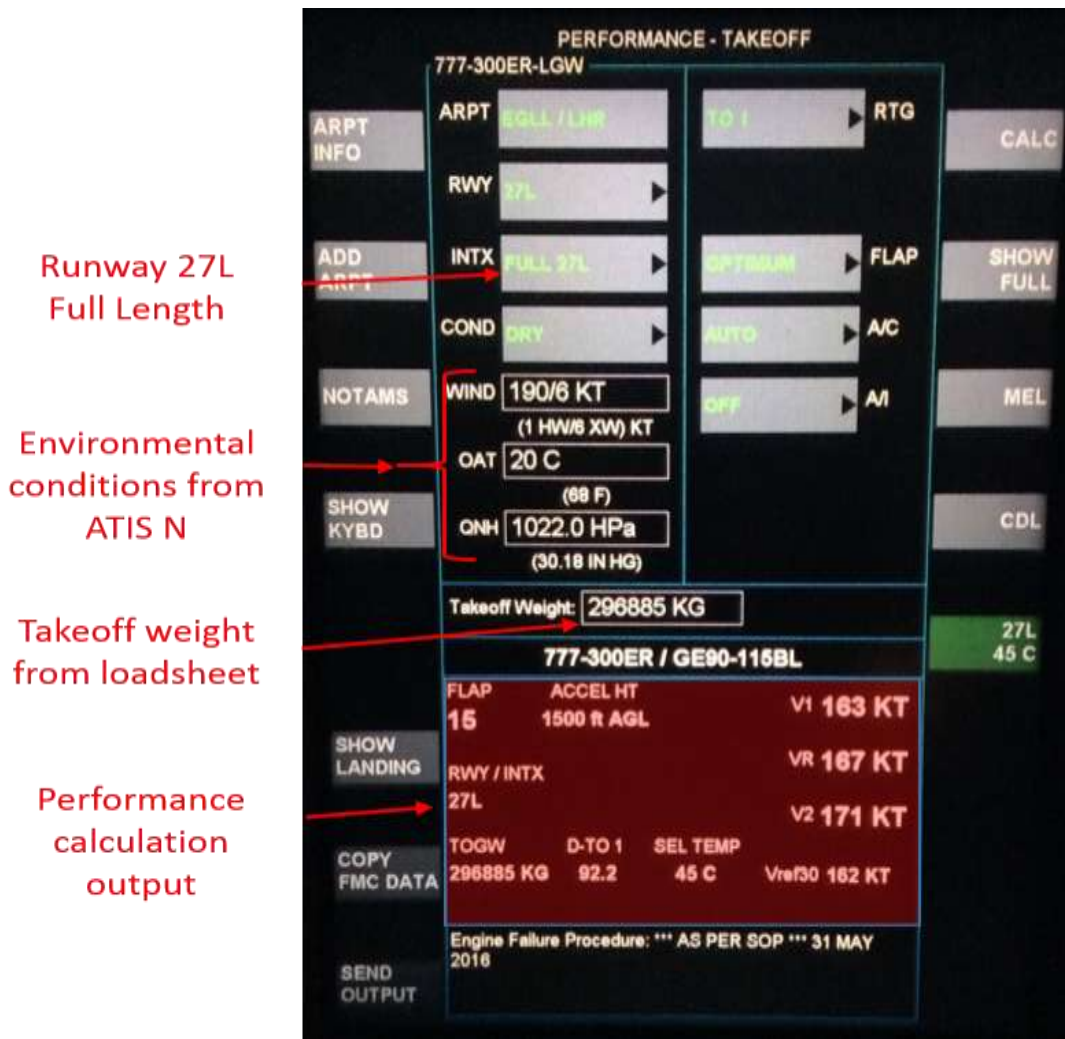
**Figure 7:** OPT output used for the takeoff

The calculation showed that, for a takeoff from the full length of Runway 27L, the takeoff power setting to be entered into the FMC was ‘D-TO 1 SEL TEMP 45° C’. This corresponded to a reduction from rated power of 10% plus a further reduction entered into the FMC using an assumed temperature of 45°C.

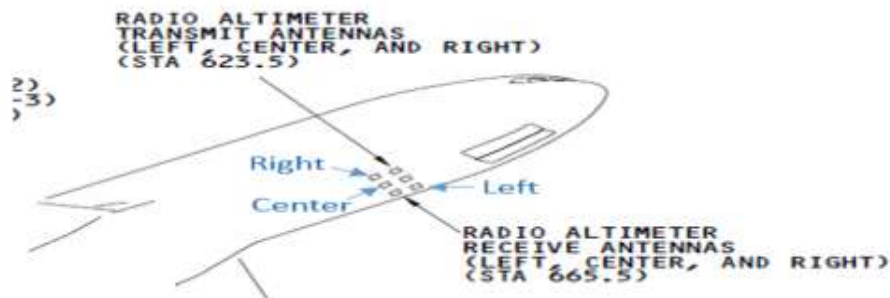
Figure: 9 showing Radio Altimeter Parameter

The ground track shows the airplane entering RWY 27L from Taxiway S4E. The analysis indicates that the takeoff was initiated at a distance of approximately 4286 feet beyond the runway threshold (7715 feet of runway remaining) at auto throttle engagement and the engines spooled up to the takeoff N1 of 92.2% at 4600 feet beyond the runway threshold. Rotation initiation occurred just prior to VR at 10,185 feet beyond the threshold and liftoff occurred at approximately 11,690 feet beyond the threshold. As the airplane climbed over the end of the runway, at 12,001 feet beyond the runway threshold, the center radio altitude parameter (shown on plot) was at 16.4 feet. The other two radio altimeter parameters, left and right (not shown), had values of approximately 16.6 feet and 17 feet, respectively. At the perimeter road, which was approximately 13,215 feet beyond the runway threshold, the center radio altitude parameter and left radio altitude were both at a value of approximately 112 feet and the right radio altitude value was 118 feet.

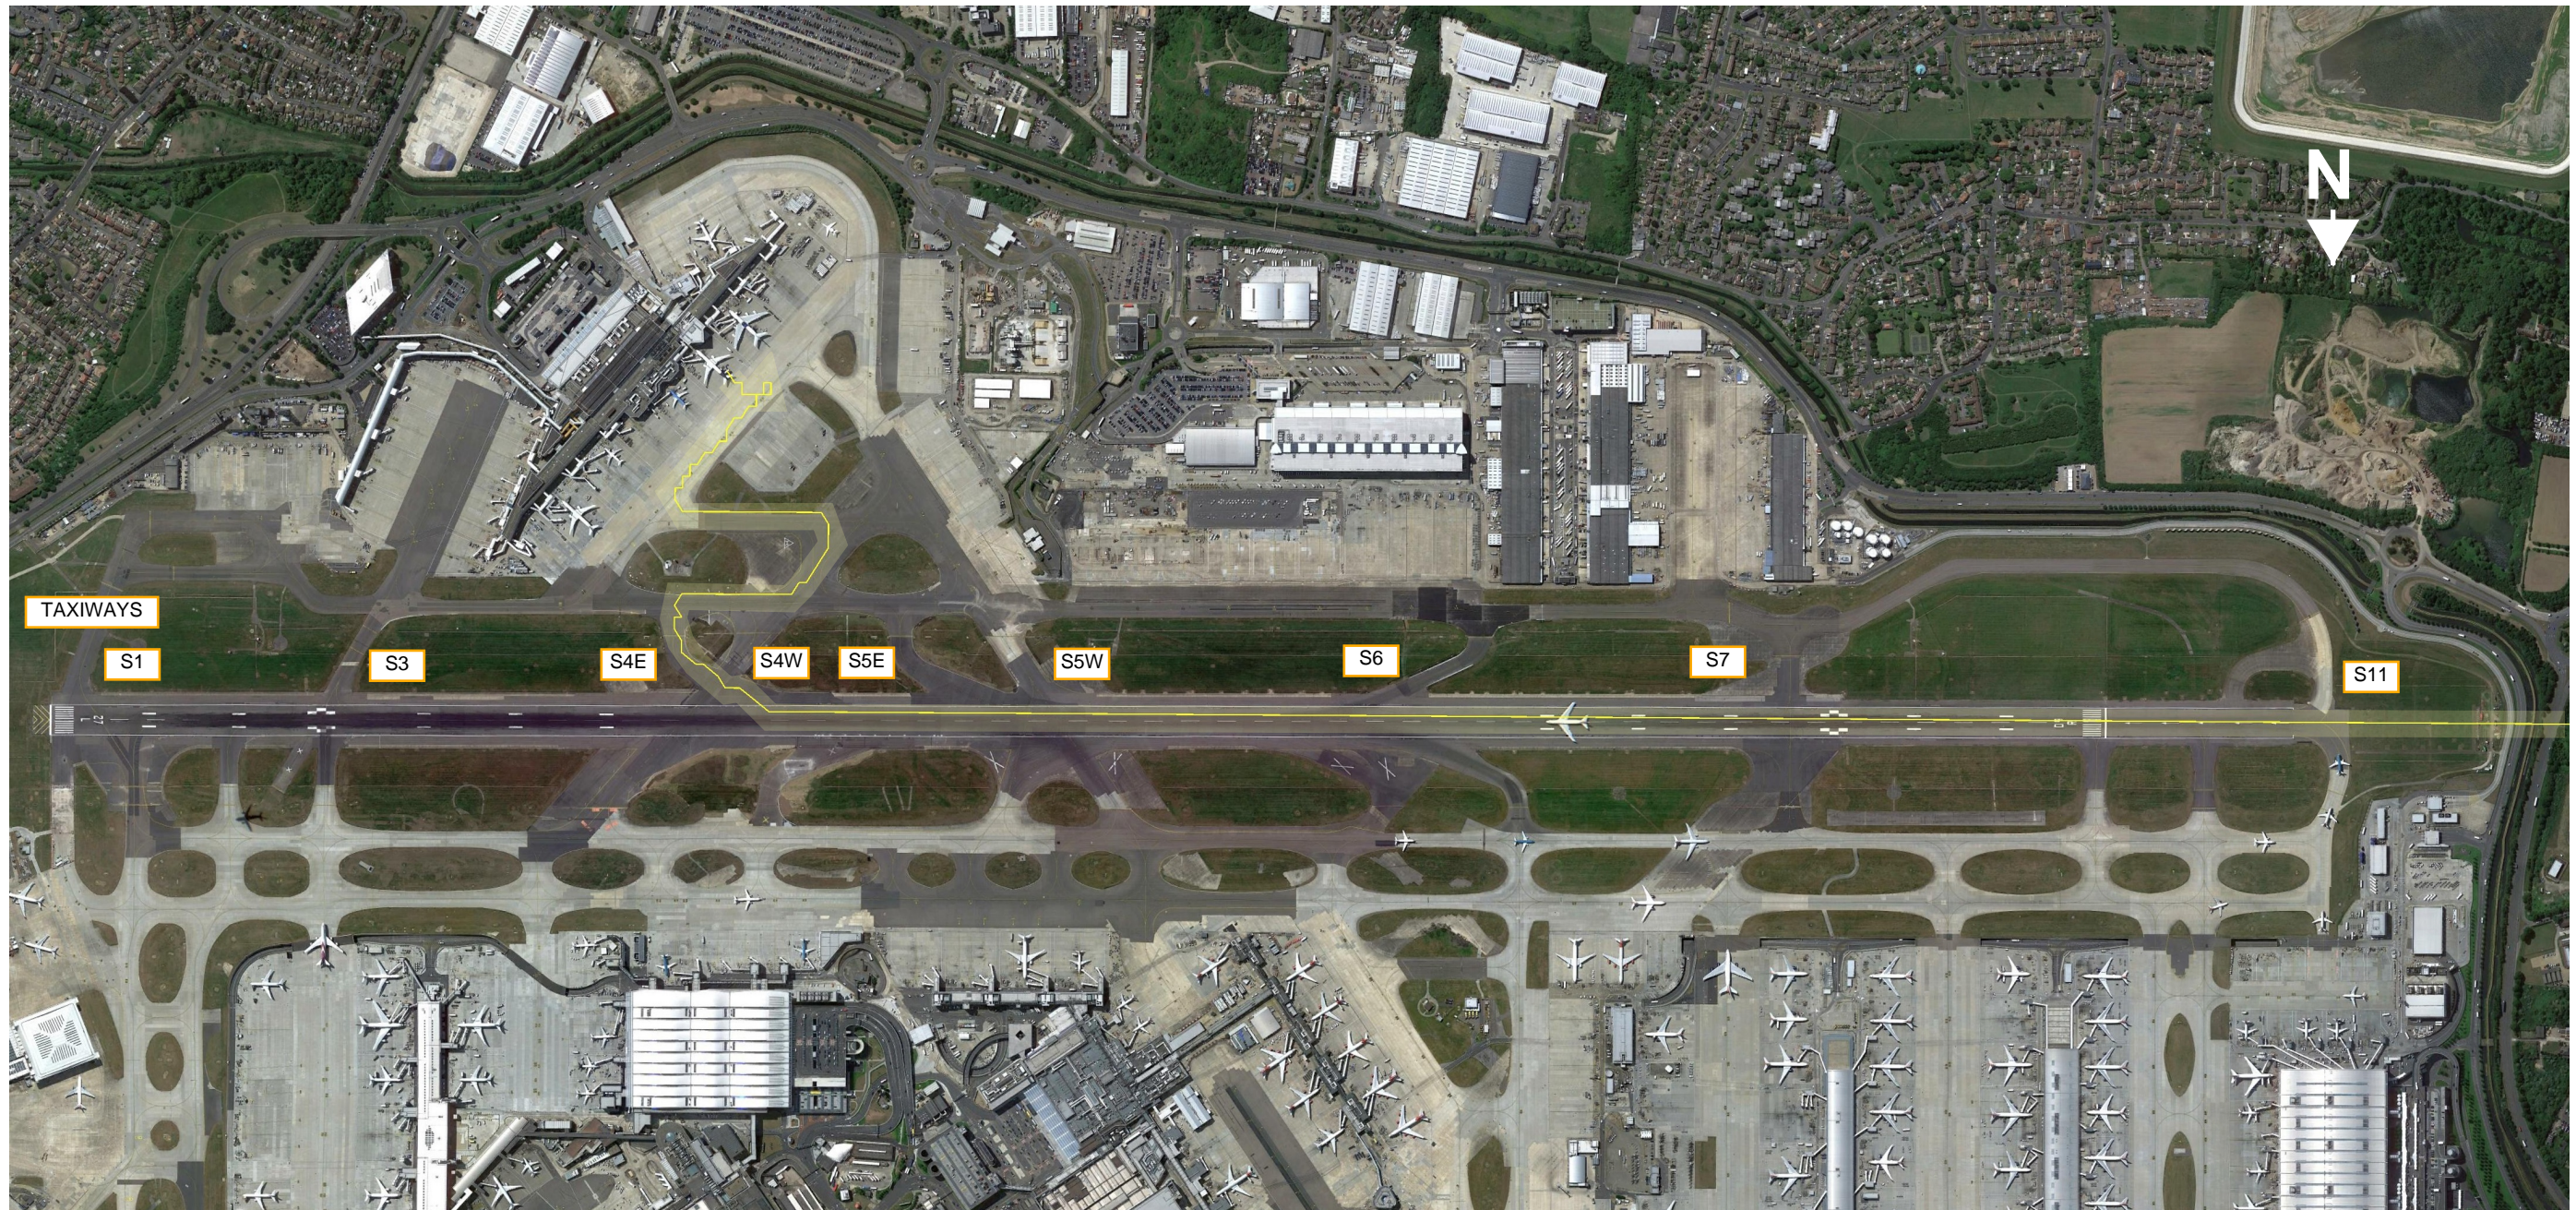
REV	CALC	AERODYNAMICS	11AUG17	REVISED	DATE	JPL 777-300ER VERY LOW TAKEOFF 30 AUG20 16 -- NON-TIME-ALIGNED QAR DATA GOOGLE EARTH MAP - LATITUDE/LONGITUDE <b>BOEING PROPRIETARY</b>	WD770/VT-JEK
	CHECK						FIGURE
	APPD						6
	APPD

Annexure II shows the QAR recorded latitude and longitude data (in yellow) on a Google Earth image of LHR starting at push back from the terminal through the takeoff roll and liftoff. The data confirmed that the airplane taxied onto RWY 27L using Taxiway S4E.
