**FINAL REPORT ON SERIOUS INCIDENT TO M/s JET
AIRWAYS BOEING 737-800W AIRCRAFT VT-JFA AT
COCHIN ON 18/08/2015**

FINAL REPORT ON SERIOUS INCIDENT TO M/s JET AIRWAYS
BOEING 737-800W AIRCRAFT VT-JFA AT COCHIN ON
18/08/2015

SYNOPSIS

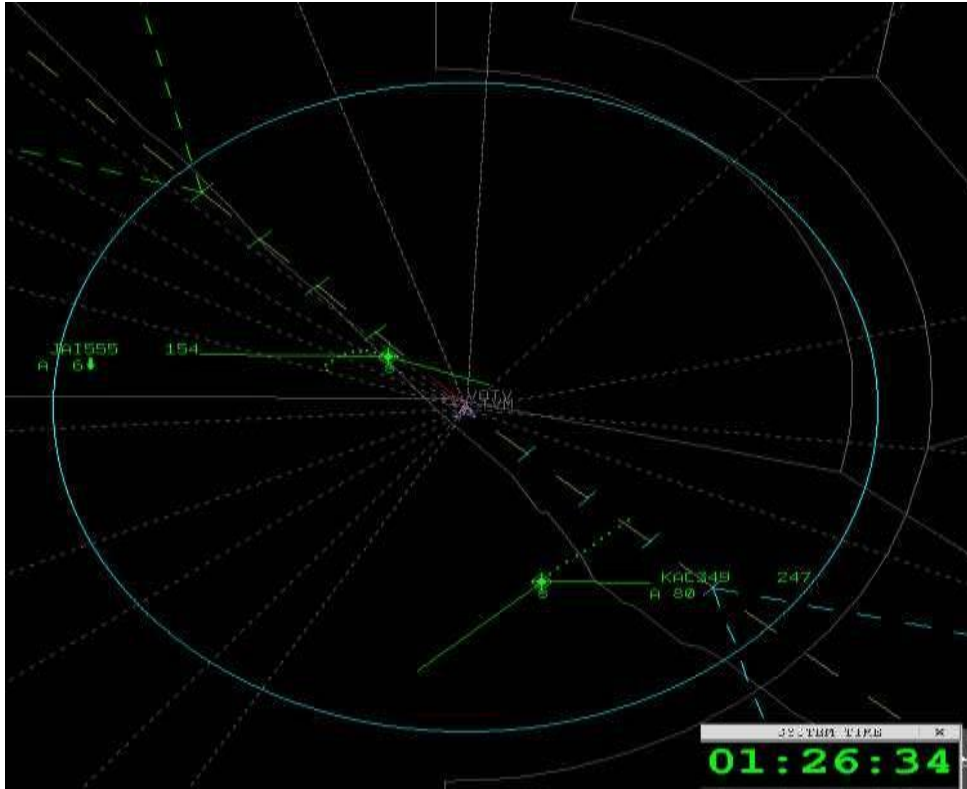
Aircraft turning right with less than 02 nm to make 2nd visual approach on runway 14 without the runway being in visual contact and thereby being unstabilized.

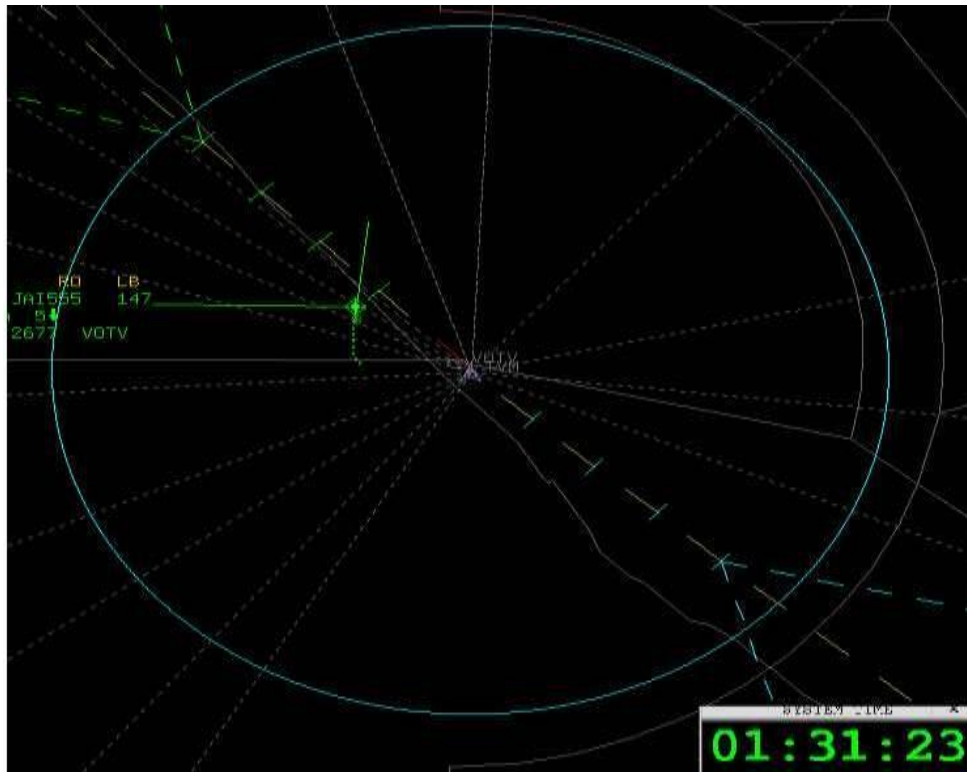
Aircraft turning right at around 02 nm to make 3rd visual approach on runway 14 without the runway being in visual contact and thereby being unstabilized

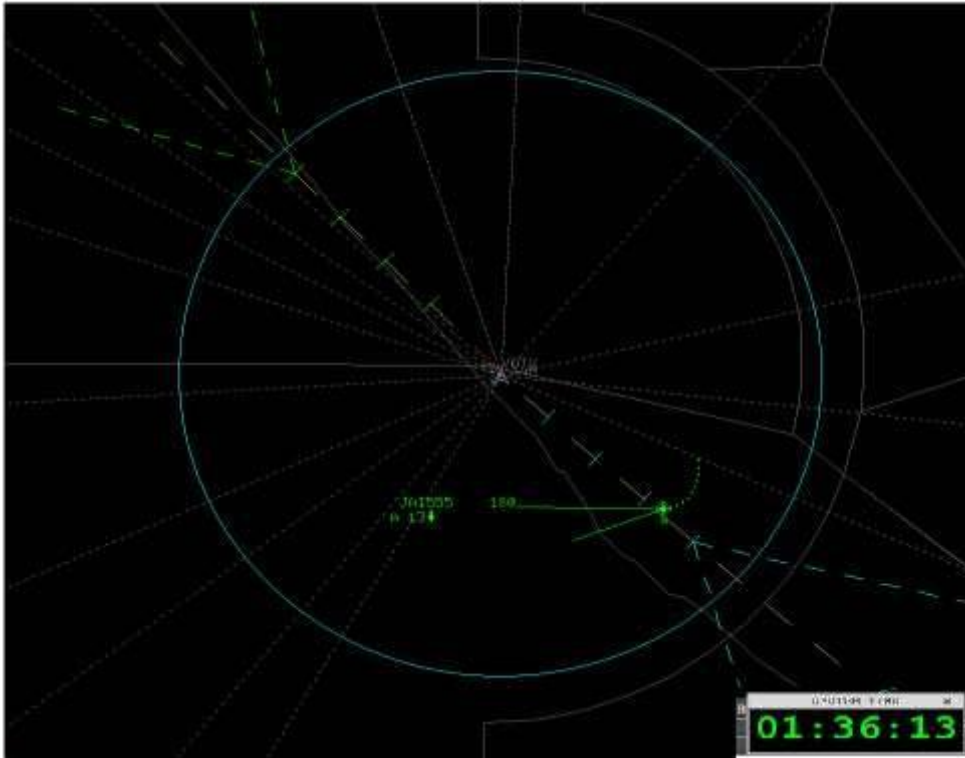
After 3^d go-around aircraft takes 360^o to self-positioned for runway 32

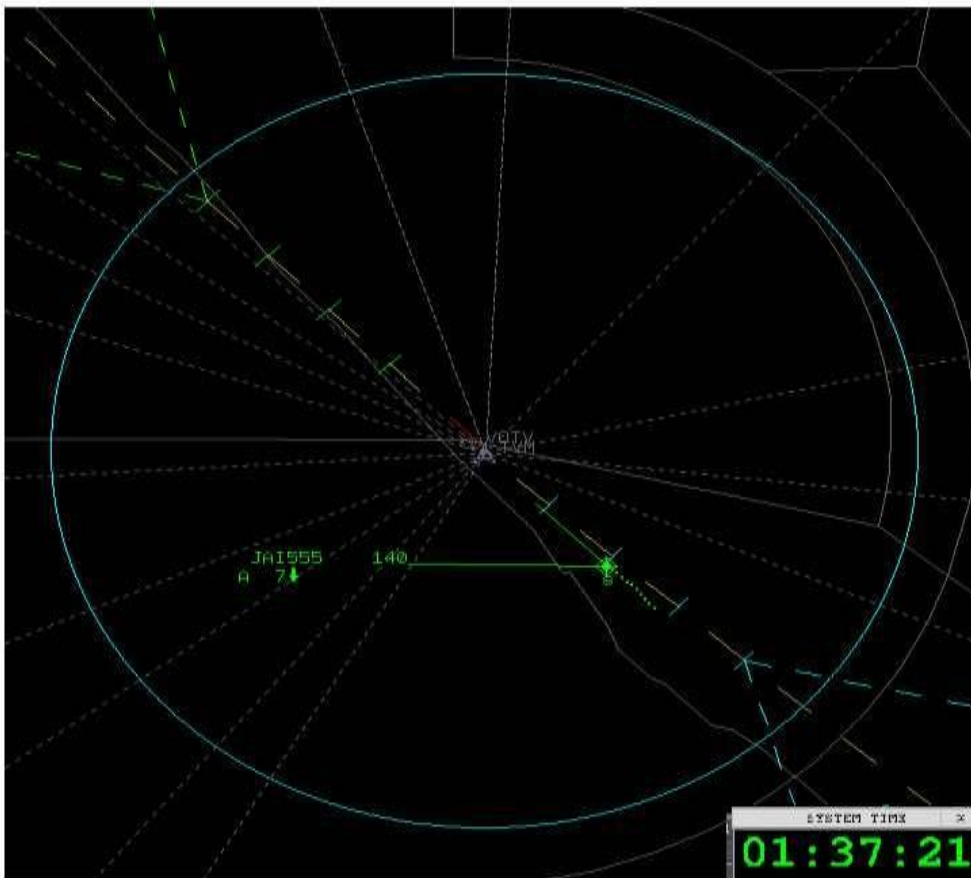
On 4th approach PIC sights the runway 32 below 500 ft for landing without being in prior visual contact with the runway.

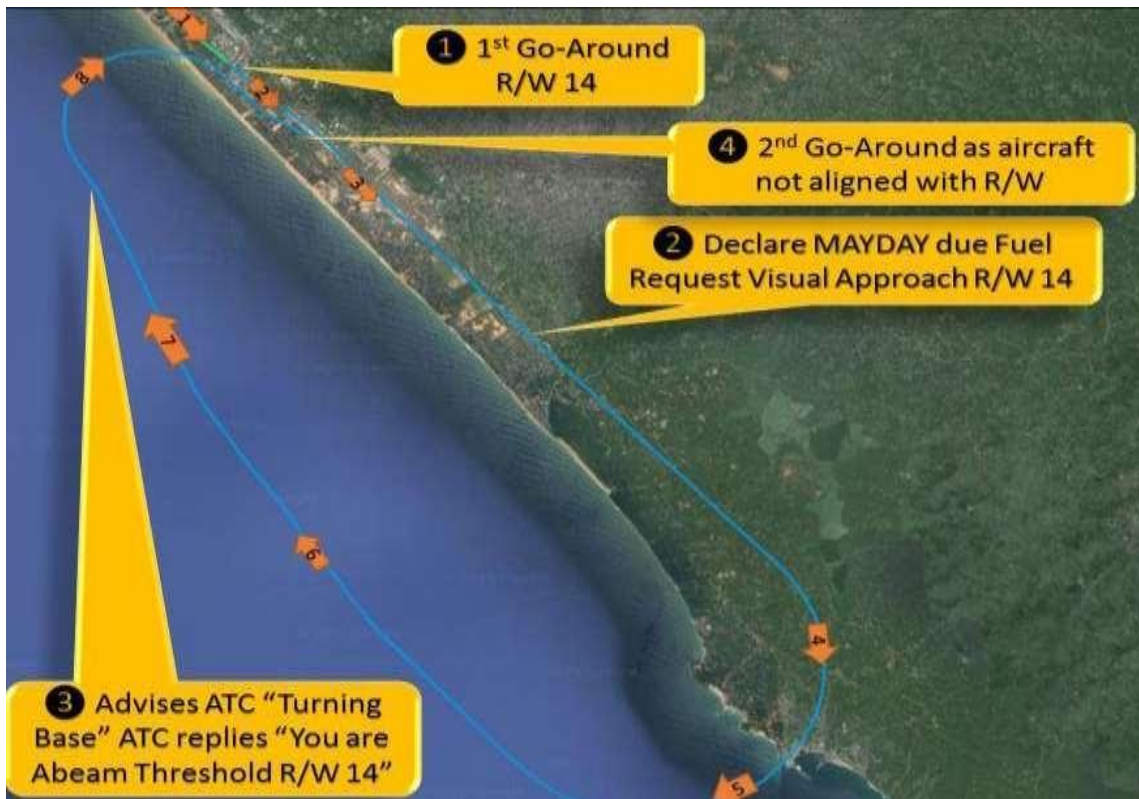
After carrying out the go-around the PIC requested ATC for right hand visual circuit for Rwy 14. As 9W-555 reported turning base, ATC advises 9W555 that they were just abeam the runway and same was acknowledged by 9W-555. During the approach to Rwy 14/32 the PIC was not in visual contact with the airfield and by the time 9W-555 sighted the runway the crew realize that they are too high and not aligned with the runway. The PIC realizing that they are too high for a safe landing, the PIC decided to initiate the second go-around (Fifth Go-Around of the flight).

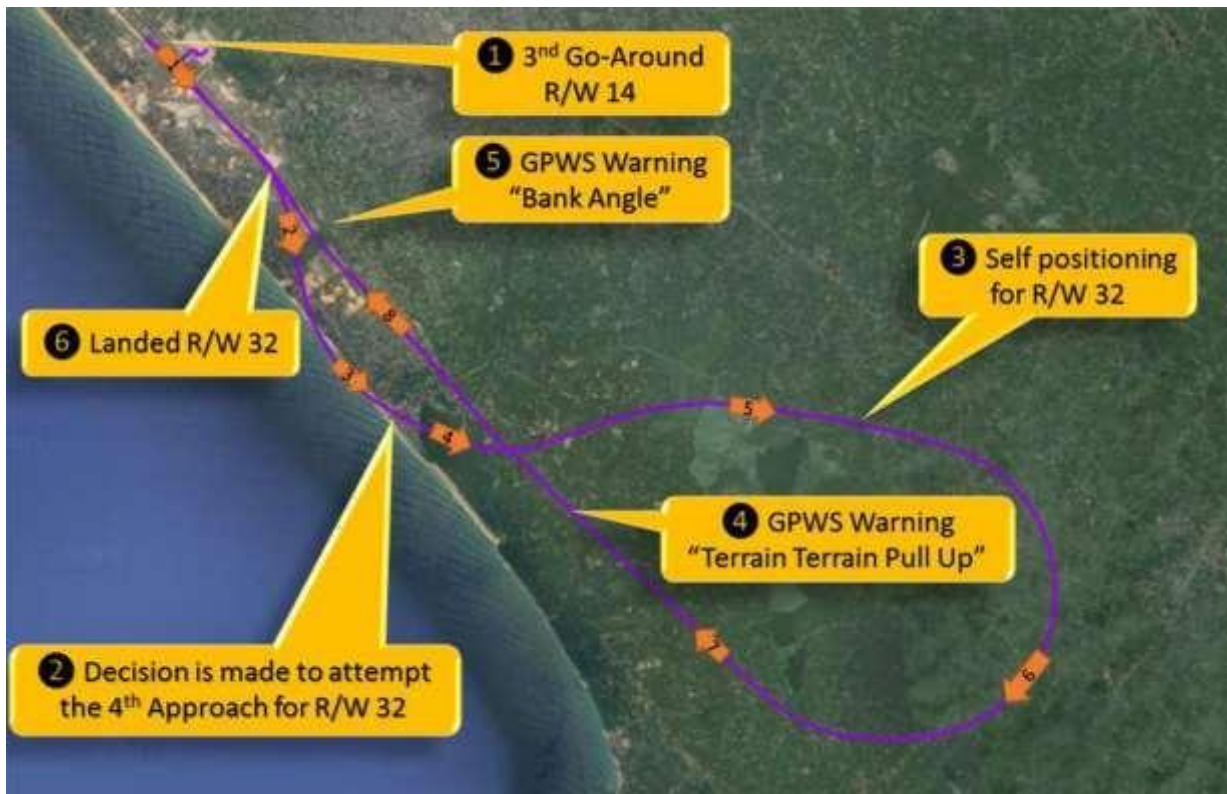
After carrying out the 6th Go around and climbing to 700 feet AGL the PIC realised that fuel was very less and requested ATC to take left 180⁰ turn and to self-position for making visual landing for inbound runway 32. The PIC continued the approach for runway 32 without any visual contact with the runway and with all GPWS warnings "TERRAIN TERRAIN PULL UP" and also the GPWS bank angle alert as the aircraft manoeuvred at low altitude. The aircraft finally landed safely on runway 32 on the 7th approach. After landing, the total fuel on board was only 349 Kgs.
