Final Investigation Report on Serious Incident to M/s Mesco Aerospace Ltd. AS 350 BA Helicopter VT- MAB on 08-04-2014 at Chakwali Village, Near Saharanpur, U.P.

| 13. | Type of Incident | | Forced landing due to Tail Rotor Pitch link failure |

SYNOPSIS:

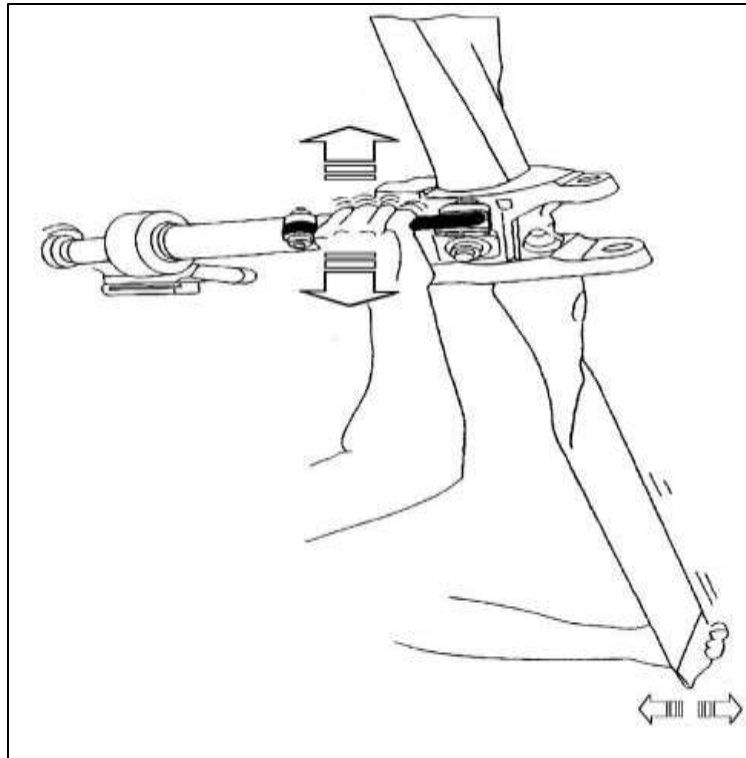
ALF Method to check for bearing play

The ALF checks, per section 05.21.00.603 of the maintenance manual, consisted of a visual inspection similar to the 600-hour service check, as well as a tactile check to confirm there was no play in the spherical bearing. The tactile check carried out by imparting an oscillating axial load on the bearing, while applying a low-amplitude, see-saw motion to the blades.

As per operator maintenance program, inspection of tail rotor Pitch Change Link and Swivel Bearing were carried out at After Last Flight / 10 hours inspection task card. There is no specific inspection of tail rotor Pitch Change Link in BFF.

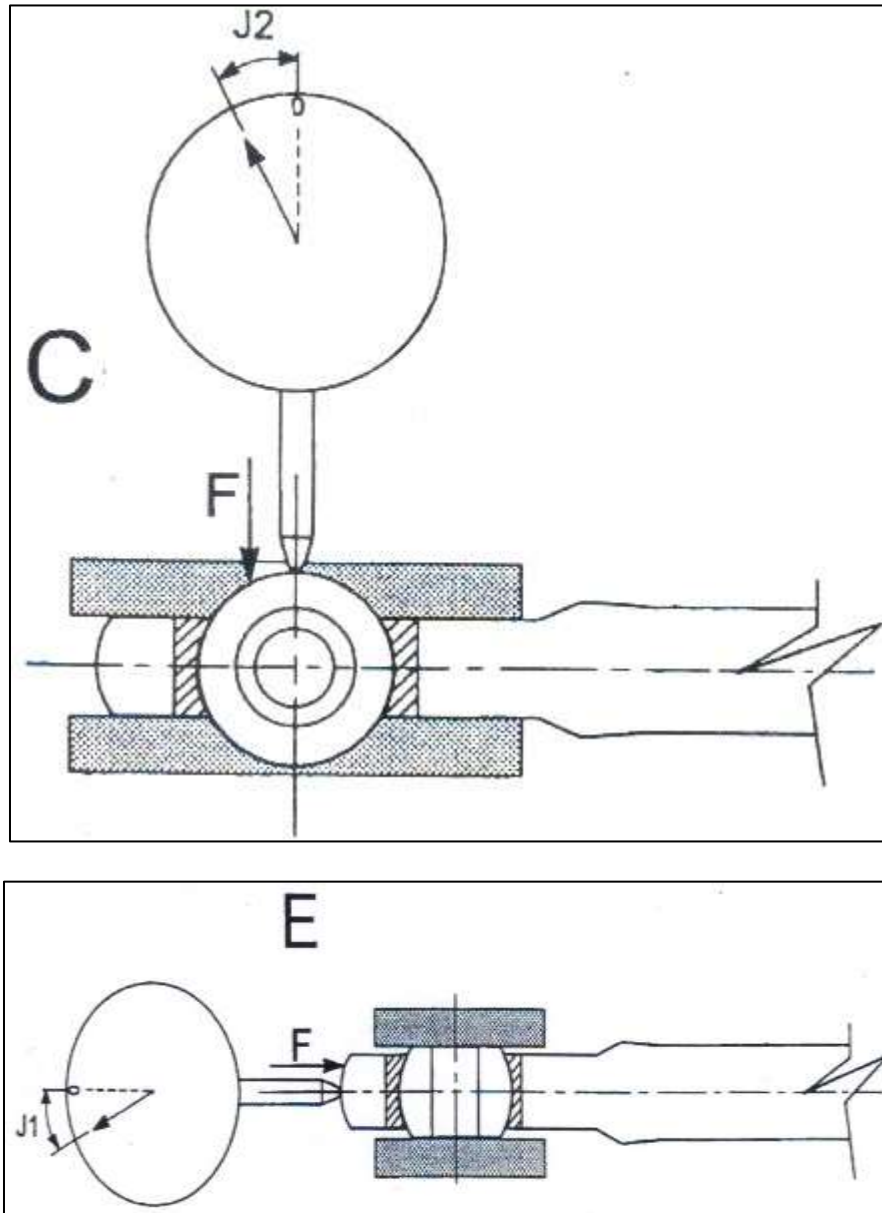
The 600-hourly inspection was carried out on 01-02-2014 when the aircraft had accumulated 4827:31Hrs hours total time in service and the links were inspected at that time with no defects recorded. As per inspection the play found was 0.0095 inch for Detail 'C' and 0.0043 inch for Detail 'E' which was within limit.

As per para 4.2.1 of Chapter 65.20.00.601, following limits was mentioned on Swivel bearing:-

The links were to be discarded if axial or radial play was measured outside of prescribed limits, the Teflon fabric was extruded from the bearing, there was persistent discoloration of the ball, or if there was any scoring of the ball.

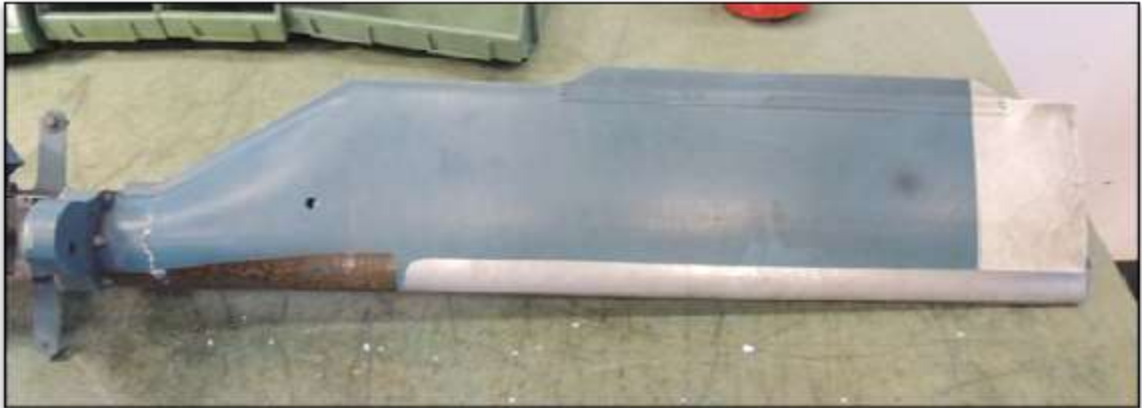
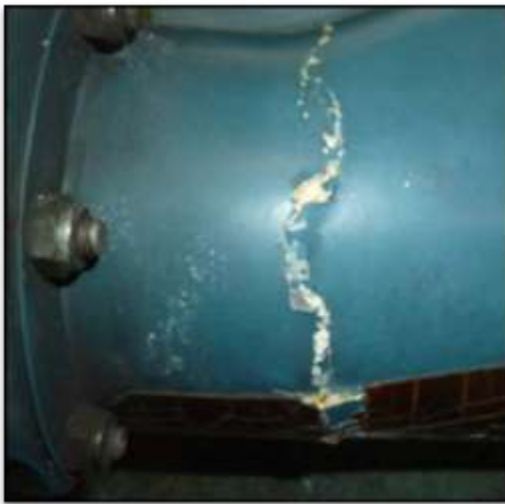
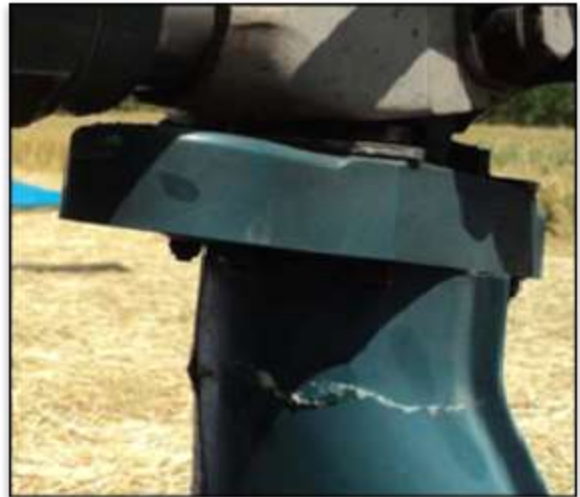
Damaged Tail Rotor Blade

The damaged blade exhibited a compressive crack (blade flapping toward the tail boom) at the junction with the chin weight. The damaged blade exhibited some marks of contact with very soft object compatible with vegetation. The impact finger was bent which is consistent with the blade contact with the tail boom due a significant flapping of the blades.

The internal half-laminated bearing of the damaged blade chin weight exhibited damages consistent with several significant blade flapping toward the tail boom. The metallic support allowing the junction on the chin weight of the internal half laminated bearing of the damaged chin weight exhibited contact marks with the hub yoke which are consistent with a significant flapping toward the tail boom.

The chin weight horn of the damaged blade was missing. The chin weight of the damaged blade exhibited contact marks with tail rotor mast and the seesaw screw exhibited contact marks with the hub yoke which are consistent with a significant blade flapping toward the tail boom.

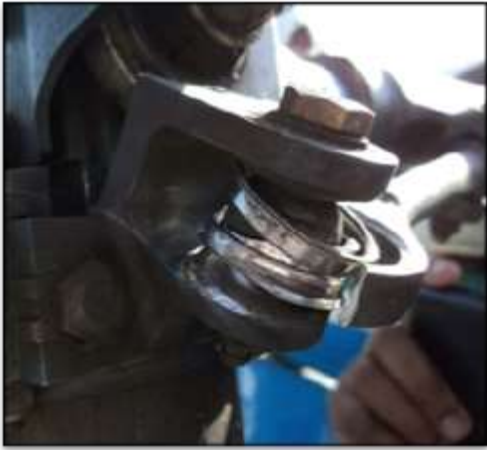
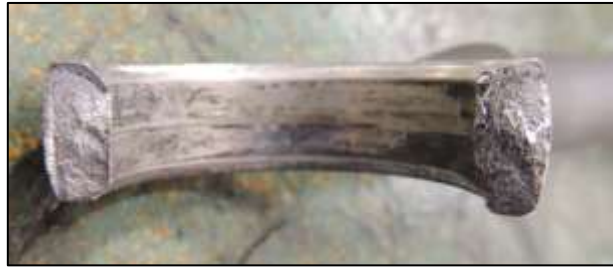
Failed pitch rod

The failed pitch rod exhibited rupture on its housing at two different locations but didn't exhibit deformations which are consistent with a fatigue rupture.

The bearing ball of the failed pitch rod exhibited wear damages consistent with a long use with play in the ball bearing.

The ball bearing cage of the failed pitch rod exhibited significant wear damages (material is missing) consistent with a long use with play in the ball bearing.

The bearing ball of the failed pitch rod exhibited wear damages consistent with a long use with play in the ball bearing. The ball bearing cage of the failed pitch rod exhibited significant wear damages (material is missing) consistent with a long use with play in the ball bearing. The failed pitch rod exhibited rupture on its housing at two different locations but didn't exhibit deformations which are consistent with a fatigue rupture. The other tail rotor pitch link shows axial play, which was within limit.

The fatigue rupture of the pitch rod is probably due to a long use of the helicopter in presence of a play into one of the tail rotor pitch rod ball bearing.
