INVESTIGATION REPORT

**INCIDENT TO M/S RAJIV GANDHI ACADEMY FOR AVIATION TECHNOLOGY,
CESSNA 172R AIRCRAFT VT-RGV AT TRIVANDRUM AIRPORT ON 03-04-2017**

O/o Director Air Safety (SR), Chennai – 600 027

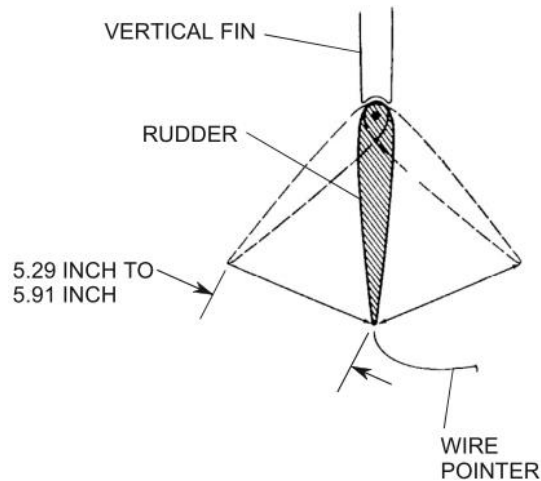
After the incident, the control surface deflection was carried out by alternate method and following discrepancy was observed:

Side	Limits as per AMM	Observed reading
LH	5.29" – 5.9"	6.2"
RH		5.2"

(Fig 1: Rudder travel check as per AMM)

As per AMM, the deflection/ movement of the rudder Left and Right side should be between 5.29" to 5.9" from the Rudder idle position, whereas LH side was deflection beyond AMM limits. This eventually creates excessive yaw moment towards the left.

- 3.1.12. The rudder travel was found beyond AMM limits.
- 3.1.13. There was no damage to the aircraft and any structures in the aerodrome.
- 3.1.14. The flight cadet was subjected to post flight medical test and was found negative for influence of alcohol.

- 3.2.1. The cause of the incident was due to Flight Cadet's incorrect handling of flight controls during cross wind landing.
- 3.2.2. The excessive rudder travel to the left has amplified the yaw moment of the aircraft.

- 4.1.1. Suitable corrective flying training to be imparted to the Flight Cadet.
- 4.1.2. M/s RGAAT shall carry out one time inspection of Rudder travel check for entire Cessna 172R.
- 4.1.3. Digital Inclinator to be used for carrying out Rudder travel check for more accurate measurements.

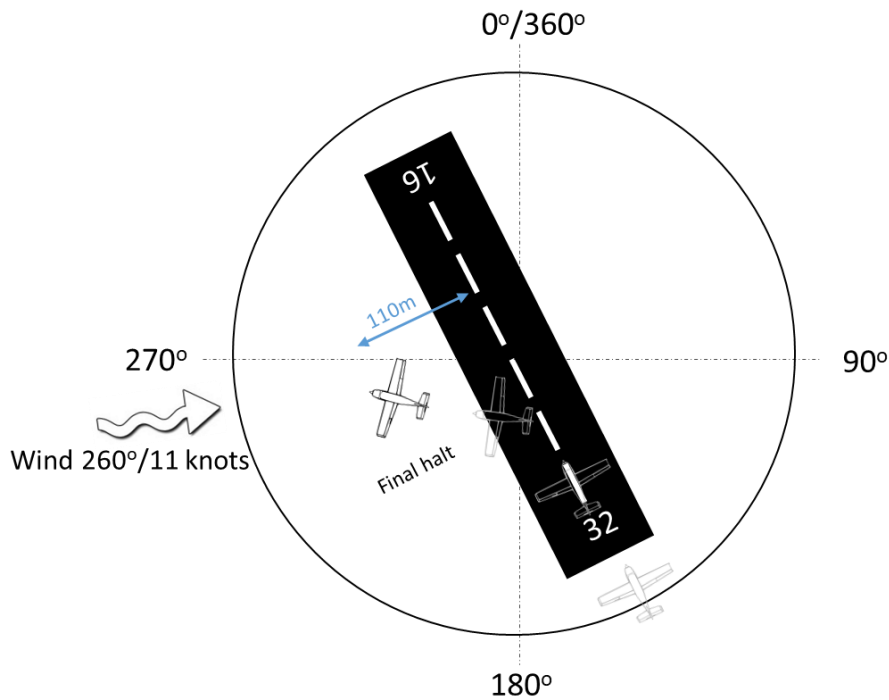
The aircraft touched down on the runway center line. Due to wind of 260° with a speed of 11 knots the aircraft drifted towards the left. The flight cadet in an attempt to align the aircraft back to the centerline had given incorrect rudder input to the left. Due to this attempt the aircraft went out of the runway leading to a runway excursion.
