**FINAL REPORT OF SERIOUS INCIDENT TO AIRLINE  
ALLIED SERVICES LTD CRJ-700 AIRCRAFT VT-RJE AT  
CHAKERI AIRFIELD, KANPUR ON 20/07/2011**

1. Aircraft  
    Type : CRJ-700  
    Nationality : INDIAN  
    Registration : VT - RJE
2. Owner/ Operator : Alliance Air Ltd.
3. Pilot – in –Command : ATPL holder on type  
    Extent of injuries : Nil
4. First Officer : CPL Holder qualified on type  
    Extent of injuries : Nil
5. Place of Incident : Chakeri Airfield, Kanpur
6. Date & Time of Incident : 20<sup>th</sup> July 2011 0652UTC(Approx.)
7. Last point of Departure : Delhi
8. Point of intended landing : Kanpur
9. Type of operation : Schedule Operation
10. Crew on Board : 4  
    Extent of injuries : Nil
11. Passengers on Board : 55  
    Extent of injuries : Nil
12. Phase of operation : Landing
13. Type of incident : Runway Excursion

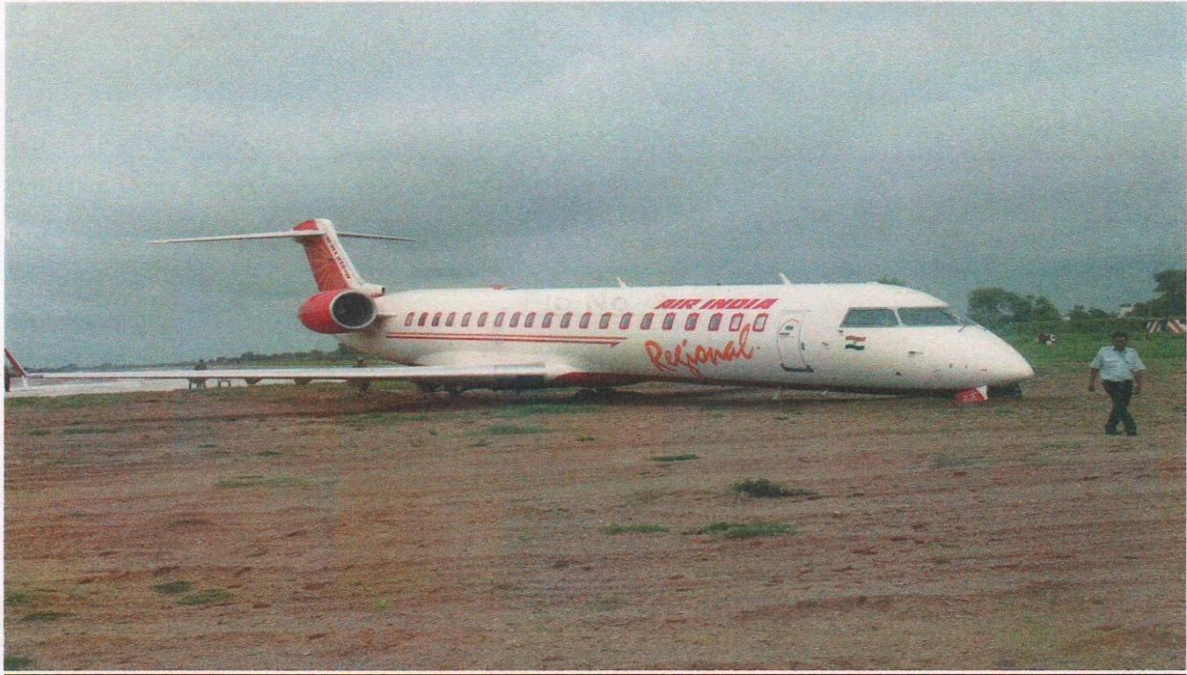
**Figure: Nose Landing Gear completely bogged down in the soft ground.**

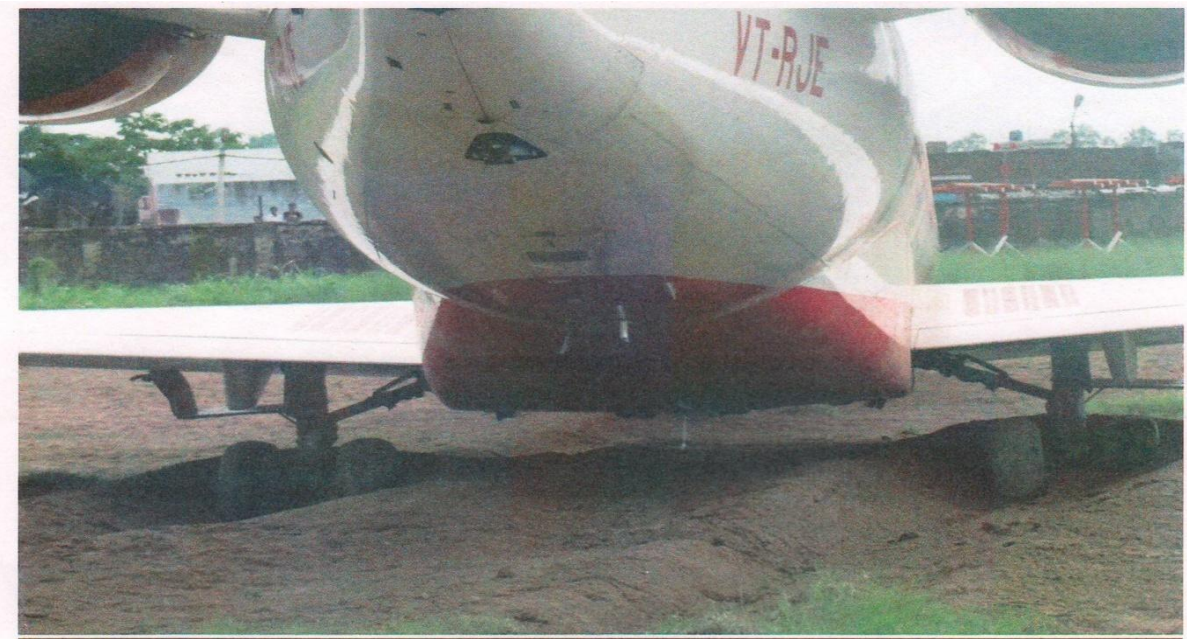
**Figure: Both Main Landing Gears Bogged down in soft ground area**

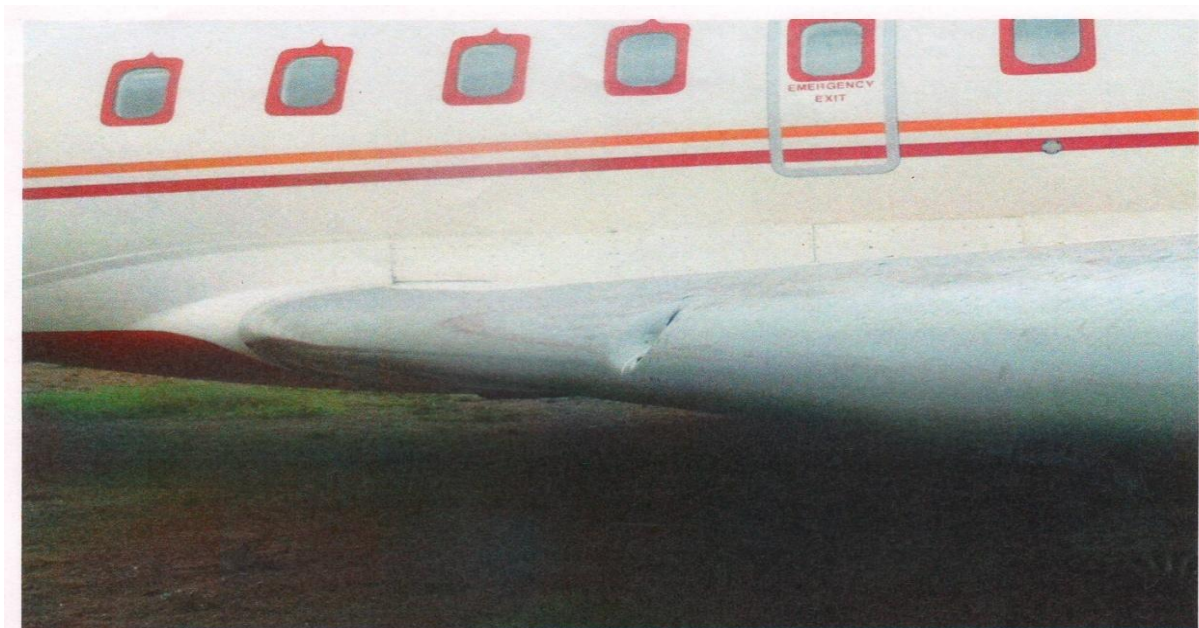
- A 3 inch hole on the leading edge of the port wing. Other than this there was no other damage on the aircraft.

**Figure: Damage on the leading edge of the port wing**

There was no major damage to the aircraft however while exiting the runway the port side wing had hit the localizer antenna which punctured a hole of approximately 3 inches on the port side leading edge. Other than this there was no damage to the aircraft.

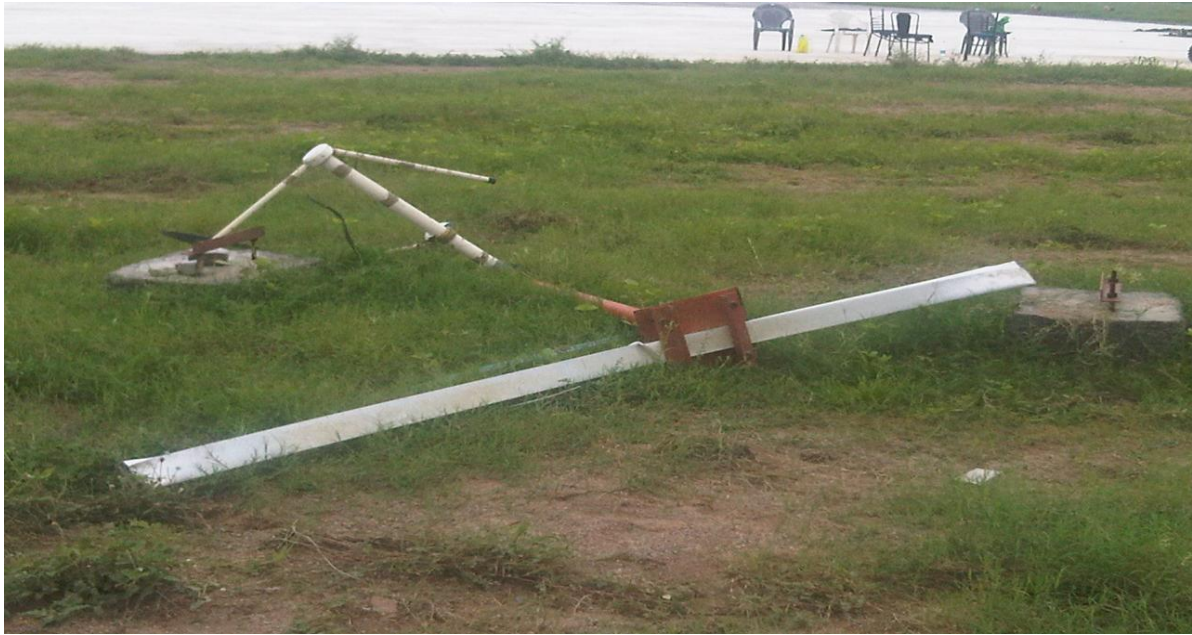
**1.4 Other damage:** The localizer antenna located at the runway end was broken by the aircraft port side wing.

**Figure: Damaged Localizer Antenna**

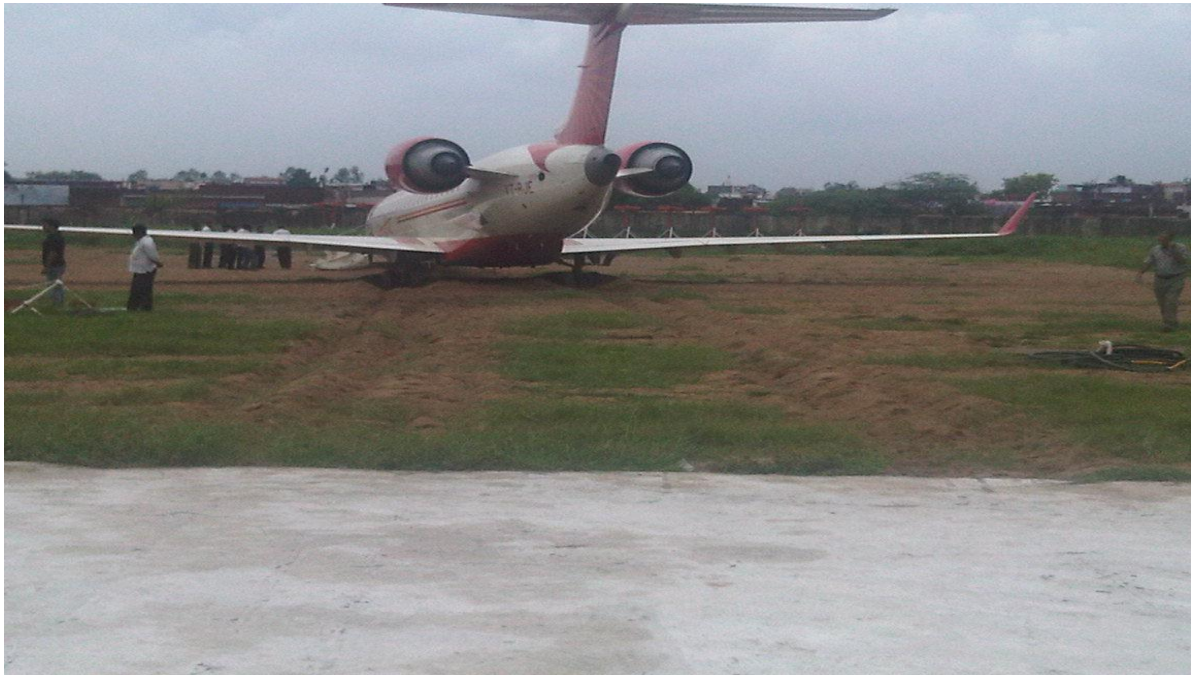
length available at Chekari, Kanpur is 9000 ft. As per the statement of the ATC controller and the first officer the aircraft landed after the middle marker which is around 4500 ft from runway end. And the remaining runway was not enough to stop the aircraft on the runway under the prevailing rainy conditions. The aircraft exited the runway at around 44 knots and entered into soft ground and thereafter rolled for another 201 ft before it came to final halt.

**Figure: Aircraft rolled over into the soft ground area**
