**FINAL INVESTIGATION REPORT
ON
NOSE WHEEL SHEAR OFF INCIDENT TO
M/S SARASWATI AVIATION ACADEMY, ALARUS CH2000
AIRCRAFT VT-RJT, WHILE LANDING AT
AMHAT AIRFIELD, SULTANPUR
ON
23.08.2014**

1. Aircraft Type : ALARUS CH2000
Nationality : Indian
Registration : VT-RJT
2. Owner : Saraswathi Aviation Academy, Sultanpur, U.P.
3. Operator : Saraswathi Aviation Academy, Sultanpur, U.P.
4. Pilot in Command : CPL Holder
Extent of Injury : Nil
5. Place of Incident : RWY 29, Amhat Airfield, Sultanpur, U.P.
6. Geographical Location of Site : N 26⁰ 14'47.47" E82⁰ 02'43.67"
7. Last point of Departure : Amhat Airfield
8. Intended place of landing : Amhat Airfield
9. Type of operation : Training sortie
10. Date and time of Incident : 23/08/2014, 12:47 Hrs
11. Passengers/Crew on Board : 02 Crew only, Passenger- NIL
Extent of Injury : Nil
12. Phase of Operation : Landing
13. Type of Incident : Nose wheel sheared off while landing

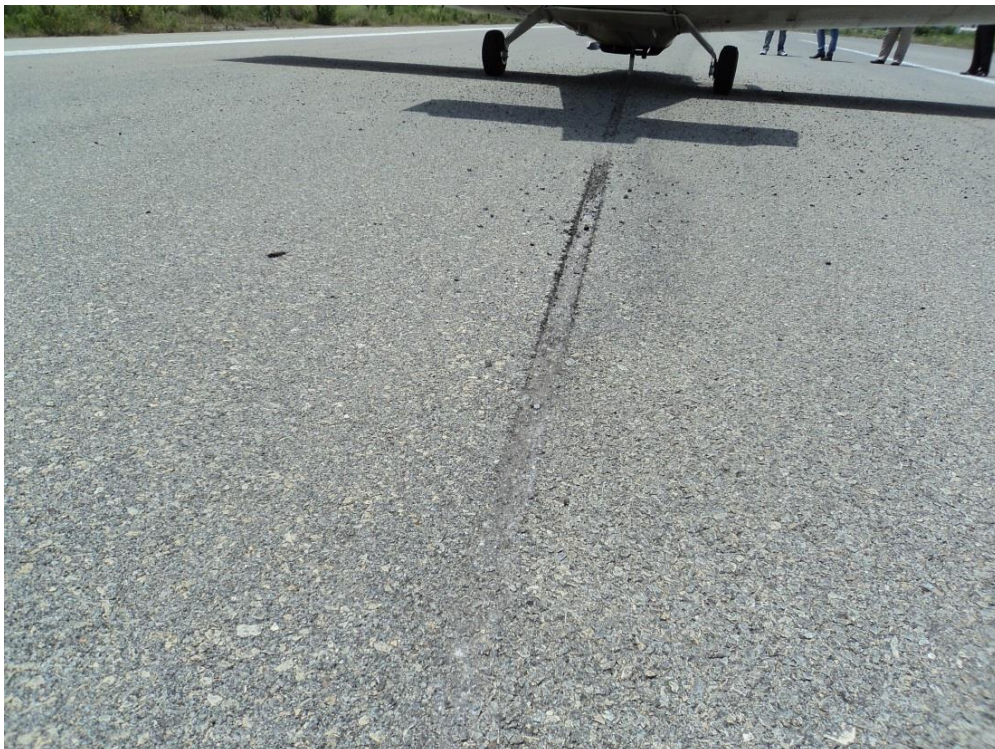
Runway surface was damaged due to several strikes of the propeller blades and dragging of nose wheel shock strut on the runway.

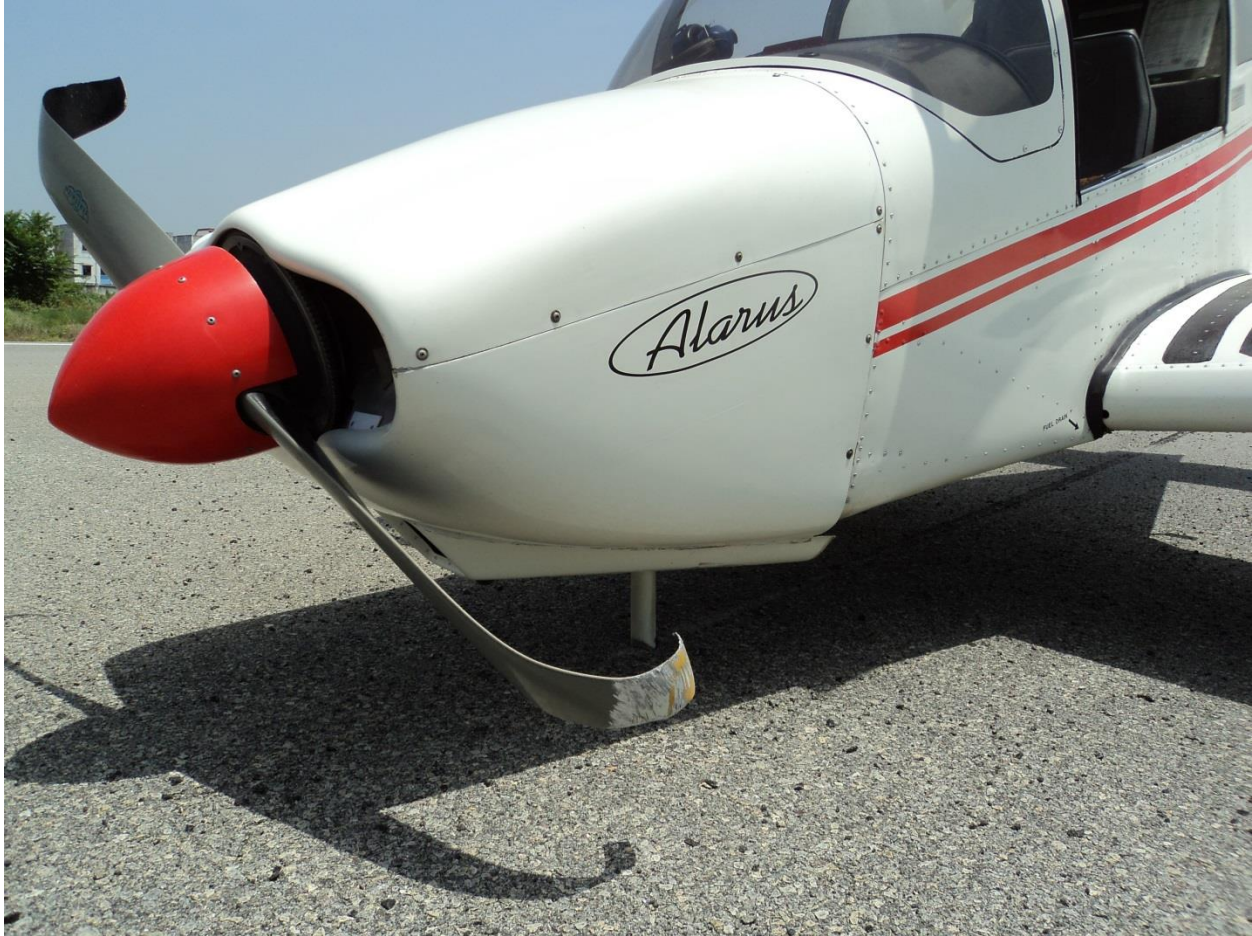
The aircraft landed on RWY 29. From the impact marks on runway it was observed that the aircraft landed on main wheels and nose wheel of the aircraft came in contact with the runway at 125 meters from the runway 29 threshold point and got detached from the aircraft after contacting the runway. After detachment of nose wheel, ground clearance of the propeller blade tip reduced and propeller started striking the runway. Ten cuts by propeller tips were clearly visible on the runway surface. Due to several strikes, both the propeller blades bent rearwards. Thereafter, the aircraft started dragging on the nose landing gear strut and it travelled about 121 meters from the touchdown point of nose landing gear. The

aircraft finally stopped at 246 meters from the runway threshold point and 4.8 meter to the left of the runway center line. Nose wheel assembly was found about 50 meters away from the aircraft on the right side of the runway.

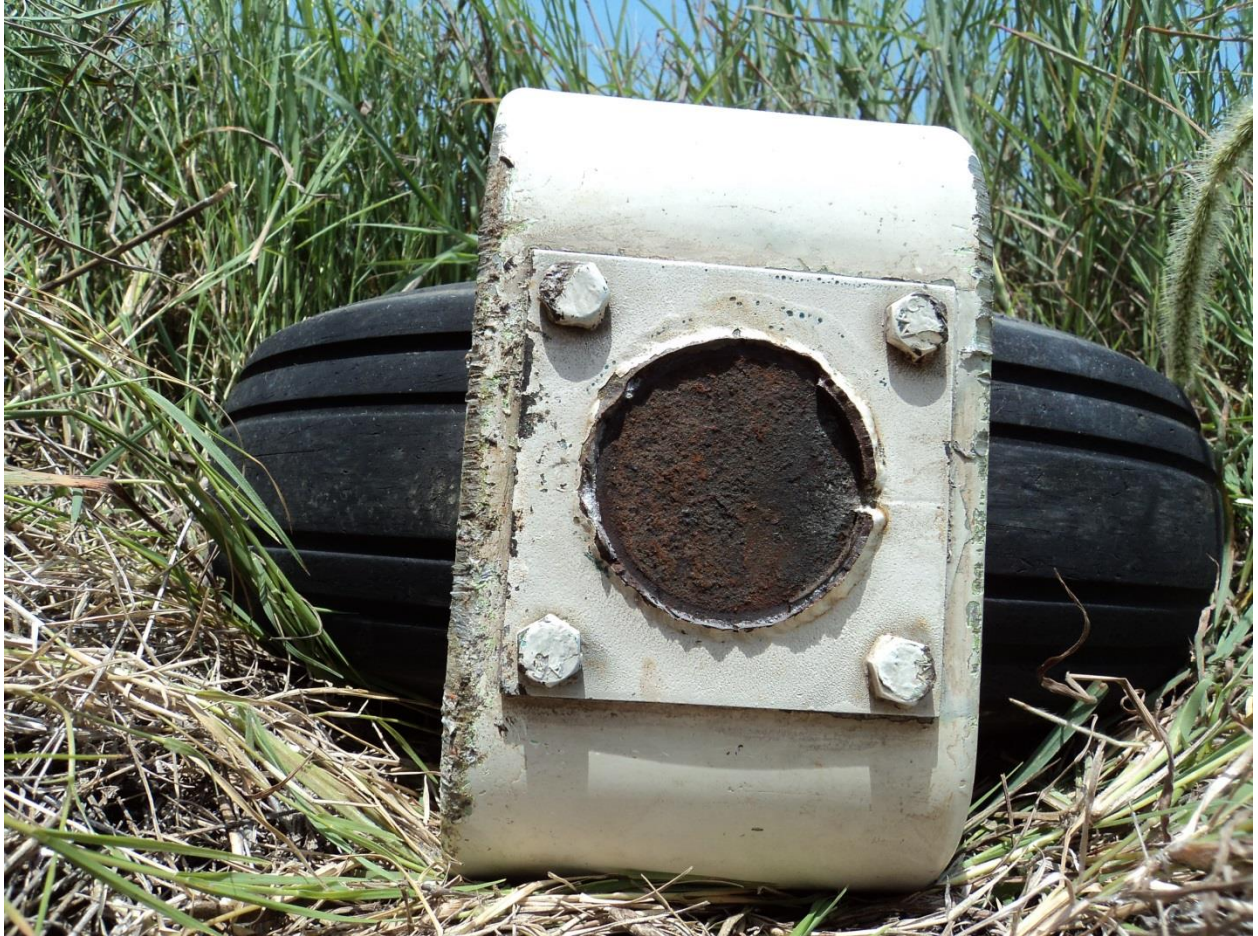
Nose wheel shock strut damaged due to continuous dragging on the runway. No other damage to the aircraft structure was observed. Both the instructor pilot and trainee pilot were safe. No sign of fuel or oil leakage/seepage was observed at the site.

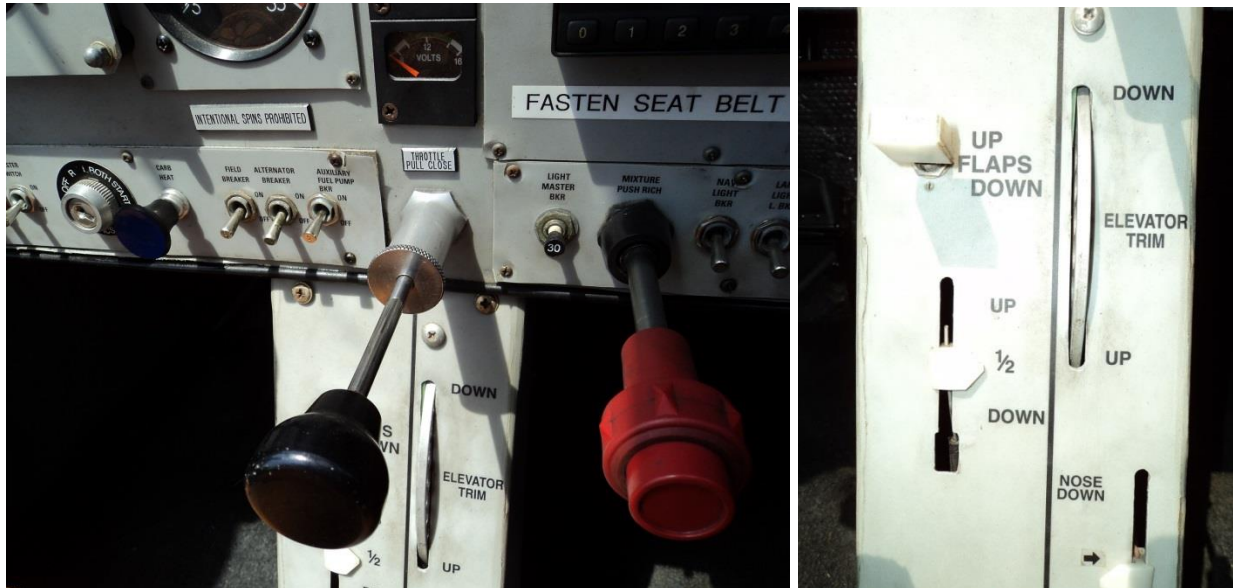
1. Throttle position was in Idle.
2. Mixture was in cut-off position.
3. Flaps were in 50% down position.
4. Elevator trim was in slightly nose up position.

5. Fuel shut off valve was in OFF position.
6. ELT was in armed position.

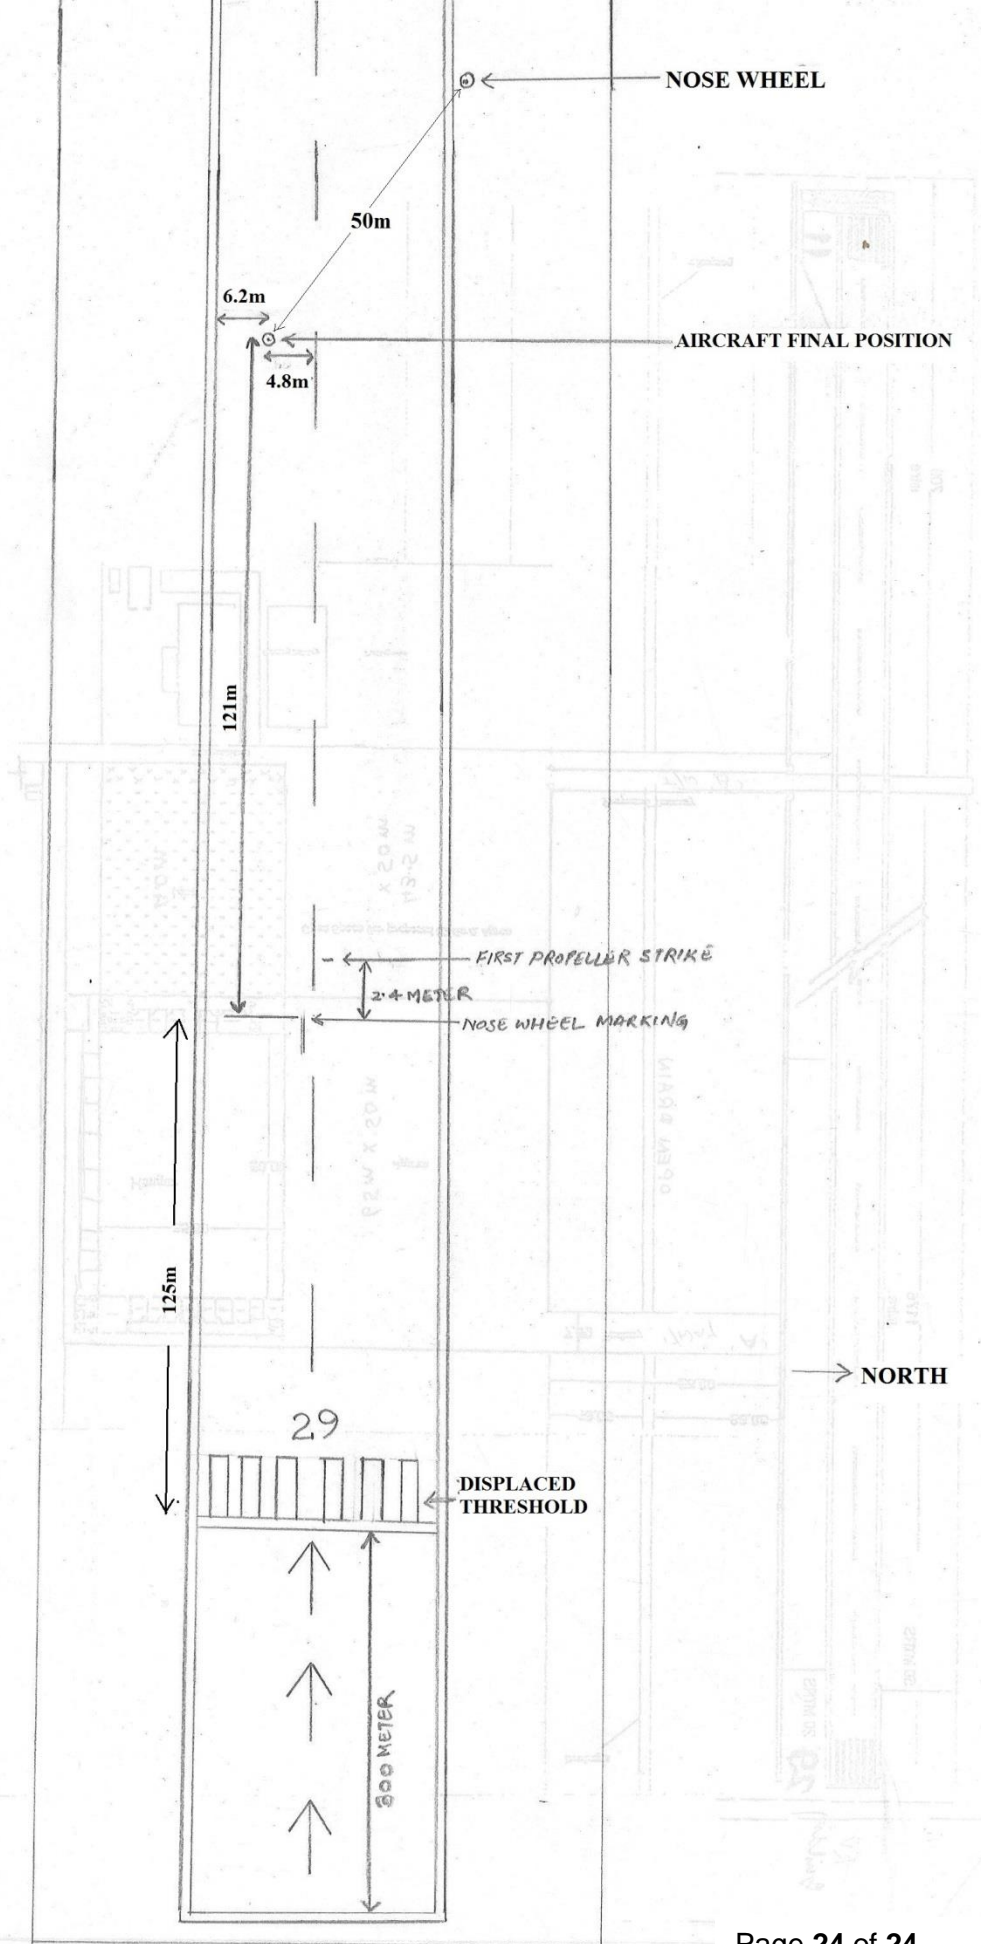
AMHAT AIRFIELD, SULTANPUR (U.P.) RUNWAY SKETCH

FINAL POSITION OF AIRCRAFT AND NOSEWHEEL ASSEMBLY
