**FINAL INVESTIGATION REPORT ON
RUNWAY EXCURSION TO
M/s AIR INDIA EXPRESS LTD BOEING 737-800 NG AIRCRAFT
VT-AXT ON 10/07/2018 AT MUMBAI**

**GOVERNMENT OF INDIA
O/o, DIRECTOR AIR SAFETY, WESTERN REGION,
NEW INTEGRATED OPERATIONAL OFFICE COMPLEX,
SAHAR ROAD, VILE PARLE (EAST), MUMBAI-400099**

On 10st July 2018, M/s Air India Express Ltd Boeing 737-800 aircraft VT-AXT was involved in runway excursion incident during landing while operating flight IX - 213 (VOBZ-VABB).

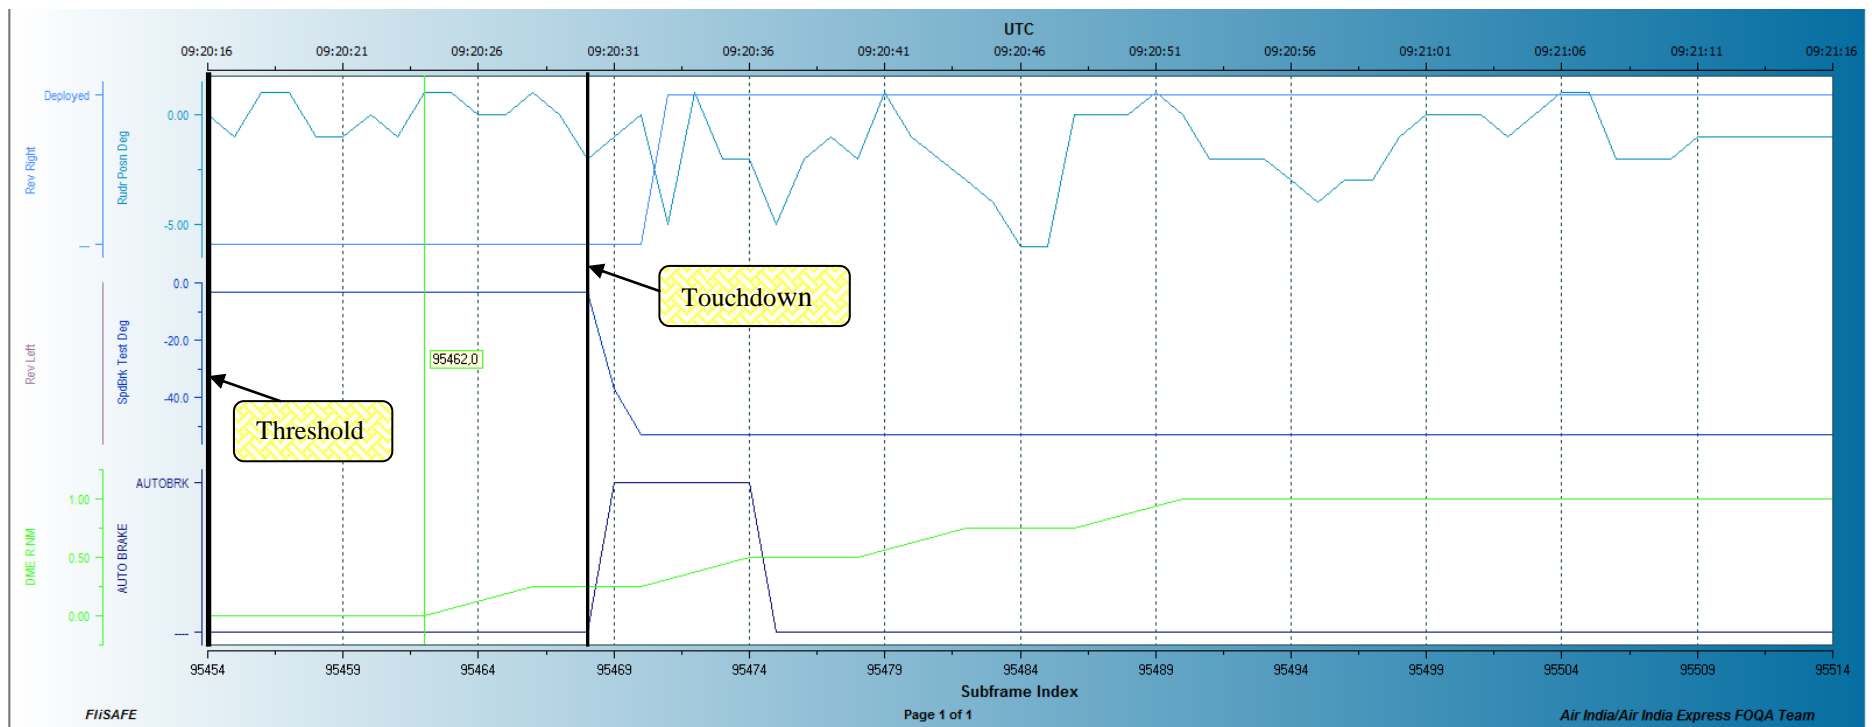
Figure # 11 Graphical representation of FDR data

The above graph depicts that the aircraft was at around 50ft RA at threshold which was considered slightly higher than normal. As per FCTM, in normal approach the aircraft is about 30ft RA on threshold. The flare started at threshold by increasing the pitch of the aircraft. The maximum pitch recorded during flare was 4.04°, which was normal. The power from Engine # 1 & 2 was observed to be 58.2% N1 and 59.5% N1 respectively at threshold which was lowered down to IDLE, 32% N1 and 32.75% N1 respectively, at 09:20:25 hrs. Subsequent to lowering the power, aircraft made firm touchdown at 09:20:30 hrs. The power was considered to be slightly higher during flare. Aircraft touched down after 14 seconds of flare at 962.6 m/ 3158 ft from the threshold. The power of Engine # 1 & 2 was immediately reduced after deployment of right thrust reverser.
