**REPORT  
OF  
COMMITTEE OF INQUIRY**

**ACCIDENT TO BSF (AIR WING) DHRUV HELICOPTER VT-BSN  
AT RAIPUR AIRPORT ON 15<sup>th</sup> JAN 2012**

**FINAL INVESTIGATION REPORT ON ACCIDENT  
TO  
BSF DHRUV HELICOPTER VT-BSN AT RAIPUR AIRPORT  
15<sup>TH</sup> JANUARY 2012**

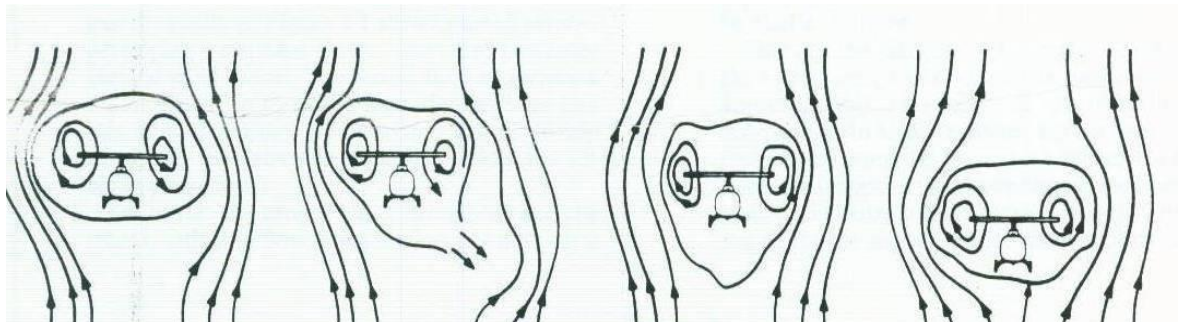
***Fig No 4: Vortex Ring flow conditions***

**1.18.2.2 Conditions for Vortex Ring** Vortex Ring is likely to occur when descending in

bladed rotor with a diameter of 13.2 m and a weight of 5400-5500 kg at OAT of 25°C would result in an induced velocity of 13-14 m/s. Therefore, although Vortex Ring State is shown to be dependant on the helicopter type and weight, a commonly accepted unsafe ROD is considered to be in excess of 500ft/min (~2.6m/sec).
