**FINAL REPORT ON ACCIDENT TO
GOVT. OF MAHARASHTRA
SIKORSKY S-76C++ HELICOPTER
VT- CMM
AT NILANGA, LATUR
ON 25/05/2017**

**A X Joseph
Deputy Director, AAIB
Chairman, Committee of Inquiry**

1. Aircraft Type : Sikorsky S76 C++
Nationality : INDIAN
Registration : VT – CMM
2. Owner : Government of Maharashtra.
3. Operator : Government of Maharashtra.
4. Pilot – in –Command : CHPL holder on type
Extent of injuries : Nil
5. First Officer : CHPL Holder on type
Extent of injuries : Nil
6. Place of Incident : Nilanga, District Latur
7. Geographical Co-Ordinates : 18°07’34’’N, 76°44’57’’E
8. Date & Time of Incident : 25th May 2017, 0625 UTC
9. Last point of Departure : Nilanga, District Latur
10. Point of intended landing : Raj Bhawan, Mumbai
11. Type of operation : Non Schedule Operation
12. Crew on Board : 02
13. Passengers on Board : 04
14. Phase of operation : Take off
15. Type of accident : Crash landing after hitting Electrical
High Tension Cables

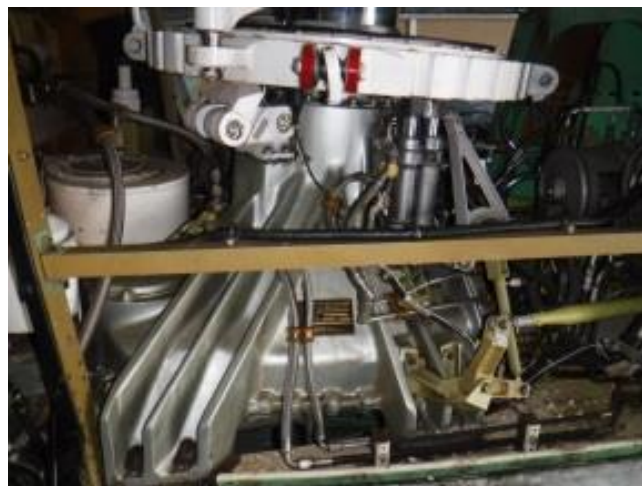
Fig:13 - Main gearbox attachment

The main gearbox remained attached to the airframe. All four mounting feet and all eight mounting bolts were intact. Mechanical continuity was confirmed by rotating the inputs and MRH and observing corresponding motions.

Both engine input driveshafts drove the main rotor head and freewheeled and the tail take-off freewheeled. The #2 input shaft was fully intact. The #1 input shaft showed traces of contact with the flexible couplings indicating misalignment.

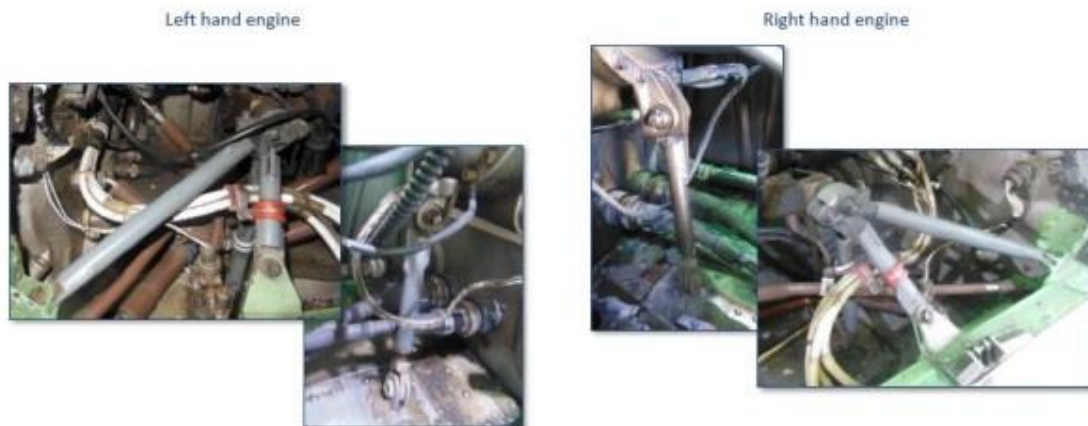
Fig:14 – Engine mountings

Engines: All engine mounting bolts were intact. Both engines were attached to the helicopter by the front and rear supports.

The engine cowling revealed impact damage to its left hand side. A rod belonging to the lorry that was hit during the crash had pierced and penetrated the cowling's left flank. The inside of the cowling was unremarkable with light heat stains (the RH one being slightly larger) in the vicinity of the engines' turbines.

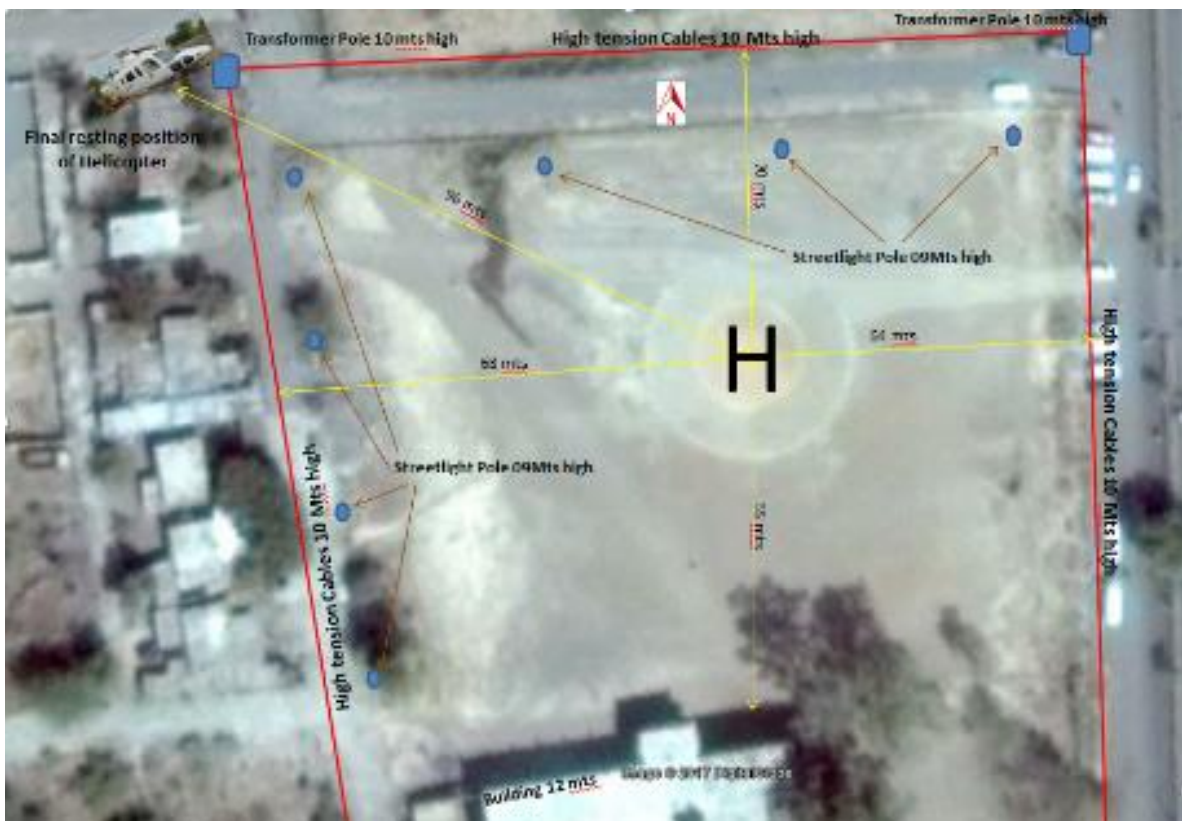
Fig:28 – Layout of the temporary landing ground.

The temporary landing ground is surrounded by high tension 11 KV electricity cables on three sides and high trees and building on one side. The electricity poles of 10m height (33 ft) carrying the 11 KV electricity cables are located at a distance of 64 mts from the centre of helipad in east direction and in the west direction electricity poles of 10m height carrying the 11 KV electricity cables are located at a distance of 68 mts from centre.

The distance of poles carrying High Tension (HT) cable in the north direction is around 70 mts from centre. On the southern direction the building is located at a distance of approximately 65 mts from the helipad centre. Apart from these there were street light pole of 9 metres in the northern and western direction on the edge on the ground.

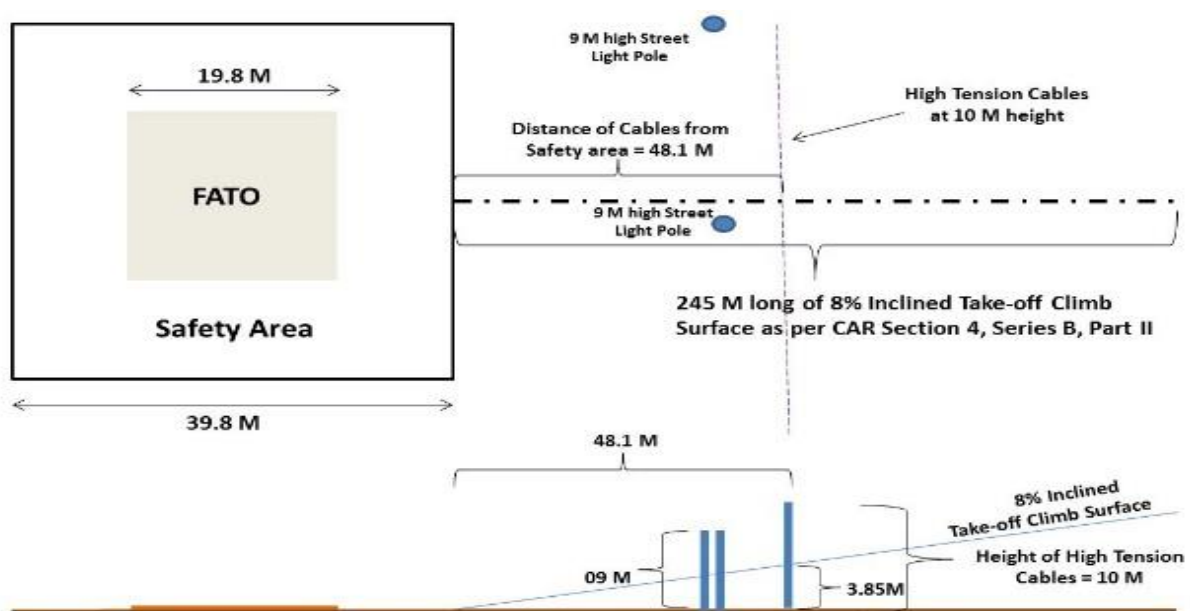
Fig:29 – Obstruction around the FATO

Further as per the para 4.6 of CAR Section 4, Series B, Part II, “An Approach and Take-off climb surface in an inclined plane sloping upwards (8%) from the end of the safety area and centered on a line passing through the centre of the FATO, should be available for a distance of at least 245 meters.”

The top and side view of the temporary landing ground is shown in the figure above. The High Tension Wires and the poles carrying them were in the take-off climb path by at least 6.15 mts.

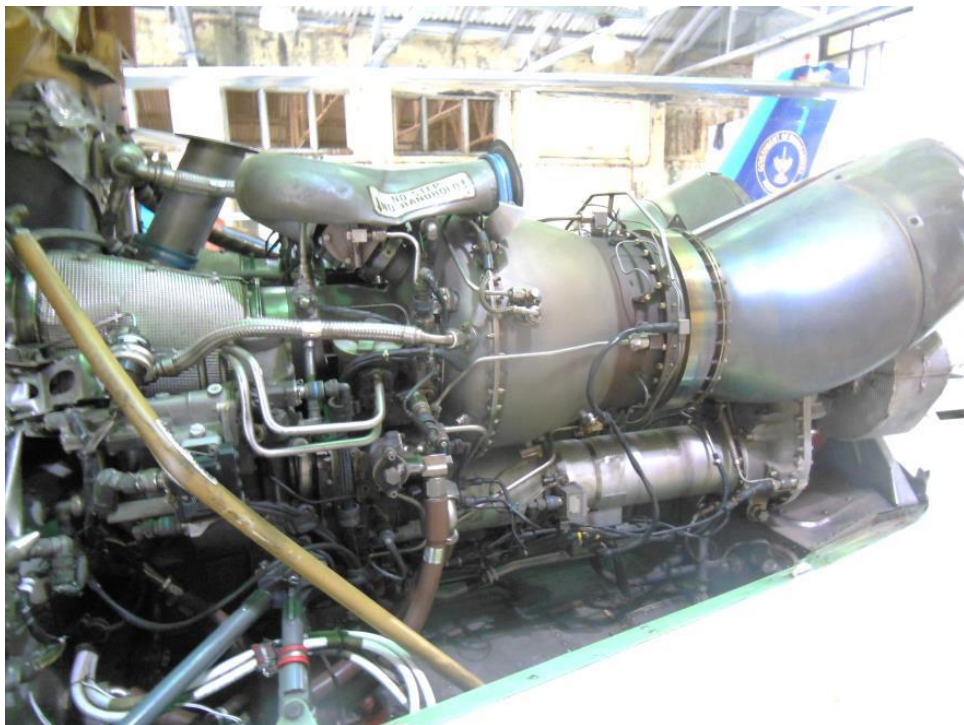
Fig:34 – LH Engine

The module 1 was in good condition. The output power drive rotated with the rotation of the Power Turbine thus confirming the continuity of the reduction gearbox gear chain.

Five fixing screws (out of 11) were sheared and were found on the engine bay floor along with their associated dowels indicating excessive lateral or vertical load at the time of impact.

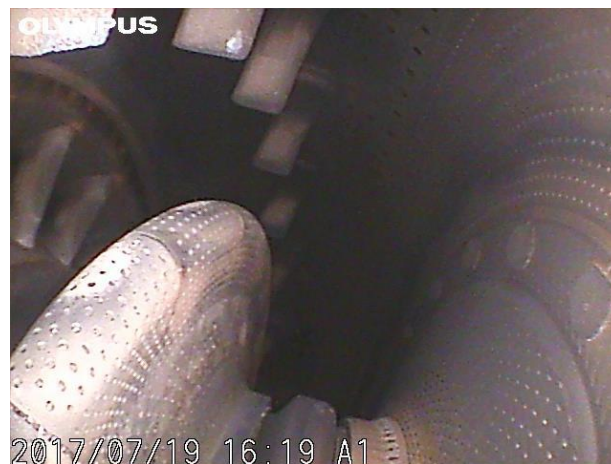
Fig:38 – LH Engine Module 3 – Combustion Chamber

The module 3 was in good condition. The boroscopic inspection of the combustion chamber showed no abnormality.

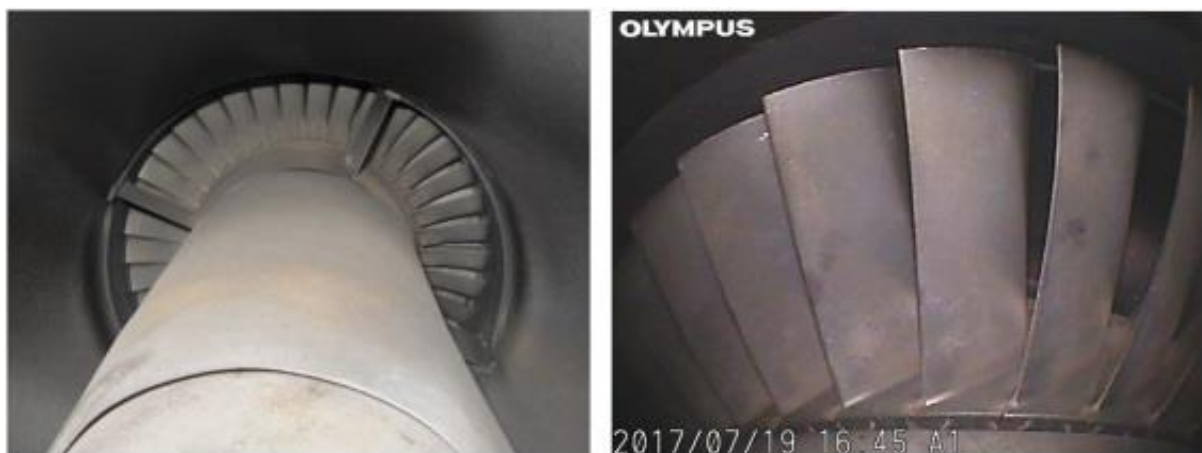
Fig:40- LH engine Module 4 – Power Turbine

The module 4 was in good condition. The examination of the Power Turbine wheel showed no abnormality or any visible impacts or traces of blade top rubbing.

The blades were clear of deposits, thus indicating that the FOD that deposited on the HP turbine did not have time to migrate to the Power Turbine. This indicates that the FOD ingestion must have occurred very shortly before the engine shut-down.

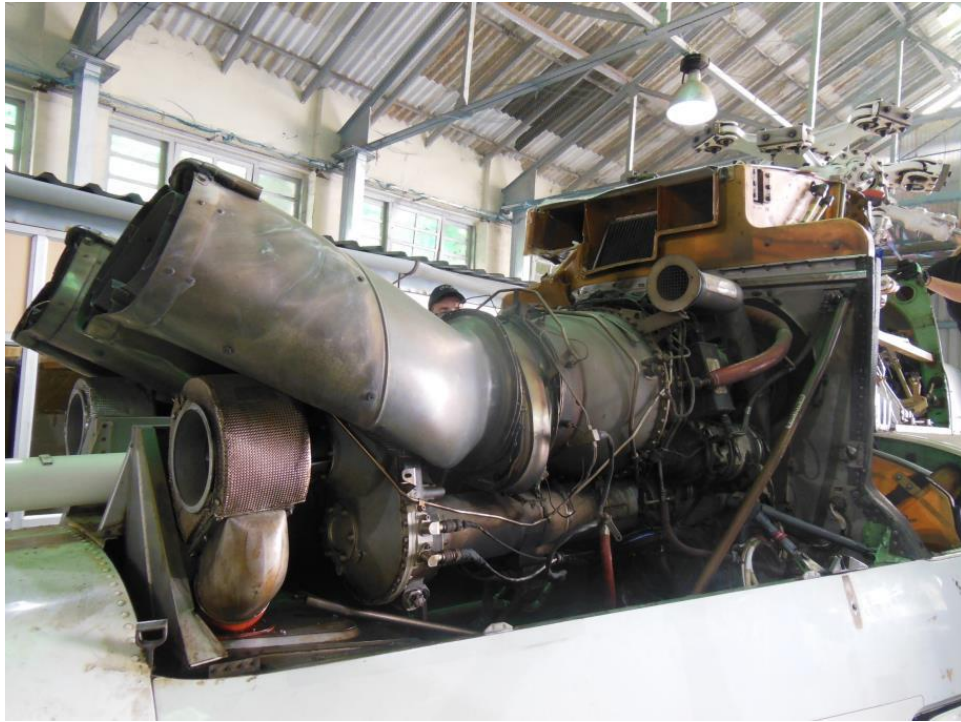
Fig:42 – RH Engine

The engine was attached to the helicopter and could be examined. The module 1 was in good condition with no particular findings to report. The output power drive shaft could be rotated smoothly manually when the engine was removed from the helicopter and separated from reduction gearbox.

Two fixing screws (out of 11) were sheared and were found at the bottom of the front support along with their associated dowels thus indicating excessive lateral or vertical load at the time of impact.

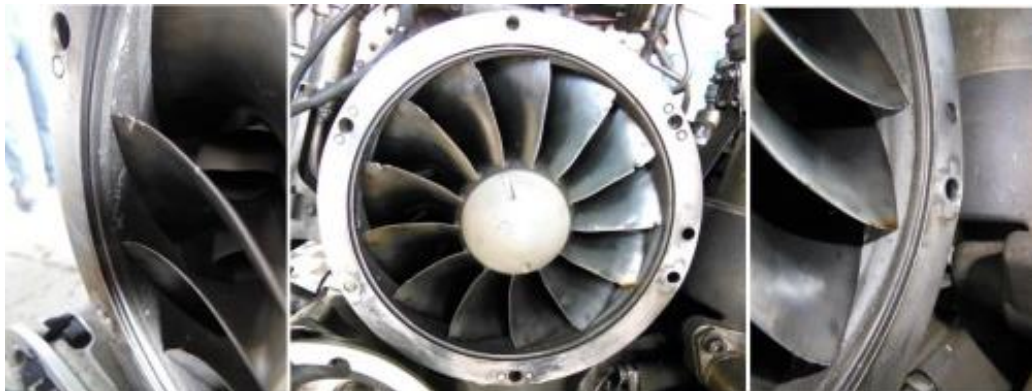
Fig:44 - RH engine Module 2 – Axial Compressor

The module 2 was in good condition with no particular findings to report. The Gas Generator was blocked initially. It could be unlocked manually and its rotation was smooth without noise although with some resistance.

The examination of the axial compressor showed FOD impacts on the leading edges of all the blades and several small impact marks on the shroud. Considering that the air intake was covered with a barrier filter, the origin of the FOD ingestion cannot be explained. There was blade tip rubbing in the 4 o'clock position. There was no visible erosion on the blades.

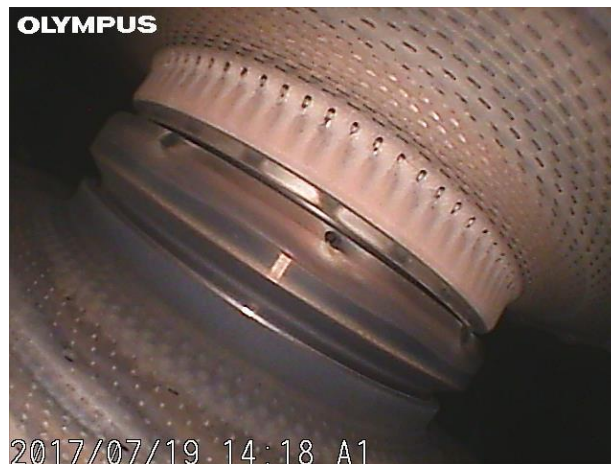
Fig:46 - RH engine Module 3 – Combustion Chamber

The module 3 was in good condition with no particular findings to report. The boroscopic inspection of the combustion chamber showed that it was in good condition with no findings to report.

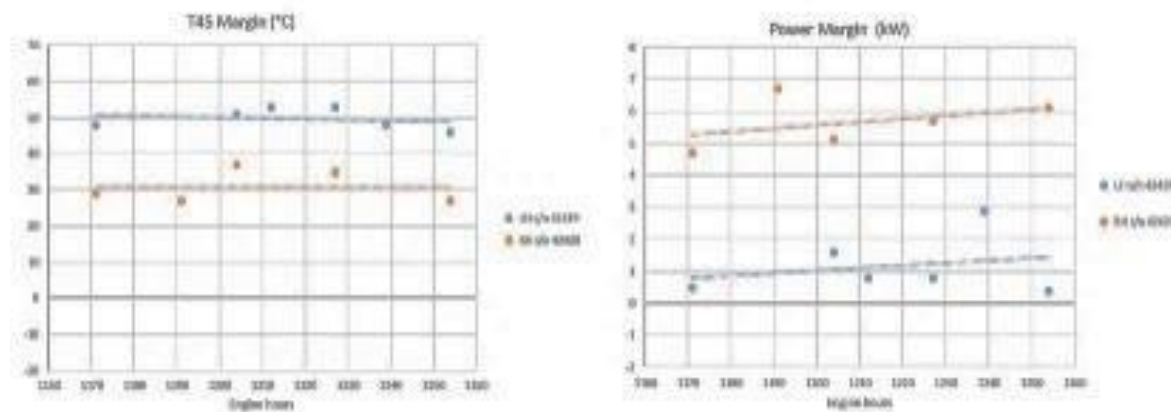
Fig:53 – Engine Power margin trend

One graph shows the T45 margin (shown in °C) and the other one shows the Power margin (shown in kW). Over the period, the trend for the T45 is observed to be stable and the trend for the Power margin is seen rising slightly. Both margins remain positive over the period.
